# Development of an Eco-Friendly, Cost-Effective Biogrout for Concrete Crack Repair

**Final Report**  
**September 2016**

**Sponsored by**  
Midwest Transportation Center  
U.S. Department of Transportation  
Office of the Assistant Secretary for  
Research and Technology

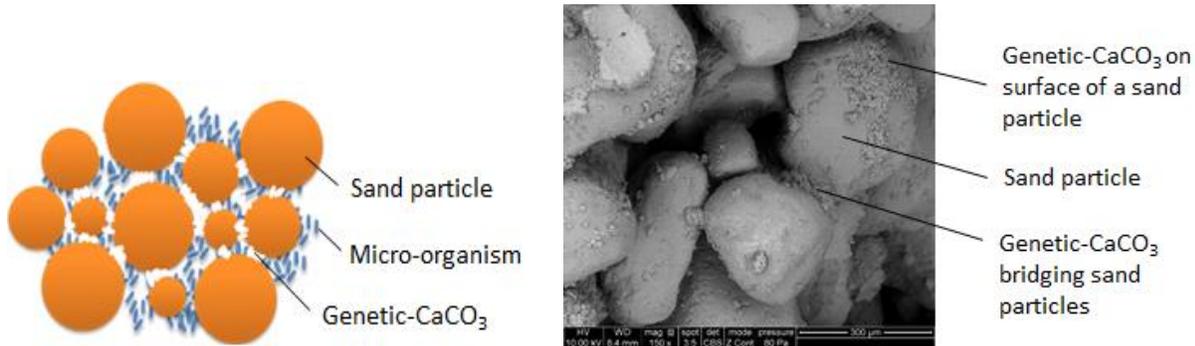
Figure 1 illustrates the concept of biocementation resulting from the MICP process.

**Figure 1. Concept of biocementation (left) and sample of biocemented sand (right) from MICP**

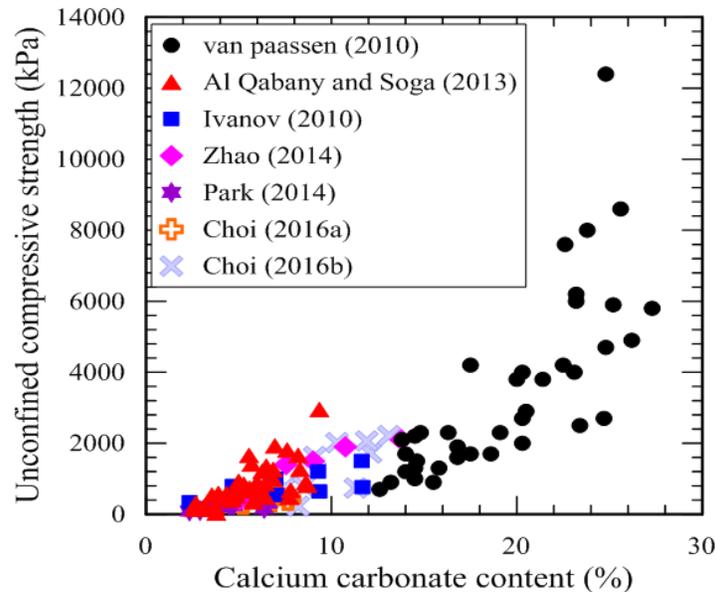
Figure 2 summarizes the relationship between  $\text{CaCO}_3$  content and UCS based on the results reported in the above reviewed literature.

**Figure 2. Effect of  $\text{CaCO}_3$  content on the UCS of MICP-treated sand**

As seen in Figure 2, the UCS of biocemented sand increases linearly with  $\text{CaCO}_3$  content when  $\text{CaCO}_3$  content is lower than 15% and increases exponentially when  $\text{CaCO}_3$  content is higher than 15%. This suggests that genetic  $\text{CaCO}_3$  content plays a very important role in the engineering properties of biocemented materials.

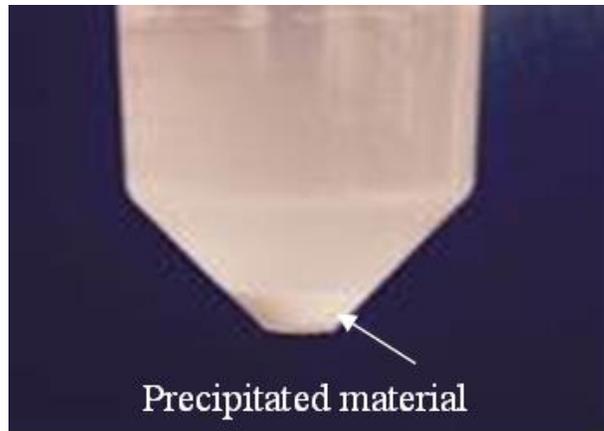
**Figure 3. Precipitated materials observed during MICP tests**

To evaluate the properties of the precipitated material, the precipitated material was filtered out and placed in a small container and oven dried at 115°C for 1 day. The dried precipitated material was then analyzed using x-ray diffraction (XRD). Figure 3 shows the precipitated material and Figure 4 shows the XRD result.

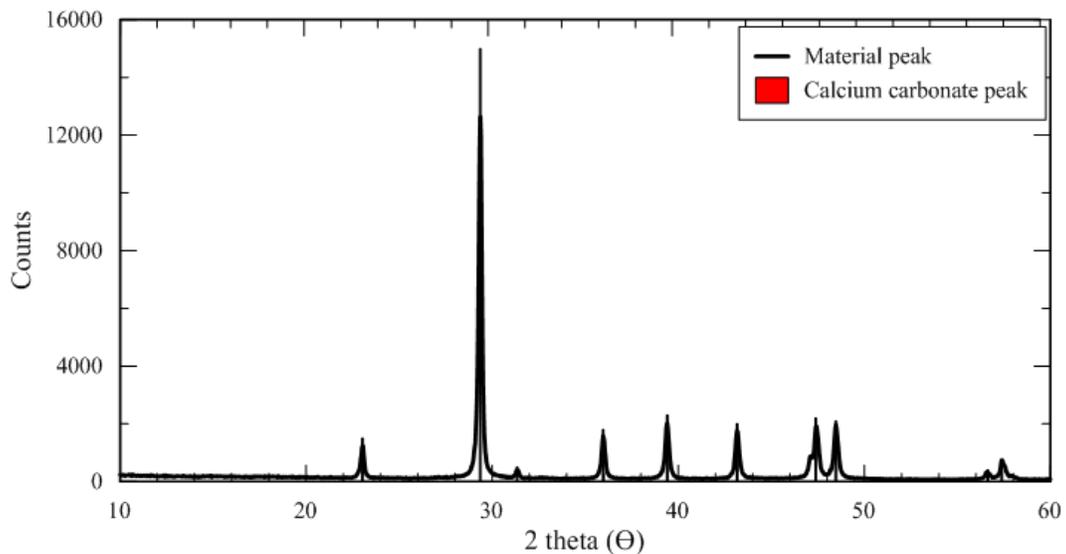
**Figure 4. XRD result of the precipitated material observed from the MICP using the calcium solution made from limestone powder and SF5**

It can be seen from Figure 4 that the XRD pattern of the precipitated material collected (black line) is overlapping with the XRD pattern of standard  $\text{CaCO}_3$  (red line). This confirmed that the precipitated material is  $\text{CaCO}_3$ .

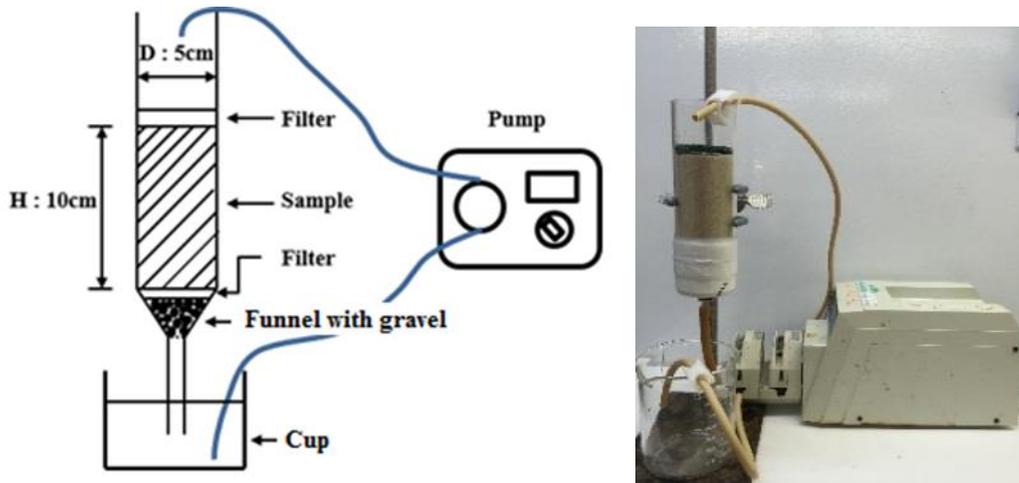
**Figure 5. Sketch of MICP test setup (left) and actual (right)**

To induce biocementation, a piece of 3M Scotch-Brite scouring pad was placed on each end of the sand samples as a filter. The samples, together with their plastic cylinder molds, were set on a funnel filled with gravel and held vertically with a sample holder. A cup was placed at the bottom of the sample to collect the solution as it penetrated through the sample (see Figure 5).

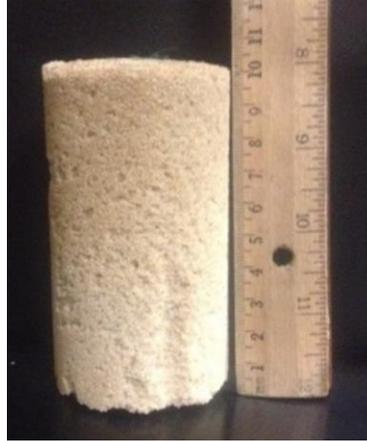
**Figure 6. Cemented sand after MICP treatment**

After 10 days of MICP treatment, the samples were washed with distilled water, the plastic cylinder molds were removed from the samples, and the samples were washed with water again. Figure 6 shows the cemented sample after washing.

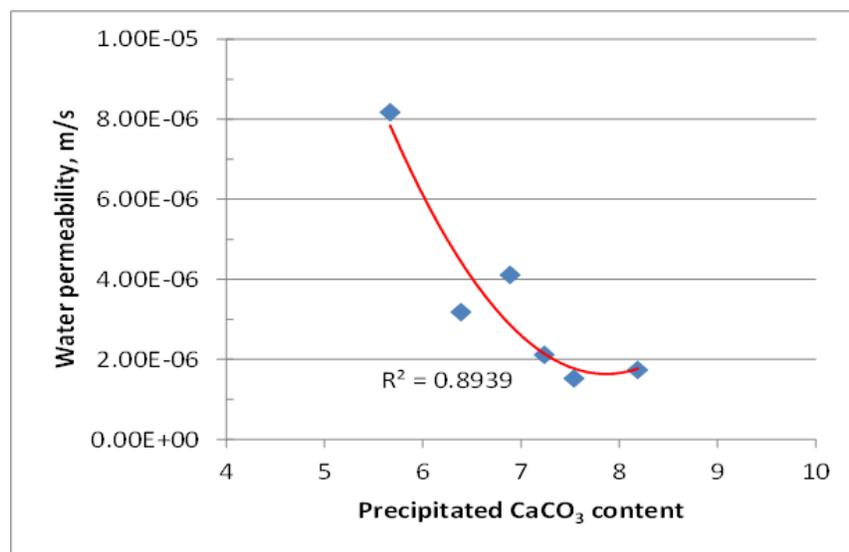
**Figure 7. Effect of CaCO<sub>3</sub> content on permeability of biocemented sand**

Permeability tests were performed on six sand cylinder samples before and after MICP tests. Before the MICP treatment, the permeability of the uncemented sand was approximately 1E-4 m/s. After the 10-day MICP treatment, the water permeability values of the biocemented sand ranged from 8.17E-6 to 1.52E-6 m/s, depending upon the CaCO<sub>3</sub> content of the samples. The CaCO<sub>3</sub> content of the samples ranged from 5.67 to 8.19%. As shown in Figure 7, permeability decreased with the CaCO<sub>3</sub> content of the samples, which is consistent with findings by other researchers (Chu et al. 2013 and Choi et al. 2016b).

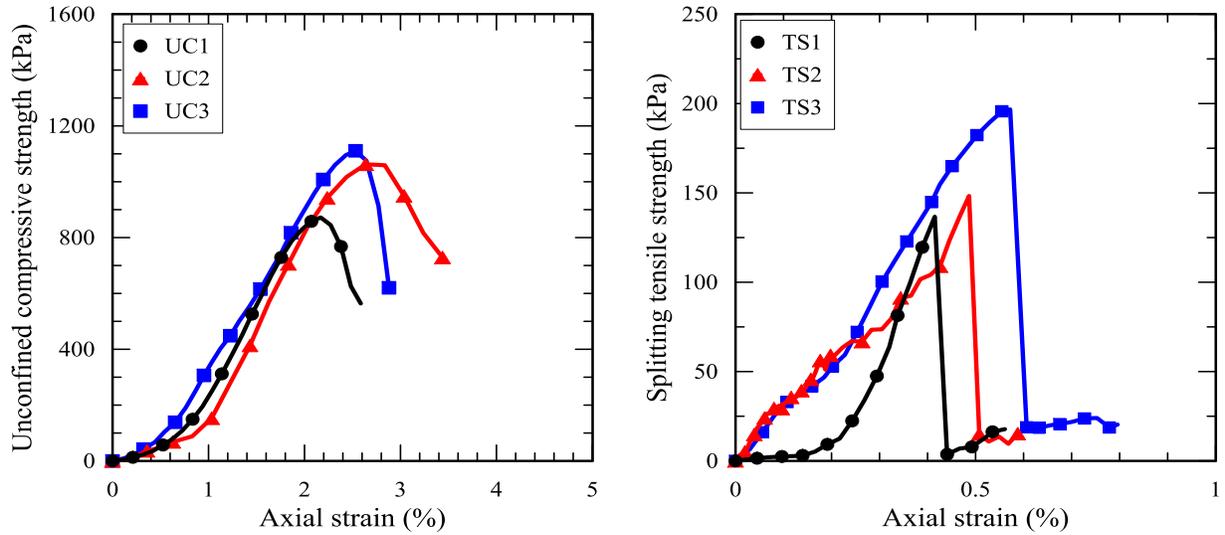
**Figure 8. Strain-stress relationships of biocemented sand showing UCS (left) and TS (right)**

The graph on the left in Figure 8 shows that, although treated under the same condition, the samples had different UCS. However, their stress-strain behavior is similar. As indicated earlier in Table 5, the elastic modulus of the three samples under compression was very close:  $E_{50}=38.3\pm 1.7$  MPa.

The graph on the right in Figure 8 shows that, under splitting tensile loading, three biocemented samples had different strength and stress-strain behavior. As indicated earlier in Table 5, the variation in the elastic modulus of the three samples under tension was relatively larger ( $E_{50}=24.3\pm 2.7$  Mpa). The measured UCS and TS ranged from 858 to 1,111 kPa and from 137 to 197 kPa, respectively. These strength values are comparable with those obtained from the biocementation using  $\text{CaCl}_2$  as a source of soluble calcium solution. For example, Al Qabany and Soga (2013) reported a UCS range of 500 to 1300 kPa obtained from biocemented sand with 4.0 to 6.5% of  $\text{CaCO}_3$  content made with 0.25 M of urea and  $\text{CaCl}_2$  solution.

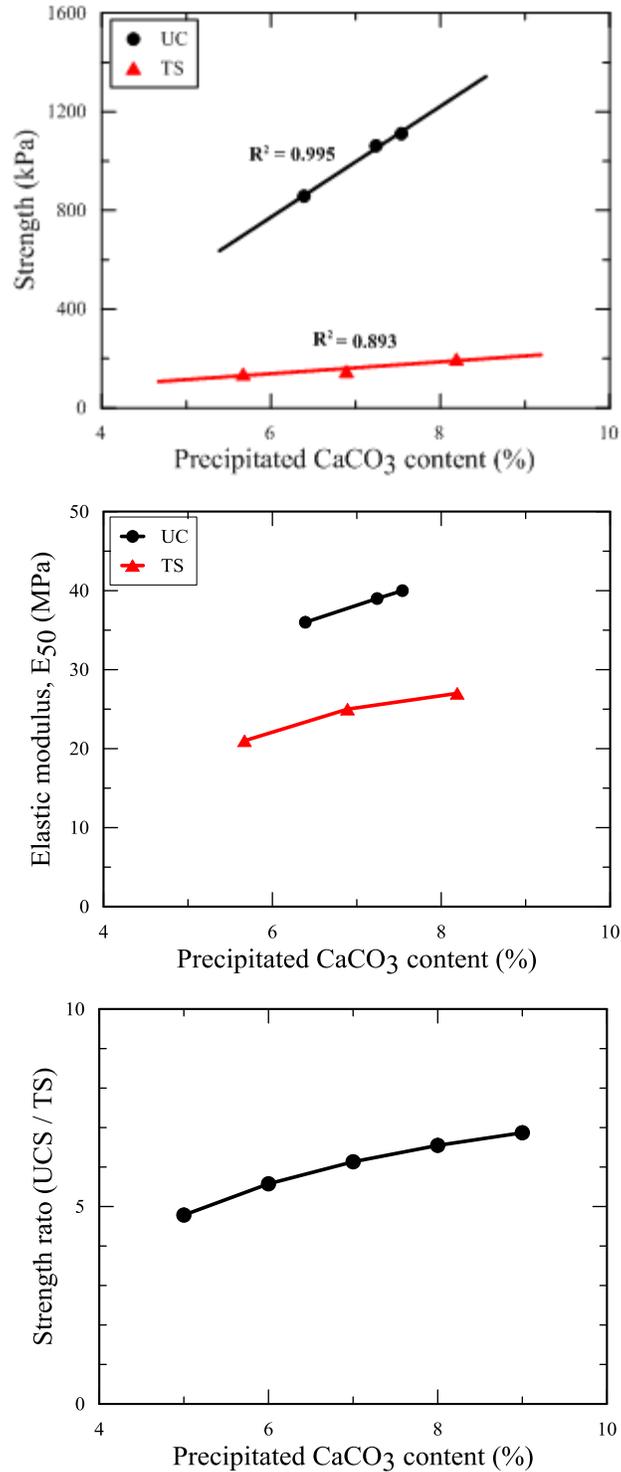
**Figure 9. Physio-mechanical properties of biocemented sand showing UCS (top), TS (middle), and UCS/TS ratio (bottom)**

Figure 9 illustrates the relationships between mechanical properties (UCS, TS, and  $E_{50}$ ) and the  $\text{CaCO}_3$  content of the samples tested in the present study.

The top graph in Figure 9 shows that both UCS and TS increased linearly with CaCO<sub>3</sub> content, which is also consistent with previous studies (Park et al. 2014, Whiffin et al. 2007, and Al

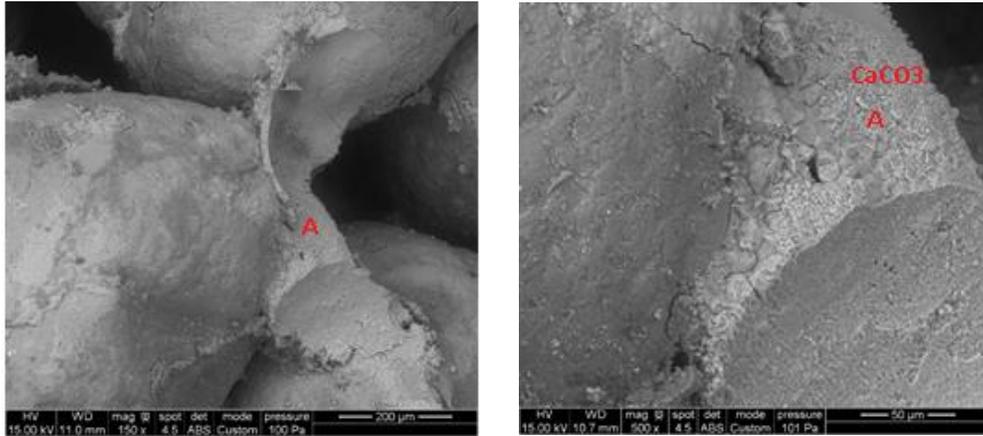
**Figure 10. Biocemented sand with two sand particles connected by  $\text{CaCO}_3$  (left) and cubic shaped  $\text{CaCO}_3$  (right) under a SEM**

After UCS tests, small pieces of biocemented sand were examined under a SEM. Figure 10 shows the images from the SEM study.

The figure shows that, after the biotreatment, most of the sand particle surfaces were covered with  $\text{CaCO}_3$ , which provided a strong bond to cement the sand particle together. In addition, clusters of  $\text{CaCO}_3$  were observed, which filled the spaces between the sand particles and bridged the particles together. Such microstructure images of the biocemented sand samples further confirm the mechanisms of biocementation (Al Qabany et al. 2013 and Zhao et al. 2014).

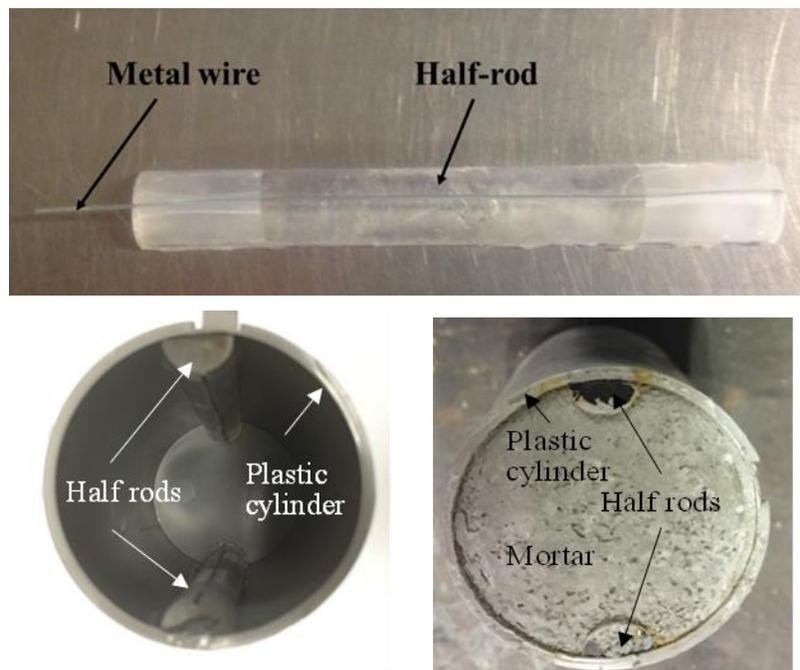
**Figure 11. Preparation of cylinder mold for mortar sample casting: metal wires attached on half rods (top), half rods in cylinder mold (left), and half rods in cast mortar sample (right)**

In order to make a single straight crack in the mortar sample, two half rods (12.5 mm in diameter and 10.16 cm in length), attached with a thin metal wire (0.75 mm in diameter) on the tips, were glued to the end of the cylinder mold (see Figure 11).

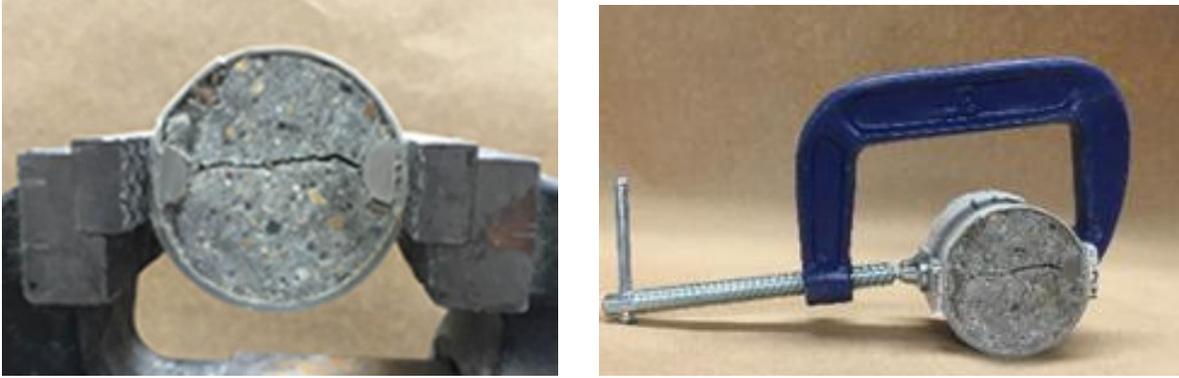
**Figure 12. Making a crack in a mortar sample by splitting mortar using a super clamp (left) and then holding crack width using a small clamp (right)**

After mortar samples were cast and cured for 21 days, 25 cm discs were cut from each end of a mortar sample, and the middle section of the sample was cut again to make two short cylinder samples (5 cm in diameter and 4 cm in height). Each of these small cylinder mortar samples (5 cm x 4 cm), with its plastic mold on, was placed in a super clamp as shown in Figure 12. Through clamping, a force was applied to split the sample slowly and make a designed crack width. The cracked mortar sample was then transferred into a small clamp so as to keep the crack open (see image on the right in Figure 12).

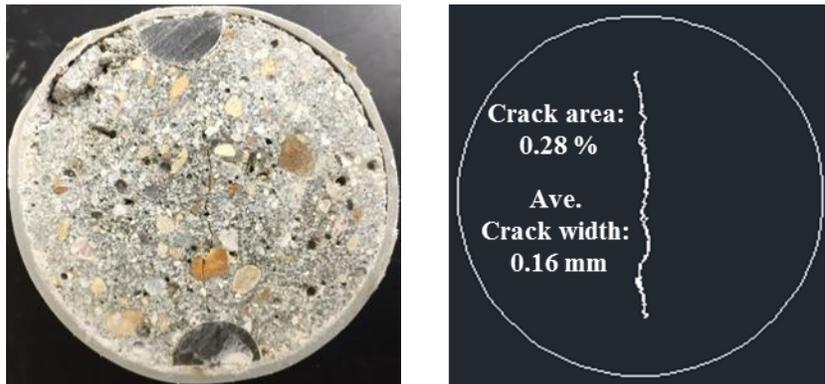
**Figure 13. Crack in a mortar sample captured by camera (left) and crack retrieved by CAD software (right)**

After 7 days, the small clamps were removed from the cracked mortar samples, and the crack feature of each mortar sample was examined. To examine cracks, a photo was taken from each end of a cracked sample using a camera (see image on the left in Figure 13). The file of the photo was then inputted into the CAD software, or computer-aided design and drafting (CADD), computer program, which highlighted the crack features and computed crack area and crack widths (see image on the right in Figure 13).

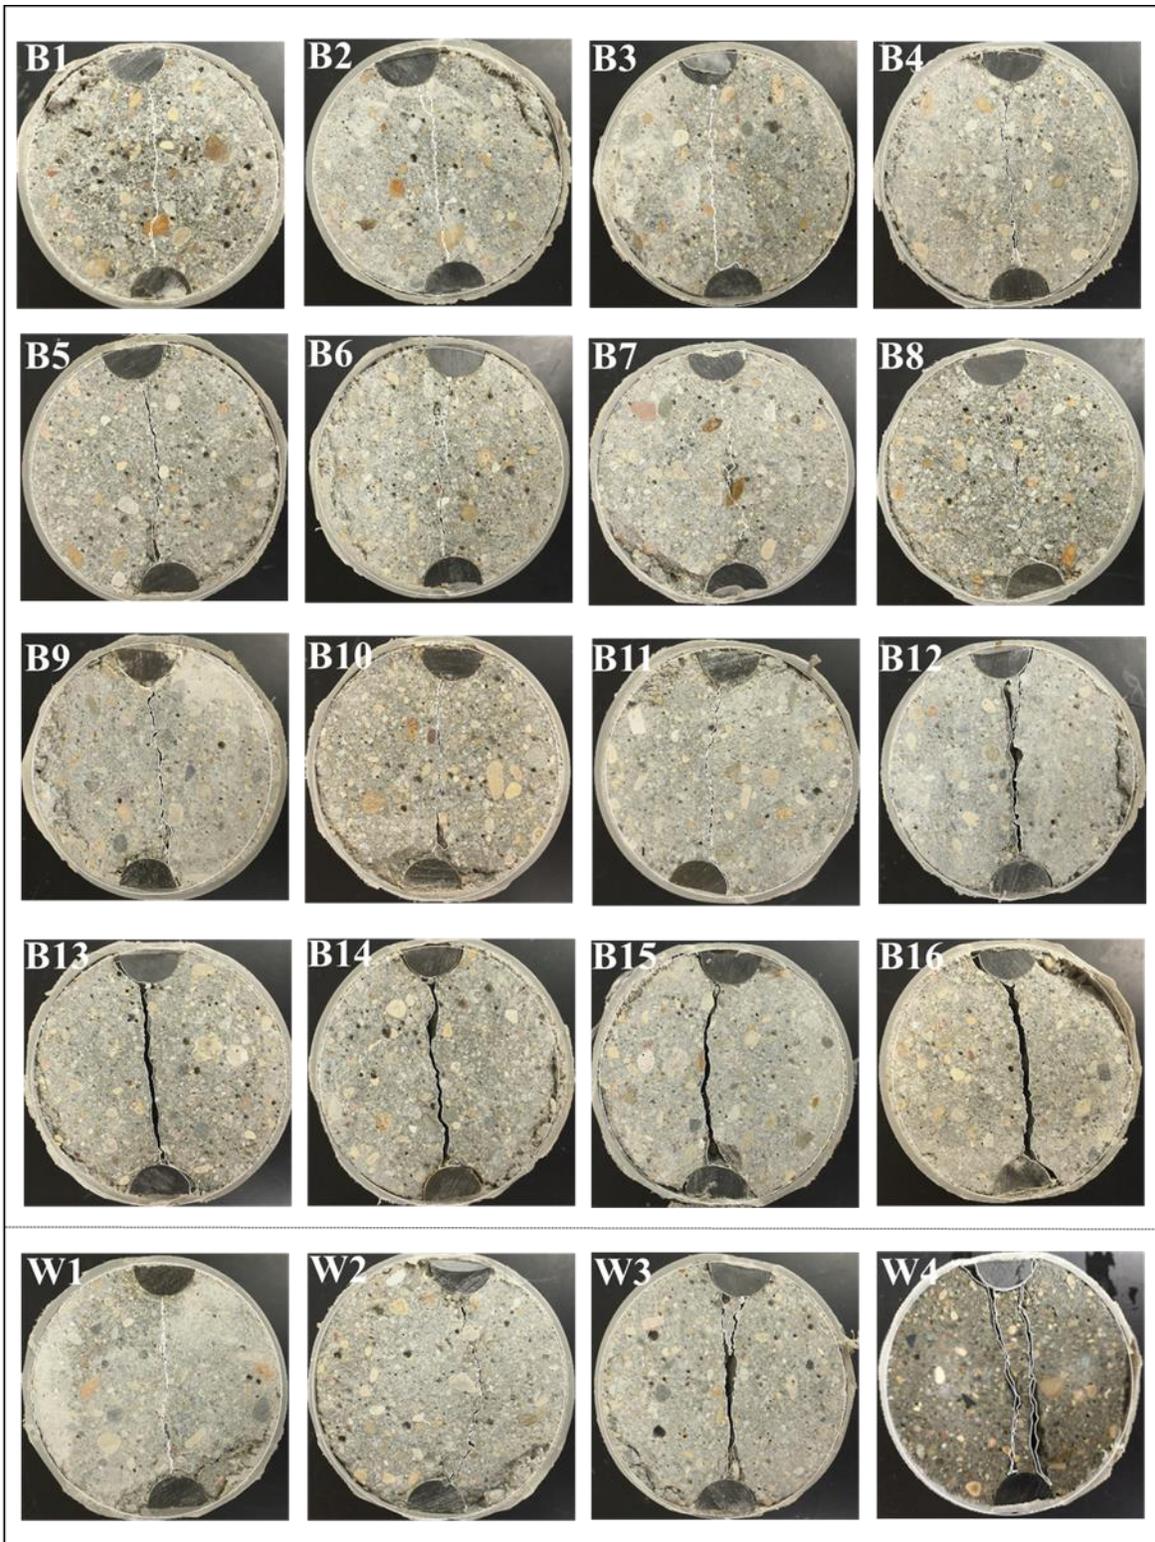
**Figure 14. Top surface of mortar samples with different crack sizes**

Figure 14 illustrates the cross sections of the 20 cracked mortar samples, and Figure 15 highlights the features of the cracks captured by CAD for the samples listed in Figure 14.

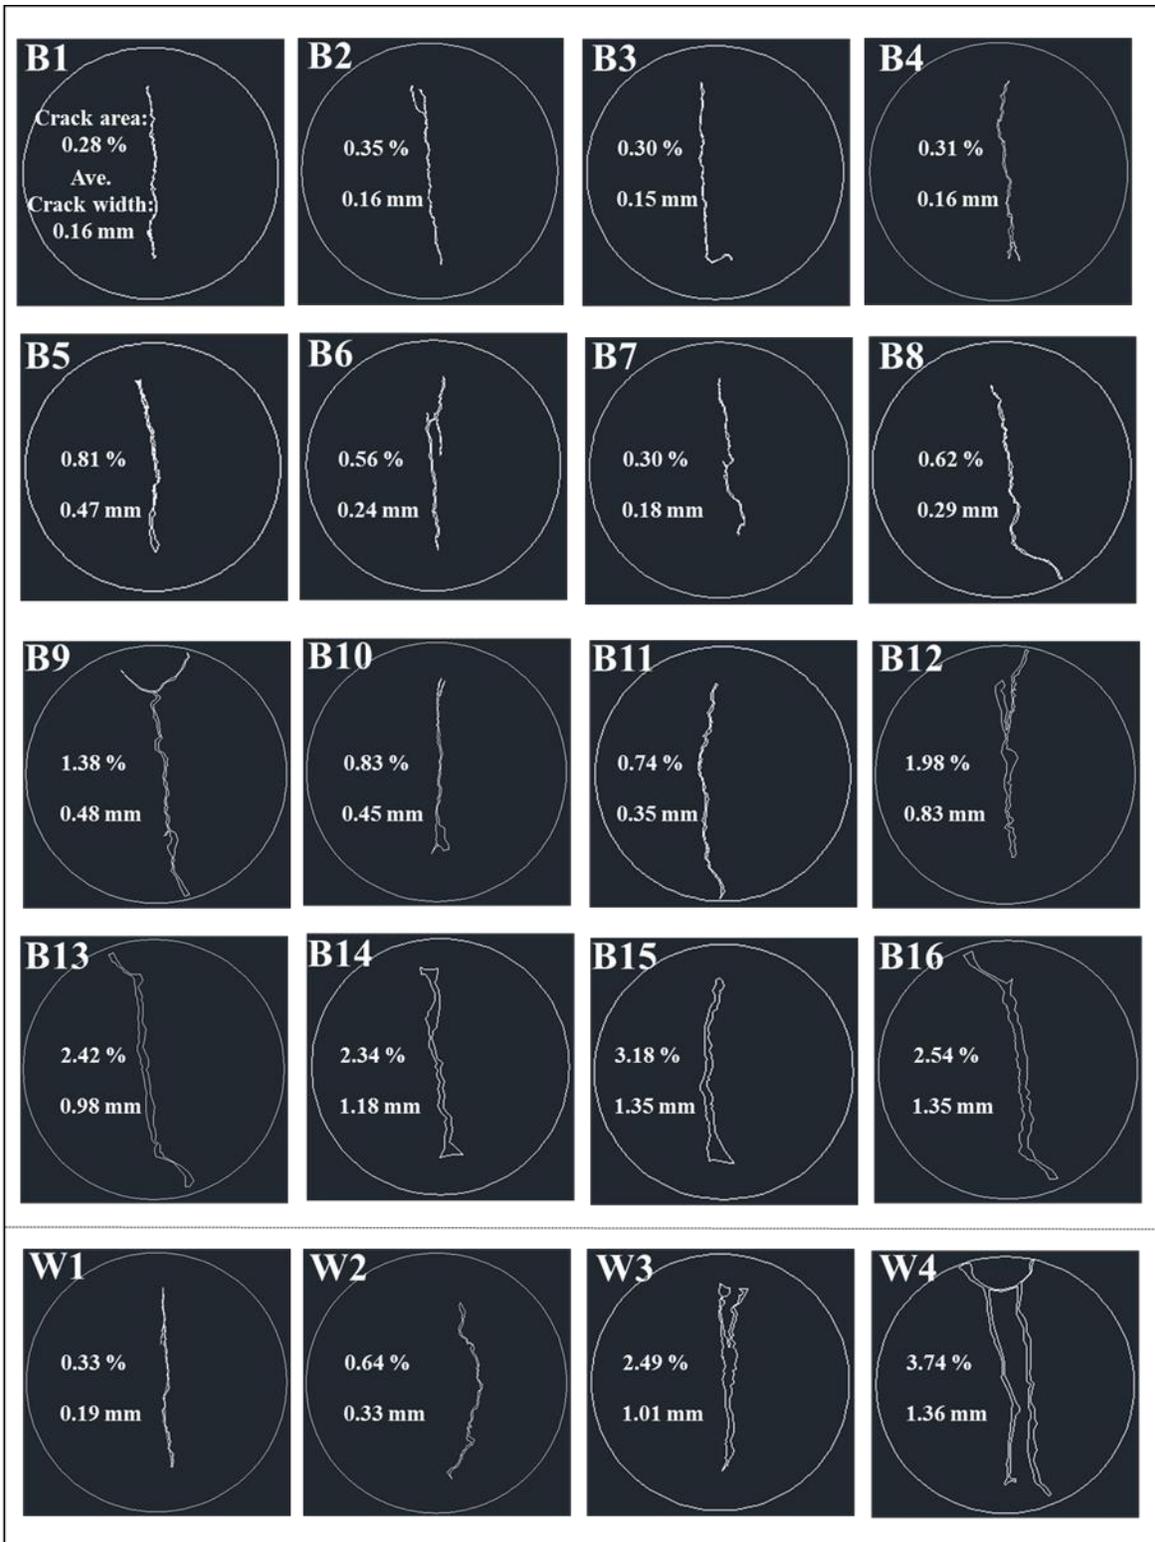
Figure 15. Top surface of mortar samples with different crack sizes captured by CAD software

In Figure 15, the crack area was expressed as a percentage of the total cross-section area of a sample:

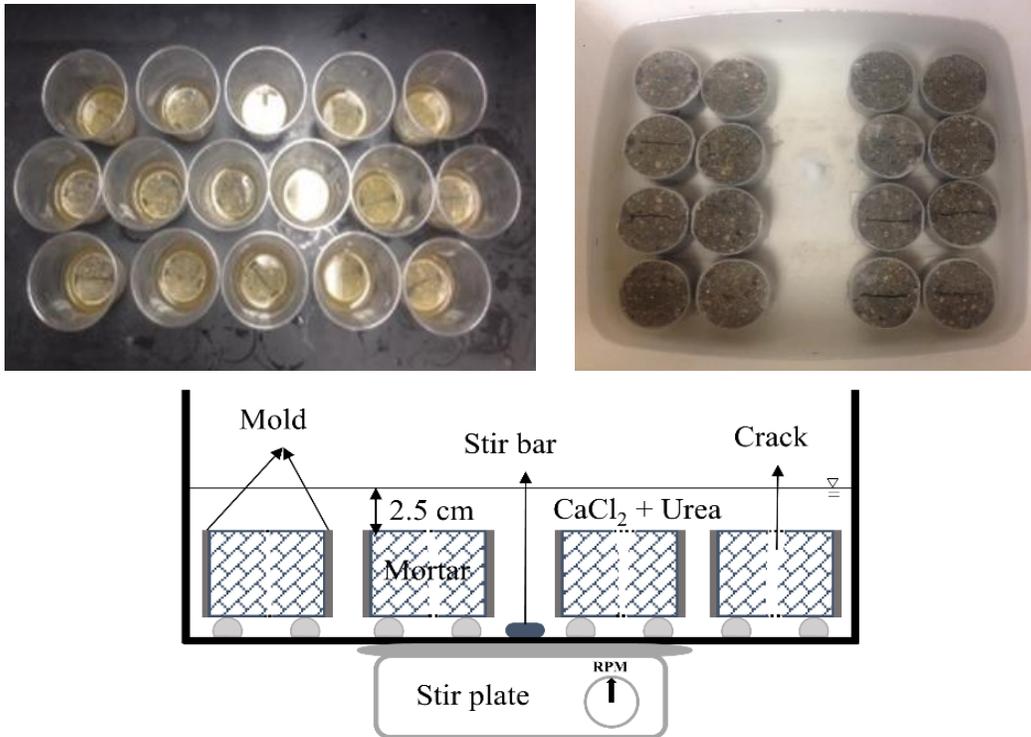
**Figure 16. Process of crack repair using the MICP method: Samples in UPB solution (upper left), samples in urea-CaCl<sub>2</sub> solution (upper right), and process sketch (bottom)**

The above steps 1 through 4 were considered as one cycle treatment, which took one day to complete. See Figure 16 for a visual representation of the entire process.

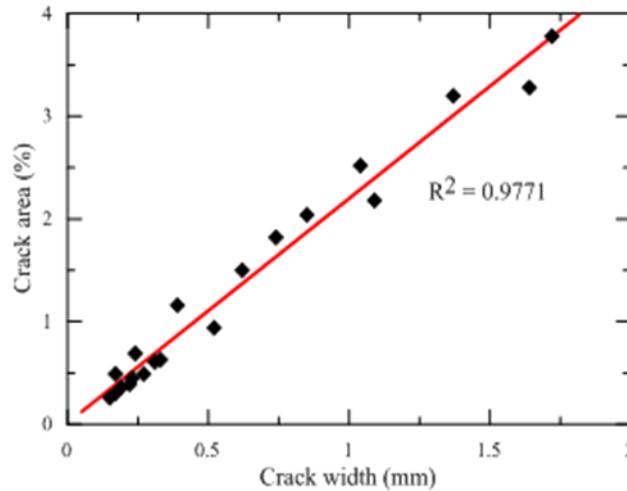
**Figure 17. Relationship between the crack width and crack area of mortar samples**

Figure 17 shows a strong linear relationship between the crack width and area of the repaired samples. Therefore, the average crack width was used as the representative crack size for the data analysis of the present study.

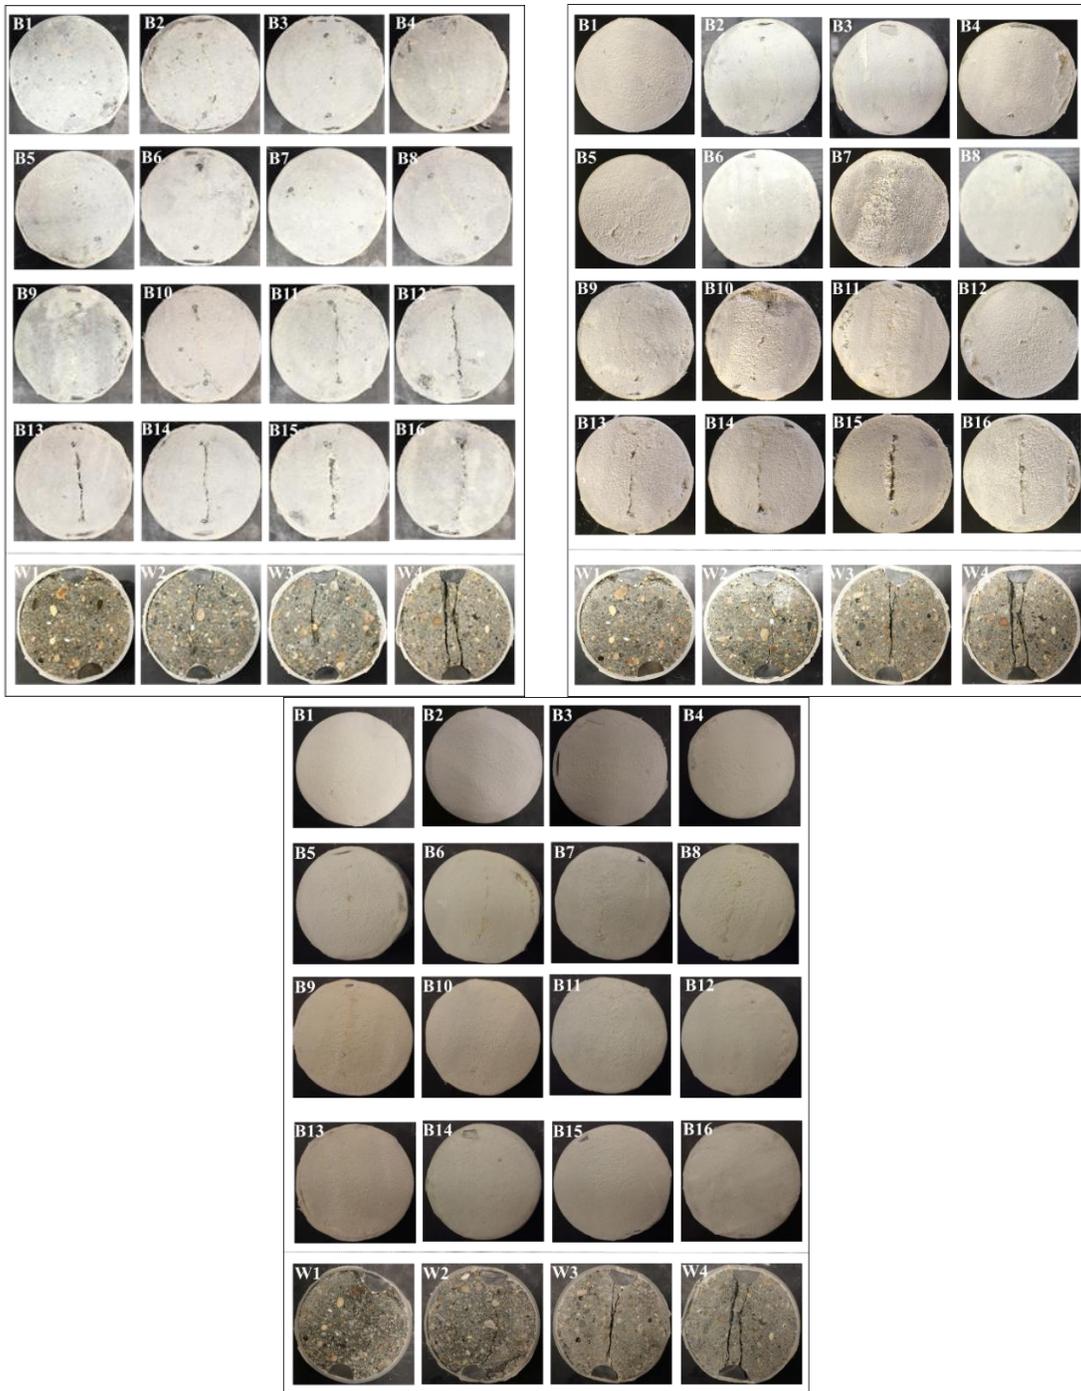
**Figure 18. Cracks in mortar samples after 7 cycles (left), 14 cycles (right), and 21 cycles (bottom) of MICP treatment**

Differently, there was little significant crack healing in samples soaked in distilled water. The surfaces of these water treated mortar samples showed clearly the cement paste and sand particles.

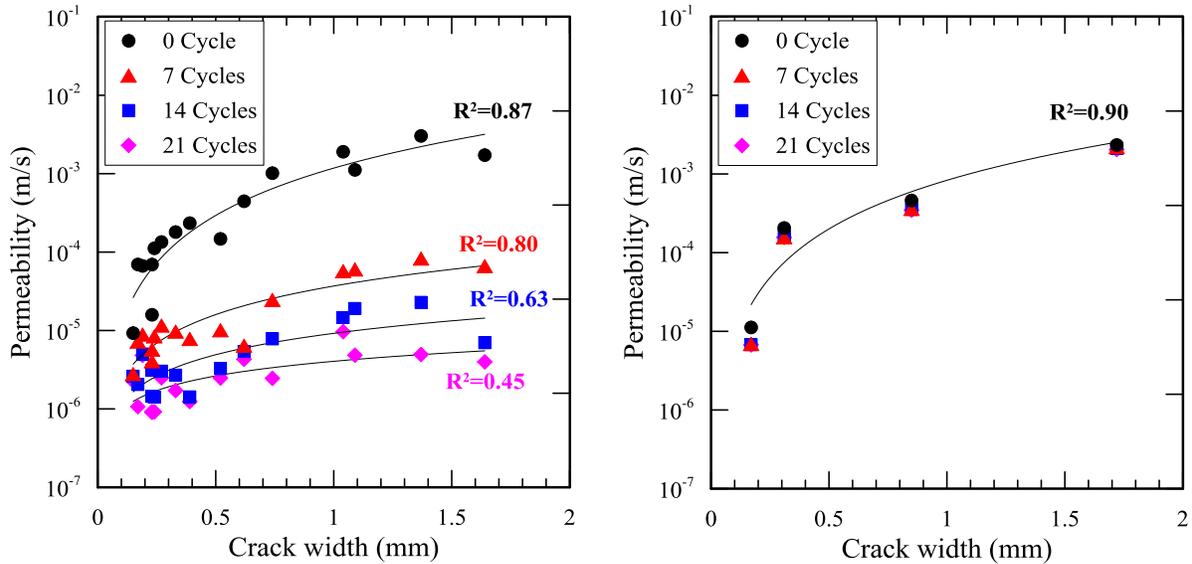
**Figure 19. Effect of initial crack size on permeability of mortar samples after MICP treatment (left) and water treatment (right)**

Figure 19 illustrates water permeability of cracked mortar samples subjected to different cycles of MICP and water treatment.

The graph on the left generally shows permeability of the mortar samples polynomial increased with their average crack widths. As the initial crack width was about 2 mm, the mortar without treatment had a permeability value of about  $8.0E-5$ , which is consistent with measurements by other researchers (Wang et al. 1997 and Van Tittelboom et al. 2010).

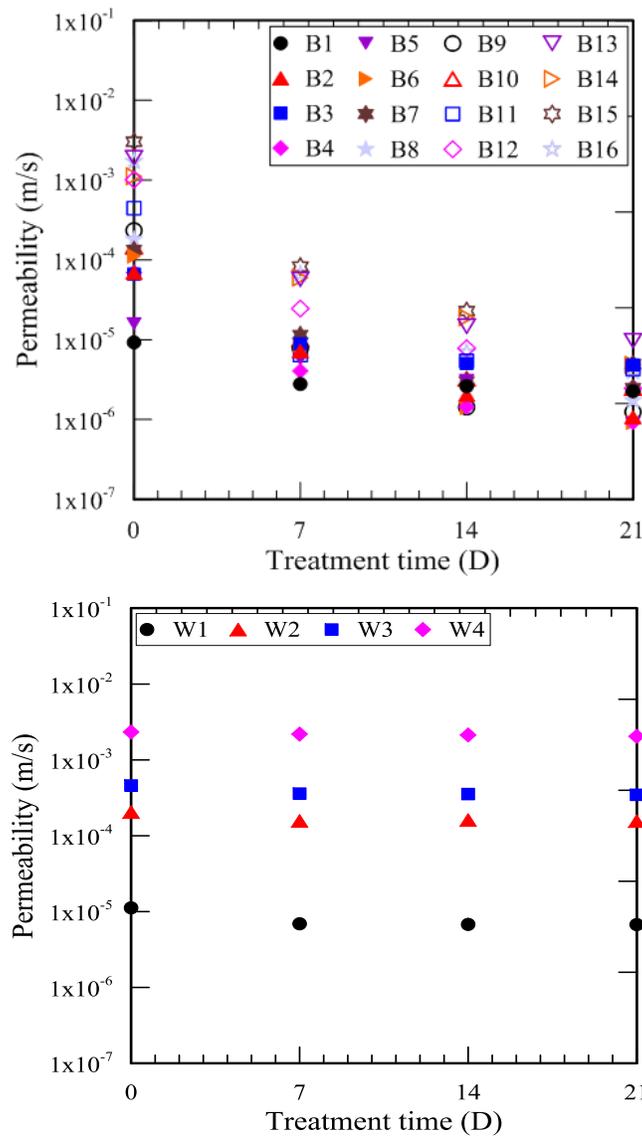
**Figure 20. Relationship between permeability and cycles time during MICP treatment (top) and water treatment (bottom)**

Figure 20 shows the effect of treatment time (in cycles) on the permeability of each sample studied.

For samples treated with MICP, permeability significantly decreased with the number of treatment cycles. The permeability decreased more rapidly during the first 7 cycles and then decreased relatively slowly. The permeability of samples with large cracks tended to decrease more rapidly than that of samples with small cracks. As discussed previously, the permeability of the sample treated with water had little change during the first 7 cycles and kept unchanged further after.

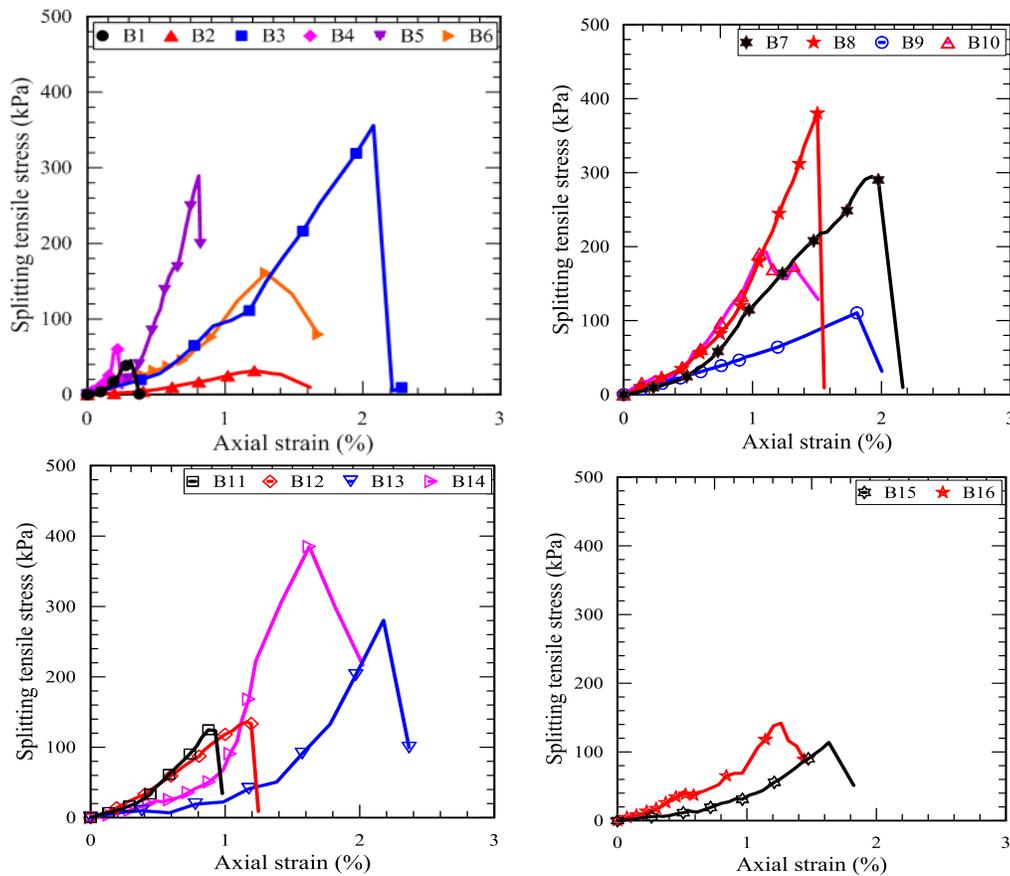
**Figure 21. Splitting stress-strain curves of repaired samples with different crack sizes: average crack width < 0.25 mm (top left), average crack width = 0.25-0.52 mm (top right), average crack width = 0.62-1.09 mm (bottom left), and average crack width > 1.09 mm**

Figure 21 shows the stress-strain curve obtained from TS tests of the MICP treated samples with different crack widths.

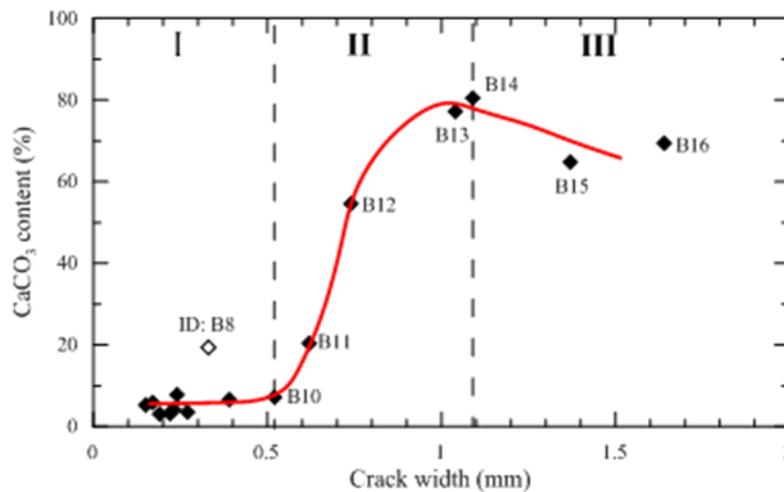
**Figure 22. Relationship between crack width and precipitated  $\text{CaCO}_3$  content**

Figure 22 shows the relationship between crack width and precipitated  $\text{CaCO}_3$  content on the crack surface.

In Region I (average crack width  $<0.52$  mm),  $\text{CaCO}_3$  content on the crack surface was very low and fluctuated around 5% (varying from 3.2 to 7.8%). This suggested that only a small amount of the chemical and bacteria solutions got into those small cracks and performed the MICP process there. In Region II ( $0.52$  mm  $\leq$  average crack width  $\leq 1.1$  mm),  $\text{CaCO}_3$  content on the crack surface increased with the crack width (up to approximately 80%). This indicated that MICP was more effective for cracks within this size range. In Region III (average crack width  $>1.1$  mm),  $\text{CaCO}_3$  content on the crack surface started decreasing slightly with the crack width.

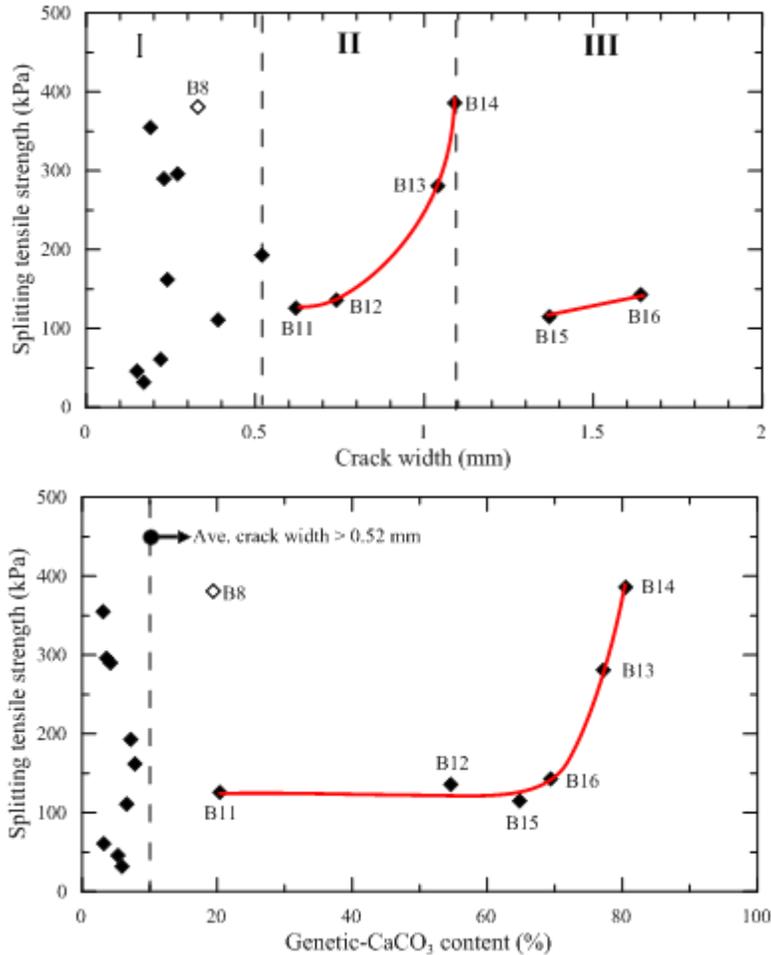
**Figure 23. Relationship between tensile strength and CaCO<sub>3</sub> content (top) and initial average crack width (bottom)**

Figure 23 shows the relationship between TS and precipitated  $\text{CaCO}_3$  content/initial average crack width.

The top graph in Figure 23 shows that in the small crack region (Region I), some samples regain relatively high TS (up to 386 kPa) while others had very low TS (32 kPa) after the MICP repair. This might happen for several reasons: (1) some samples might not split totally, and their uncracked portion might carry some loads during the splitting tests; (2) since the crack widths of the samples were very small, or their two cracked surfaces are close together, a little precipitated CaCO<sub>3</sub> in the cracks might generate a high adhesion on the cracked surfaces, which helped the splitting resistance; and (3) after a few MICP cycles, the precipitated CaCO<sub>3</sub> quickly sealed the small crack on the top of the cylinder samples and prevented UPB and urea/CaCl<sub>2</sub> solutions from easily penetrating into the internal cracks, thus increasing the variation in the effectiveness of the MICP repair, which resulted in inconsistent TS test results. In the large crack region (Region III), the TS of the MICP-repaired samples were relatively low, probably due to the insufficient CaCO<sub>3</sub> bridging the cracks. It appeared that MICP was more efficient for repair of mortar cracks with a size ranging from 0.5 to 1.1 mm (Region II).

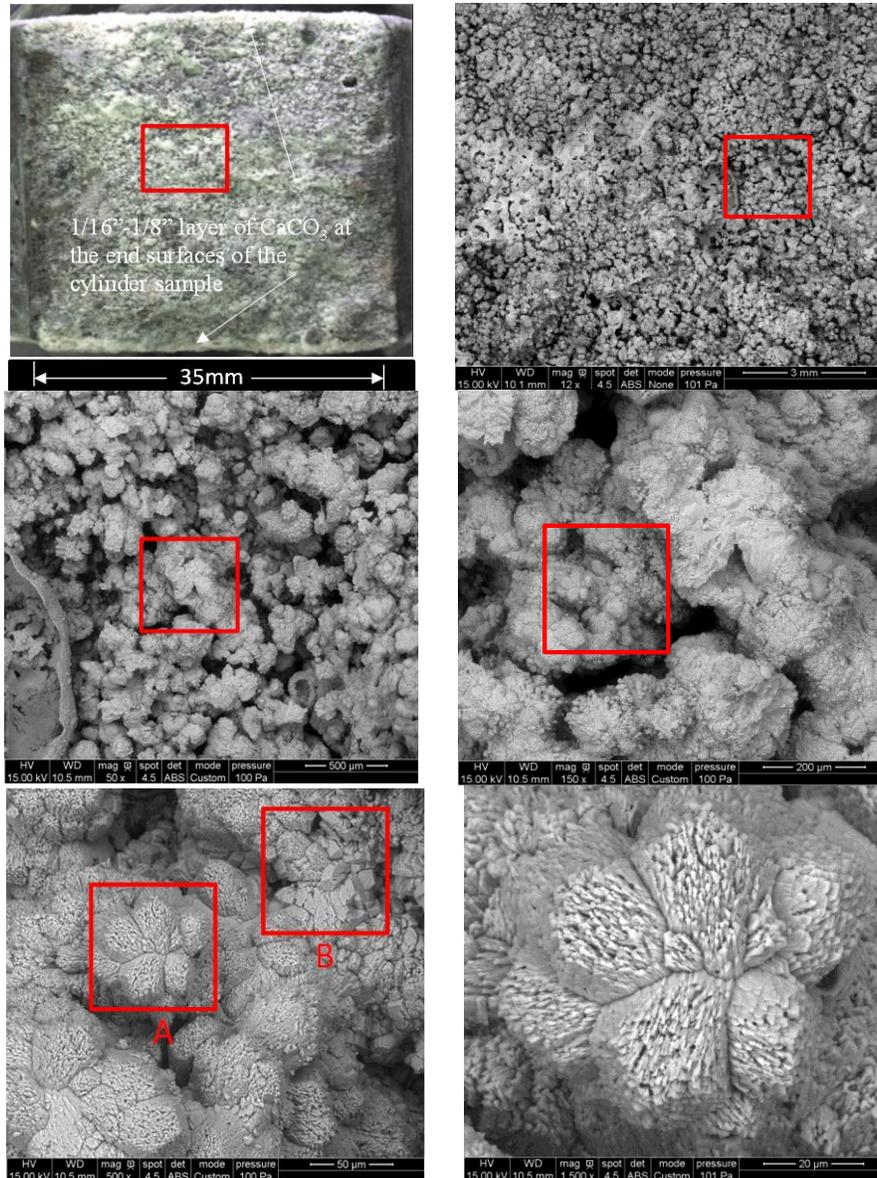
**Figure 24. Precipitated  $\text{CaCO}_3$  on the cracked surface of mortar sample B14: crack surface of the split sample (top left), 12X magnification of the crack surface (top right), 50X magnification (middle left), 150X magnification (middle right), 500X magnification (bottom left), and 1,500X magnification (bottom right)**

After the TS tests, the samples were examined under a SEM, and the distribution and morphology of the precipitated  $\text{CaCO}_3$  on the surfaces of the sample cracks were observed. Figure 24 shows images of one sample surface (ID B14).

The top left image in Figure 24 shows that after being subjected to the MICP treatment for 21 cycles, the end surfaces of the cylinder sample were covered with a 1/16 in. to 1/8 in. layer of precipitated  $\text{CaCO}_3$ , which might have served as the front line for resisting water penetration. However, the top right and middle left images in Figure 24 show the growth and distribution of precipitated  $\text{CaCO}_3$  on the cracked mortar surface. It appeared that precipitated  $\text{CaCO}_3$  was relatively uniformly distributed on the crack surfaces, and it formed a porous matrix at a microscale. The middle right, bottom left, and bottom right images in Figure 24 show the structure and texture of the precipitated  $\text{CaCO}_3$ . It can be observed in Figure 13 that there were two different  $\text{CaCO}_3$  formations in the crack of sample B14: one was the flower-shaped clusters made with many well-arranged thin (or plate/sheet-like) hexagon  $\text{CaCO}_3$  and the other was the granular clusters of thick (or coarse) hexagon-shaped  $\text{CaCO}_3$  at multiple scales, which was also observed in the cracks of other MICP-repaired mortar samples (see Figure 25).

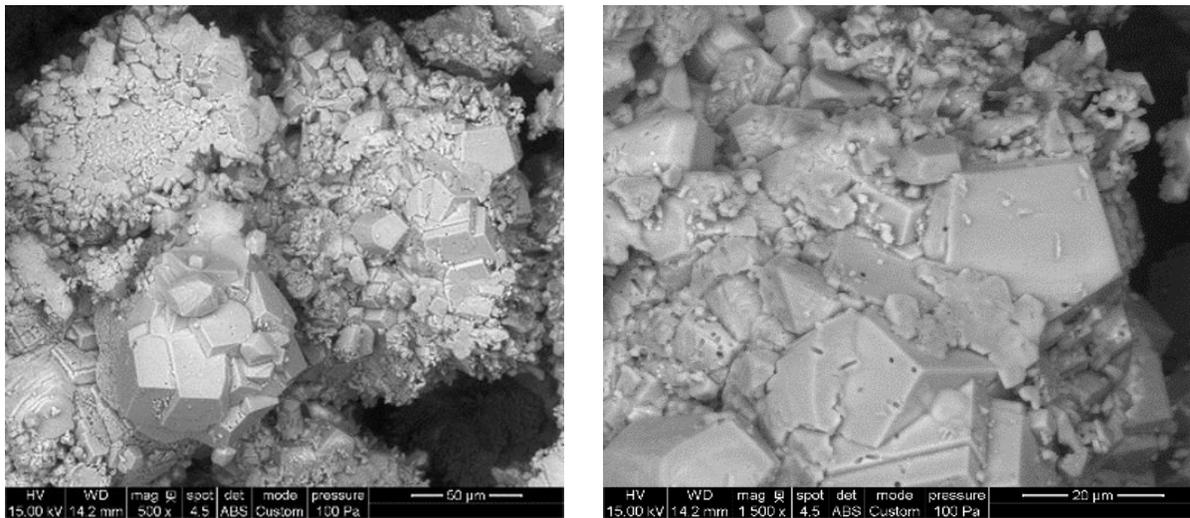
**Figure 25. Coarse hexagon-shaped  $\text{CaCO}_3$  observed on the cracked surface of sample B15 at 500 times the actual size (left) and at 1,500 times the actual size (right)**

Research has indicated that the precipitated material during a MICP process involving UPB and  $\text{CaCl}_2$  solutions are often coarse hexagon-shaped  $\text{CaCO}_3$ , or calcite (Abo-El-Enein et al. 2012 and Choi et al. 2016b), which is a thermodynamically stable form of  $\text{CaCO}_3$  under normal conditions. Generally, a smaller size (less than  $10\ \mu\text{m}$ ) of calcite provides better strength for the biocemented materials (Choi et al. 2016b). In the present study, the precipitated  $\text{CaCO}_3$  was also in a calcite form and had a size ranging from  $5$  to  $20\ \mu\text{m}$ , which was similar to samples observed by Al Qabany and Soga (2013). The sheet-like, thin hexagon-shaped  $\text{CaCO}_3$ , as observed in Figure 24 might be vaterite. Vaterite is a metastable phase of  $\text{CaCO}_3$ , and it might convert to calcite after being exposed to water. Further study is needed to find out why different forms of  $\text{CaCO}_3$  were observed in a given sample.
