Investigation of Deterioration of Joints in
Concrete Pavements

Conclusions from the Investigation of Deterioration of Joints in Concrete Pavements

tech transfer summary

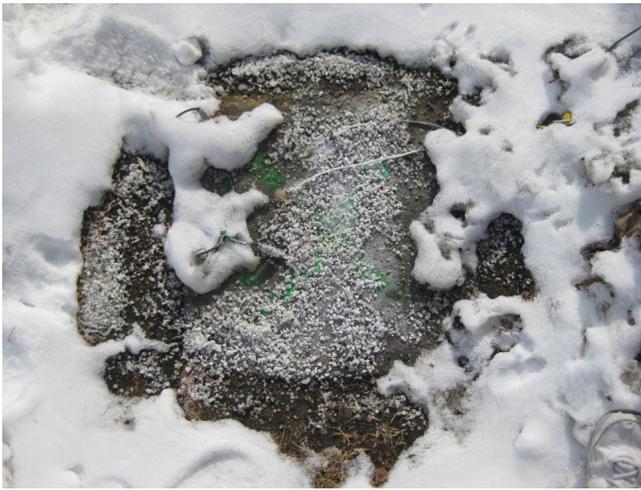
Instrumented slab buried in the ground during a snow event, showing sodium chloride applied

This test examined the influence of the environment on concrete internal temperature and relative humidity. An instrumented concrete slab, 20 × 20 × 8 inches, was built using a typical concrete pavement mixture containing 20 percent fly ash.

The slab was cast in early October, moist-cured for two weeks, placed in a freezer for one month, and then placed into the ground. Sodium chloride was applied to the top of the slab during snow events. Temperature data were recorded.

- The temperature at the bottom of the slab did not fluctuate as markedly as the top surface. During one of the greatest temperature swings, the difference between the top and bottom of the slab never exceeded about 8°F.
- The edge of the slab showed higher temperature differentials, likely because the soil at the edge of the slab was not thoroughly compacted and thus acted as a better conductor of heat than the concrete. This is also likely true of the interior of a sawn joint.

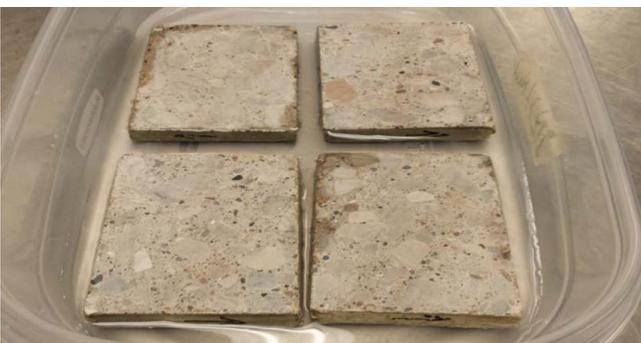
Samples partially immersed in testing solution

The beams were cured in a fog room for 28 days and then cut into 1/2 inch thick slices. The slices were partially immersed in either water, 3 percent sodium chloride (NaCl), or 3 percent magnesium chloride (MgCl₂) at a constant 40°F for 56 days. After 56 days, the slices were cut into two halves to examine the effects of the solutions through the thickness of the samples.

- Exposure to water and NaCl above freezing temperatures results in negligible distress.
- The failure mechanism in MgCl₂ does not appear to be related to freezing/thawing of water, salt crystallization, or dissolution of the interfacial transition zone.
- The paste appears to expand in the presence of MgCl₂ and thus becomes debonded from the coarse aggregate particles that are not expanding. The mechanism of expansion is likely the formation of calcium oxychloride (Ca(OCl)₂) in the paste.

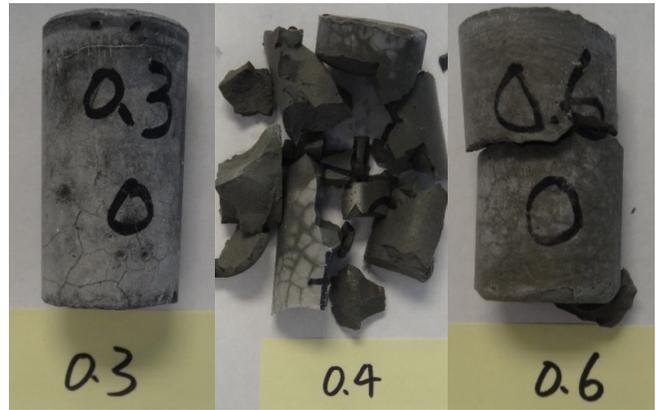
Oven-dried paste samples with different w/cm ratios after one freeze-thaw cycle

Paste samples were cured in sealed containers for 24 hours after mixing while being continually rotated. Samples were kept in sealed bottles for 7 days at 75°F before a cyclic freeze-thaw test. The lids were then removed, and the oven-dried samples were kept in an oven at 122°F until constant mass was achieved.

Samples were then sent for mercury intrusion porosimetry testing. Paste samples prepared from the same mixtures were also subjected to freeze-thaw cycles following the same preparation and curing procedures. The dried samples were placed in a freezer at 0°F (18°C) for 12 hours and thawed to 70°F (21°C).

- Increasing the w/cm ratio increases the total porosity and pore sizes of the hardened cement paste. Notably, the peak pore sizes in the lower w/cm ratio mixtures were within the range considered to be problematic based on the mixtures' abilities to allow water to evaporate.
- The high w/cm mixture had similar peaks in the fine zone but had a far larger peak on the coarse side, likely meaning that water is able to enter and leave the system readily, which allows the system to dry out enough to avoid freezing-related distress. This does not justify choosing mixtures with high w/cm ratios but does mean that systems with a w/cm ratio of about 0.4 have to be protected by other means.

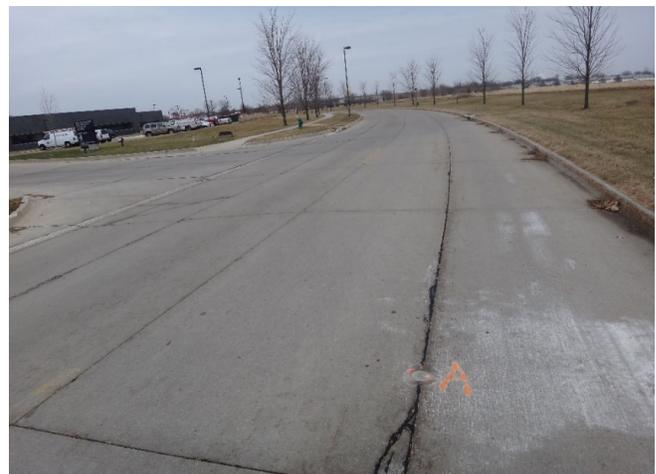
Joint distress on a city street in Ames, Iowa

This test examined the relationship between pavement performance and the permeability of subsurface layers. Field tests were conducted on a city street in Ames, Iowa, which had been paved in 1997 in one day using a full-width slipform paver. Joint sealing details and the extent of the pavement's distress were mapped.

Five cores were extracted over two years, with cores from a sound joint and a distressed joint sent for petrographic examination. Field borehole permeameter tests were also conducted. The influence of freezing on the moist base material's permeability was then evaluated in the laboratory.

- The results of the field borehole permeameter tests indicate that a low-permeability subsurface layer may correlate with joint deterioration under freezing conditions.
- The laboratory falling head permeability tests show that permeability decreases as moisture content increases and that freezing of the moist base material significantly reduces permeability.

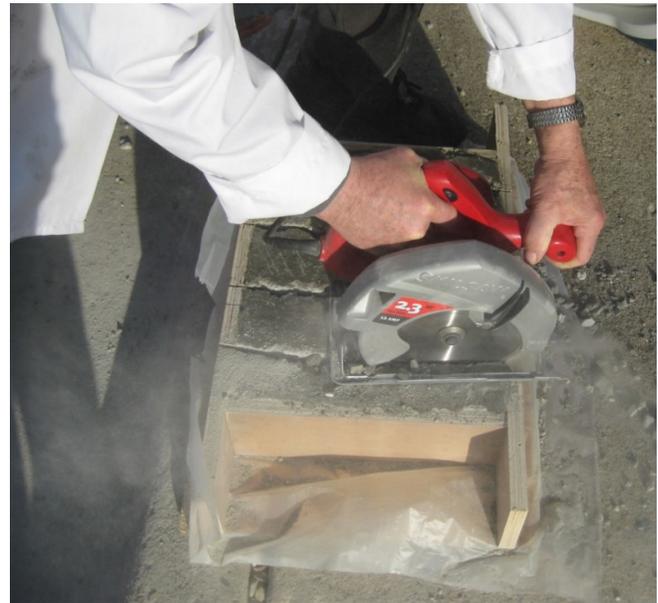
Saw cutting a test slab using poor practices

This test assessed whether sawing practice influences joint damage. A 12 × 18 × 4 inch slab was cast outdoors using a standard paving mixture. A handheld saw fitted with a diamond blade was used to dry-cut joints in the slab starting too early, causing extreme raveling. The operator was asked to push hard on the blade and to induce a curve to mimic poor practice.

After the slab hardened and gained strength, a full-depth section was cut perpendicular to the hand-sawn joints to observe the concrete condition at the bottom of the cuts.

- Under an optical microscope, the only evidence of joint-related damage due to sawing was a small piece of aggregate cracked at the tip of one of the cuts.
