Evaluation of the Need for Longitudinal Median Joints in Bridge Decks on Dual Structures

September 2015

Sponsored by
Iowa Highway Research Board
(IHRB Project TR-661)
Iowa Department of Transportation
(InTrans Project 13-470)

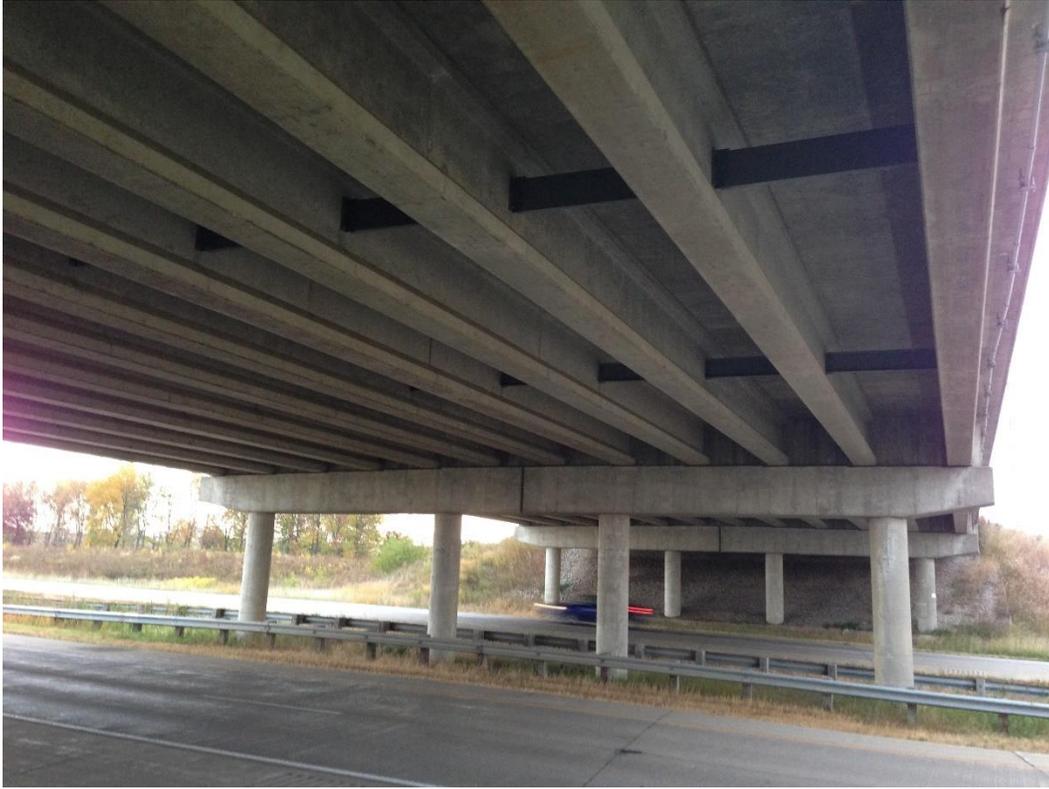
The bridge consists of an integral abutment and 12 pre-stressed concrete girders. In general, the bridge is in very good condition. Figure 4 through Figure 6 illustrate the overall bridge geometry and crack conditions on the top of the deck.

Figure 4. Underside view of the bridge

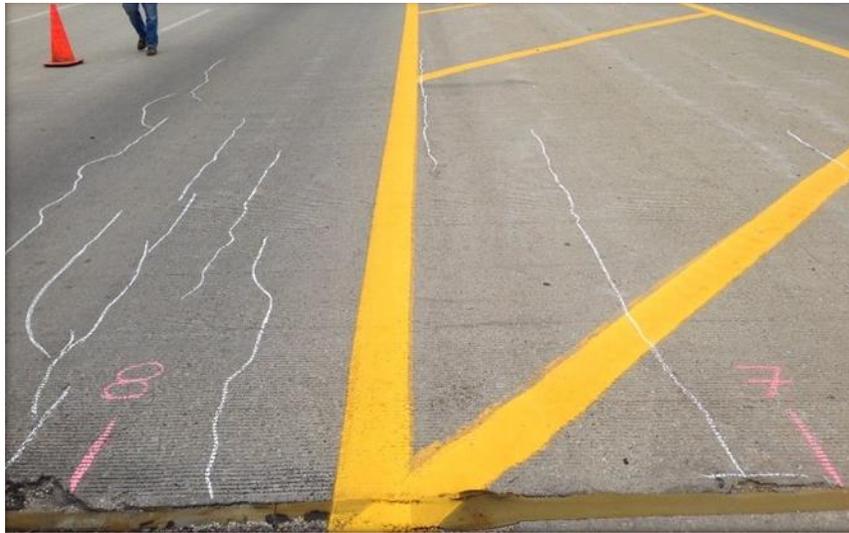
Figure 5. Longitudinal cracks at the center of the south end

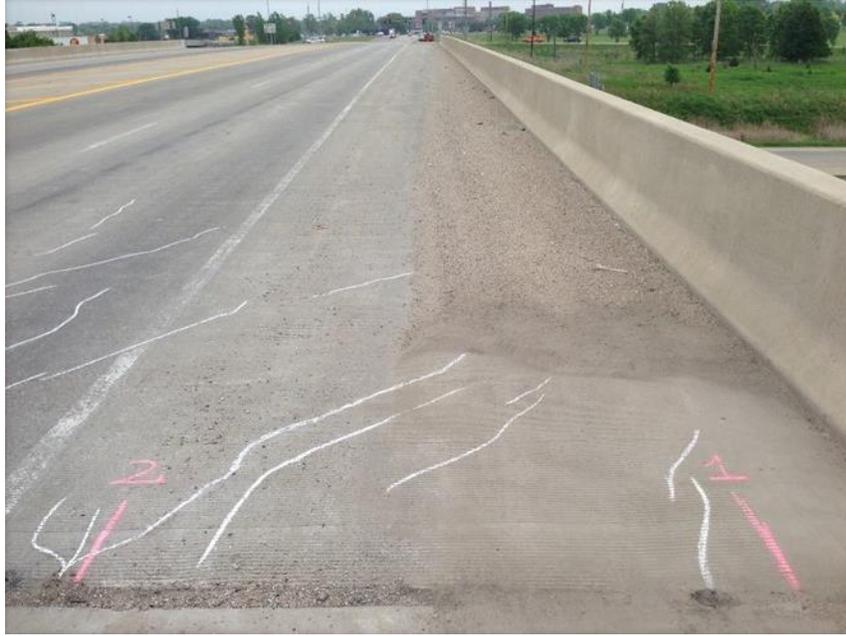
Figure 6. Diagonal cracks at the corner of the deck

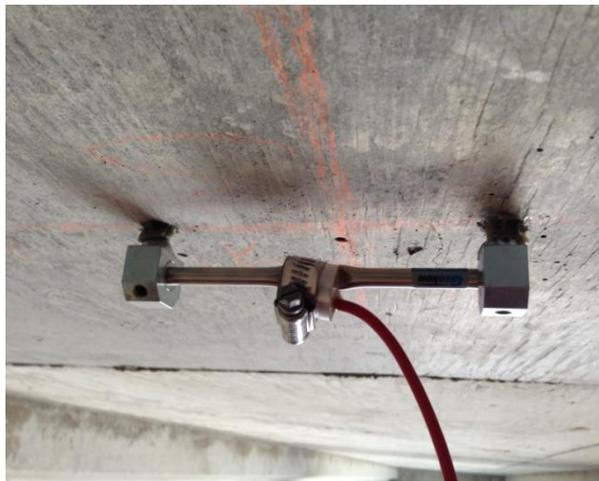
Figure 16. Vibrating wire strain gauge at the bottom of the deck

Figure 16 shows a photograph of a vibrating strain gauge mounted to the bottom of the concrete deck prior to the installation of the protective cover.

In both the middle-span section and the pier section, the vibrating strain gauges were attached in the first bay, third bay, and fifth bay on the east side of the bridge.

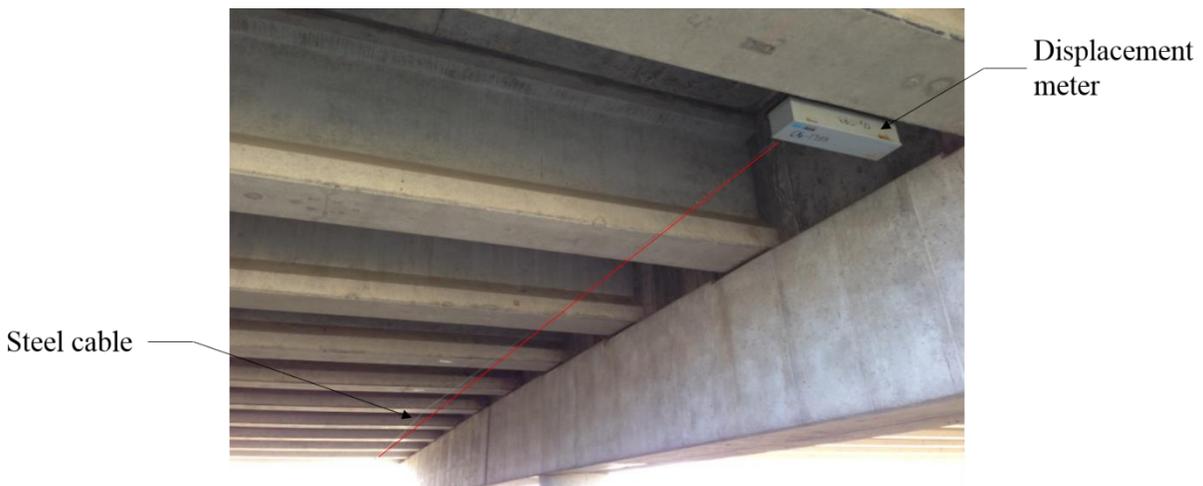
Two displacement meters were installed at the bottom of the deck in the two exterior bays near the first interior girder to measure the relative longitudinal displacement between the abutment and pier in the first span on the south side of the bridge. The other two displacement meters were used to measure relative displacement in the transverse direction. One of them was placed at the bottom of the girder near the surface of the abutment on the south side of the bridge. The other one was installed at the bottom of the girder near the surface of the pier in the first span on the south side. Figure 18 shows a vibrating wire long-range displacement meter attached to the bottom of the girder near the pier that measures the relative displacement in the transverse direction.

Figure 18. Vibrating wire long-range displacement meter

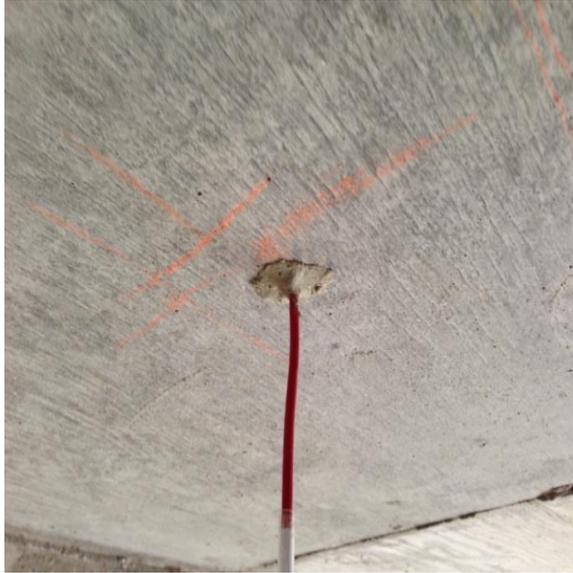
Figure 21. Thermistor within deck

Figure 21 shows a thermistor attached within the deck. The locations of the four thermistors installed in the abutment are shown in Figure 20.

In addition to the temperature at the bottom surface of the deck, the temperatures inside the deck and within the abutment were also measured using a Geokon 3800 thermistor placed at mid-depth of the deck and 3 in. below the surface of the abutment. The relative positions of the cover of the vibrating strain gauge and Geokon 3800 thermistors is shown in Figure 19. During long-term testing, five such thermistors were installed in the deck and 54 in. from the surface of the abutment (shown in Figure 20).

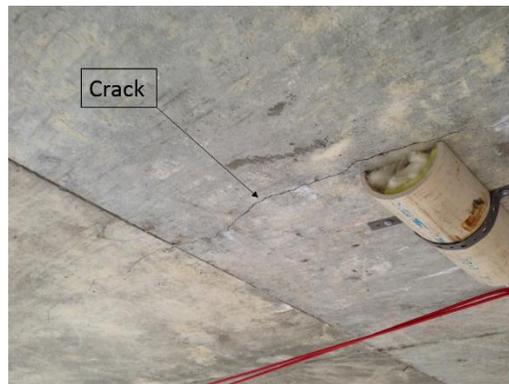
For the fifth bay, a crack parallel to the girders was found at the bottom of the deck within one inch from one side of the strain gauge (Figure 45).

Figure 45. Relative positions of crack and strain gauge in the fifth bay
