# Monitoring Vibrations on the Jefferson City Truss Bridge

**Final Report**  
**March 2017**

<b>1. Report No.</b> MoDOT Report cmr 16-012		<b>2. Government Accession No.</b>		<b>3. Recipient's Catalog No.</b>	
<b>4. Title and Subtitle</b> Monitoring Vibrations on the Jefferson City Truss Bridge				<b>5. Report Date</b> March 2017	
				<b>6. Performing Organization Code</b>	
<b>7. Author(s)</b> Glenn Washer, Pedro Ruiz Fabian, and James Dawson				<b>8. Performing Organization Report No.</b>	
<b>9. Performing Organization Name and Address</b> University of Missouri-Columbia Department of Civil and Environmental Engineering E2509 Lafferre Hall Columbia, MO 65211				<b>10. Work Unit No. (TRAIS)</b>	
				<b>11. Contract or Grant No.</b> USDOT/OST-R Grant DTRT13-G-UTC37 and MoDOT Project TR201605	
<b>12. Sponsoring Organization Name and Address</b> Midwest Transportation Center                      U.S. Department of Transportation 2711 S. Loop Drive, Suite 4700                      Office of the Assistant Secretary for Ames, IA 50010-8664                                      Research and Technology Missouri Department of Transportation              1200 New Jersey Avenue, SE (SPR)

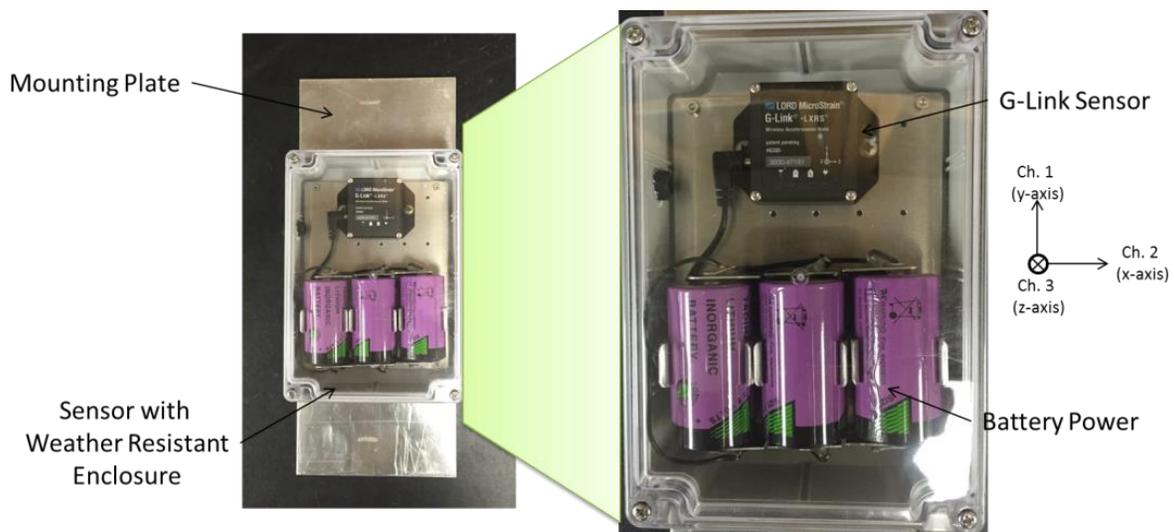
Four wireless Microstrain G-Link sensor nodes were used to monitor vibrations of the vertical members. The Microstrain G-Link sensor is a battery-operated high-speed tri-axial accelerometer with user-programmable sampling rates of up to 4,096 Hz. These sensors are capable of measuring accelerations of up to 10 G (with 1 G being equal to the acceleration from gravity). Figure 2 shows one of the sensor nodes.

**Figure 2. Microstrain G-Link sensor with power supply and enclosure attached to mounting plate**

The sensor and supporting batteries were mounted in a weather-resistant enclosure. In order to attach the enclosure to the flanges of the vertical members, an aluminum mounting plate was fabricated and attached to the back of the enclosure. The mounting plate with the sensor enclosure was attached to the flanges of the vertical member using small flange clamps. In this orientation, the y-axis of the accelerometer was aligned vertically with the member so vibrations resulting from member resonance would not be expected on the vertical axis of the sensor (Channel 1). The x-axis and z-axis of the accelerometer were aligned to detect flexural and torsional vibrations of the member, respectively. The four wireless sensor nodes were identified as Node 48, Node 49, Node 50, and Node 51.

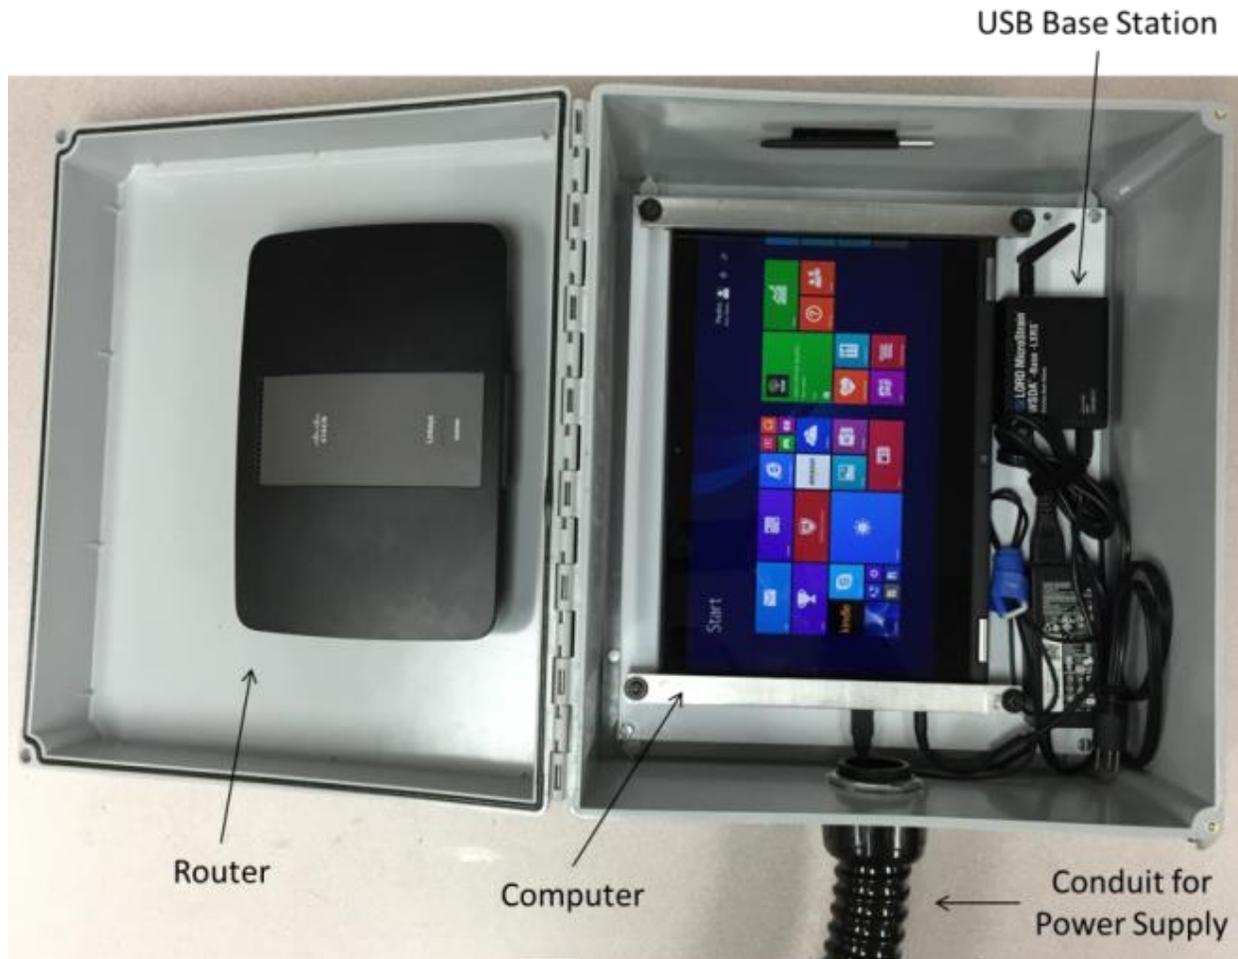
Figure 3 shows the data acquisition system used in this research: a Dell notebook, Microstrain USB base station, and Cisco router, all enclosed in a fiberglass enclosure, with conduit out of the enclosure for the connection to the power supply.

**Figure 3. Data acquisition system integrated with essential components**

The data acquisition enclosure was used to protect the base station and computer from the elements. The notebook and USB base station were both attached to a mounting plate via screws, and the mounting plate was attached to the fiberglass enclosure. The router was attached to the enclosure using Velcro strips. The notebook computer was used to run the software necessary for the wireless sensor nodes to communicate with the Microstrain USB base station and to store the data received from the sensors. The router was used for wireless communication with the computer for the purpose of downloading data. An Ethernet connection was also used to download the data. The system was powered by alternating current (AC) power, provided on-site.

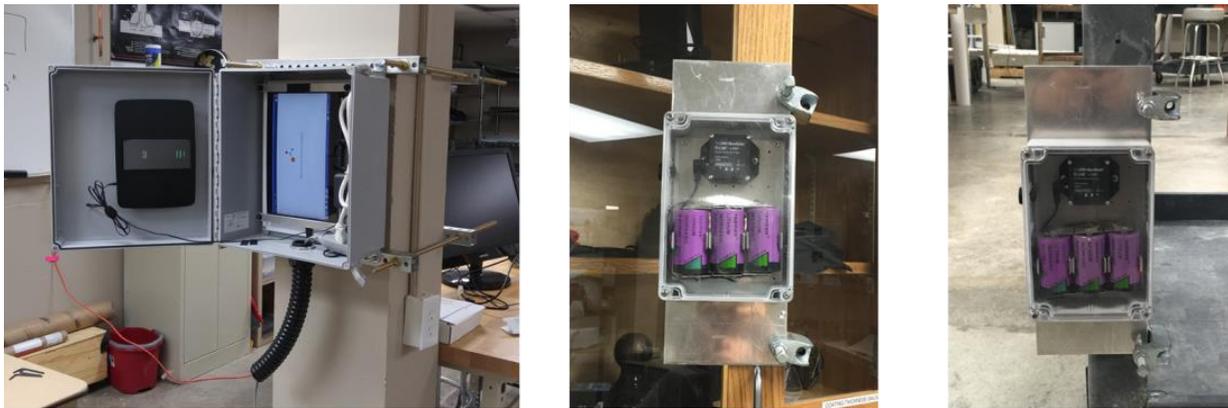
The monitoring system was tested in the laboratory to ensure proper operation. Testing was geared towards troubleshooting the data collection system and ensuring that data were being successfully collected and downloaded. Figure 5 illustrates the system in a laboratory-based setup.

**Figure 5. System laboratory setup including a data acquisition system attached to a column (left), sensor node attached to a cabinet (middle), and sensor node attached to a movable cart (right)**

The data acquisition system was attached to a column to simulate the system's attachment in the field, and the sensor nodes were mounted to various objects in the laboratory, such as a cabinet and movable cart. Data were collected over a period of several weeks and downloaded periodically to simulate the anticipated field conditions. These tests were used to ensure that the software was operating reliably, data could be downloaded without interruption to system operation, and estimates could be developed for the time required to download datasets of different sizes.

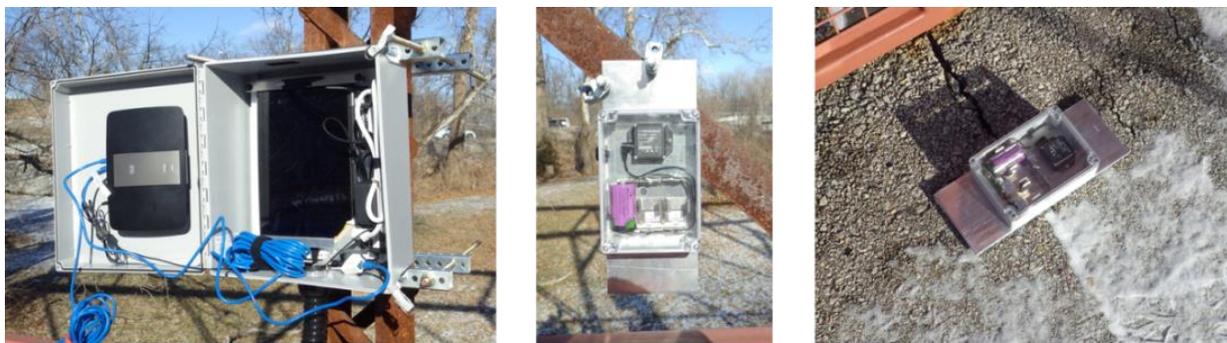
The sensor nodes were mounted on tension ties that were observed to be carrying different amounts of tensile load based on their vibrations following an impact on the tie. Different amounts of tension in the diagonal ties produced different frequencies when impacted. This allowed for a variety of different vibration frequencies to be tested. Figure 8 shows the attachment of the data acquisition system to a vertical member and sensor node placement on a tension tie and on the bridge deck.

**Figure 8. Attachment of the data acquisition system (left), attachment of sensor to a tension tie (middle), and placement of sensor on the deck (right) during field implementation test**

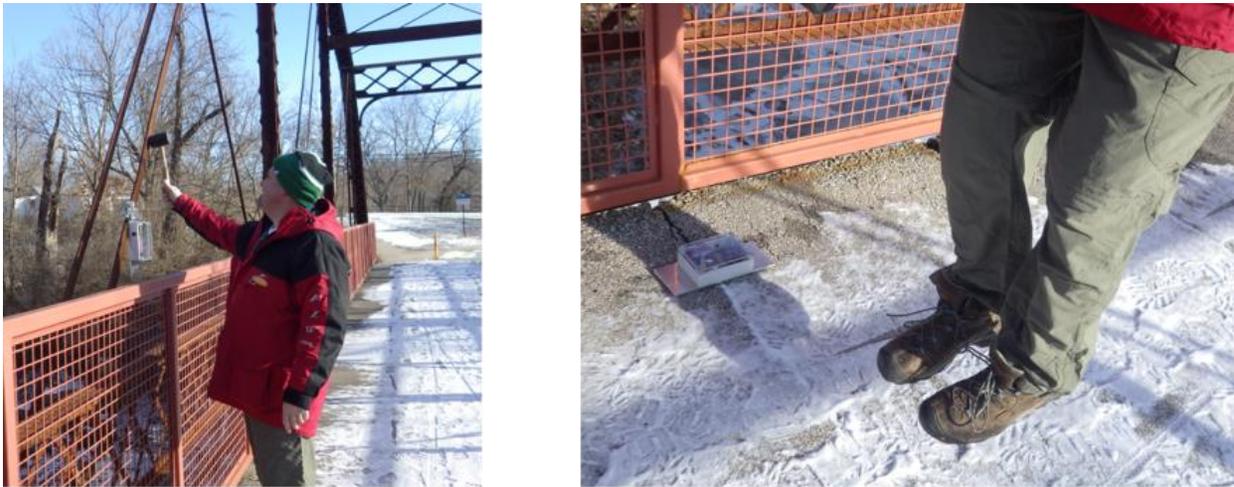
jumping on the bridge deck. Figure 9 shows the impacts on a tension tie with a rubber mallet and a jump near the sensor on the deck of the bridge.

**Figure 9. Impact on a tension tie via rubber mallet (left) and impact on the deck by jumping (right) during field implementation testing**

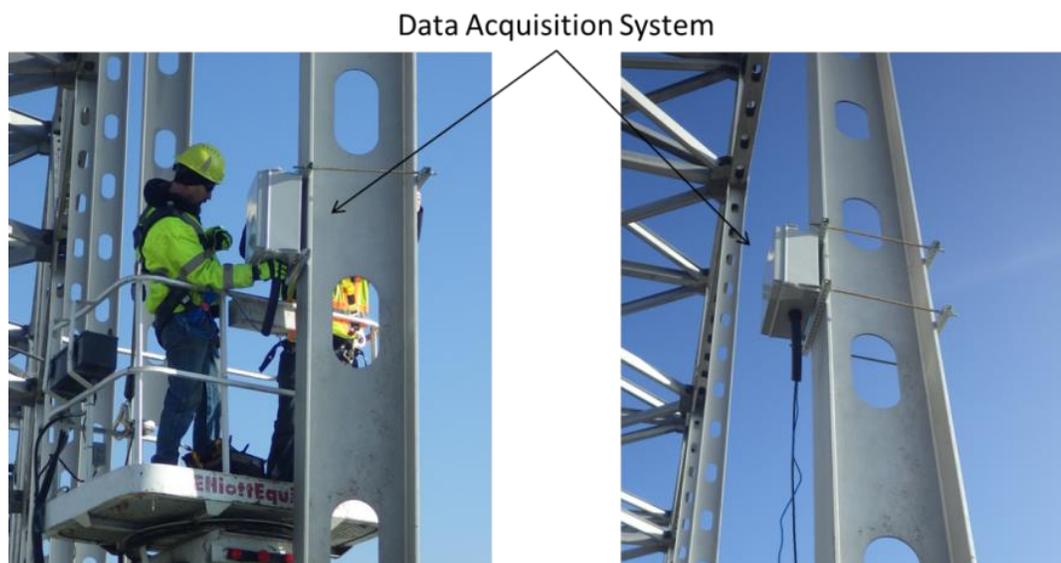
The installation of the field monitoring system on bridge A4497 was successfully completed with the aid of MoDOT staff on Wednesday, January 27, 2016. Installation began by closing down the right driving lane of the bridge to allow for the installation of the AC power necessary for the monitoring system to operate. Once the power was installed, the data acquisition system was installed about 10 ft up on vertical member L22, located on the bridge's east side. Figure 11 shows the data acquisition system installed on L22.

**Figure 11. Installation of the data acquisition system on vertical member L22**
