Guide for Optimum **JOINT PERFORMANCE** of Concrete Pavements

1. Report No. FHWA DTFH 61-06-H-00011 (WP 26)		2. Government Accession No.		3. Recipient's Catalog No.	
4. Title and Subtitle <i>Guide for Optimum Joint Performance of Concrete Pavements</i>				5. Report Date July 2012

Guide for Optimum
JOINT PERFORMANCE
of Concrete Pavements

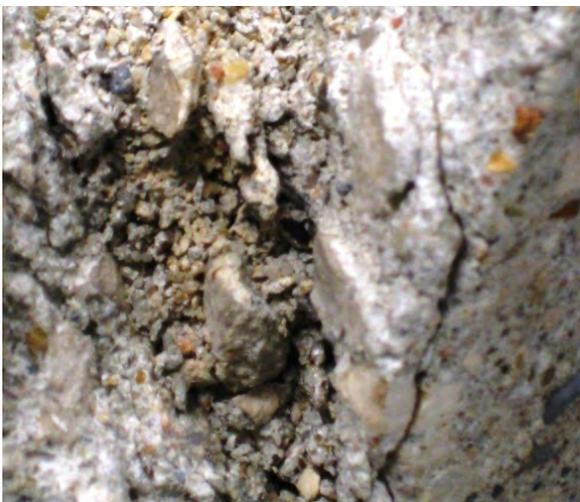
Figure 1. Typical slivers from freezing and thawing cycles

- Pavement saturated for long periods, regardless of the source of water.
- Pavement with marginal air-void systems (total air content, spacing factors, and specific surface).
- The use of significant quantities and/or potentially aggressive deicing salts.
- Secondary ettringite deposits that fill the air-void system under saturated conditions.
- The damage appears as thin flakes of mortar that form parallel to the exposed surface (Figure 1)

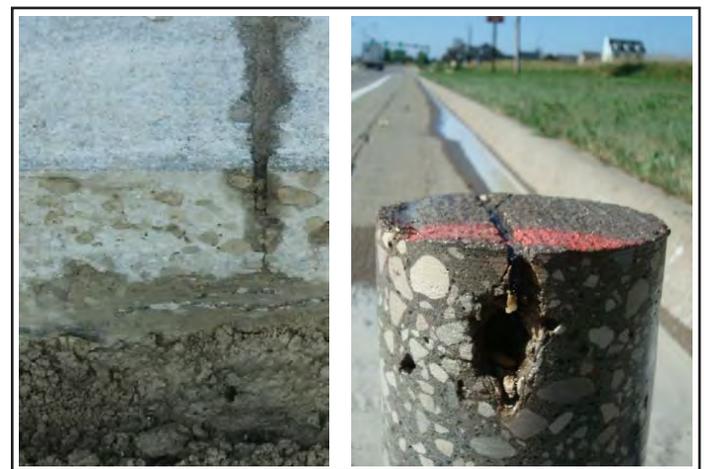
Figure 3. Saturated soils due to inadequate drainage and roadside irrigation (left) leading to joints showing frost damage (right) (Source: Snyder and Associates)

non-draining joint. Weiss and Nantung have modeled how a joint face can be saturated when a seal fails to prevent water ingress (1) (Figure 2). Figure 3 illustrates how inadequate subsurface drainage can be a contributor, especially when coupled with excessive roadside irrigation.

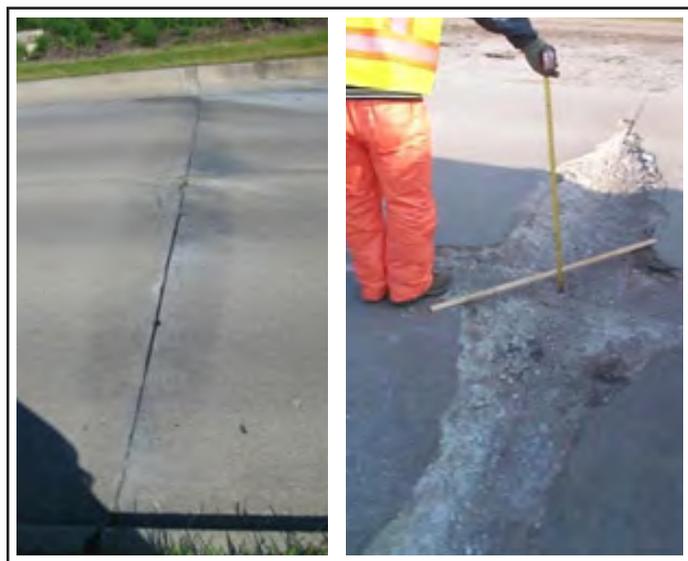
Figure 4. Evolution of joint deterioration from shadowing (left) to high severity (right)

Deterioration is sometimes first observed as shadowing or darkening of a zone a few inches on either side of a joint. This effect is the result of a fine network of microcracks that develop near and parallel to the joint. The cracks trap water, which lead to the darker color. Over time significant loss of material may occur (Figure 4). In most cases where shadowing is observed the system is not well drained (Figure 5), and the air-void system is often marginal or poor. It is also common to observe evidence of secondary ettringite deposits in the air voids (Figure 6). This indicates abundant water within the concrete, although the exact mechanisms and effects of this ettringite are still not resolved.

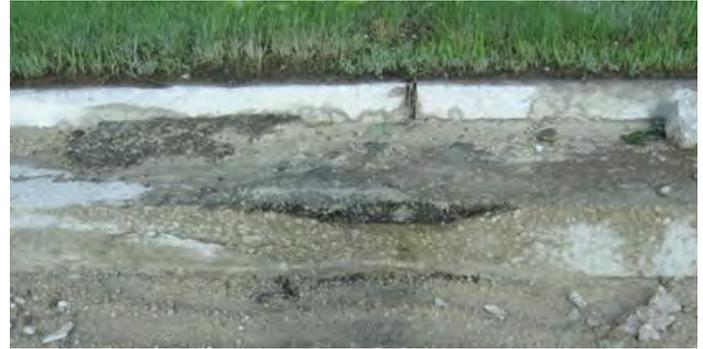
Figure 5. Typical saturated foundations under a shadowed section (Source: Snyder and Associates)

When the pavement is placed on a non-draining base and/or when the water table is above the bottom of the slab, the top of the pavement may appear to be in reasonable condition, but coring reveals concrete that has been seriously damaged in the joint (Figure 7). Interestingly, the damage is more pronounced in the saw-cut than in

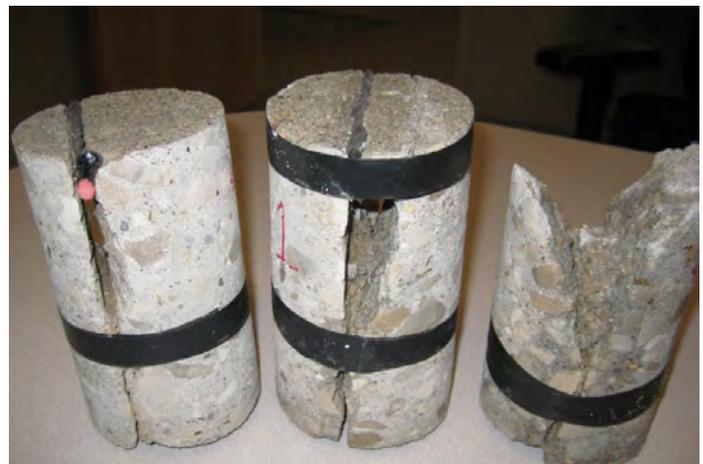
Figure 7. Three cores illustrating progression of distress from bottom-up moisture

the crack, presumably because a significant amount of water can collect in the saw-cut while cracks tend to be tight. Figure 8 illustrates the site where these cores were extracted, showing the clear signs of abundant water flow.

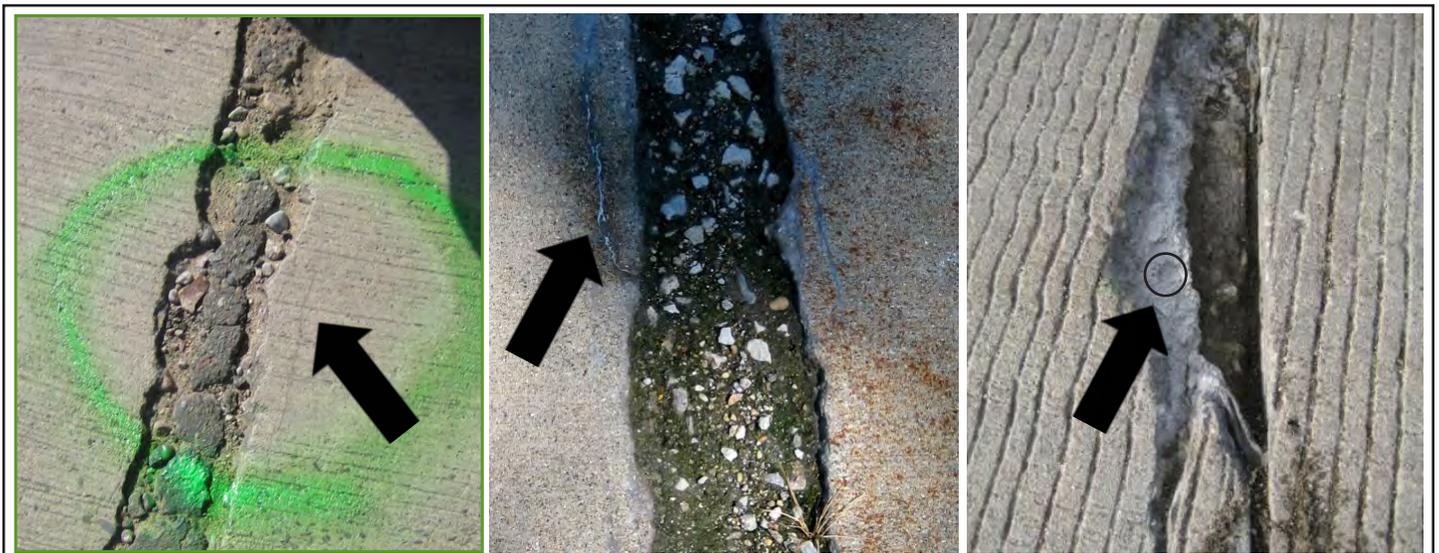
Figure 9. Typical incremental cracking: Note (left to right) the crack parallel to the ready-patched face, the signs of water passing through the crack, and the exposed aggregate remaining in the concrete

Joint deterioration is also seen as parallel cracks that form at approximately one-inch increments starting from the joint face (Figure 9). The concrete between the crack and the free face is normally sound, as is the remaining concrete next to the crack; which is not typical of normal frost damage. The coarse aggregate still embedded in the concrete is often free of adhering mortar on the exposed face (Figure 10) and the joint is often filled with loose aggregate. This indicates a mechanism that is attacking the paste alone.

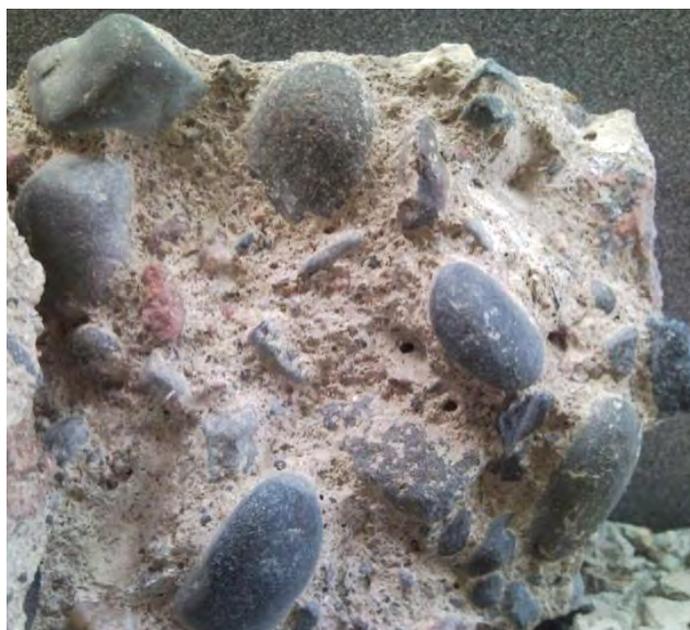
Figure 10. Coarse aggregate exposed by damage to the paste

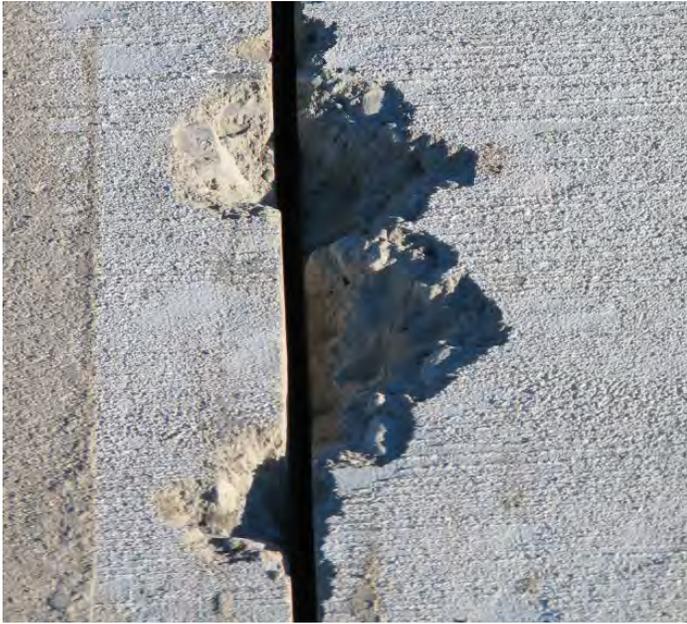
Figure 14. Raveling due to poor sawing practice (Source: Iowa Department of Transportation)

Raveling of a saw cut can also be caused by aggregate particles being dislodged during sawing, typically because the concrete strength is too low when conventional sawing is conducted. Alternatively, raveling is observed when the

shoe on an early-entry saw is not functioning properly (Figure 14). Such spalling is typically found at the surface and will rarely extend through the depth of the slab.

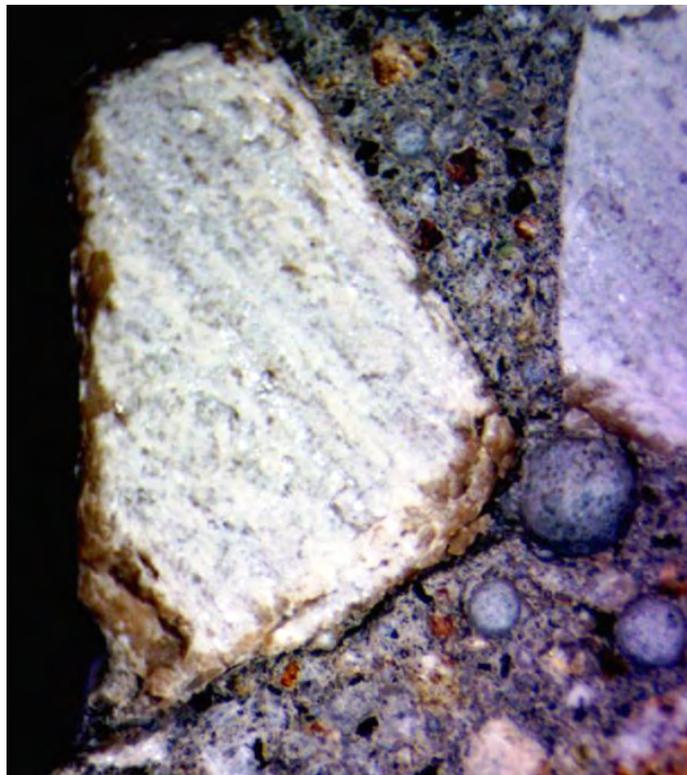
Figure 15. Photograph of an aggregate particle dislodged by inappropriate sawing (Field of view 5mm)

Concrete at the bottom of a saw cut may become damaged during sawing using machines with worn bearings or an inappropriate blade, or when cutting on a curve (Figure 15). Erosion and/or a zone of microcracking is possible, which can lead to water being trapped, thus increasing the risk of damage from frost action.

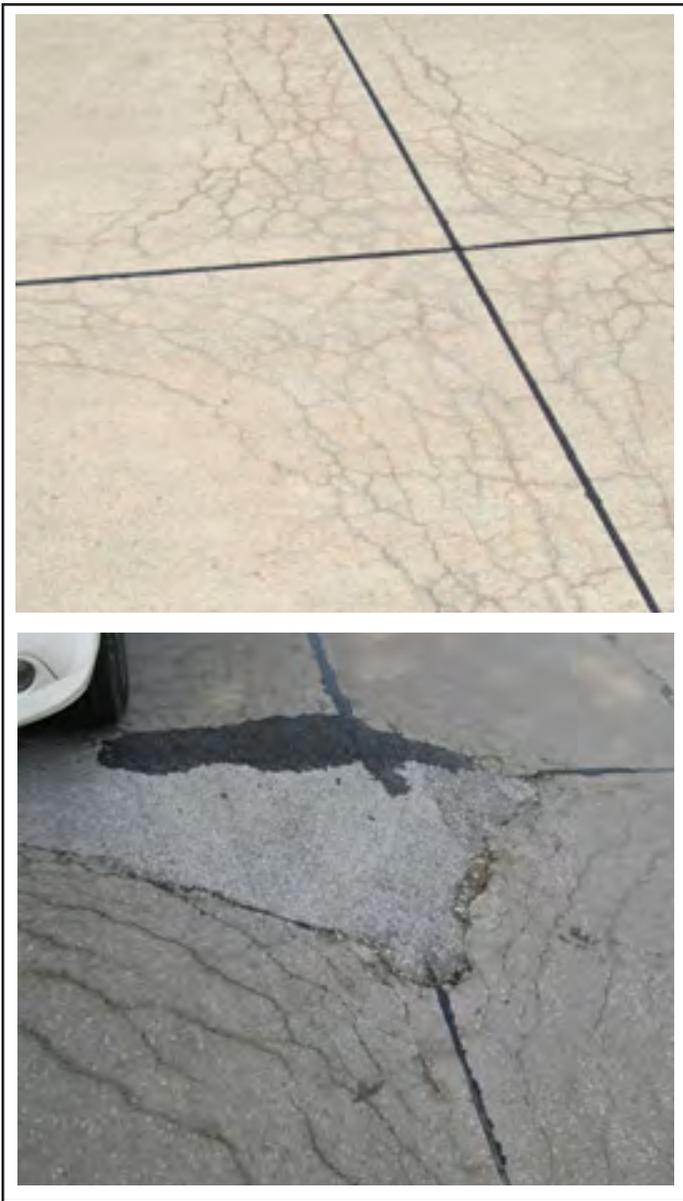
Figure 16. D cracking of low severity (top) and high severity (bottom) (Source: The Transtec Group)

D-cracking is a type of deterioration caused by expansive freezing of water trapped inside some types of aggregate particles. The damage normally starts near joints and forms a characteristic crack pattern (Figure 16). The damage is generally worse at the bottom of a slab than at the top. As long as freeze-thaw cycles continue, the distress cannot be stopped.

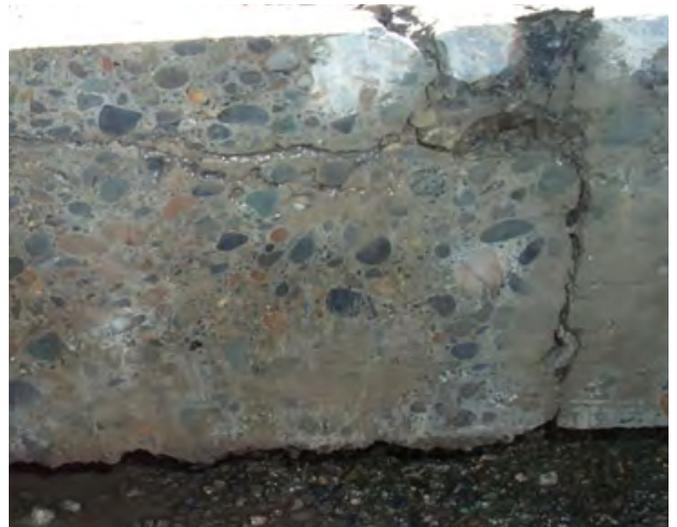
Figure 18. Example of delaminationspalling (Source: Washington State)

process is illustrated in Figure 17 and the result is shown in Figure 18.

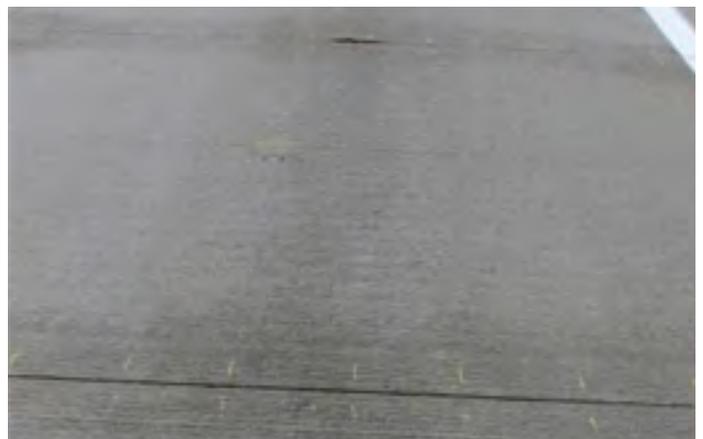
Figure 19. Shadowing at the joints, which is commonly followed by loss of material

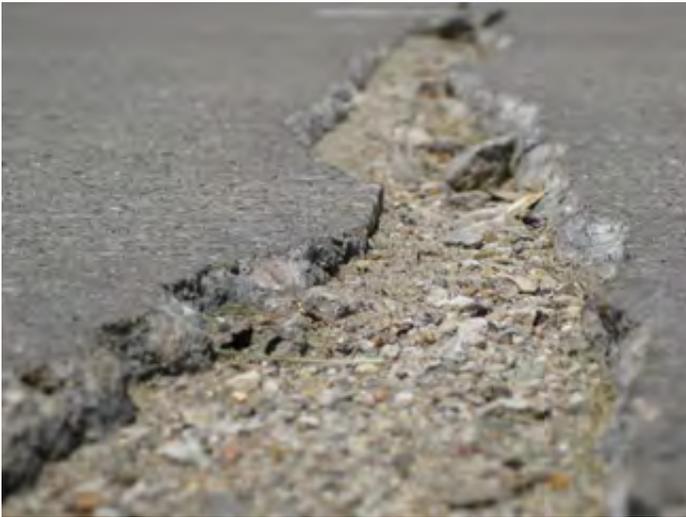
Figure 20. Top-down joint distress, with vertical edges and shallow depth

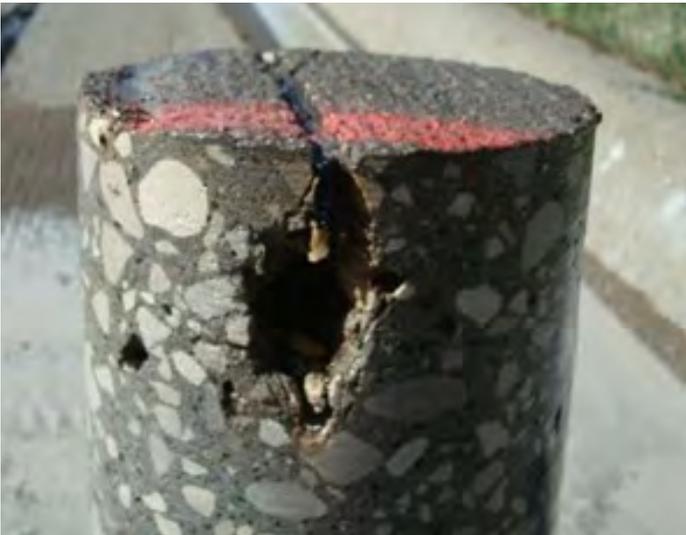
Figure 21. Joint deterioration evident below the joint sealant

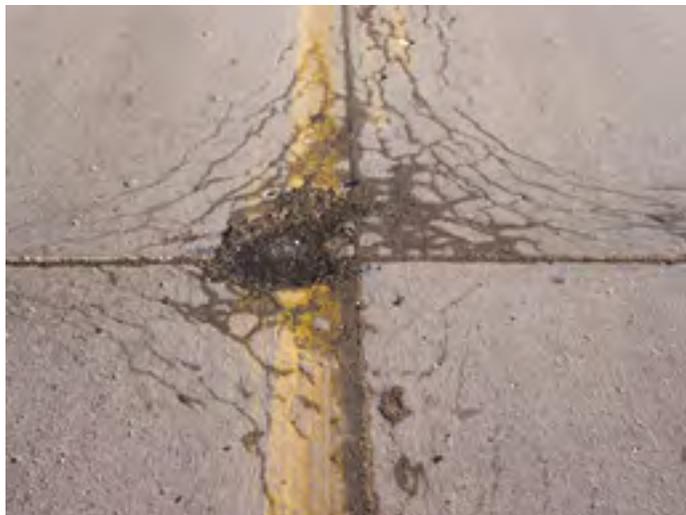
Figure 22. Deterioration due to D cracking

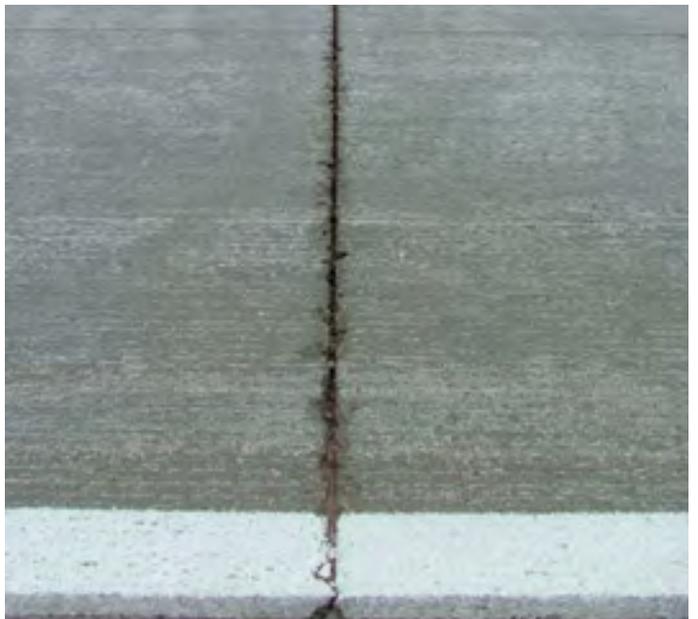
Figure 24. Joint deterioration due to raveling from improper saw-cut procedures

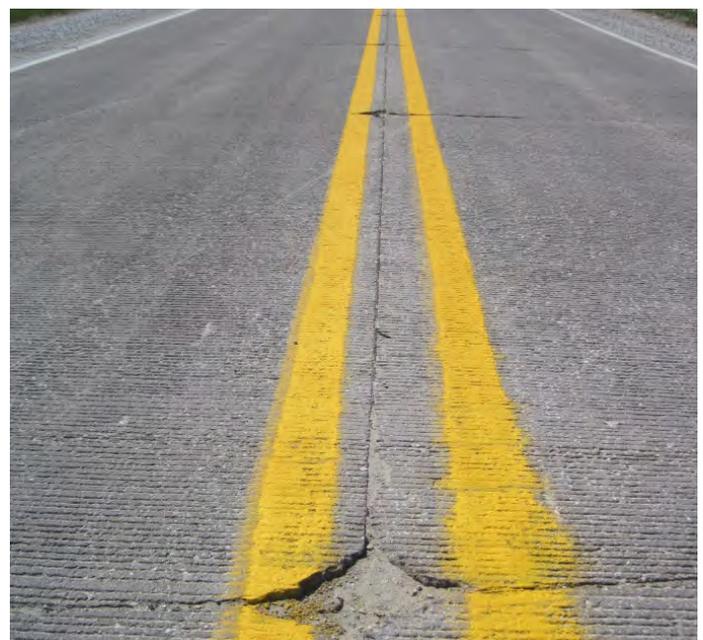
Figure 25. Damage starting at joint intersections

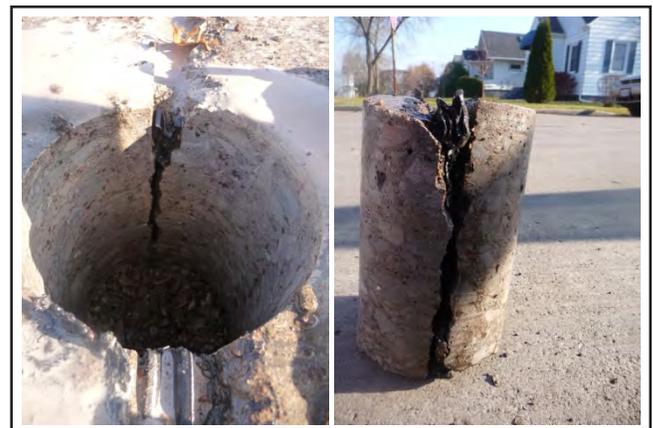
Figure 26. Coring at deteriorated joints to help identify causes of failure

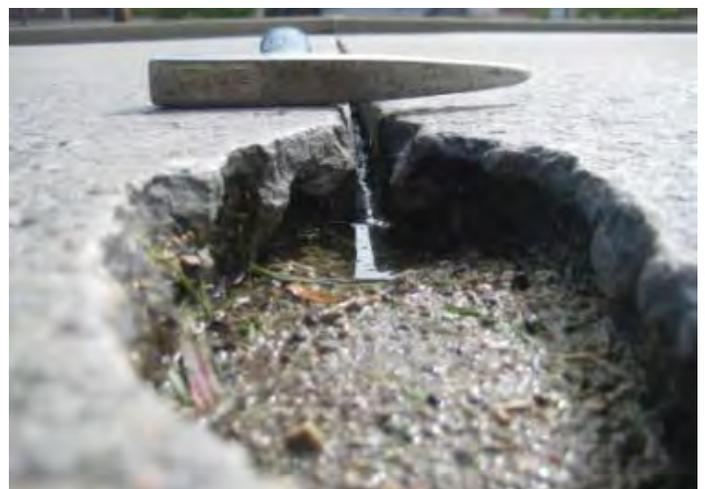
Figure 27. Example of a poorly draining pavement

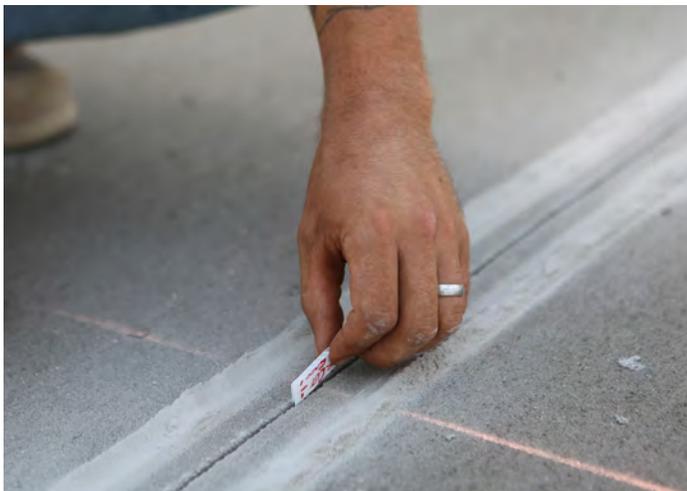
Figure 30. Using temporary joint spacers to protect and minimize damage due to early entry sawing (Source: Husqvarna)

When using early-entry saws, it is recommended that temporary spacers be inserted where cuts intersect existing cuts, in order to prevent corner damage and the subsequent risk of other joint deterioration mechanisms (Figure 30).

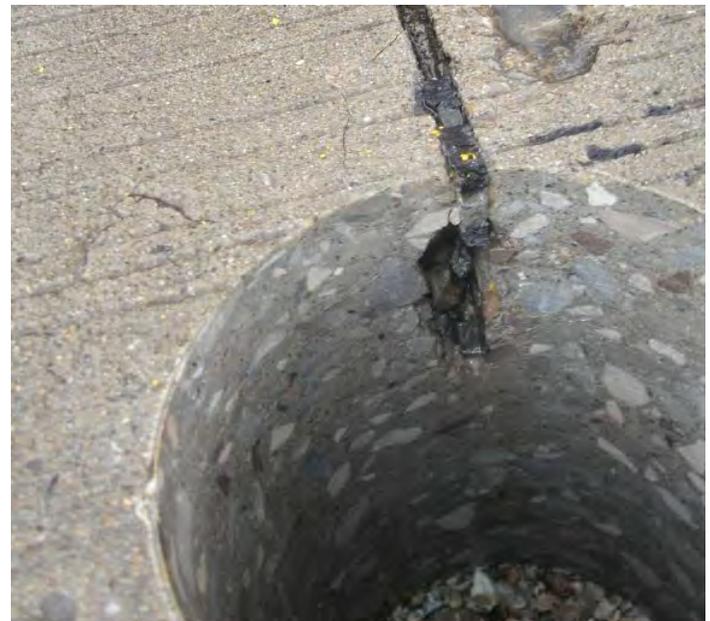
Figure 31. Evidence of saturation within joint beneath seal (Source: Purdue)

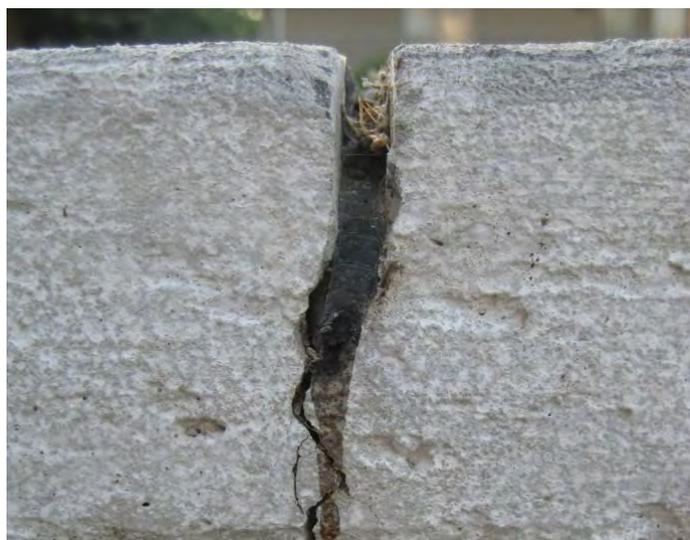
Figure 32. Joint filled with hot-pour sealant (Source: The Transtec Group)

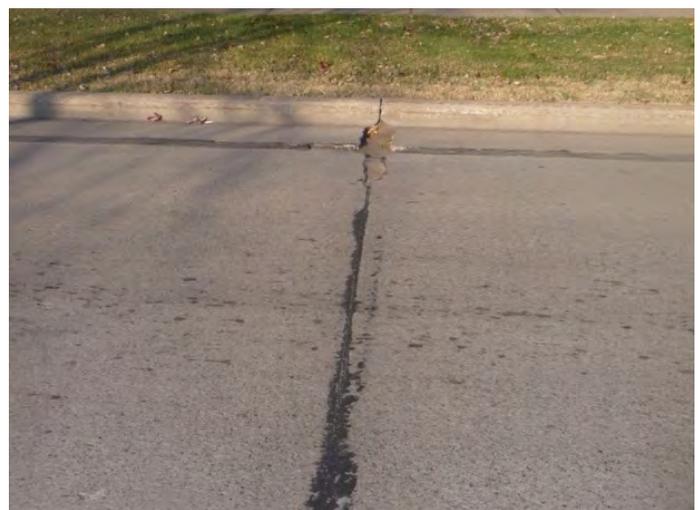
Figure 33. Failing transverse joint associated with poor drainage at gutter

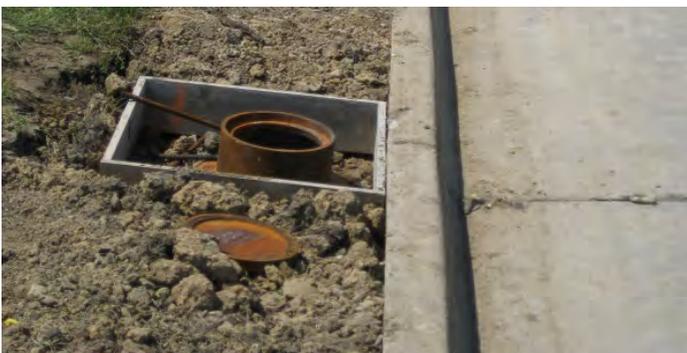
Figure 35. Subdrain retrofit operation including cleanout (The Transtec Group)

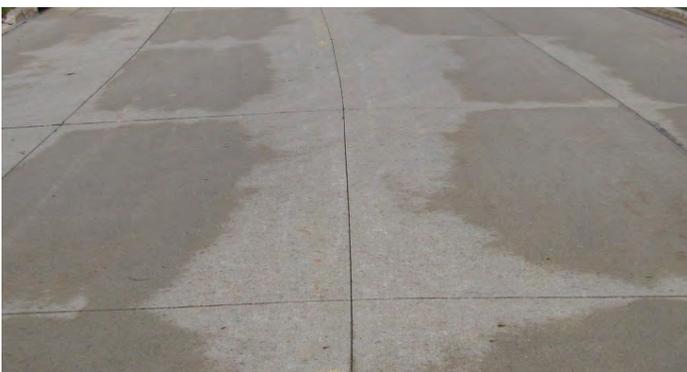
Figure 36. Example of effective drainage of unsealed joints

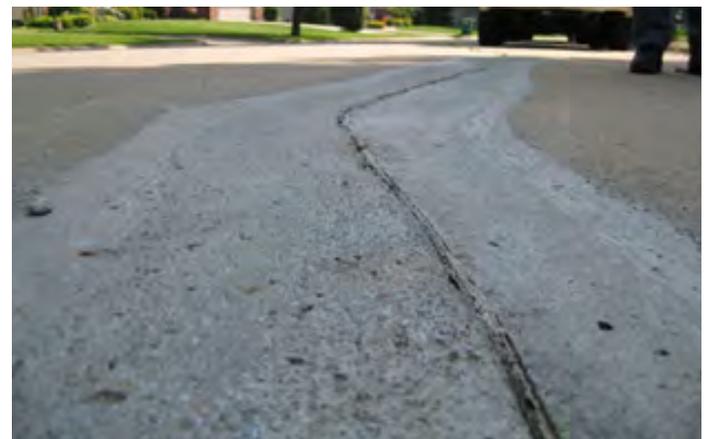
Figure 39. Completed patch (Source: The Transtec Group)

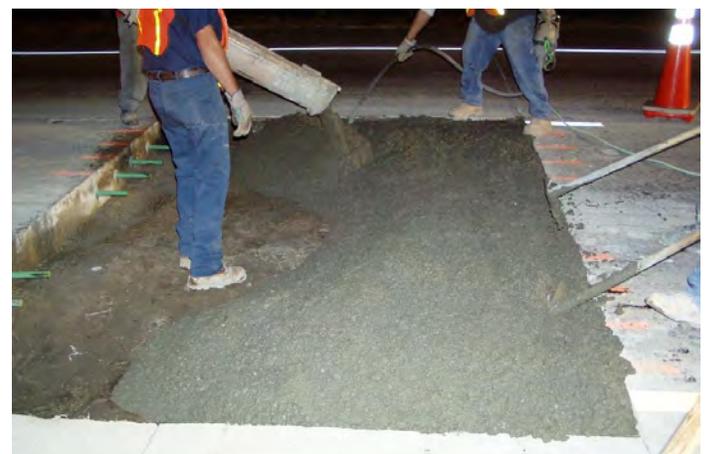
Figure 40. Full-depth patching

In cases where deterioration has occurred through more than one-half the depth of the pavement, a full-depth repair is required. As shown in Figure 40, a full-depth repair is a cast-in-place concrete repair that extends through the full thickness of the existing concrete slab.
