IN-PAVEMENT PEDESTRIAN FLASHER EVALUATION: CEDAR RAPIDS, IOWA

CTRE Project 03-145

Final Report • April 2004

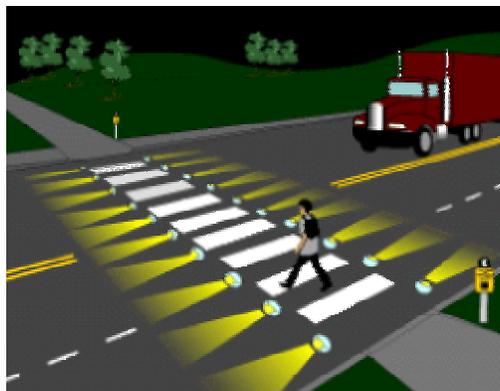
Figure 1. In-pavement flashing warning lights (walkinginfo.org)

Prior to MUTCD approval in 2000, several experimental applications of in-pavement flasher systems (see Figure 1) were completed and evaluated in other states, including Florida, New Jersey, Washington, and Hawaii. The use of in-pavement flashing lights has, to-date, been restricted to uncontrolled intersections and to mid-block locations to avoid becoming commonplace and to ensure that drivers are made aware of the special condition that exists at the specially-marked crossing. The in-pavement flashing units direct two or more flashing lights to the drivers when a pedestrian, or cyclist enters the cross walk. The lighting system is activated by a push-button or by a passive system that detects the breaking of a beam of energy by a cross walk user. Important design and operational details for the system include the method of activation, the number and placement of lights, the duration of the flashing period, and more. The following literature review will highlight portions of those issues, but the common feature in all of the systems is that the flashing units are placed to help drivers recognize the presence of crosswalk users and are the equivalent of a stop sign or a red traffic signal.

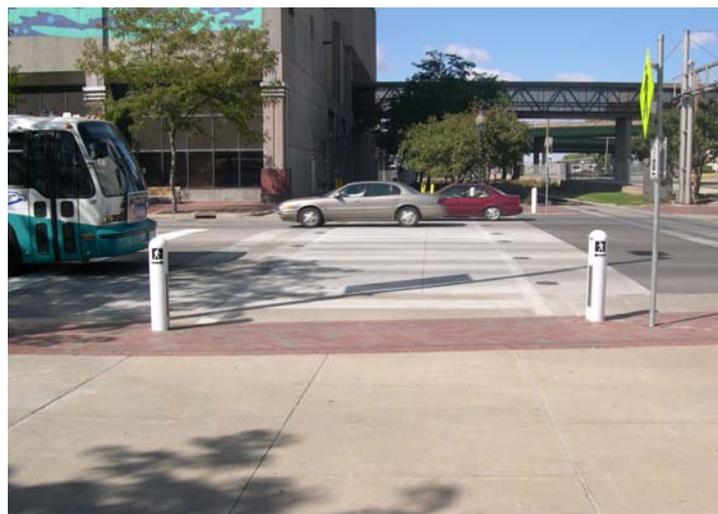
Figure 4. Crosswalk at ground level, looking northbound

The location has many complexities that cause pedestrian crossings to become more difficult to execute safely. The Union Pacific Railroad, which services nearby industry, has a spur line that runs parallel to 4th Street NE; a bicycle/pedestrian trail runs adjacent to the rail line and crosses 1st Avenue NE at this crosswalk location. A 15-foot-wide service drive from the Crowne Plaza Hotel is located on the east side of the hotel and falls partially within the crosswalk where it meets the north curb line. Figure 4 is a northbound view showing the site after the in-pavement system was in place. In addition, the total distance to be crossed is rather large—approximately 80 feet from curb to curb across five lanes of traffic and two parking lanes. Traffic volumes on 1st Avenue NE are approaching 25,000 vehicles per day, with heavy peaking characteristics centered around the A.M. and P.M. peak periods. The posted speed limit through the corridor is 25 mph, but the 85th percentile speeds approach 30 mph. All of these issues make the crosswalk at this location difficult for pedestrians, bicyclists, and motorists to navigate while avoiding conflicts with each other and with the different physical features of the project location.

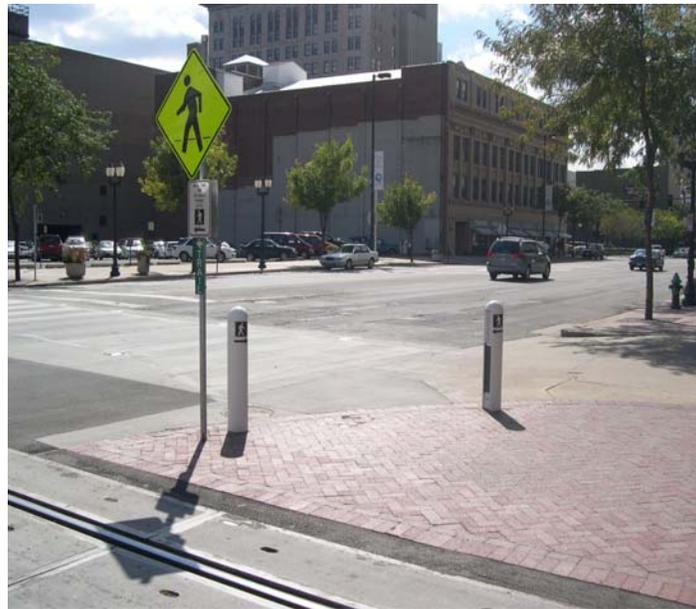
Figure 5. Crosswalk at ground level, looking southbound

The access drive posed a special design challenge to the contractors and the city. The city selected a passive detection system whereby the pedestrians were detected by passing between pairs of bollards located with one on each side of the crosswalk, as seen in Figure 4. Because the access entrance occurred in the crosswalk area on the far side of the street, vehicles entering the access drive would have activated the system if the detecting bollards on the north side were placed as widely as the bollards seen in Figure 4 on the south side of the street. As a result, pedestrians and cyclists approaching from the north had a smaller detection zone, as seen in Figure 5. Crosswalk users approaching from the right (west) had to make a greater effort to activate the flashers before they crossed.

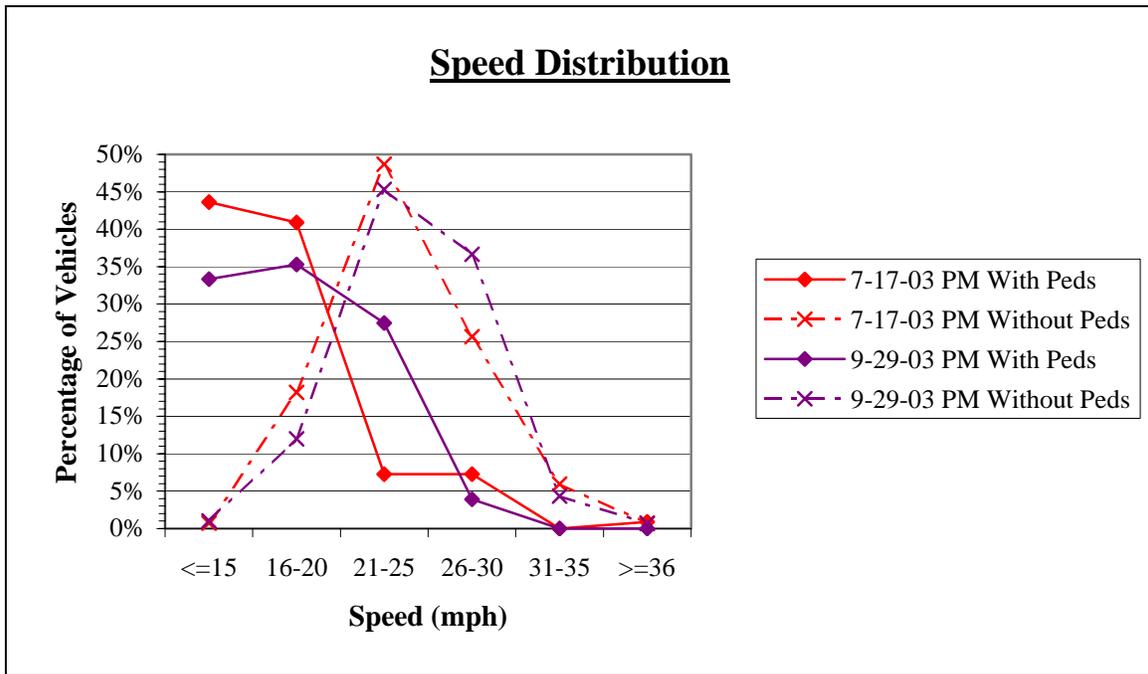
Figure 6. Spot speed distribution before and after project implementation

Figure 6 shows a slight shift to the right from before the improvement to after, indicating a slight increase in the average speed of vehicles through the project location. Additional analysis of the data, as shown in Table 1, indicates the changes in mean, 85 percentile, median, and speed range.

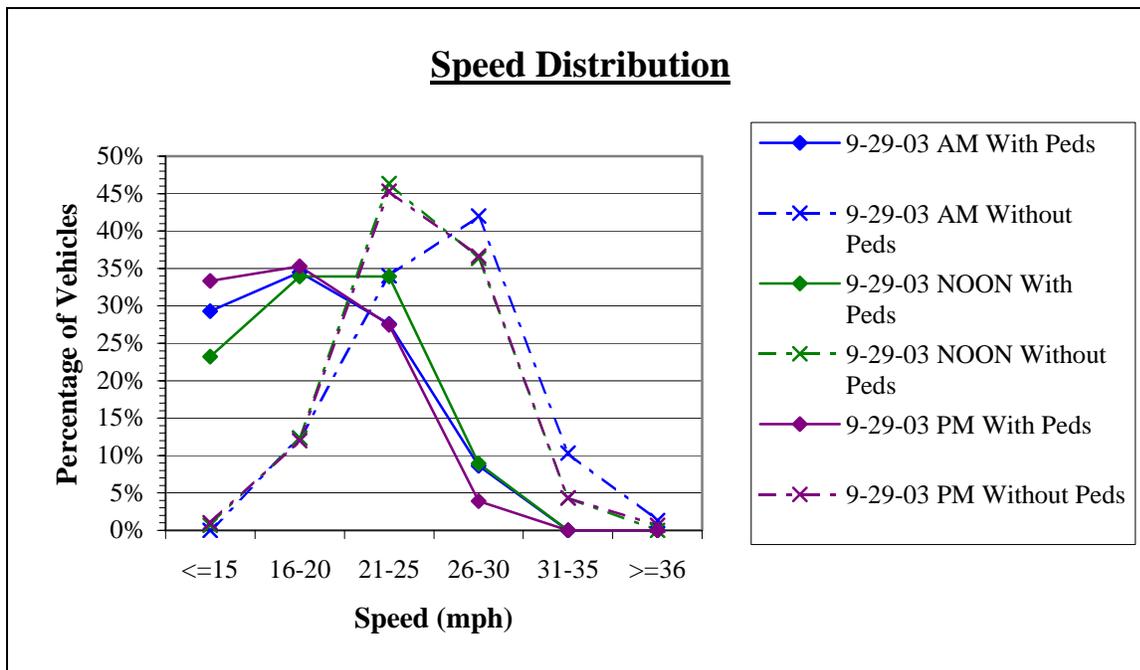
Figure 7. Spot speed distribution after project implementation by time of day

A distribution of speeds, separated by time of day, is shown in Figure 7. The distribution in general supports the conclusion drawn from the data in Table 2. Time of day does not appear to have a significant impact on the average approach speed at the project location. The distribution shows the normal distribution pattern that is expected for standard statistical modeling. The times in which pedestrians were present had fewer observations and were not quite as evident to have the expected bell-shaped curve.

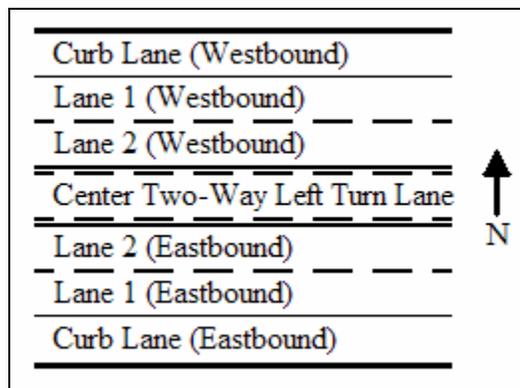
Figure 8. General representation of lane designations

Perhaps the best measure for estimating the safety impacts of the in-pavement flashing lights installed during this project is the change in motorist behavior in relation to yielding to pedestrians and bicyclists in the crosswalk. The measure of effectiveness utilized for this study was to calculate the percentage of occurrences in which the first, second, third, or fourth vehicle to approach the crosswalk yielded to or completely stopped for pedestrians in the crosswalk. The ideal situation would be for the first vehicle approaching the crosswalk to yield to pedestrians in the crosswalk 100 percent of the time. The cumulative percentages of vehicles yielding to pedestrians were tabulated and sorted by lane and direction of travel. A general representation of the system for labeling lanes for both directions of travel at the Cedar Rapids project location is shown in Figure 8. In general, the lane adjacent to the curb is utilized for on street parking through the corridor, lane 1 is always adjacent to the curb lane, lane 2 is adjacent to lane 1, and the center two-way left turn lane separates the eastbound lane 2 from westbound lane 2.

1. Lane 1 – motorist had a responsibility to yield if a pedestrian had stepped from the curb into the curb (parking) lane or had entered the adjacent lane 2 from the center two-way left turn lane.
2. Lane 2 – motorist had a responsibility to yield if a pedestrian had entered either of the adjacent lanes (lane 1 or the center two-way left turn lane).
3. Center two-way left turn lane – motorist had a responsibility to yield if a pedestrian had entered either of the adjacent lanes (lane 2 for either side).
