PREVENTING CRACKING AT DIAPHRAGM/PLATE GIRDER CONNECTIONS IN STEEL BRIDGES

Sponsored by the
Iowa Department of Transportation
and the Iowa Highway Research Board
Iowa DOT Project HR-393

JUNE 1998

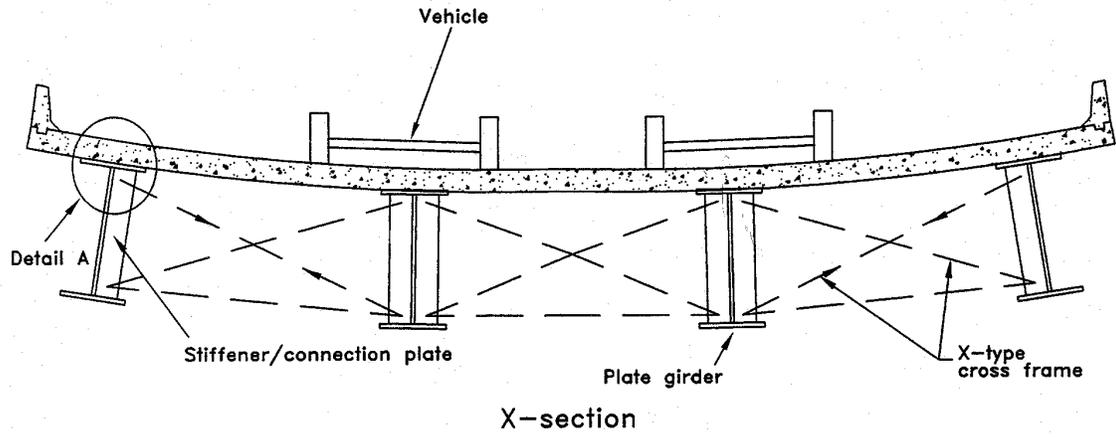
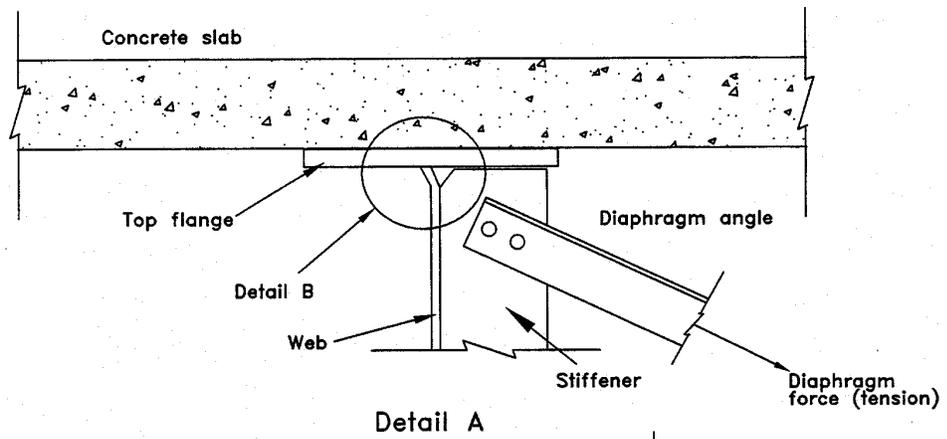
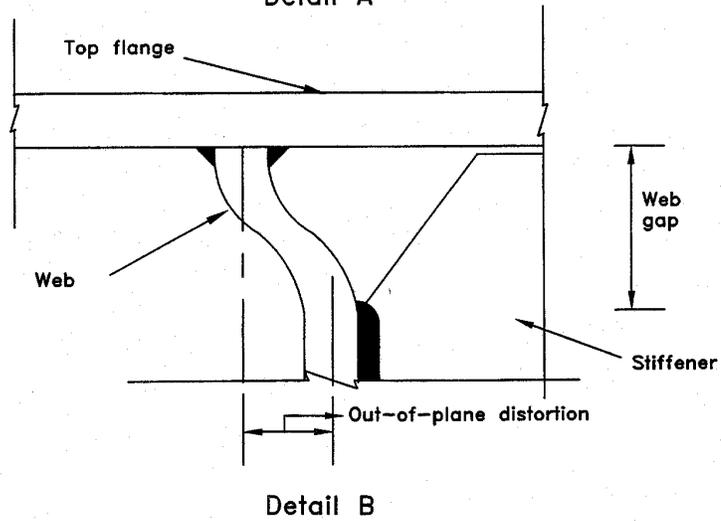
Figure 1. Description of out-of-plane girder web distortion in the gap region

Figure 1 shows a schematic of the out-of-plane distortion at the end of diaphragm connection plates in plate girder bridges. Under typical vehicle loading, differential vertical deflection of adjacent girders causes forces to develop in the diaphragm elements which cause the out-of-plane loading on the girder web (Detail A). Without the connection plate attached to the top flange and with the top flange rigidly connected to the bridge deck by shear connectors, these forces pass through the girder web causing out-of-plane distortion and, hence, bending of the web gap immediately adjacent to the top flange (Detail B). In the negative moment regions, high cyclic stresses due to this distortion cause cracking in the web gap region typically parallel to the longitudinal tensile stresses [2]. Various types of diaphragms and girder spacing have been subjected to this type of cracking. Diaphragms ranged from X- and K-type bracing to rolled beam sections [3].

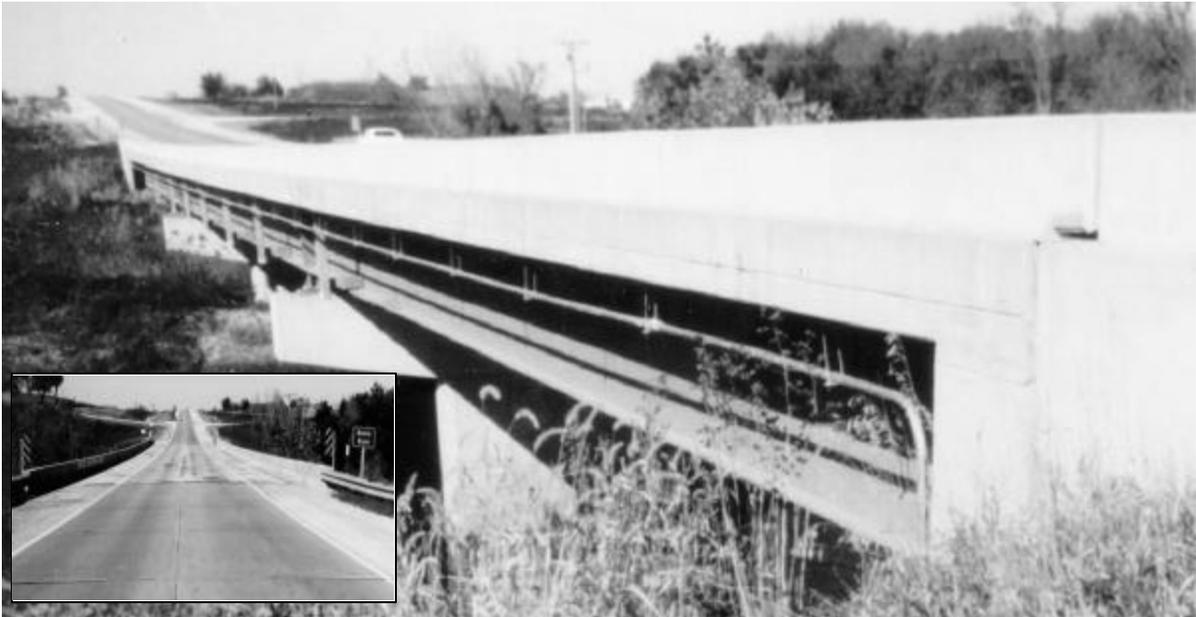
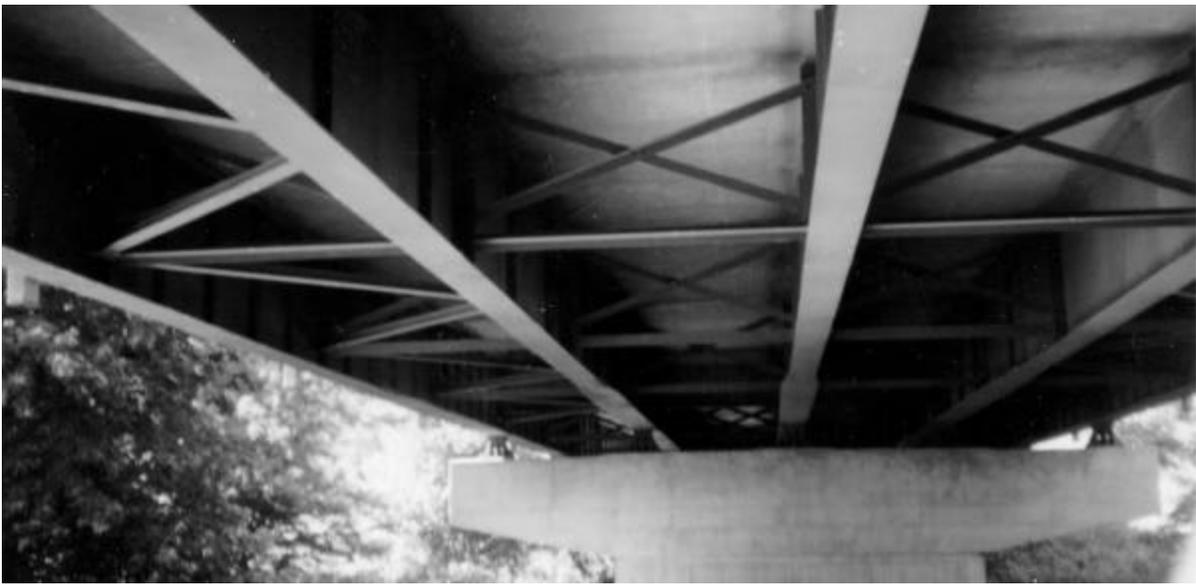
(a) Overview and roadway

(b) Diaphragm system

Figure 2. Boone River Bridge on IA-17 (Bridge X1)

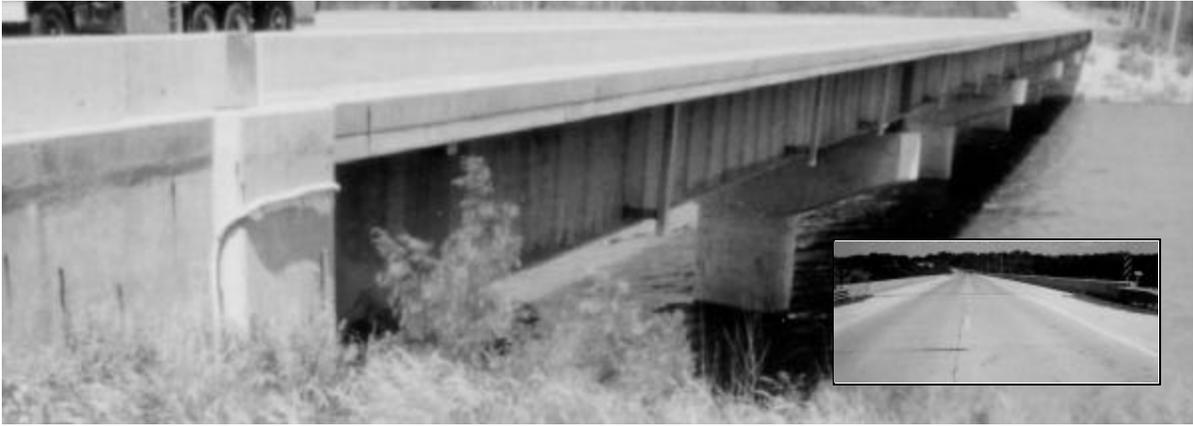
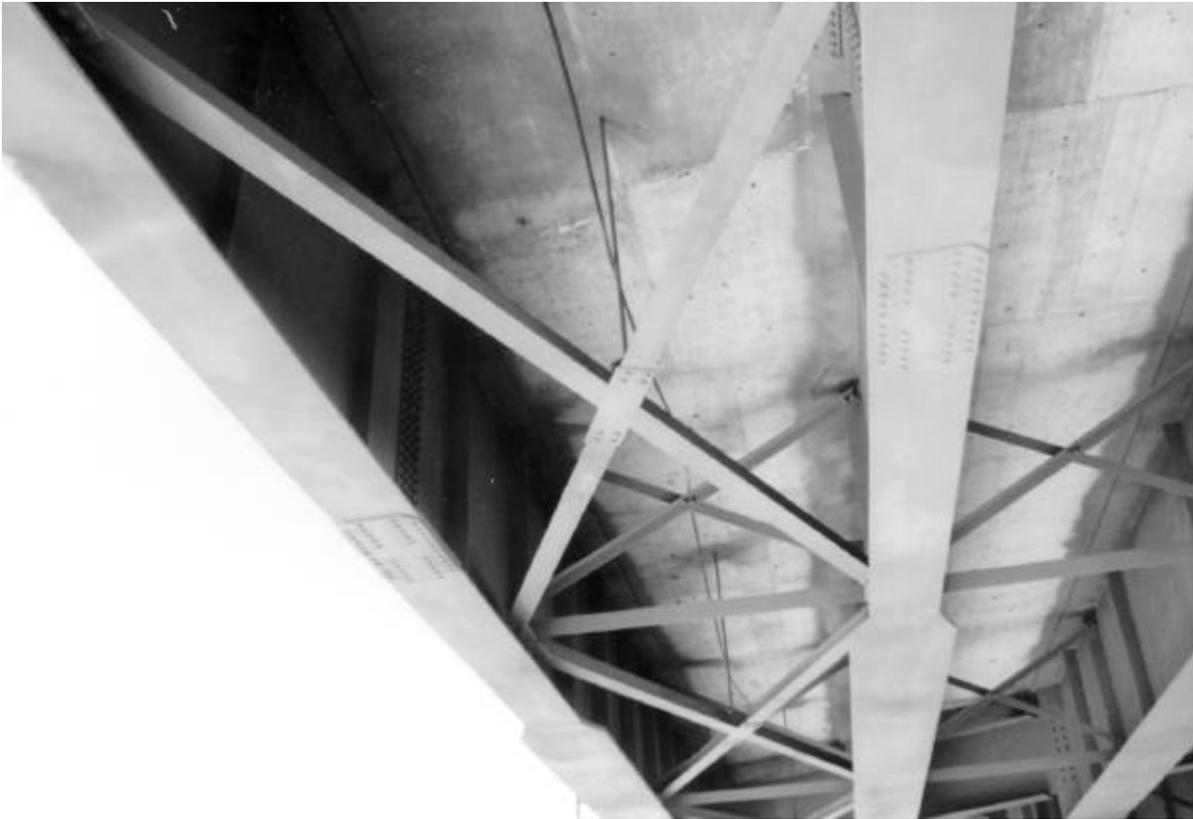
(a) Overview and diaphragm system

(b) Roadway

Figure 3. Des Moines River Bridge on IA-210 (Bridge X2)

The Des Moines River Bridge (Br. No. 0804.9S210) carries Iowa Highway 210 (IA-210) over the Des Moines River west of Madrid in Boone County (Figure 3). The roadway

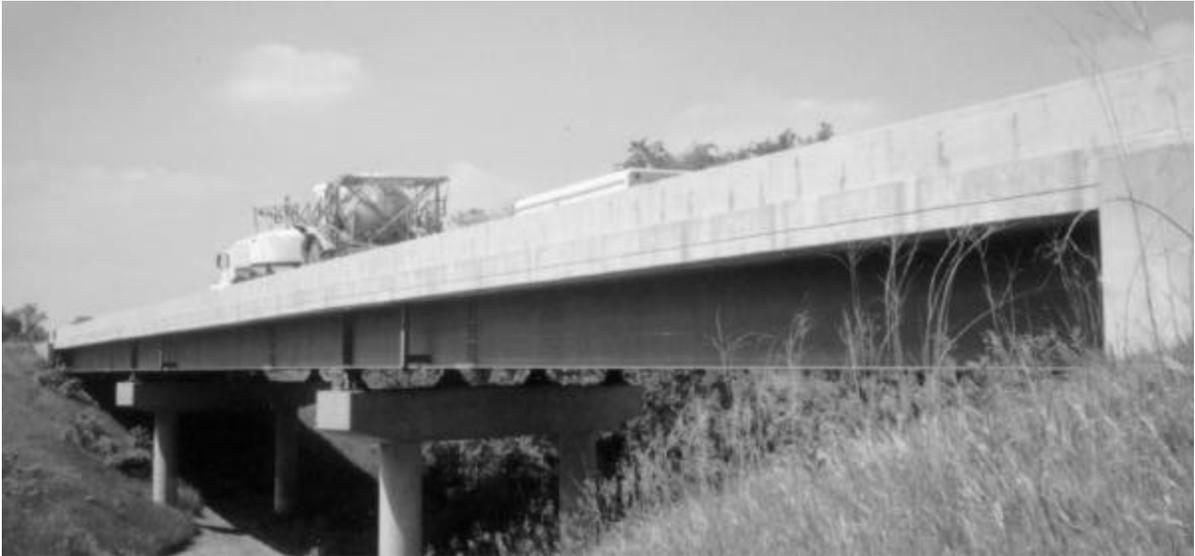
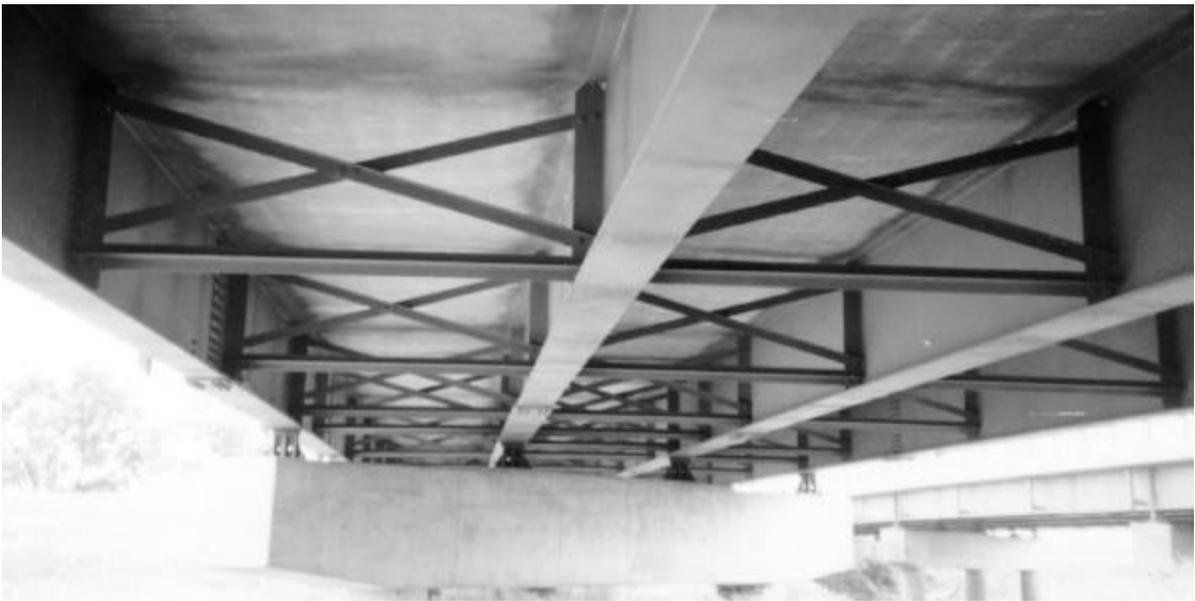
(a) Overview

(b) Diaphragm system

Figure 4. The I-80 Bridge no. 7804.8L080 (Bridge X3)

This bridge (Br. No. 7804.8L080) is located in Pottawattamie County, 3.7 miles (5.9 km) west of the junction of Interstate 80 (I-80) with U.S. 6 Highway. It carries the westbound traffic of I-80 over an abandoned railroad (Figure 4). The bridge was constructed in 1965. The superstructure consists of four continuous steel plate girders topped by a reinforced concrete deck slab. The girders have three spans of 91.5, 117, and 91.5 ft (27.9, 35.7, and 27.9 m), respectively, with a lateral spacing of 9 ft-8 in. (2.9 m) and a total bridge width of 32 ft (9.8 m). The bridge has X-type diaphragms spaced at approximately 22 ft (6.7 m) intervals. The bridge superstructure is skewed 30° , and its supporting two piers and two stub reinforced concrete abutments are supported on piles. Vertical stiffeners are provided at intervals that do not exceed 3 ft-7 in. (1.1 m). Stiffeners are closely fitted to the tension flange with an average web gap height of 1.75 in. (44 mm). Fatigue cracks have been detected in the web gap region at nine locations. As a retrofit, holes were drilled at the crack tips. However, the cracks extended beyond the drilled holes in some locations. Crack extensions were treated by drilling holes at the new crack tip locations. The last fatigue-type inspection of the bridge was in September 1995. The bridge was tested on July 29, 1997. This bridge is referred to as Bridge X3.

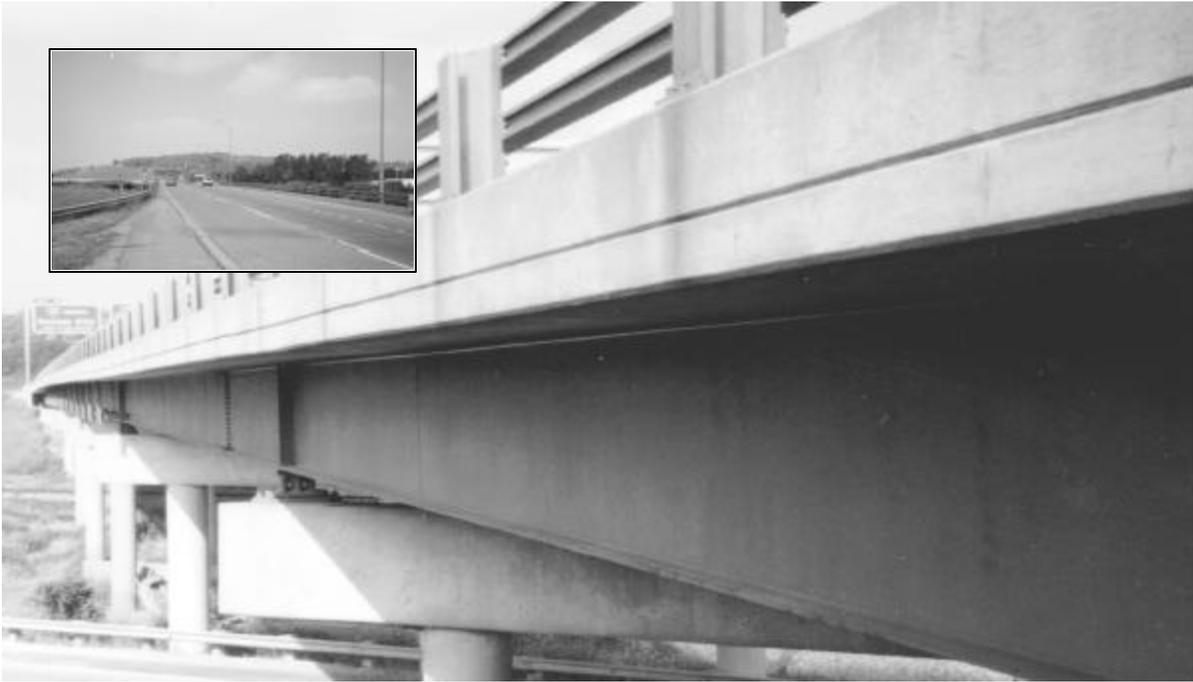
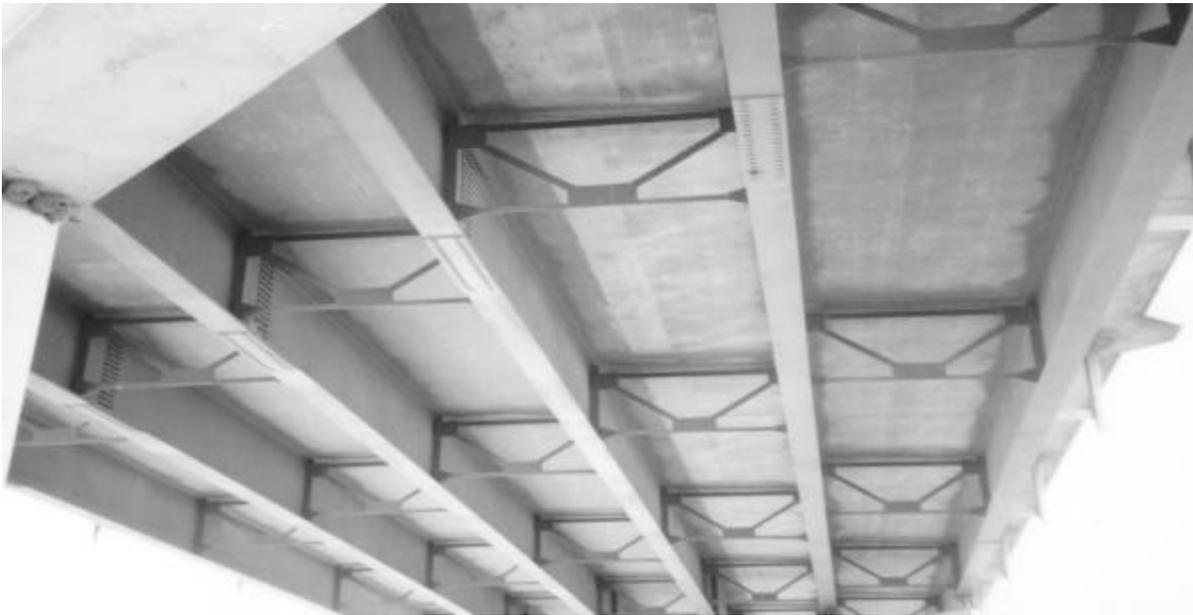
(a) Overview and roadway

(b) Diaphragm system

Figure 5. The I-80 Bridge over the Mosquito Creek (Bridge K1)

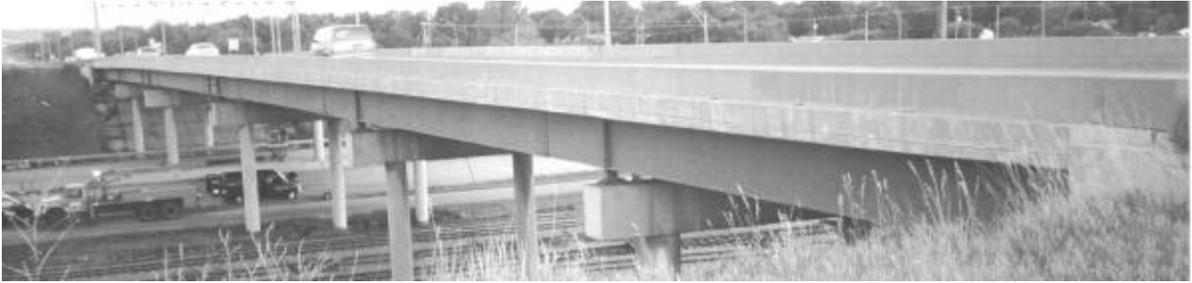
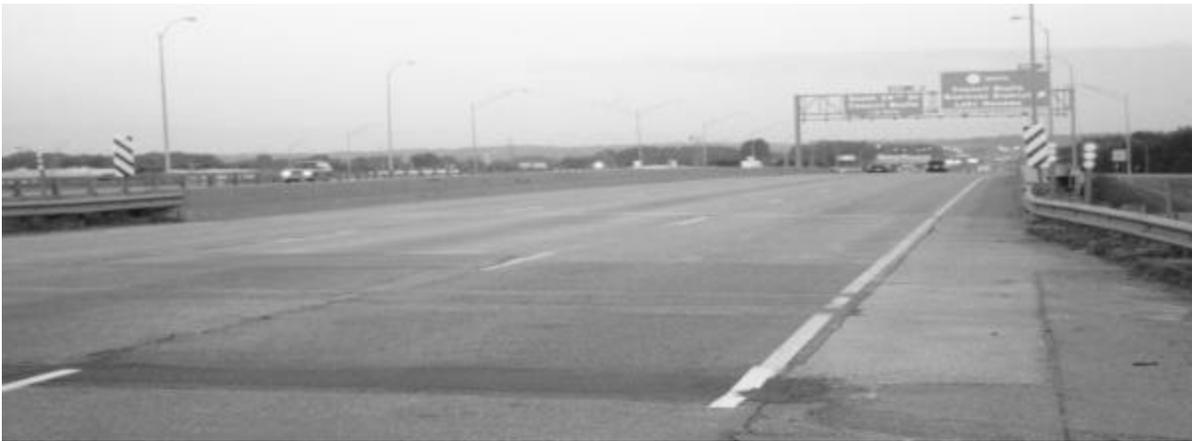
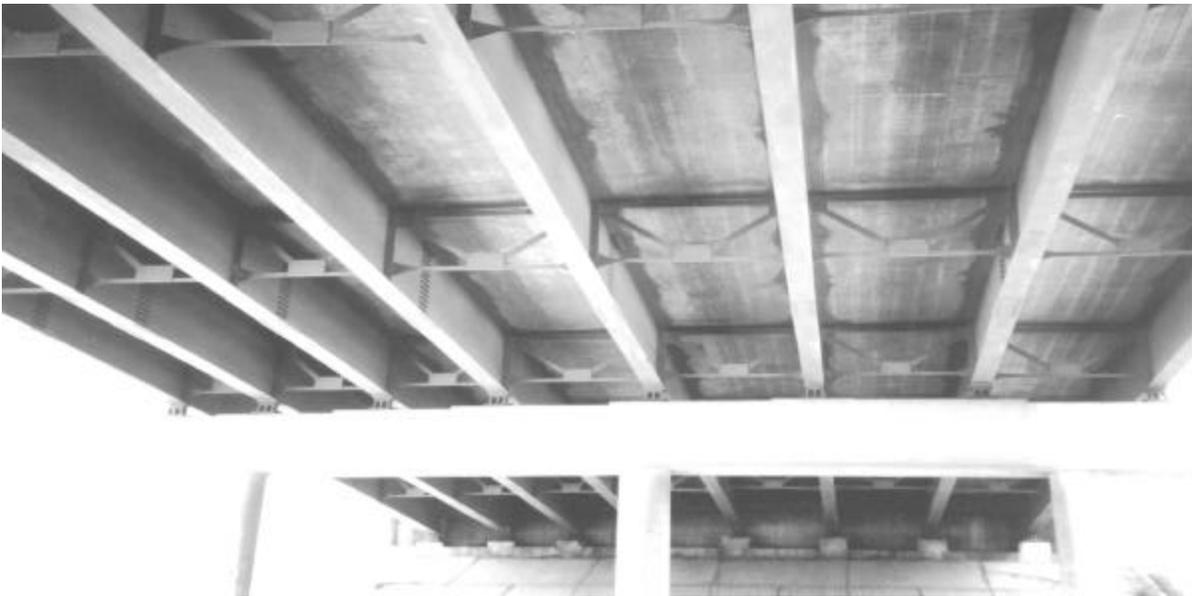
(a) Overview

(b) Roadway

(c) Diaphragm system

Figure 6. The I-80 Bridge over IA-192 (Bridge K2)

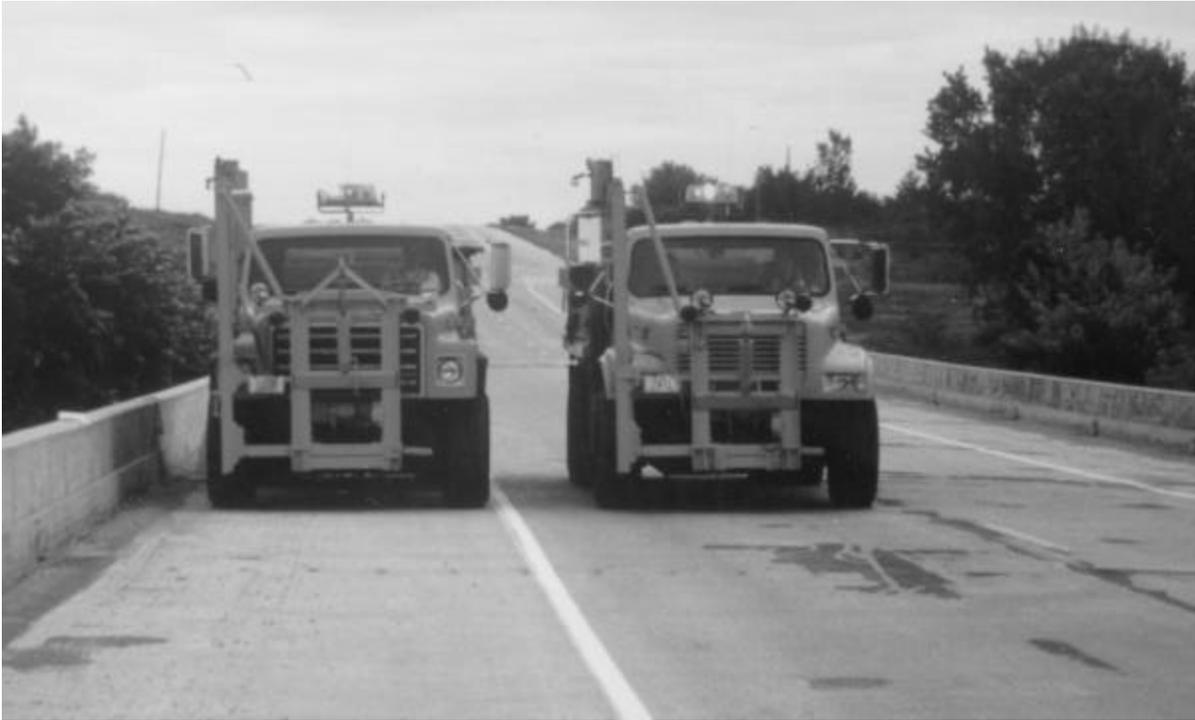
Figure 7. Trucks used for testing Bridge X1

The Iowa DOT provided two loaded rear tandem axle trucks for each bridge (see Figure 7 for trucks used for testing Bridge X1). The majority of the tests (described later) utilized only one truck traveling on the bridge in different lanes and shoulders at speeds varying from 5 mph (8 km/h, crawl speed) to more than 60 mph (96 km/h). For two bridges, however, the two trucks were run side by side in a few tests at the crawl speed. Different trucks were used during tests on different bridges; however, the dimensions and weights were consistently similar. Before testing, each truck was measured and weighed. The gross truck weight ranged from 49 kips (220 kN) to 53 kips (238 kN). Table 1 lists the front axle, rear axle, and gross weights of the test trucks. Although not reported here, additional data were collected during ambient heavy truck traffic.

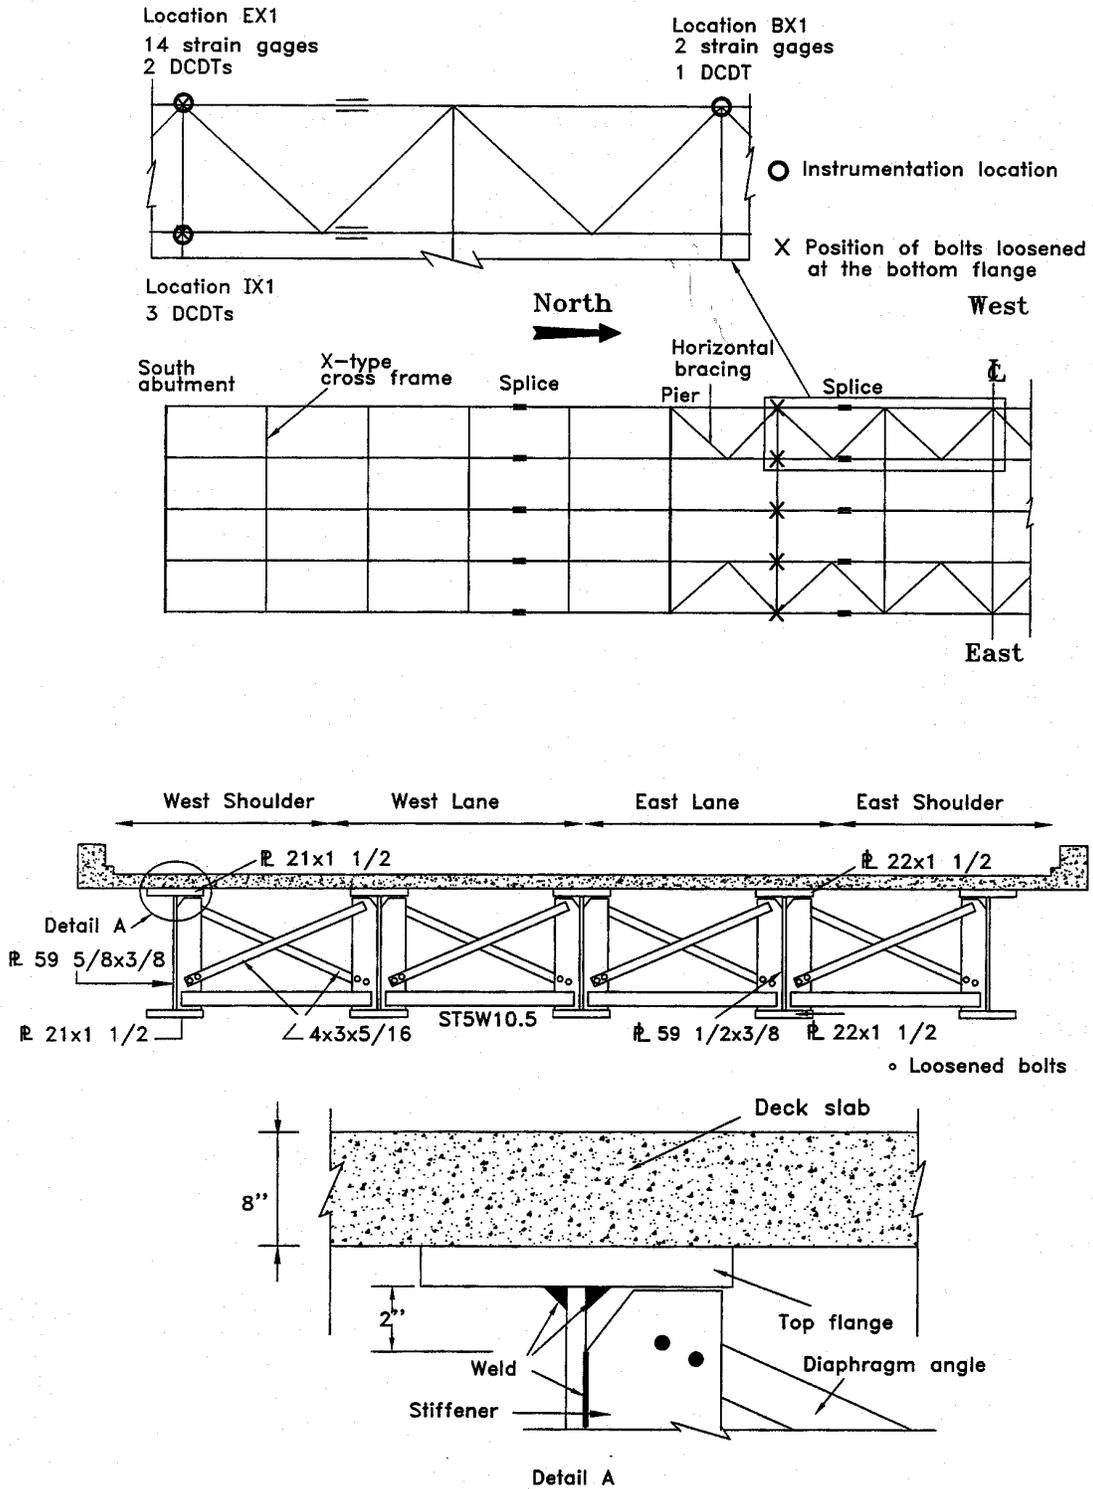
Figure 8. Schematic plan and cross section of Boone River Bridge (Bridge X1) showing instrumentation and loosened bolts locations

For Bridges X1 and X2, 18 tests were conducted (see Table 2 for test description). During testing, ambient traffic was restricted on the bridges. To assess the quasi-static response, a single truck traveling in different lanes and shoulders at crawl speed was used. The dynamic response was recorded for a single truck traveling only in the driving lanes at speeds of 30 and 50 mph (48 and 80 km/h). First, Tests 1-9 were performed (tight condition), then bolts at the chosen locations were loosened, and Tests 10-18 were conducted (loose condition). In Bridge X1, bolts of the lower connections between the diagonal elements and the girders were loosened at the first diaphragm in the intermediate span (see

Figure 8). In Bridge X2, the lower connection bolts of four diaphragms (see Figure 10), in the negative moment region, were loosened to investigate the effects of lateral load distribution to the girders. The north side bolts were kept tight because they could not be accessed safely due to high-speed winds on the test day. During loosening, the strains in the web gaps were monitored continuously.

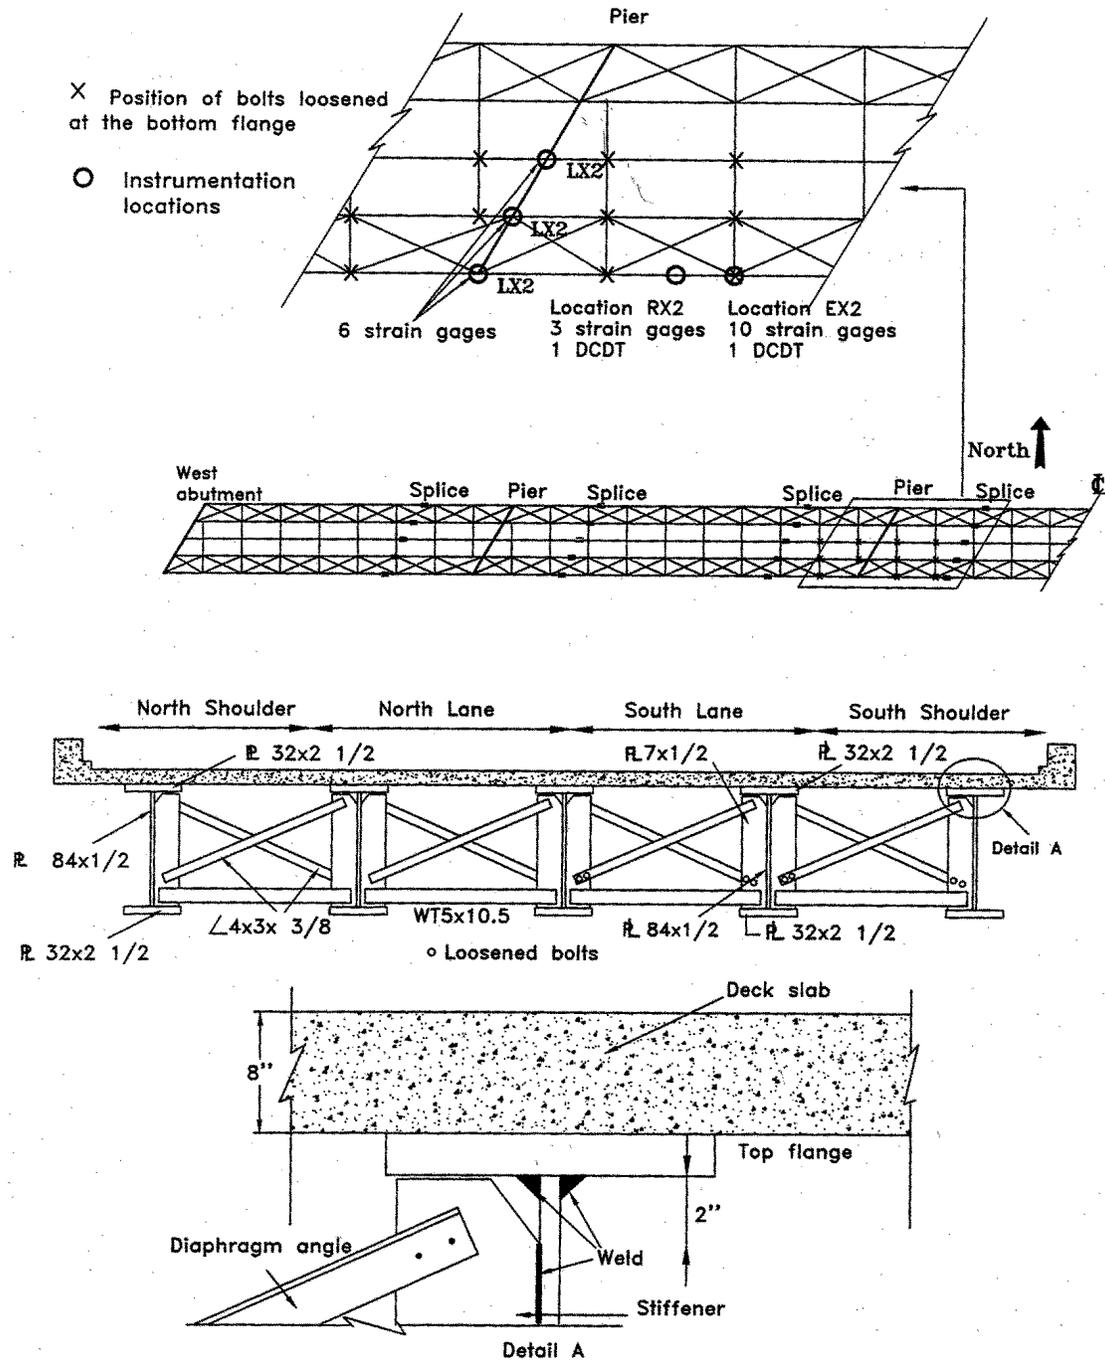
Figure 9. Schematic plan and cross sections of Des Moines River Bridge (Bridge X2) showing instrumentation and loosened bolts locations

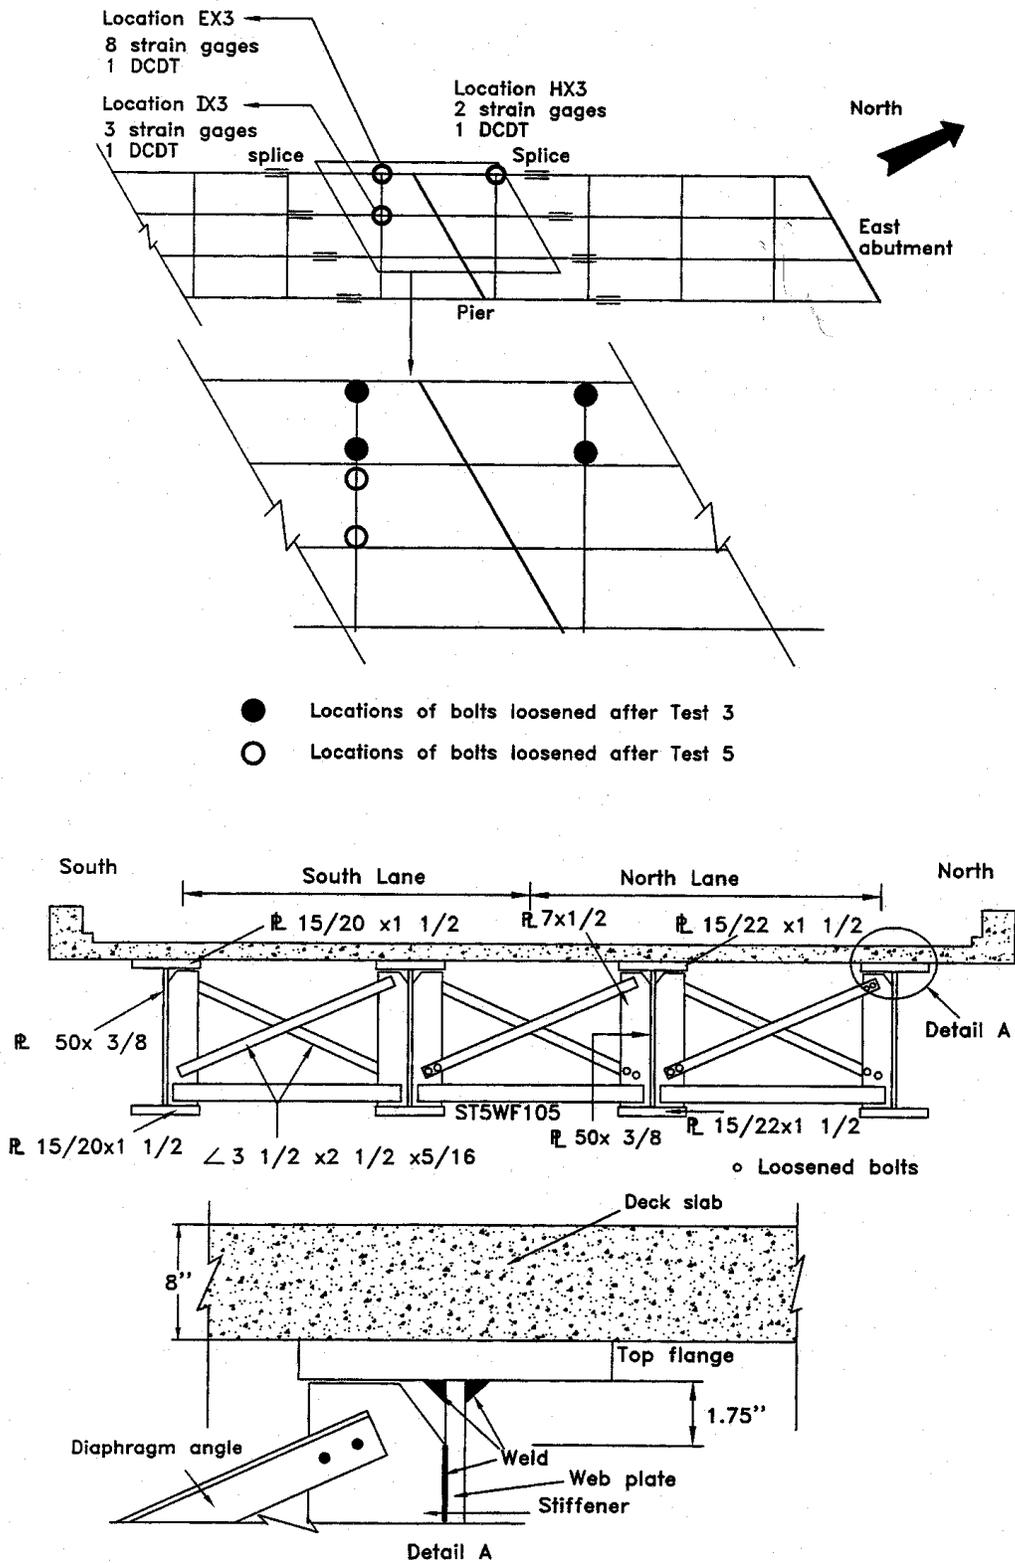
Figure 10. Schematic plan and cross sections of Bridge no. 7804.8L080 (Bridge X3) showing instrumentation and loosened bolts locations

For Bridge X3, eight tests were conducted. Table 4 shows the condition of the bolts and truck speed and position during these tests. With the bolts tight, Tests 1-3 (tight condition) were conducted. After that, the lower connection bolts of the diaphragm diagonals at Locations EX3 and HX3 were completely loosened (see Figure 12). Next, Tests 4 and 5 (partial loose condition) were performed. Partial loosening is defined here as completely loosening the lower connection bolts of the exterior diaphragm panel. These tests allowed an investigation of the effects of loosening the bolts of only exterior panels on the web gap behavior of both exterior and interior girders. Later, the lower connection bolts of the interior panel at Location IX3 were loosened and Tests 6 and 7 (loose condition) were conducted.

To investigate the effect of loosening the bolts of all connections (upper and lower), the upper connection bolts of the exterior diaphragm panel at Location EX3 were loosened and Test 8 (called all bolts loose) was conducted.

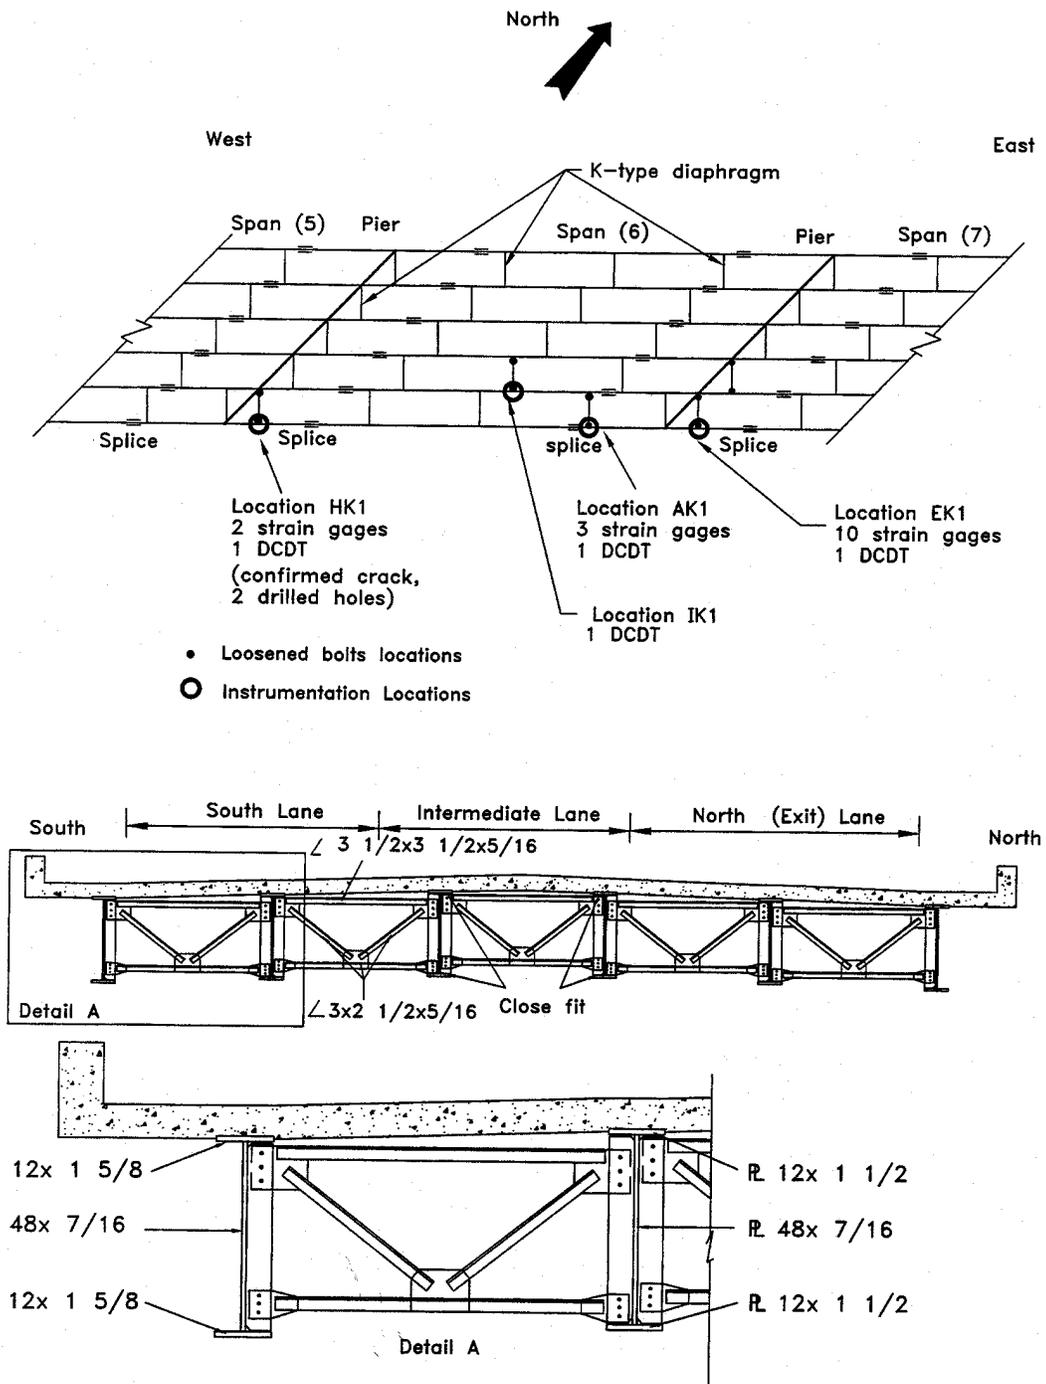
Figure 11. Schematic plan and cross sections of Mosquito Creek Bridge (Bridge K1) showing instrumentation and loosened bolts locations

Table 5 shows the arrangement of the seven tests performed on Bridge K1. All tests were conducted using a single truck. First, Tests 1-4 (tight condition) were conducted. After these tests, the six bolts of the upper connections between the diaphragms and the girders were loosened at the locations marked in

Figure 13. As the nuts were loosened, the diaphragm panel at Locations EK1 and AK1 rotated about a transverse axis passing through the lower connection bolts. This caused the top bolts of the upper connections to bear against their holes even with the nuts totally removed. Next, Tests 5-7 (loose condition) were conducted. Truck speed ranged from 40 to 60 mph (64 to 96 km/h).

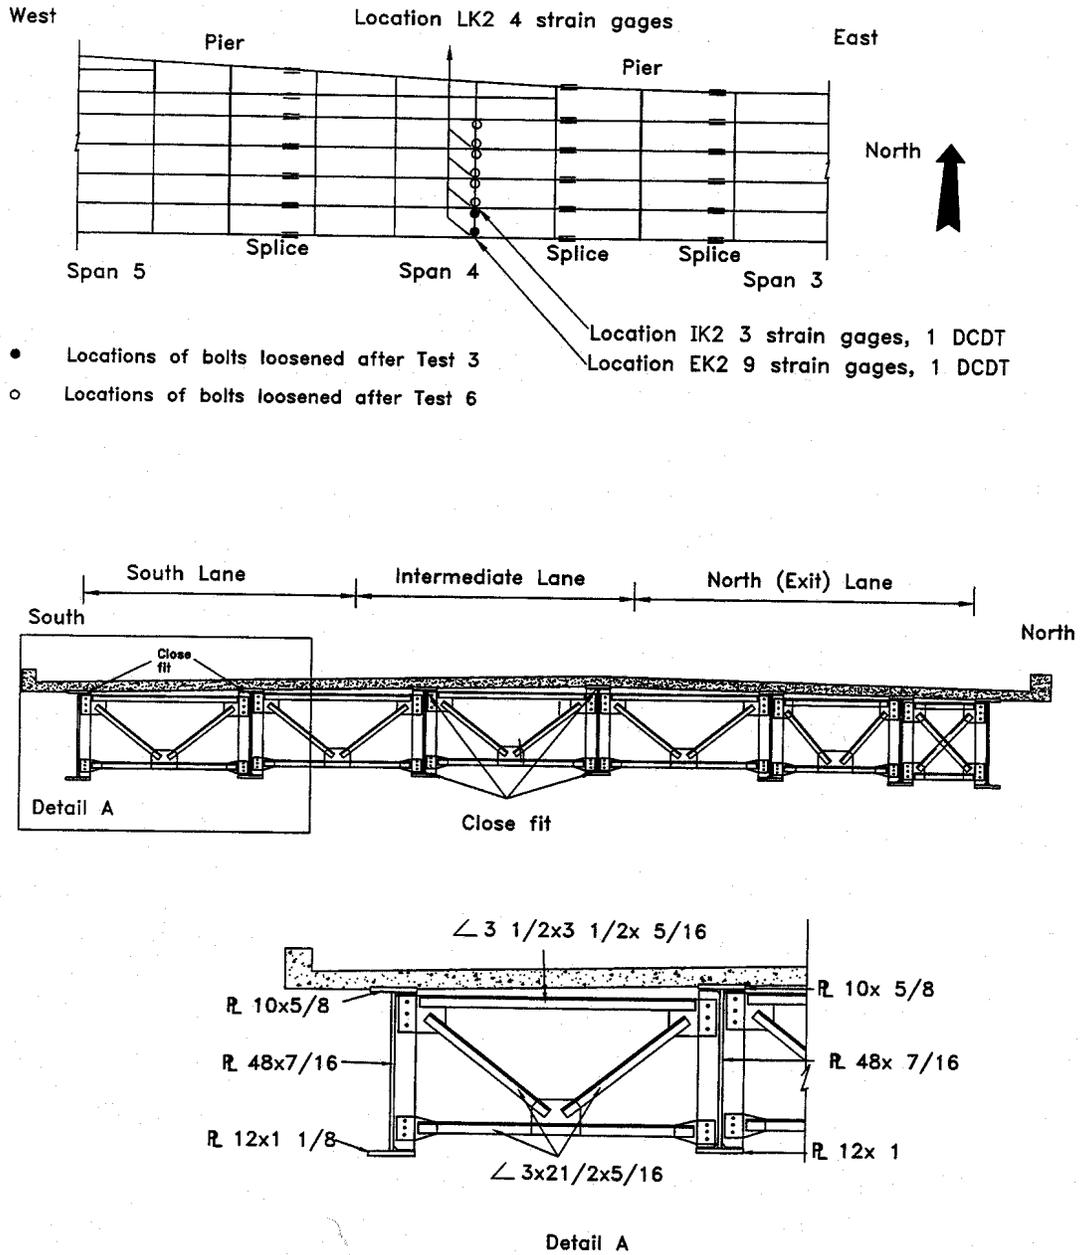
Figure 12. Schematic plan and cross sections of IA-192 Bridge showing instrumentation and loosened bolts locations

For Bridge K2, ten tests were conducted as shown in Table 6. All tests were conducted using a single truck. With the bolts tight, Tests 1-3 (tight condition) were conducted. Next, the six upper-connection bolts that attach the exterior diaphragm panel to the stiffeners of both the exterior and interior girders were loosened (see Figure 14). Tests 4-6 (partial loose condition) were conducted. Later, the upper connection bolts in three interior panels through the fifth girder were loosened and Tests 7-9 (loose condition) were conducted. Afterwards, the lower connection bolts of the exterior diaphragm panel between the exterior and interior girders at Location EK2 were loosened. Then, Test 10 (all bolts loose) was conducted. Truck speed ranged from 45 mph (72km/h) to 65 mph (104 km/h) during different tests. Additional data were collected during passage of heavy trucks on the bridge.

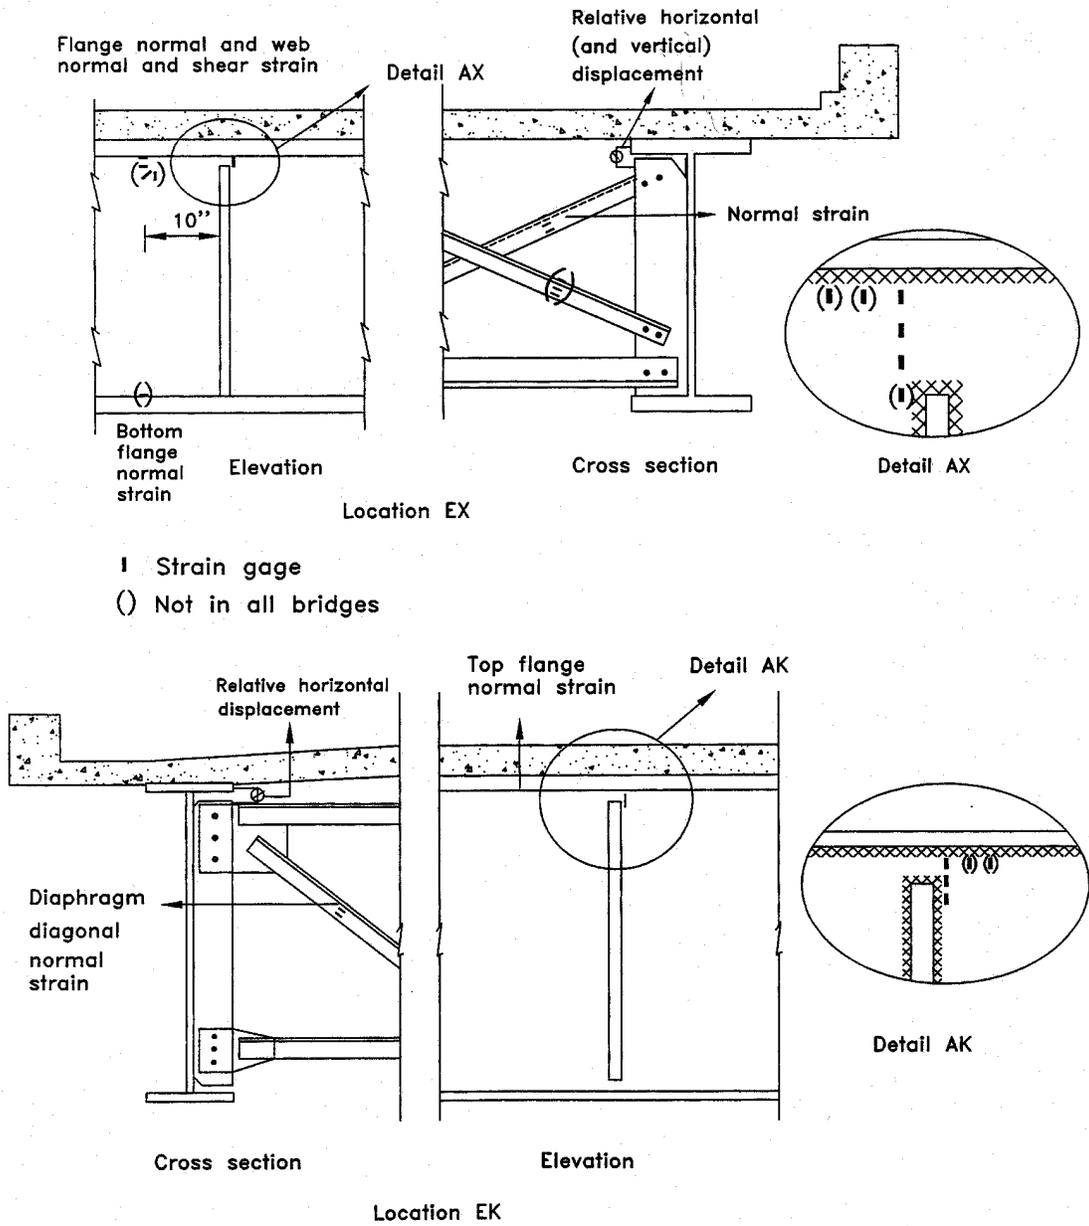
Figure 13. Typical EX and EK instrumentation details

Typical instrumentation details for these gaps in X- or K-type diaphragm bridges are shown in Figure 15. Each location was instrumented with 8 to 14 strain gages and one or two displacement transducers to record the following: (1) strains in the web gap region due to out-of-plane deformation, (2) strains in diaphragm diagonal(s), (3) girder flange and web strains remote from the local effect of the out-of-plane distortion, and (4) amount of out-of-plane distortion. It must be noted that strains in the web gap regions would be expected to be highest at the toe of the top flange to web weld; however, it was not possible to place strain gages exactly at these locations. Strain gages were placed as close as possible to the vertical stiffener with the centerline of the gage within 0.5 in. (13 mm) from the edge of the stiffener plates. The top gages were within 0.63 in. (16 mm) from the bottom of the top flange. Closer distances were not possible because of the weld connecting the web to the top flange. In some locations, additional gages were used to allow extrapolating the recorded strains to obtain the values at the most critical locations (inside the gap at the weld toes).

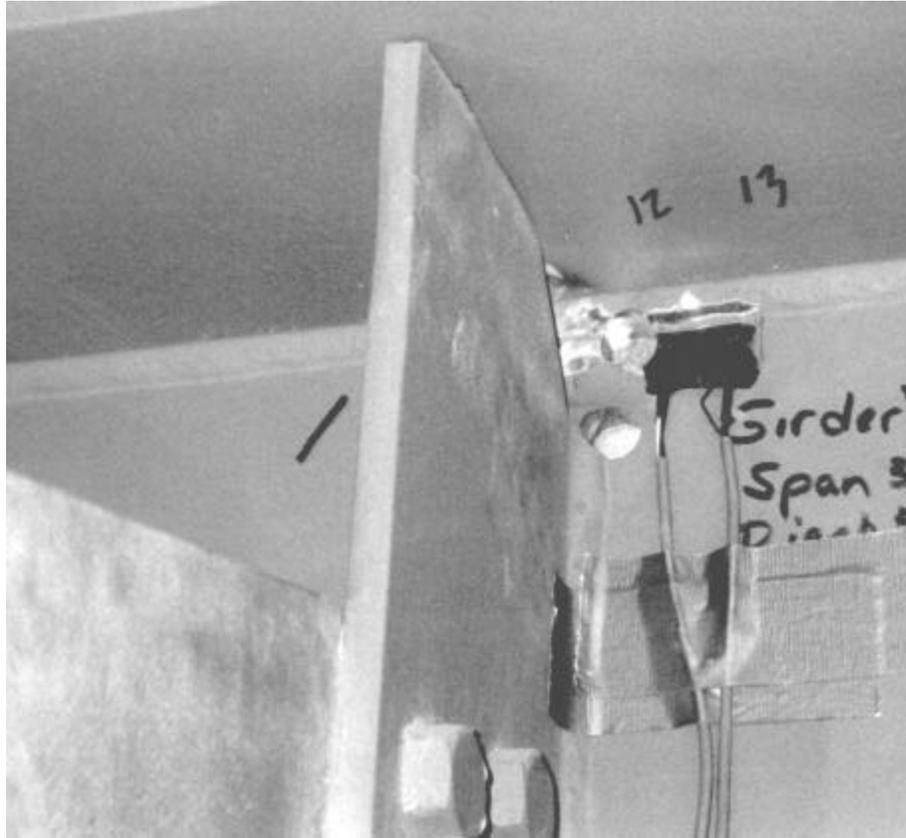
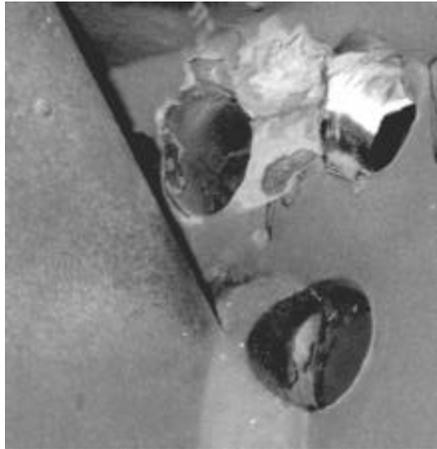
(a) Overview

(b) Drilled holes and cracks

Figure 16. Crack and drilled holes at Location HX3

In addition, for bridges where holes were drilled, sensors were located at the cracked web gap (with diaphragm connection in the negative moment region) with the greatest out-of-plane moments. These are Locations HX3 and HK1 for Bridges X3 and K1, respectively. Figure 16 is a photo for Location HX3 with horizontally oriented cracks and drilled holes. In these locations (HX3 and HK1), the horizontal distribution of the out-of-plane distortion strains and the horizontal out-of-plane displacement were measured. Web gaps of interior girders in the negative moment regions are also susceptible to fatigue cracking. Therefore, four locations were instrumented: IX1, IX3, IK1, and IK2, respectively. At these locations, the out-of-plane distortion was recorded. Further, the strain distribution in the web gap region due to the out-of-plane distortion was measured (using at least three strain gages) in all of them except Location IX1. For Location IX1, two vertically oriented displacement transducers were attached on either side of the web to measure the relative vertical displacement between the flange and the web.
