PREVENTING CRACKING AT DIAPHRAGM/PLATE GIRDER CONNECTIONS IN STEEL BRIDGES

Sponsored by the
Iowa Department of Transportation
and the Iowa Highway Research Board
Iowa DOT Project HR-393

JUNE 1998

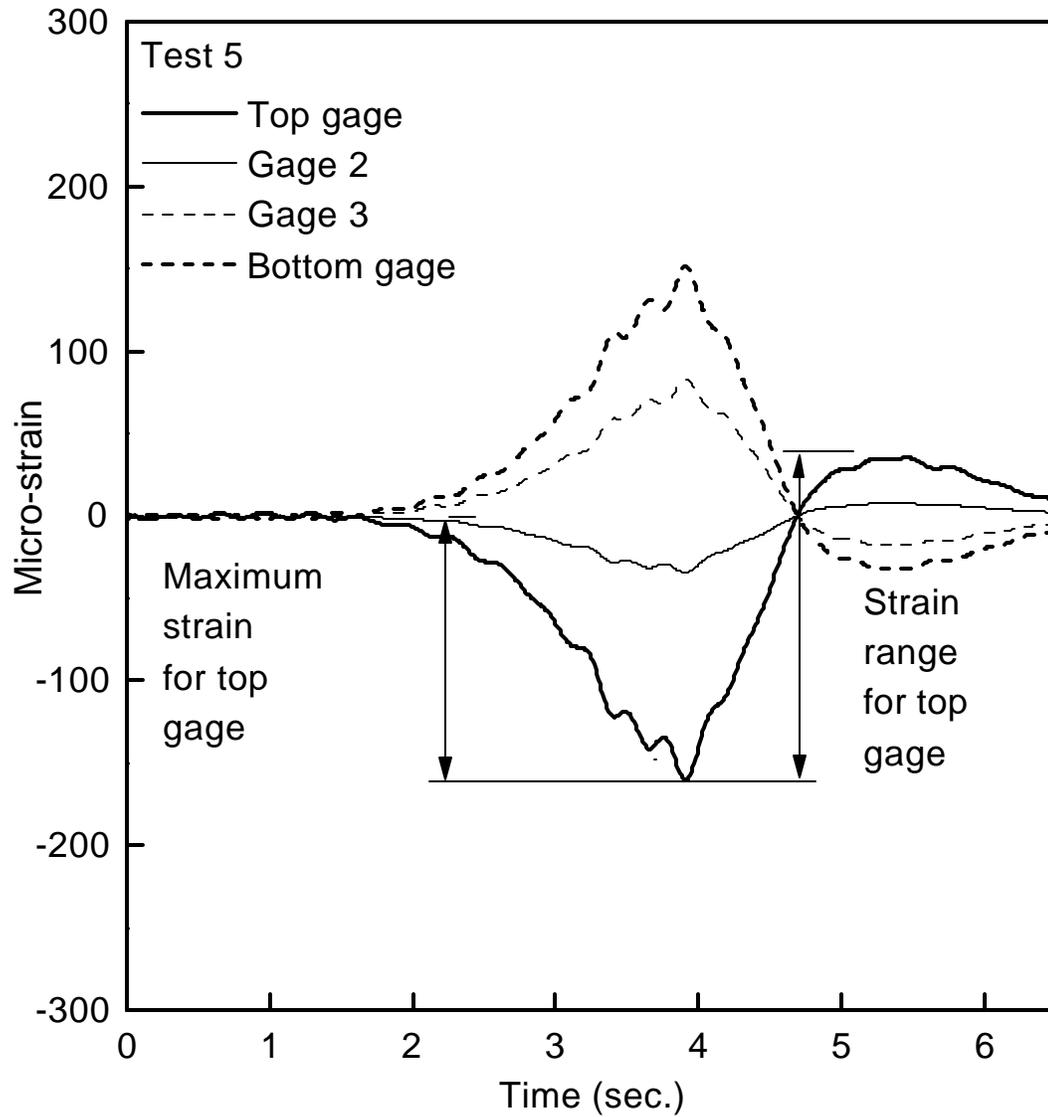
Figure 17. Strain recorded in the web gap region at Location EX1 during Test 5

Figure 17 shows the strain readings of the four gages installed in the web gap at Location EX1 during Test 5. Like all strain plots, it is characterized by a single maximum value followed by a small rebound strain. During Test 5, the maximum recorded strain for Gage 1 was 160 micro-strain (4.64 ksi or 31.97 mPa). This figure illustrates how the strain range is estimated. Strain range is an absolute value with no associated sign. After graphically finding the strain range, the stress range is estimated as described in the previous chapter.

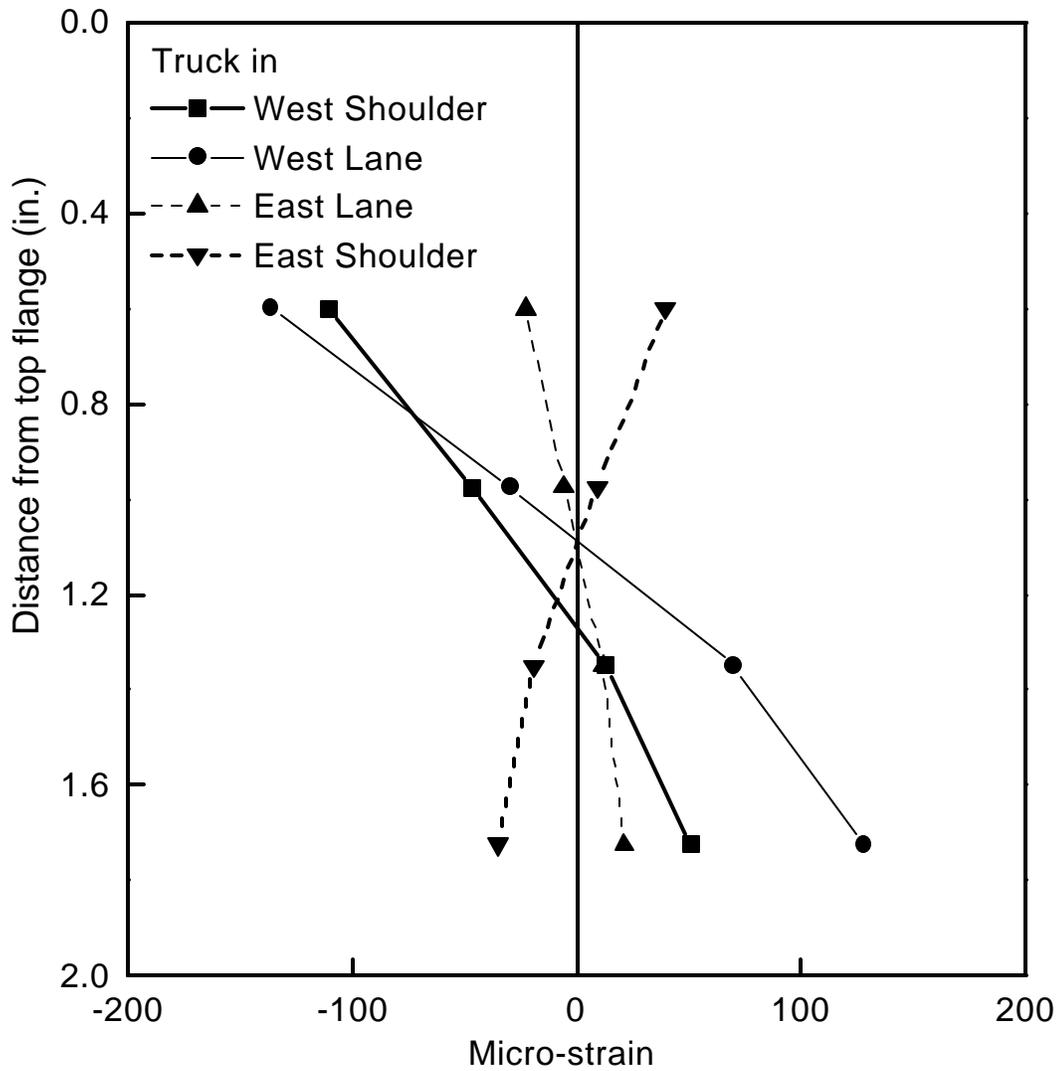
Figure 18. Vertical profile of the maximum strains in the web gap at Location EX1 during Tests 1-4

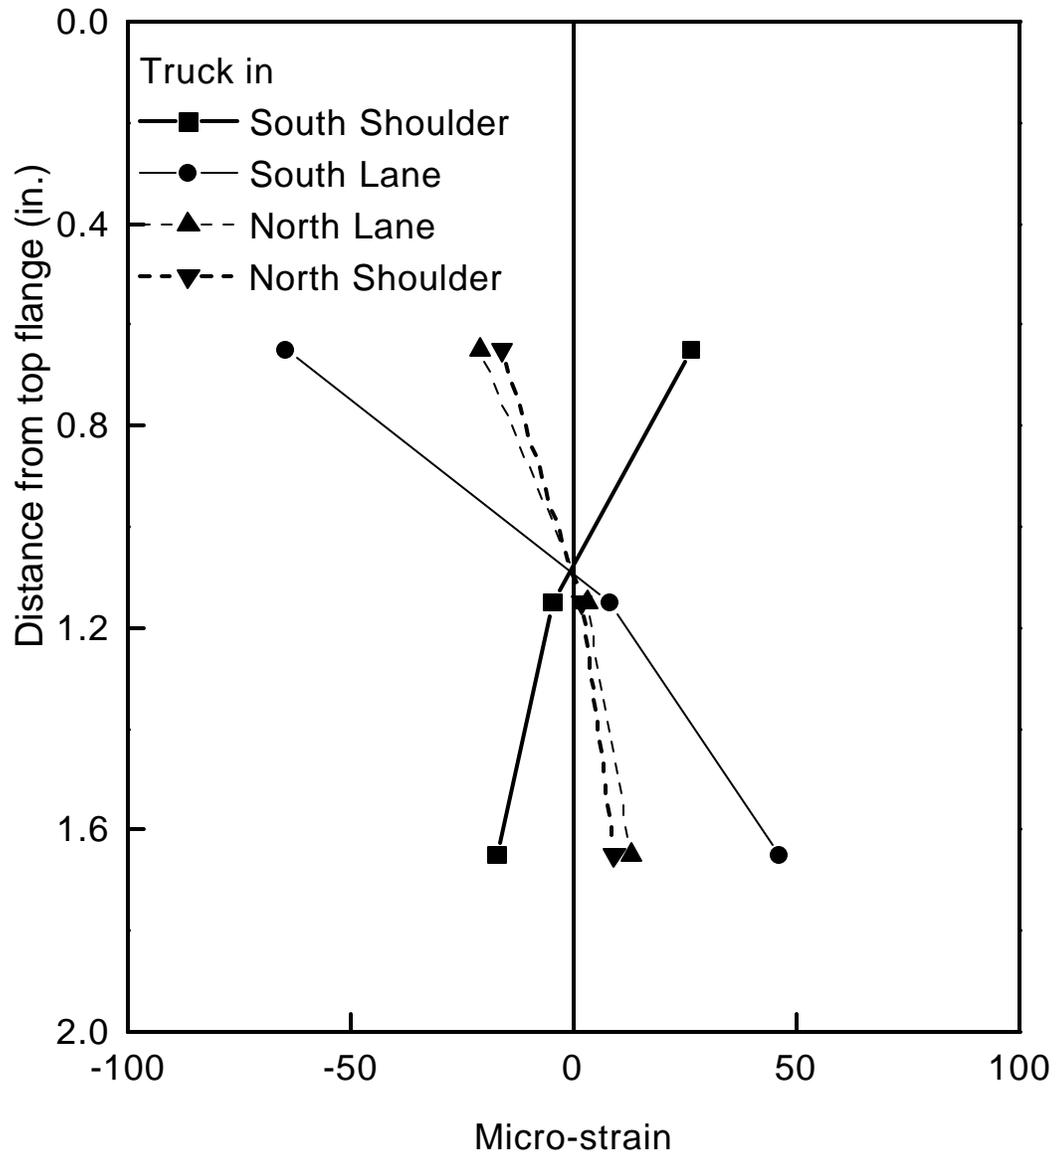
Figure 19. Vertical profile of the maximum strains in the web gap at Location EX2 during Tests 1-4

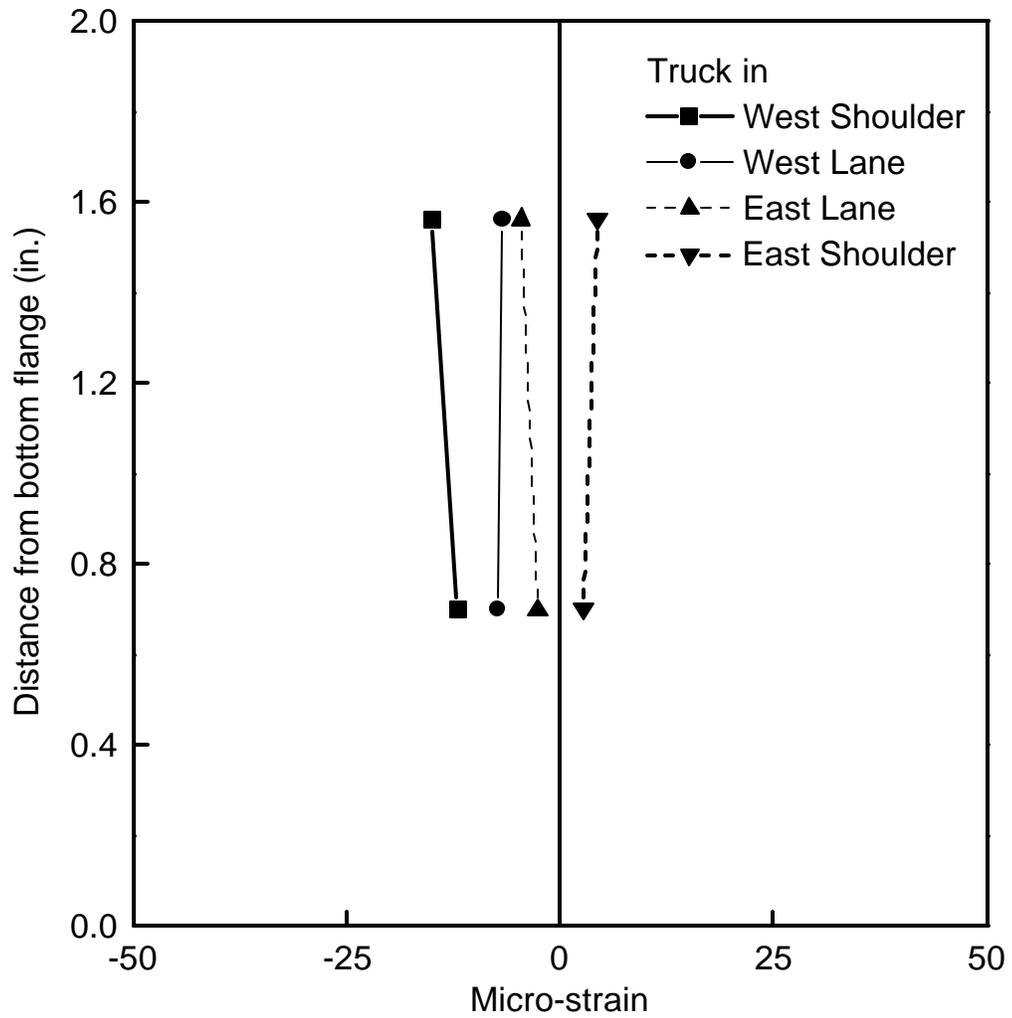
Figure 20. Vertical profile of the maximum strains in the web gap at Location BX1 during Tests 1-4

that the strains and stresses, in addition to being location dependent, are bridge dependent. At Location BX1 near the bottom flange in the positive moment region, the strain distribution in the web gap is shown in Figure 20. The distribution did not exhibit bending behavior. The values of these strains are less than 10% of those at Location EX1 in the negative moment region, explaining why it is more likely that a web gap in the negative moment region would crack.

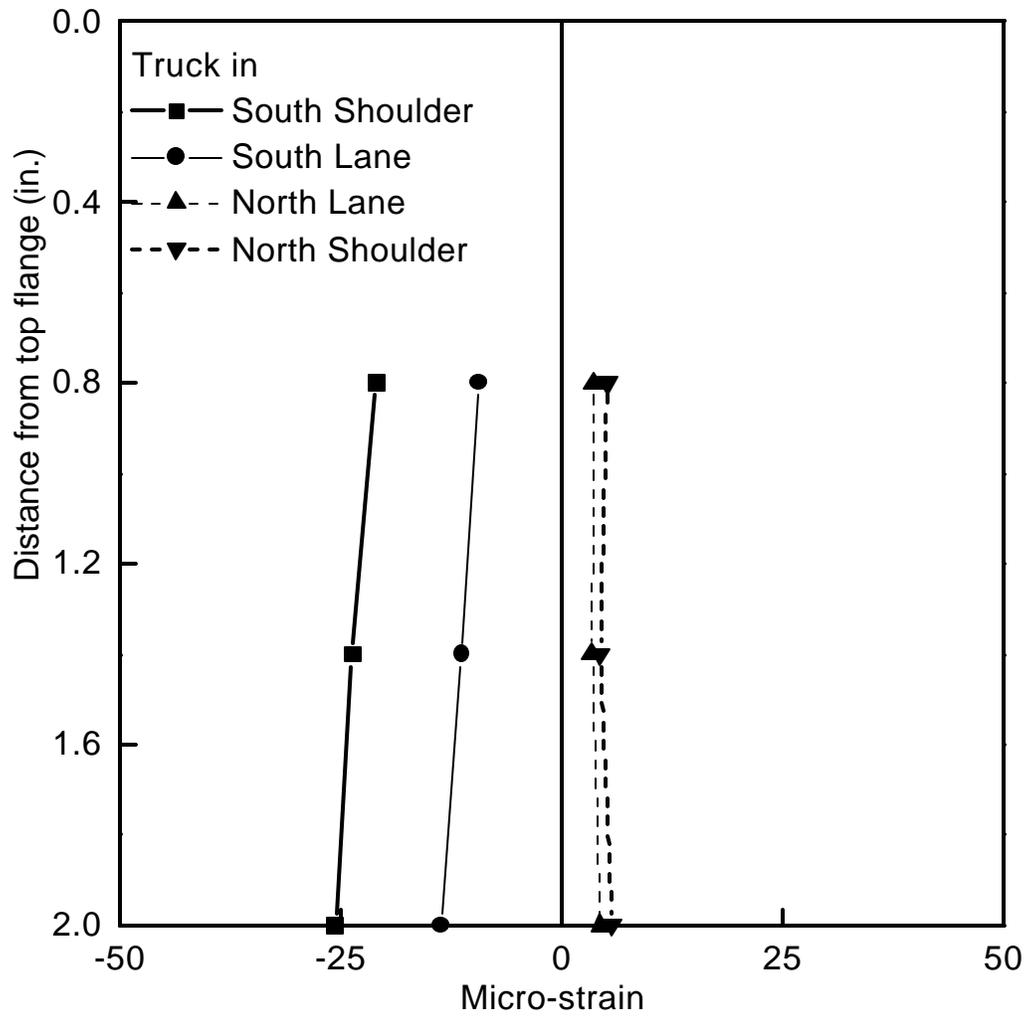
Figure 21. Vertical profile of the maximum strains in the web gap at Location RX2 during Tests 10-13

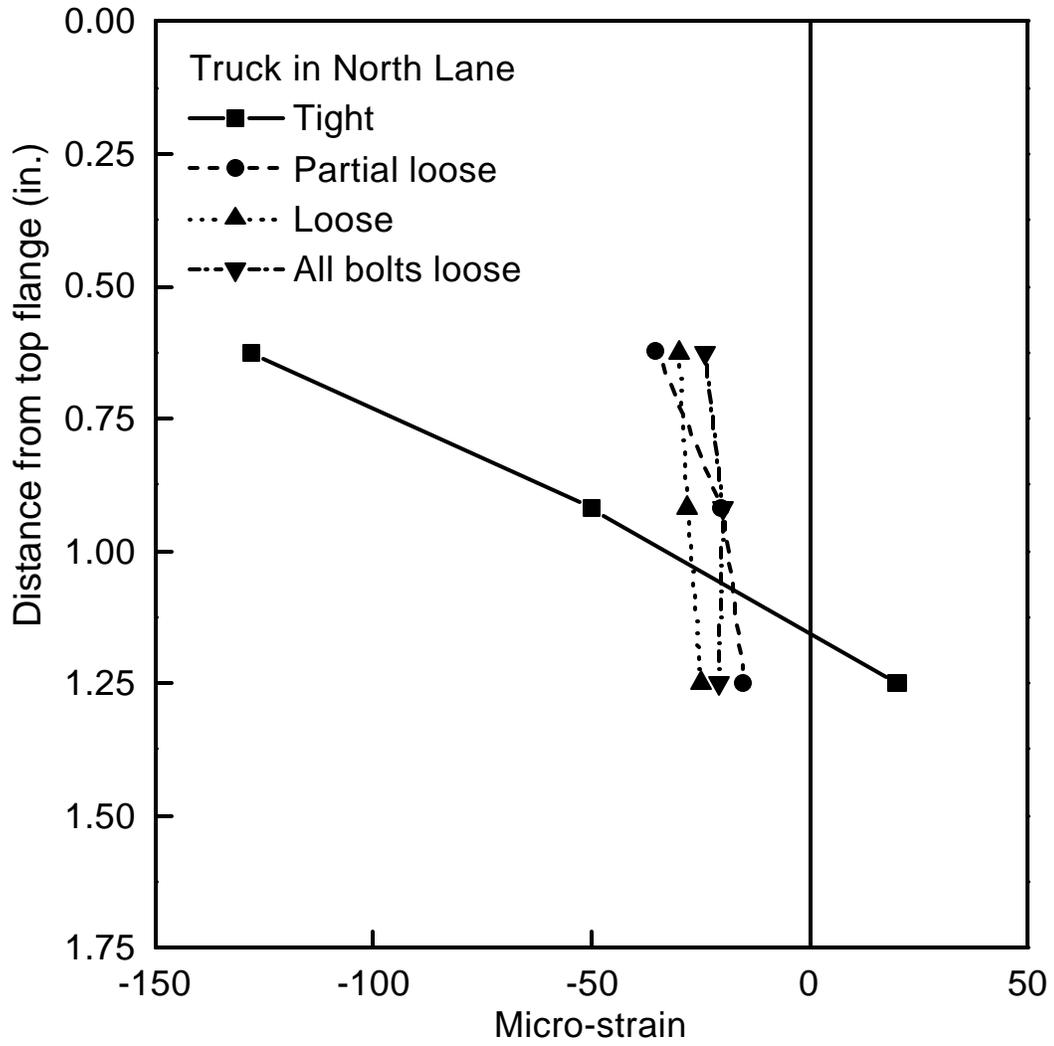
Figure 22. Comparison among maximum strains at Locations EX3 during Test 2 (tight), Test 5 (partial loose), Test 7 (loose) and Test 8 (all bolts loose)

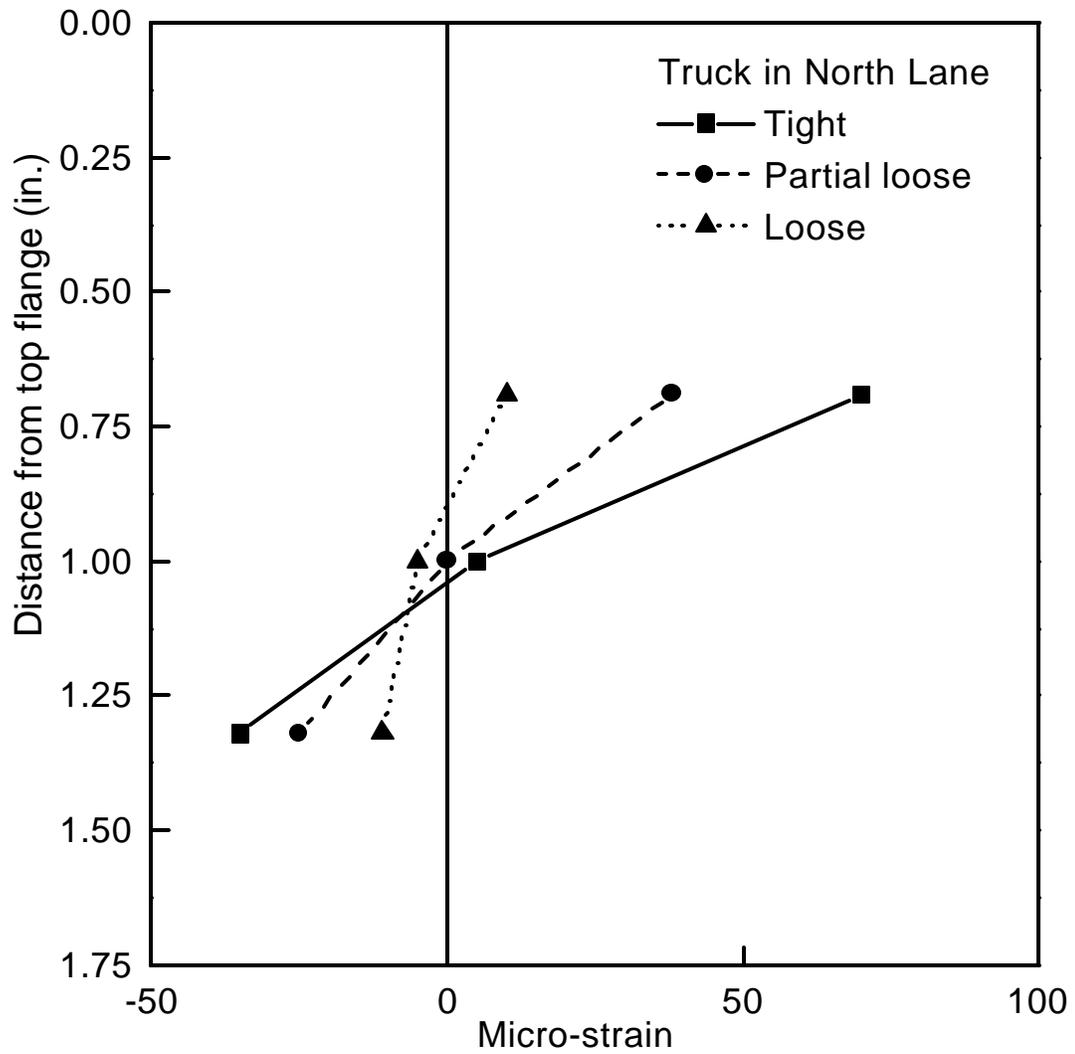
Figure 23. Comparison among strains before and after loosening the bolts at Location IX3

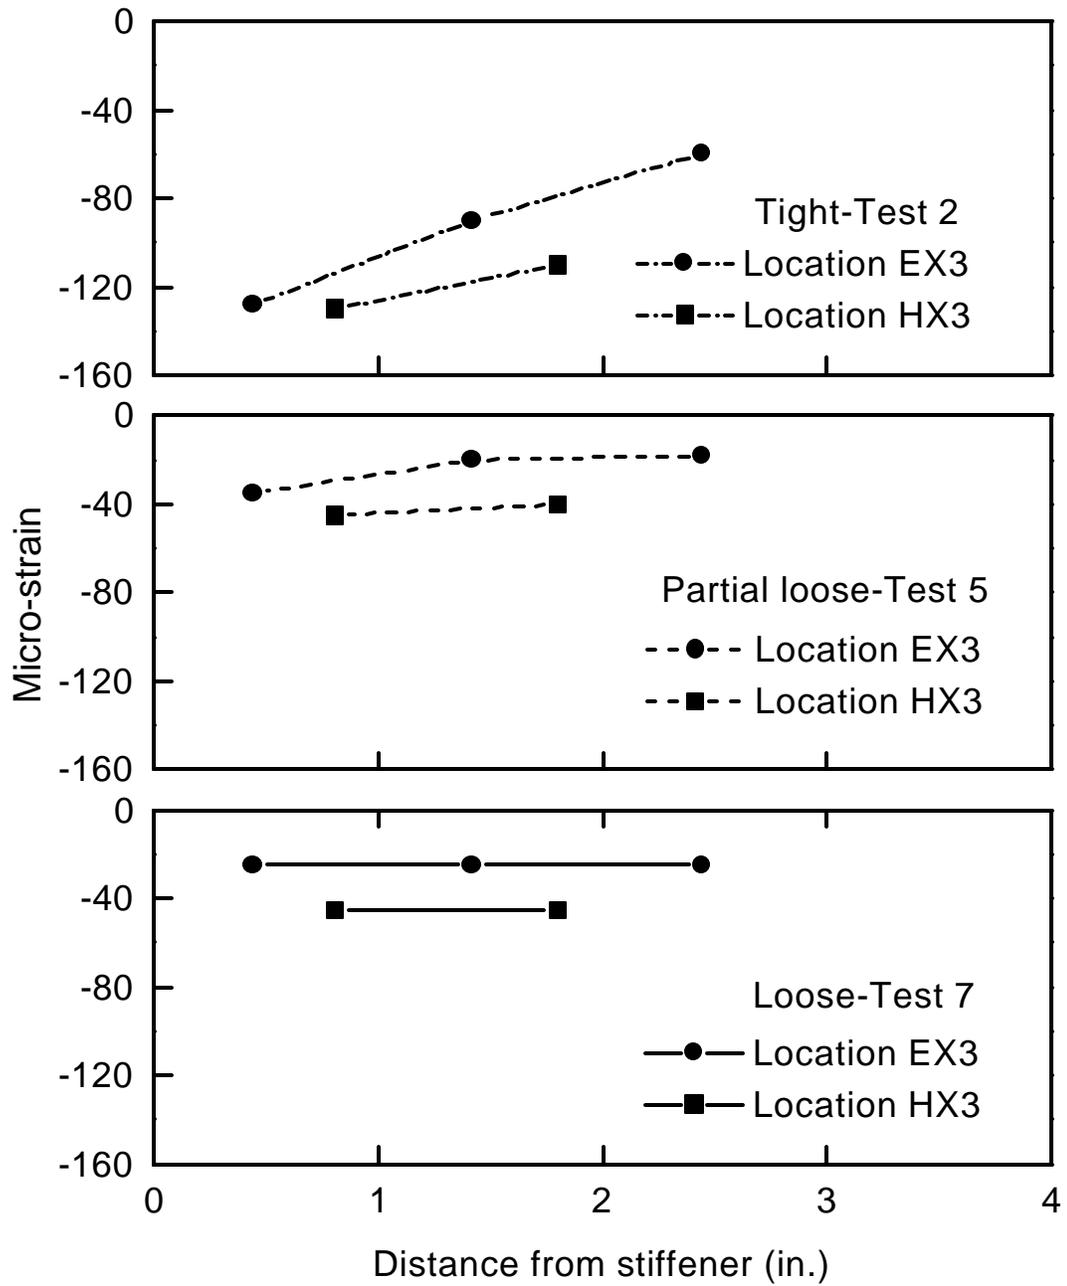
Figure 24. Horizontal profile of maximum vertical strains in the web gap of Locations EX3 and RX3 during Tests 2 (tight), 5 (partial loose), and 7 (loose)

To illustrate the local effect of the out-of-plane distortion and the effect of the proposed method, the horizontal distribution of the resulting strains is plotted in Figure 24 for Locations EX3 and HX3 for both tight and loose conditions. With the bolts tight, the

strains gradually increased towards the stiffener plate. After loosening the bolts, however, the strain distribution was nearly constant, implying that the local effect had diminished. Linear extrapolation of the recorded strains at Location EX3 showed that a maximum projected strain of 220 and 180 micro-strains, or 6.38 and 5.22 ksi (43.96 mPa, 35.97 mPa), would have occurred at the longitudinal flange to web weld toe and stiffener to web weld toe, respectively. That explains why most web cracks resulting from out-of-plane distortion initiate at either of these two locations.

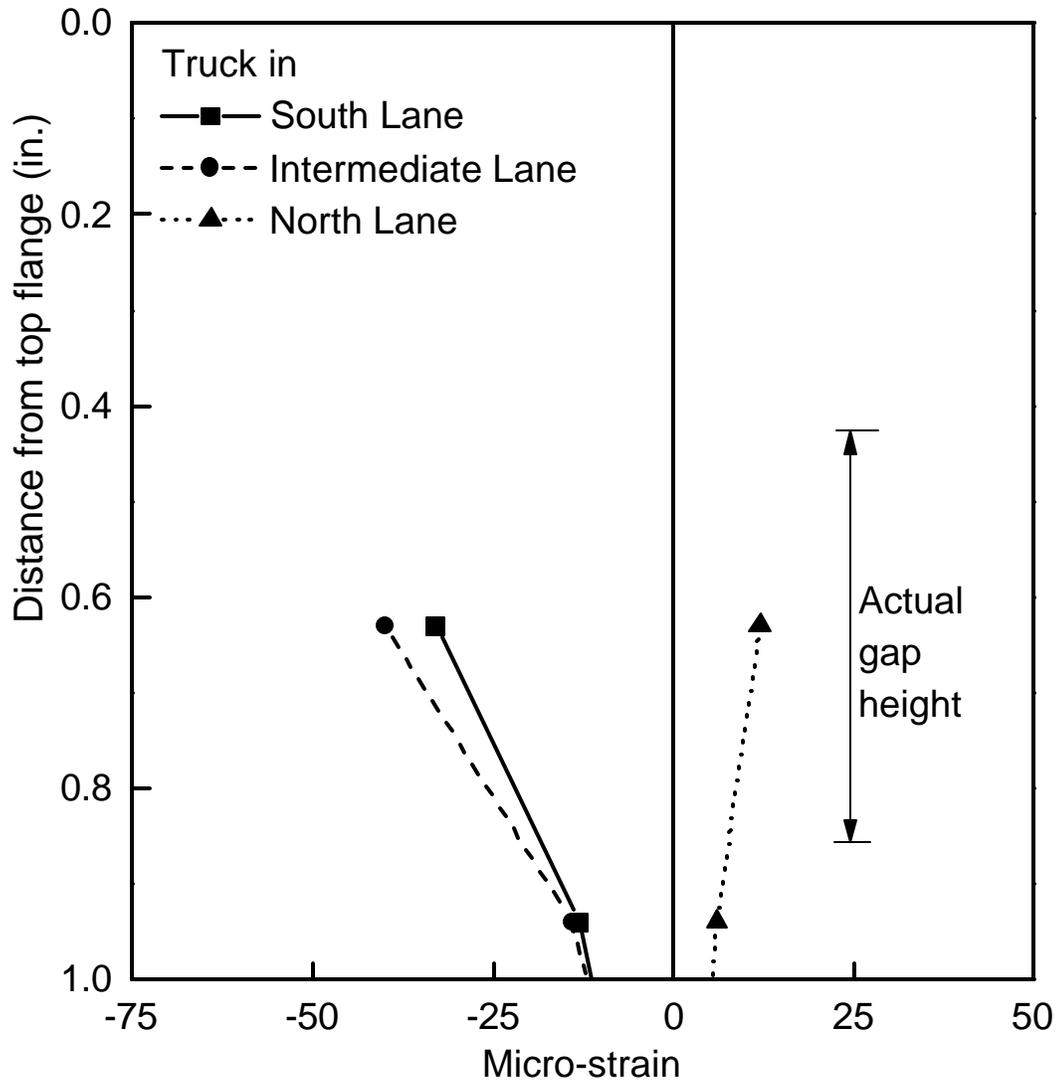
Figure 25. Vertical profile of maximum strains in the web gap at Location EK1 during Tests 1-3 (tight condition tests)

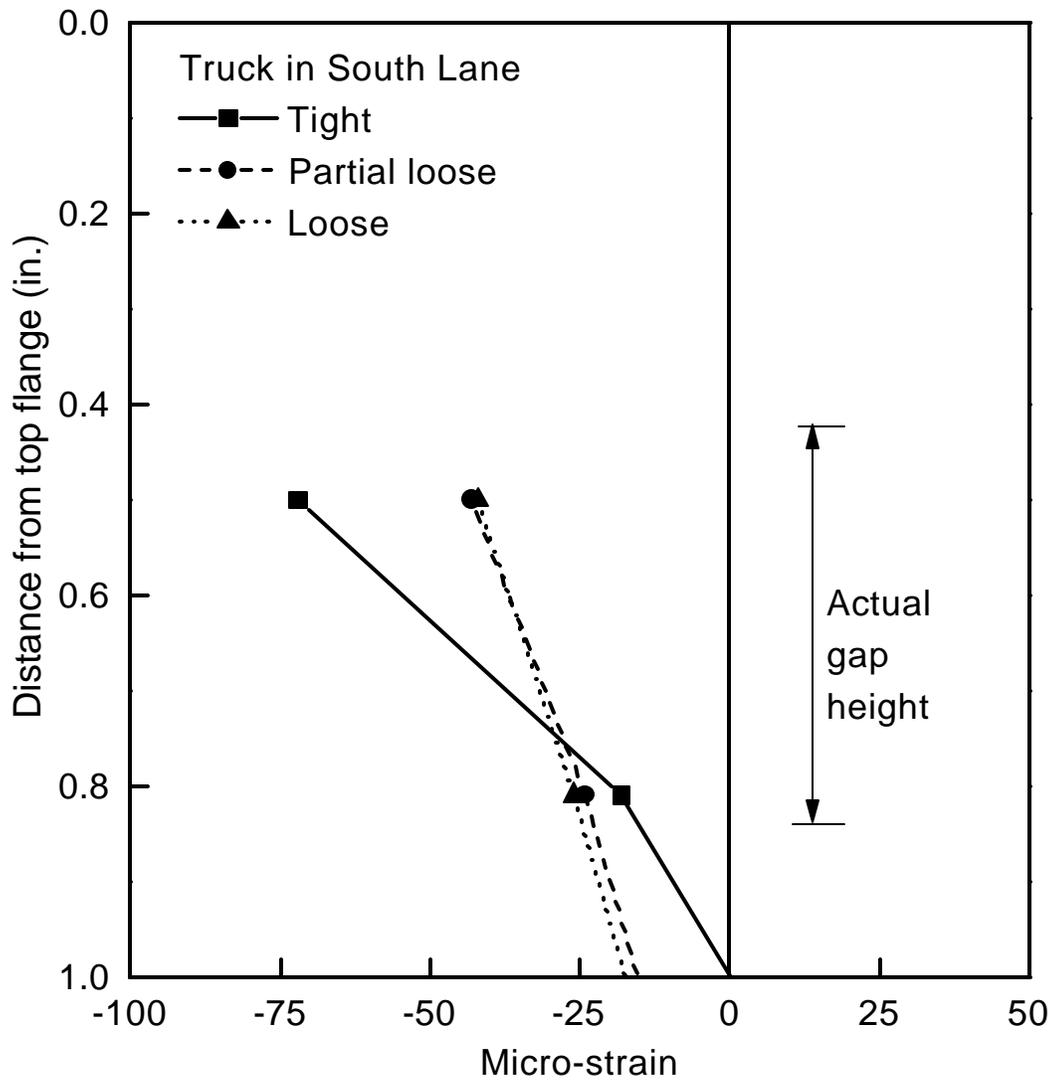
Figure 26. Vertical profile of the maximum strains in the web gap at Location EK2 during Test 1 (tight), Test 4 (partial loose), and Test 7 (loose)

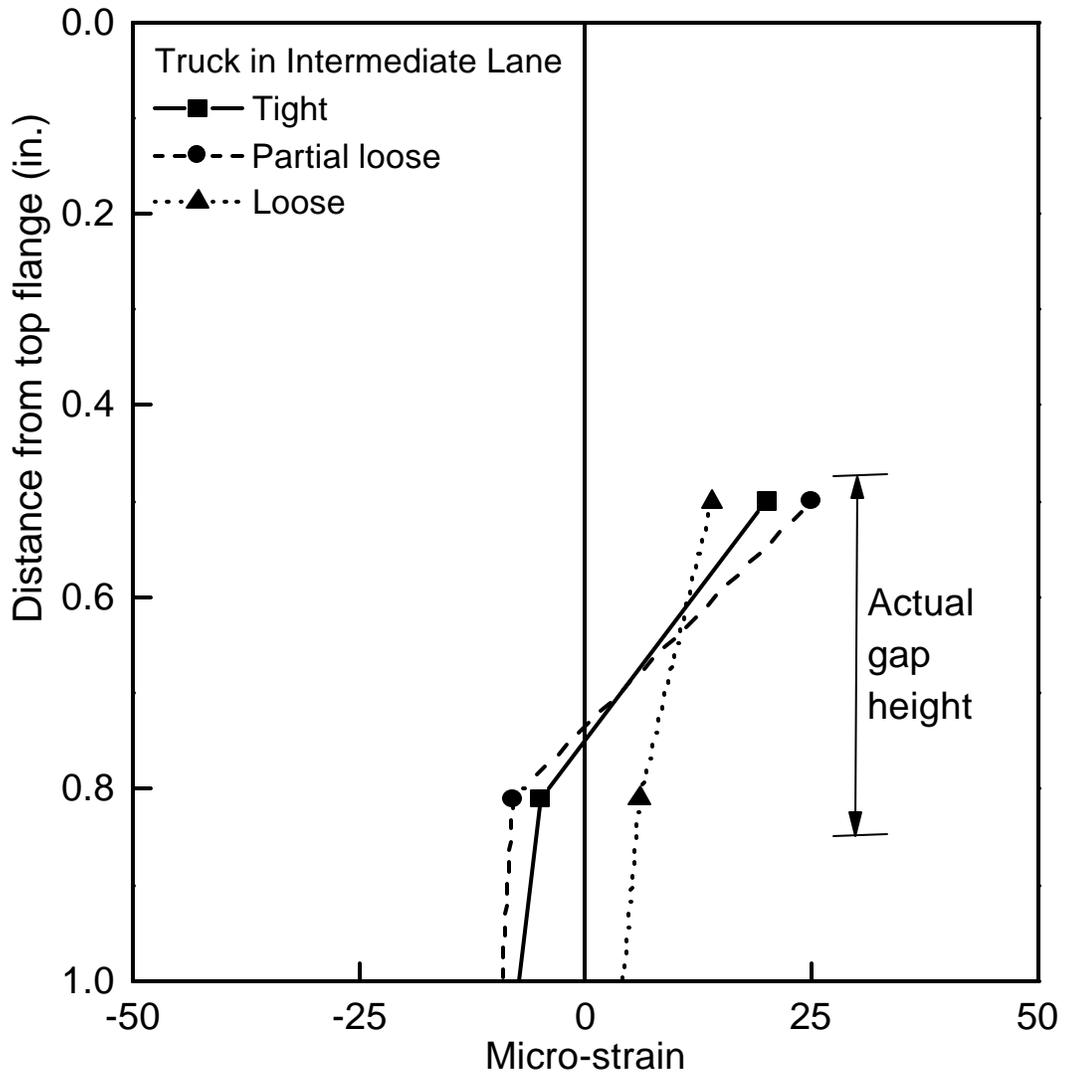
Figure 27. Vertical profile of the maximum strains in the web gap at Location IK2 during Test 2 (tight), Test 5 (partial loose), and Test 8 (loose)

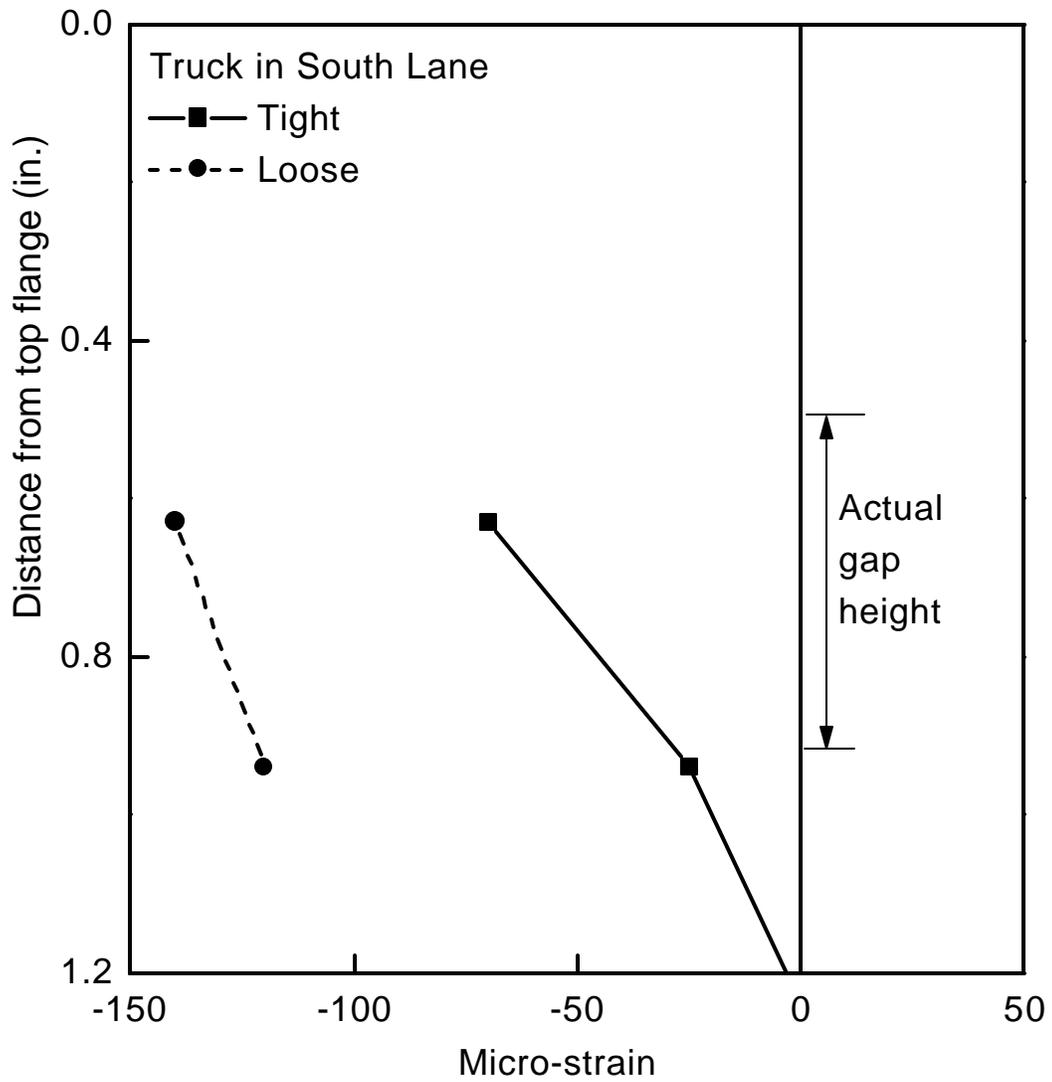
Figure 28. Vertical profile of the maximum strains in the web gap at Location AK1 during Test 1 (tight), and Test 5 (loose)

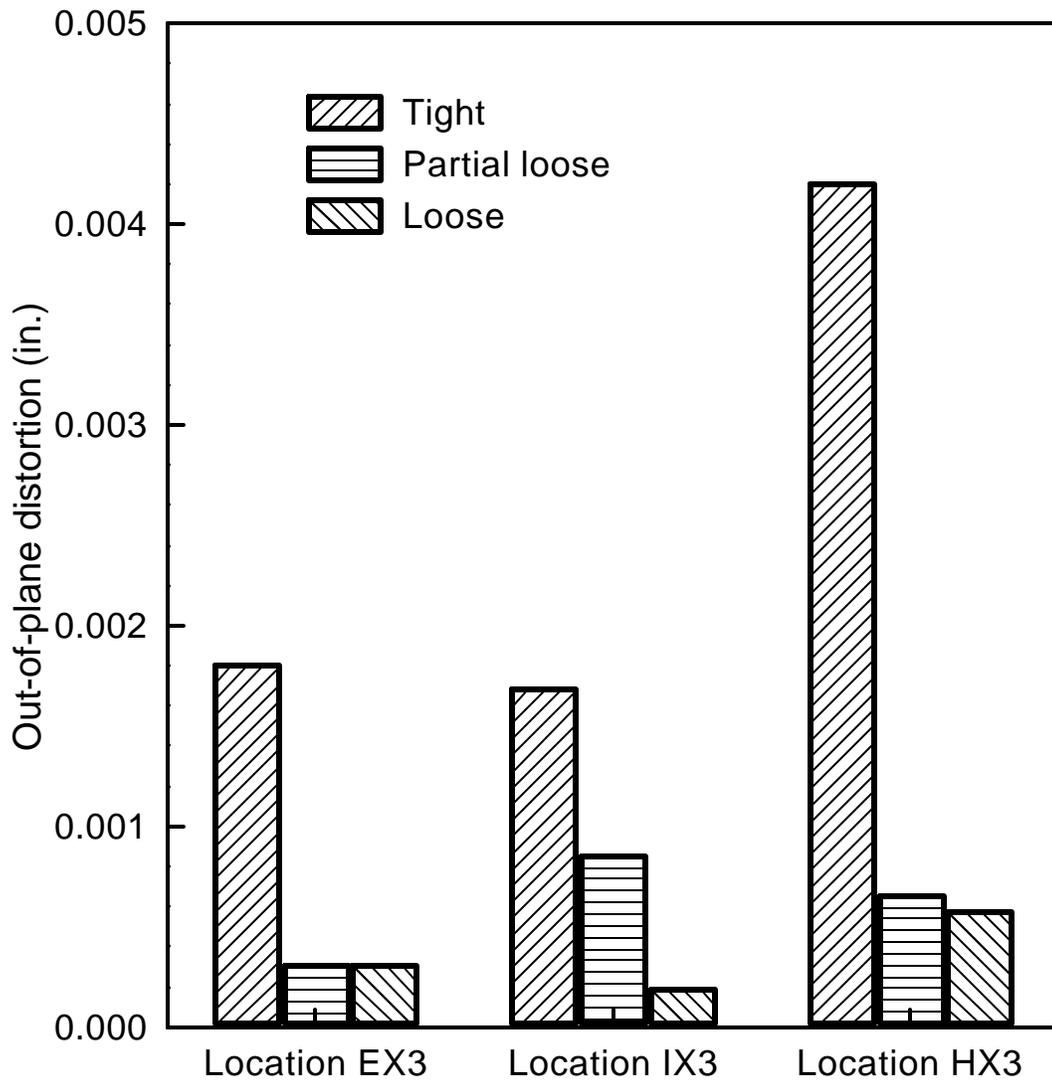
Figure 29. Maximum out-of-plane displacements of Locations EX3, IX3, and HX3 during tight, partial loose, and loose tests

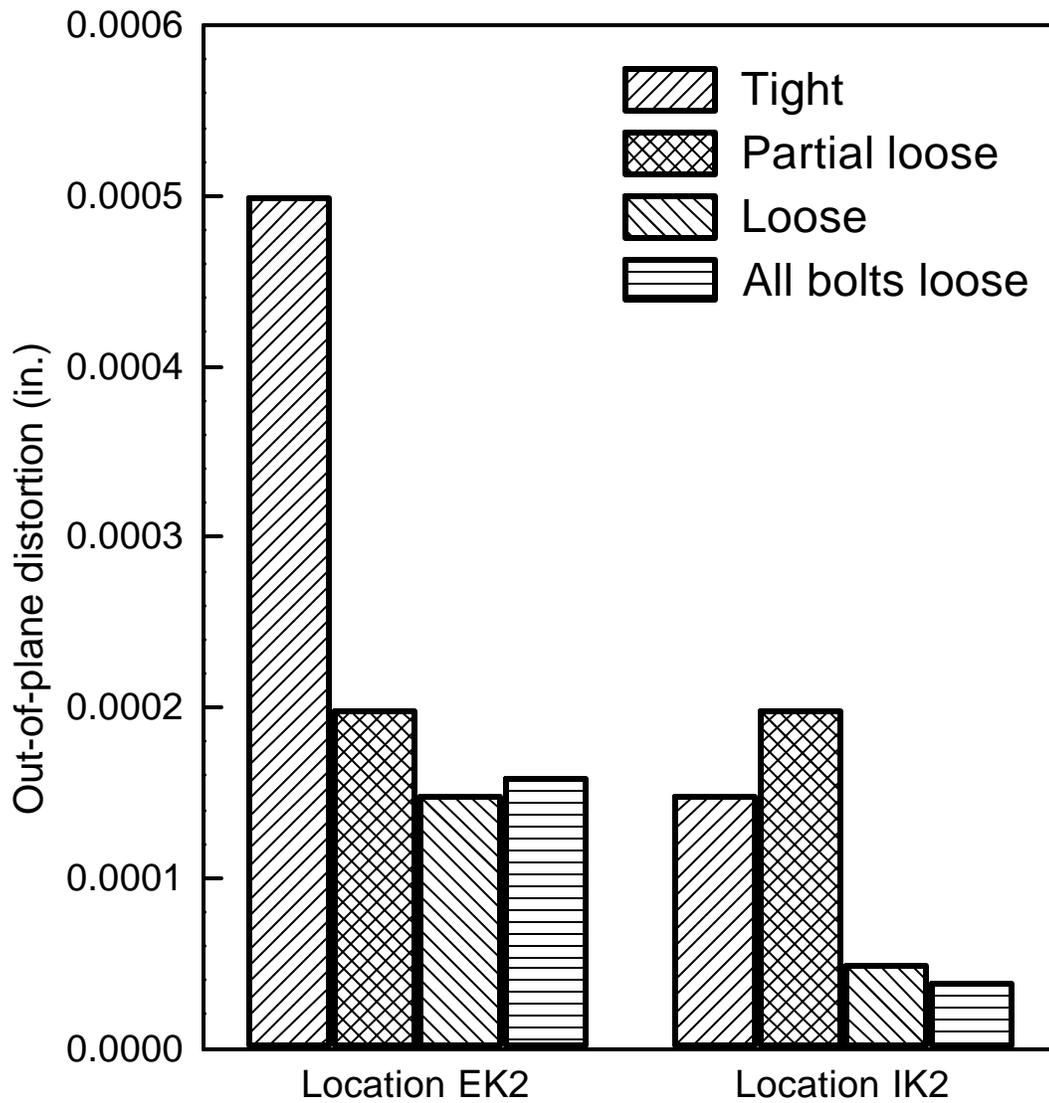
Figure 30. Maximum out-of-plane displacements of Locations EK2 and IK2 during tight, partial loose, loose, and all bolts loose tests

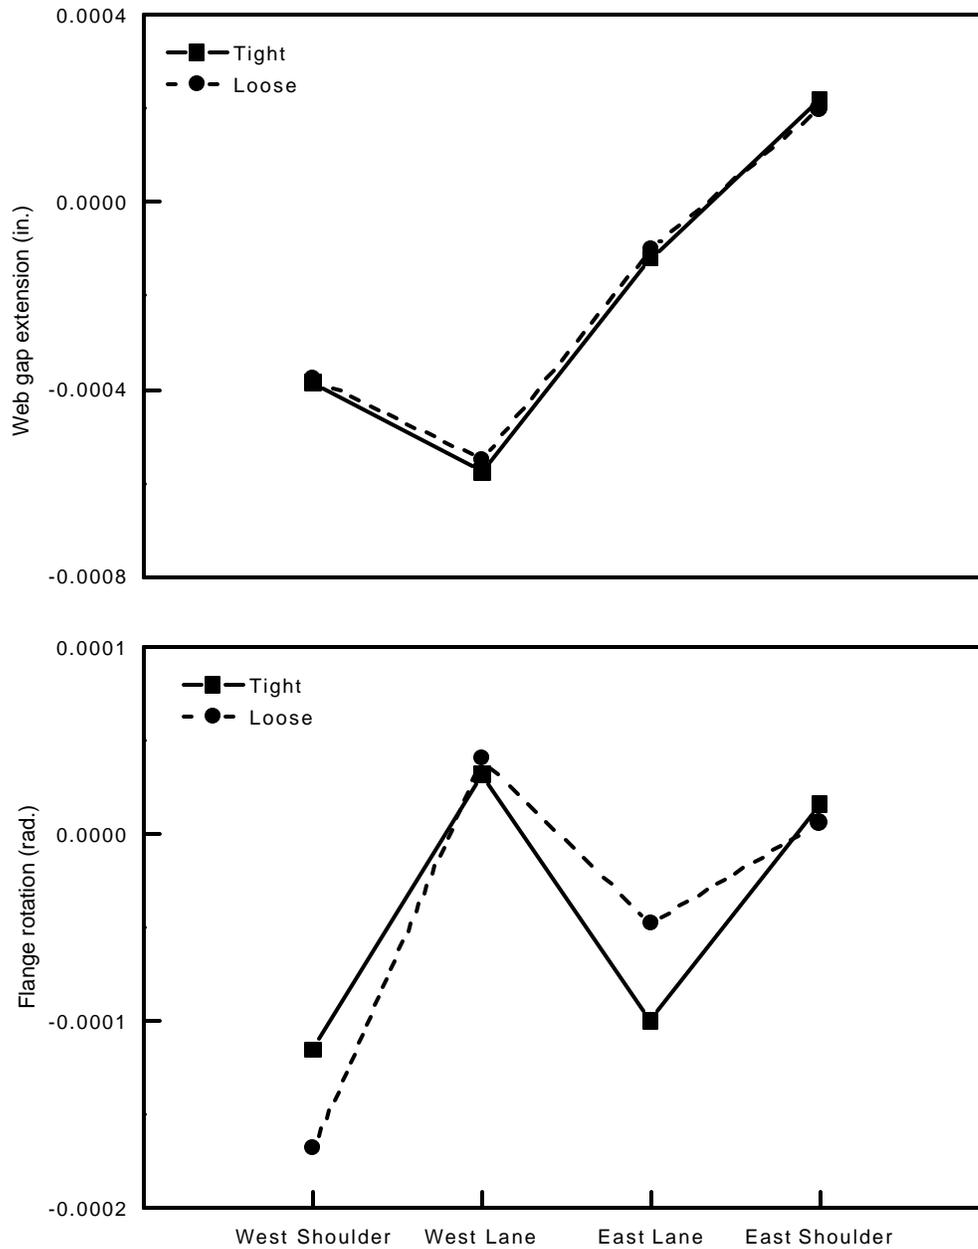
Figure 31. Web extension and flange out-of-plane rotation at Location IX1 during Tests 1-4 and 10-13

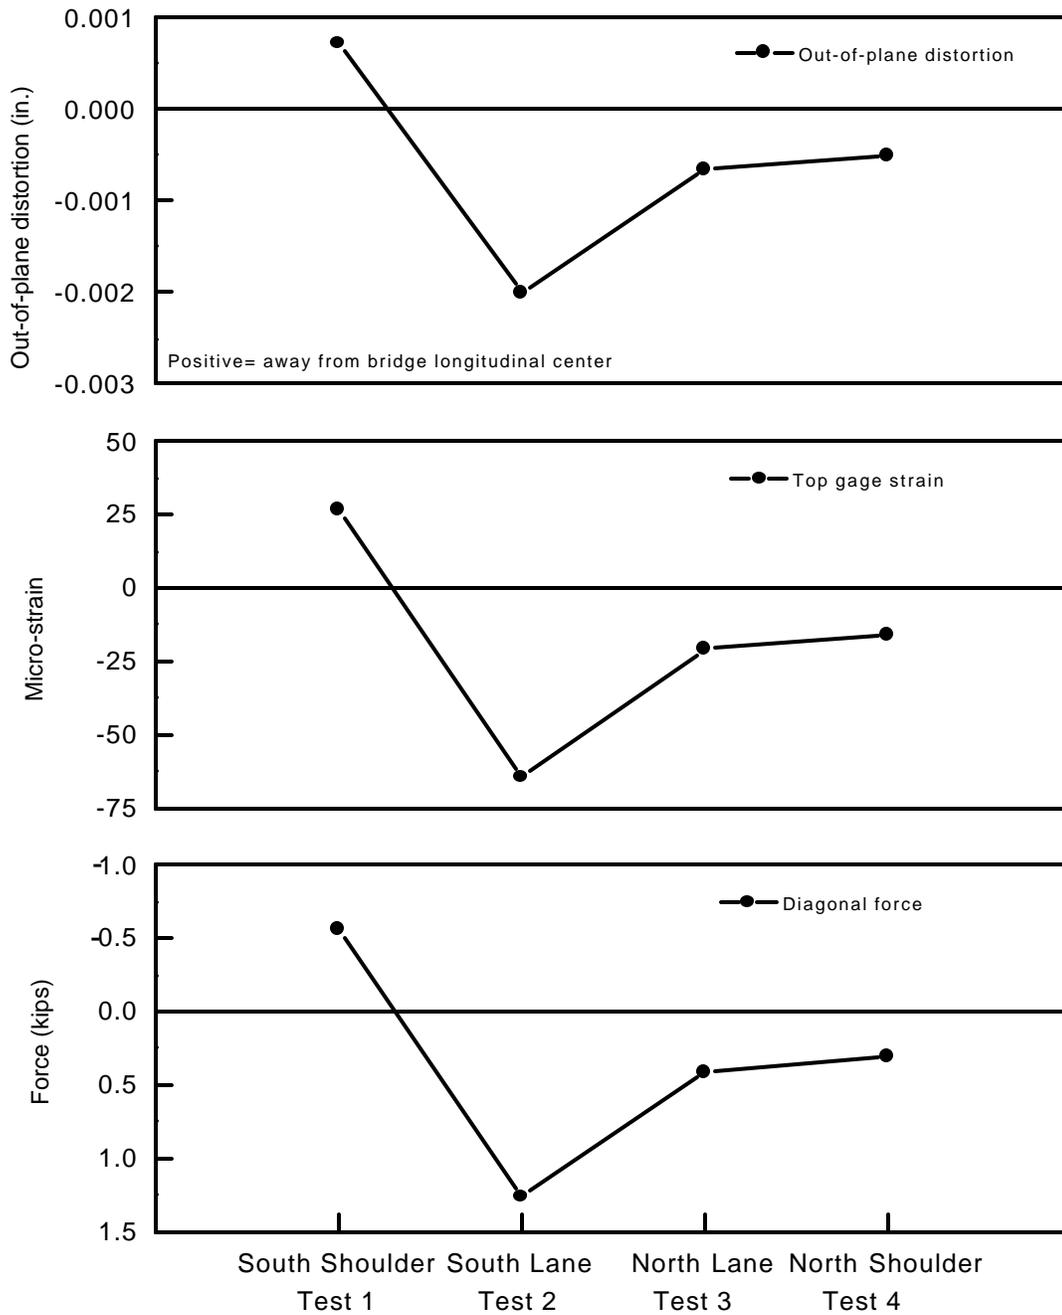
Figure 32. Out-of-plane distortion, top gage strain, and diaphragm diagonal force at Location EX2 during Tests 1-4

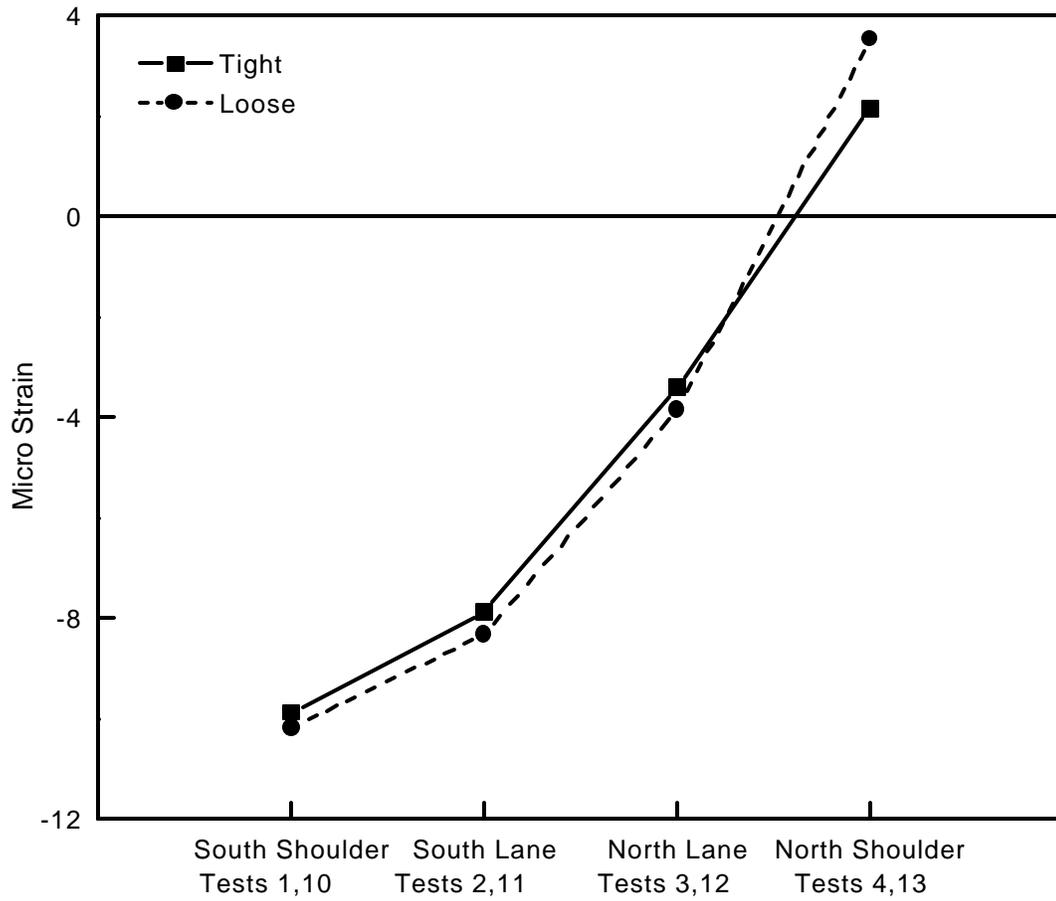
Figure 33. Maximum exterior girder bottom flange strains in Bridge X2 during tight and loose condition tests

The effect of the proposed retrofit method on the lateral live load distribution was investigated in Bridges X2 and K2. Figure 33 shows the maximum exterior girder bottom flange strains during crawl speed tests (Tests 1-4 and Tests 10-13). Apparently, there is a slight change in the strains after applying the proposed method. The investigation showed that loosening the diaphragm diagonal connection bolts had a small effect (within 12% and 15% for Bridge X2 and K2, respectively) on the distribution.
