# The Effectiveness of Iowa's Automated Red Light Running Enforcement Programs

**Final Report**  
**December 2007**

**Sponsored by**  
the Iowa Department of Transportation  
(CTRE Project 05-226)

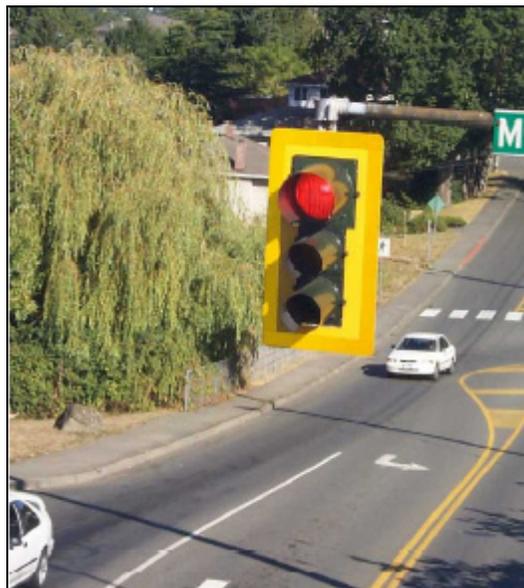
**Figure 1.1. Signal with high intensity yellow retroreflective tape on backplate (Miska et al., 1998).**

In 1998, a research study conducted in British Columbia, Canada, by Miska, de Leur, and Sayed, investigated the effects of installing yellow reflective tape on the edge of the backplates to combat various claims of not being able to visually see the traffic signals at studied intersections. As shown below in Figure 1.1, a 75mm, reflective, 3M tape border was installed on single heads of six traffic signals at six intersections. The cost of installation was minimal at \$35 per signal and around \$420 per intersection. Miska, de Leur, and Sayed concluded that the numbers of claims were reduced up to 60% (Miska et al., 1998; NCUTCD, 2001).

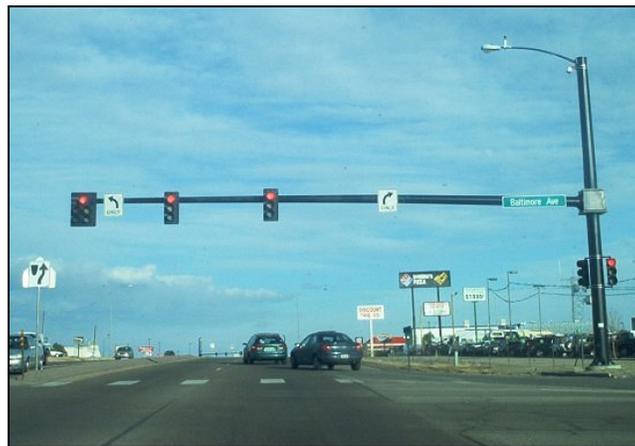
**Figure 1.2. CDOT specified high-speed intersection traffic signal (Salek, 2006)**

Placement: Although the MUTCD does not specify or require that the traffic signals be over each lane and attached to a pole, studies in Iowa and Missouri have shown 32% and 25% reductions in crashes at intersections with traffic signals attached to mast and poles (McGee et al., 2003). An FHWA report states that traffic signals located above each lane overcome three important obstacles that median or roadside traffic signals have: (1) they generally do not provide good conspicuity, (2) mounting locations may not provide a display with clear meaning and (3) motorists' line-of-sight blockage to the signal head due to other vehicles, particularly trucks, in the traffic stream (McGee et al., 2003). Shown below in Figure 1.2 is a typical high-speed intersection in Colorado where 12-inch diameter traffic signal heads are located over each travel lane. Also note the 8-inch diameter pole-mounted signal head to aid vehicles that cannot see the overhead traffic signals due to blockage from trucks or other large vehicles.

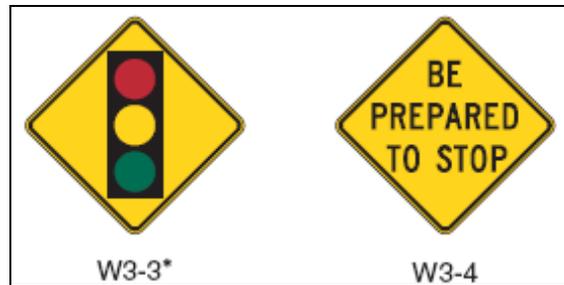
**Figure 1.3. Advance intersection warning signs (MUTCD, 2002)**

One of the most commonly used countermeasures to warn drivers of an approaching intersection is advance warning signage, as shown in Figure 1.4. The sign on the left, a W3-3, is typical in urban areas where advance warning may sometimes be needed in heavy congestion. Furthermore, these signs can be accompanied by flashing warning lights or flags attached to them. In a study conducted by Polanis, it was found that W3-3 warning signs reduced right-angle crashes by 44% at signalized intersections (Polanis, 2002).

Another type of advance warning device is also shown in Figure 1.4, which is the “Be Prepared to Stop” (W3-4) sign, as specified in the MUTCD. This sign can be used as a stand-alone warning sign for either signalized intersections or conventional four-way stops (MUTCD, 2001). In some cases, flashing lights have been attached to this sign and coordinated with intersections to flash during the green phase of the approach leg. Bonneson et al. state that this sign has been found to particularly reduce RLR-associated crashes up to 67% (Bonneson et al., 2003).

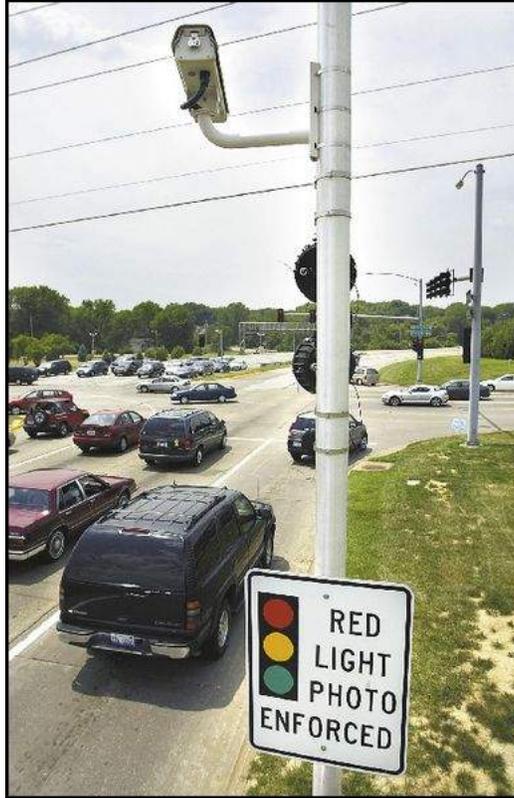
**Figure 1.5. Transol RLR camera (Davenport, IA, image source: Quad City Times)**

When a traffic signal switches to a red phase, the automated enforcement system is activated, and the camera is ready to take a picture. Vehicles in violation will cross a trigger mechanism, which could include road tubes, inductive loop sensors, piezoelectric strips (pressure sensors), radar, or lasers. A minimum time period and preset speed limit are built into the trigger mechanism, allowing the system to differentiate between vehicles attempting to make a stop, turn, or run through the intersection. This grace period is typically three-tenths of a second, with a typical minimum speed limit of 15–20 mph (Passetti and Hicks, 1997). A second photo of the violating vehicle is taken seconds after the first photo and shows the traffic signal color and offending vehicle in the middle of the intersection. In some cases, a third photograph is taken to capture the offending vehicle's license plate.

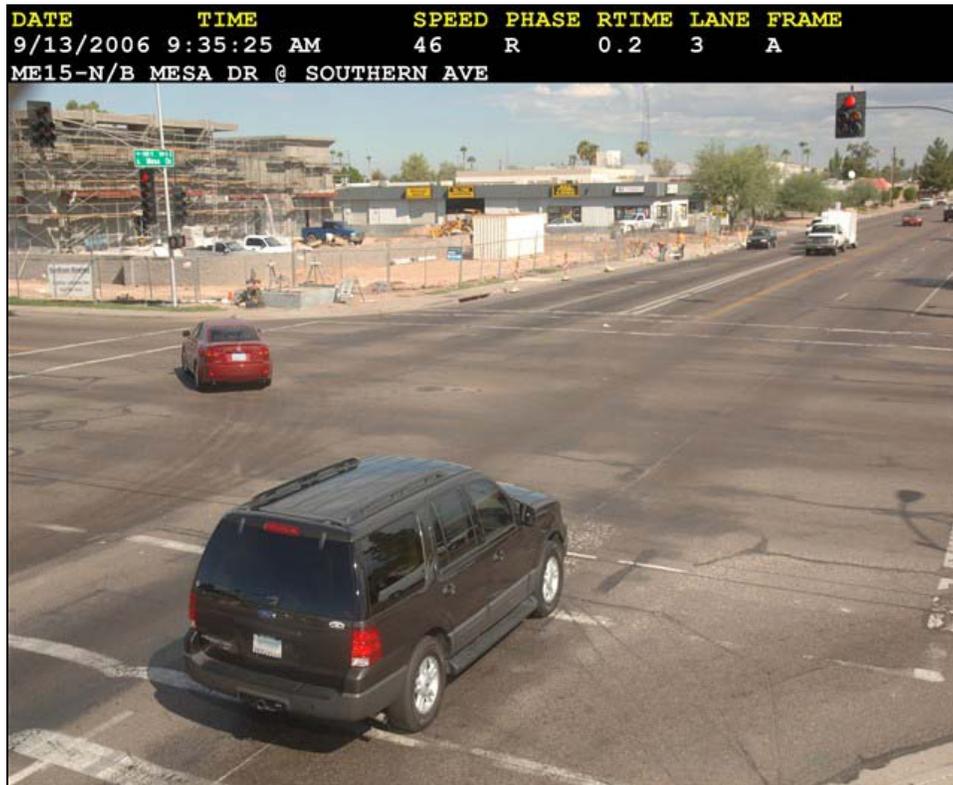
**Figure 1.6. First picture taken by an automated RLR enforcement camera (Mesa, AZ)**  
(Image source: City of Mesa Police Department:  
[http://www.cityofmesa.org/police/traffic/redlight\\_photos.aspx](http://www.cityofmesa.org/police/traffic/redlight_photos.aspx))

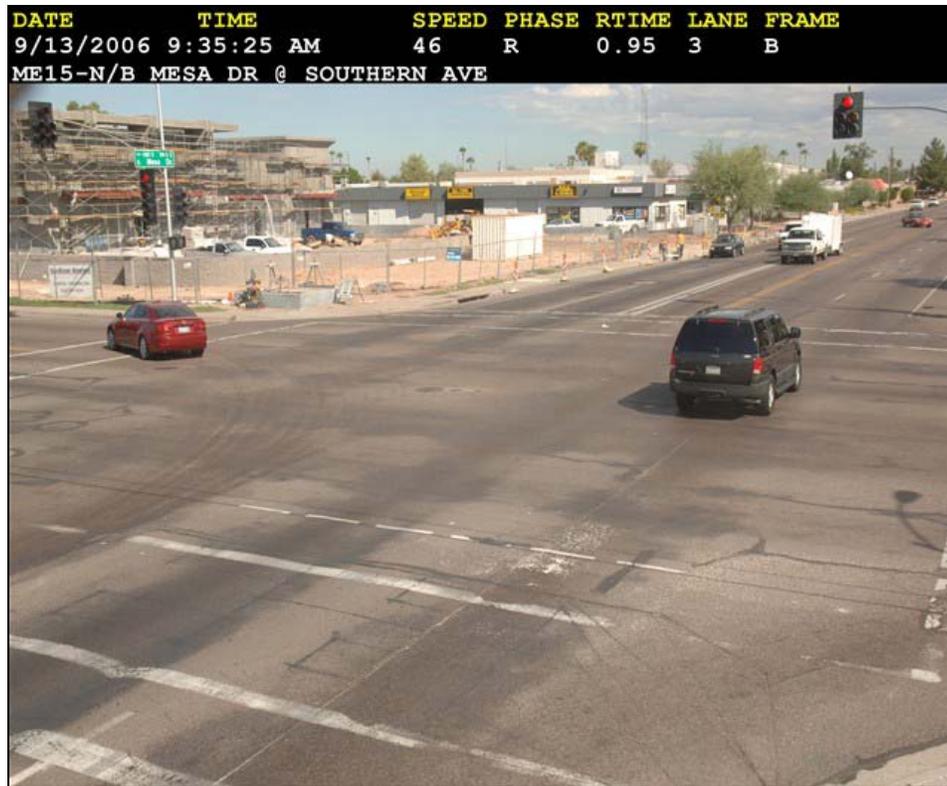
**Figure 1.7. Second picture taken by an automated RLR enforcement camera (Mesa, AZ)**  
 (Image source: City of Mesa Police Department:  
[http://www.cityofmesa.org/police/traffic/redlight\\_photos.aspx](http://www.cityofmesa.org/police/traffic/redlight_photos.aspx))

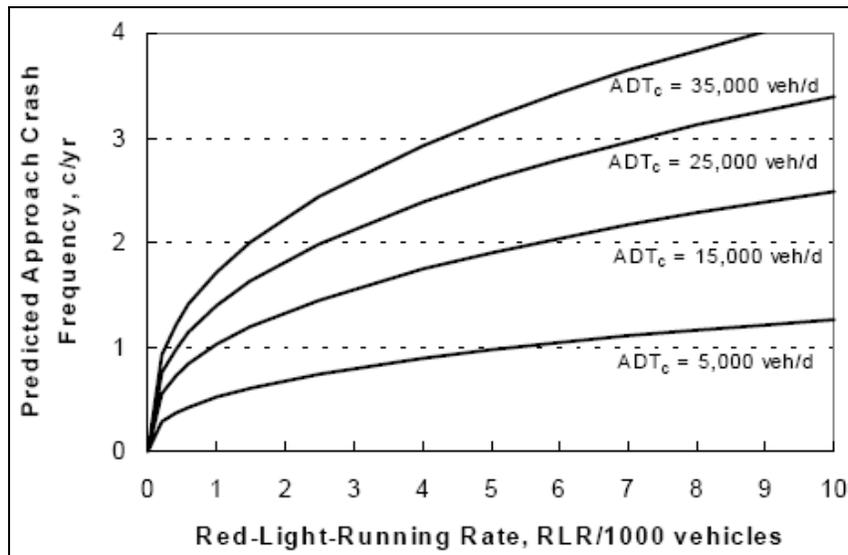
Figure 1.8. Predicted effect of RLR on intersection crash frequency (Bonneson et al., 2003).

$C_1$  in the above equation is the predicted annual crash frequency rate (crashes per year, right-angle plus left-turn) for a typical intersection approach. The studied intersections approach term (ADT) was not used in the final model calculation because its regression coefficient ( $b_1$ ) was close to zero (Bonneson and Zimmerman, 2004). It was also found that the variable  $b_3$ , which is associated with RLR rate, had a large standard deviation in the model. Bonneson et al. concluded “the crash frequency increases with increasing cross-street volume and RLR rate.” This conclusion is illustrated in Figure 1.8; as ADT increases, the crash frequency and RLR rates increase logarithmically.

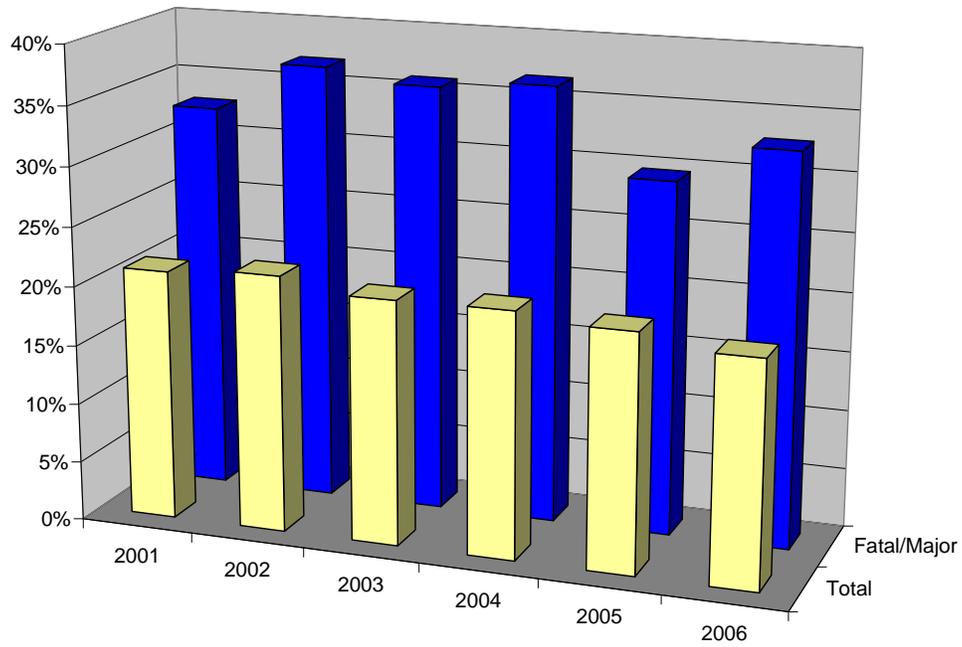
**Figure 2.1. RLR crashes as a percentage of all signalized intersection crashes**

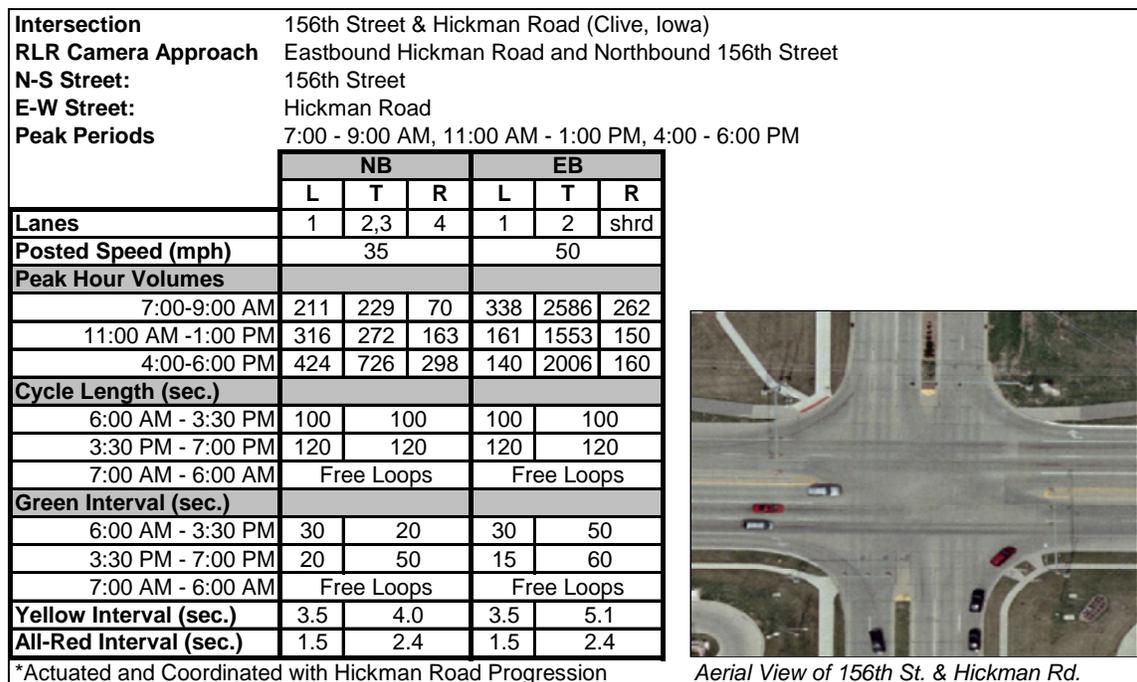
**Figure 3.5. Roadway, traffic, and signal timing characteristics for 156th St. & Hickman Rd.**

The intersection at 156th Street and Hickman Road is the farthest west camera-enforced intersection in Clive and is also the last major intersection before the city of Waukee, which is located just west of Clive. On the southeast side of the intersection is a Dahl's grocery store, which is surrounded by residential developments. On the southwest side are a gas station and small commercial businesses. On the northwest side of the intersection is a commercial development and on the northeast side are private residences. This intersection is also has significant pedestrian and bicycle traffic on the north side traveling east and west. One Hundred Fifty-Sixth Street connects to Douglas Avenue to the north and University Avenue to the south. Summary information for 156th Street and Hickman Road are provided in Figures 3.5, 3.6, and 3.7.

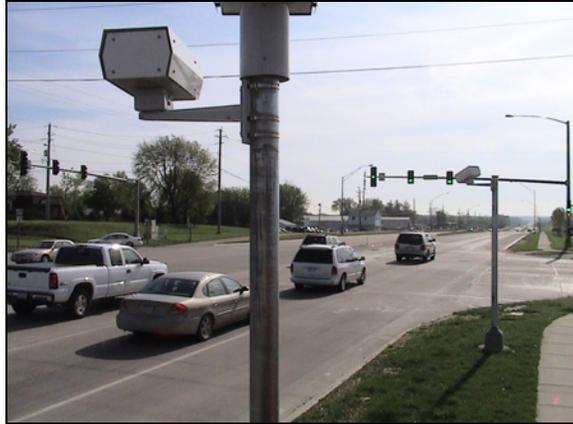
**Figure 3.6. RLR camera system monitoring eastbound traffic at 156th St. & Hickman Rd.**

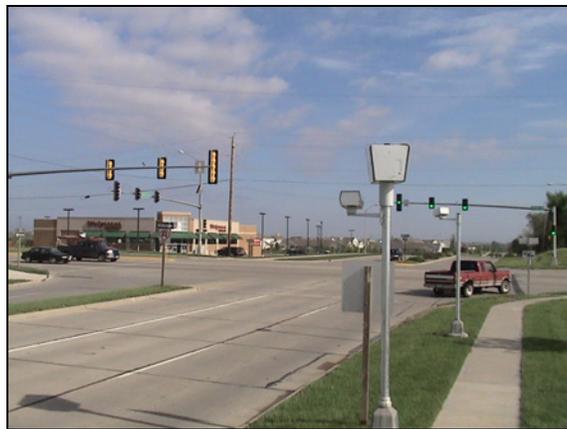
**Figure 3.7. RLR camera system monitoring northbound traffic**

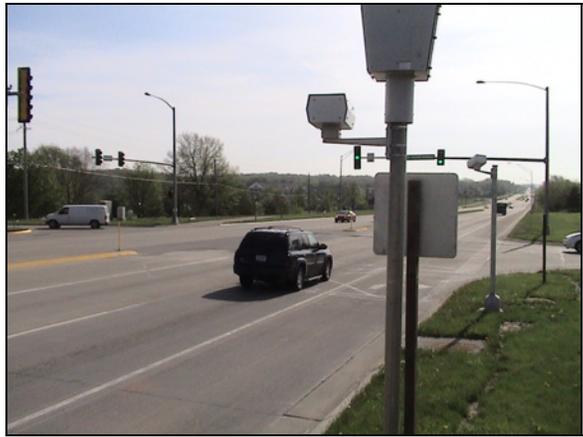
**Figure 3.9. RLR camera system monitoring eastbound traffic at 142nd St. & Hickman Rd.**

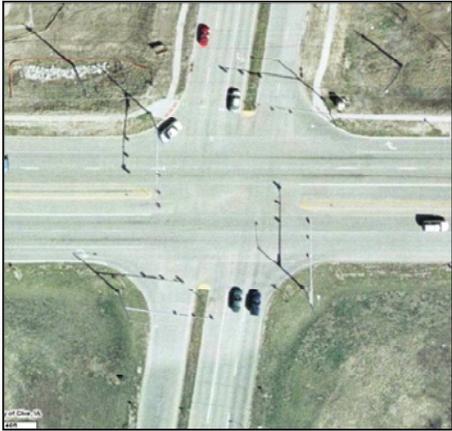
Aerial View of 128th St. & Hickman Rd.

**Figure 3.10. Roadway, traffic, and signal timing characteristics for 128th St. & Hickman Rd.**

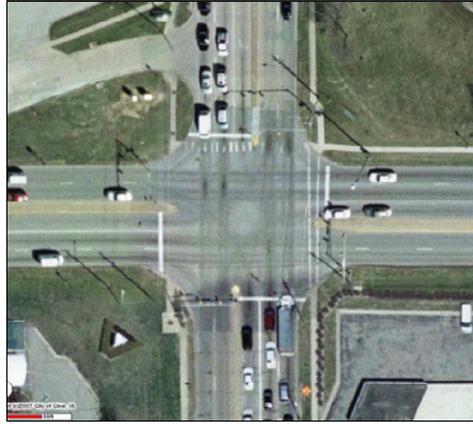
Aerial View of 86th Street & Hickman Road

**Figure 3.14. Roadway, traffic, and signal timing characteristics for 86th St. & Hickman Rd.**

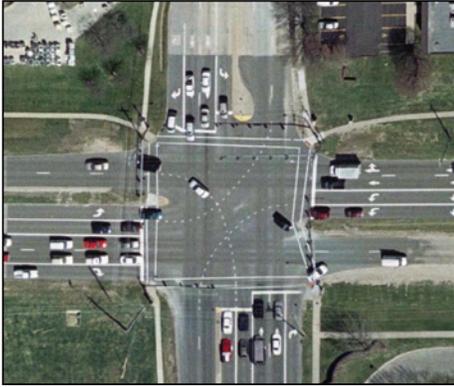
**Figure 3.16. Roadway, traffic, and signal timing characteristics for 86th St. & Douglas Ave.**

11:00 AM -1:00 PM	100			100		
4:00-6:00 PM	100			100		
<b>Green Interval (sec.)</b>						
7:00-9:00 AM	9.6	32.2	44.8	6.0	23.5	9.6
11:00 AM -1:00 PM	11.8	38.6	51.5	10.6	26.0	10.5

4:00-6:00 PM	12.7	32.5	47.5	11.9	27.9	10.5
<b>Yellow Interval (sec.)</b>	3.0	3.6	3.0	3.0	4.0	3.0
<b>All-Red Interval (sec.)</b>	1.0	2.1	1.0	1.0	2.1	1.0
*Actuated and Coordinated with 100th Street & Douglas Avenue

Aerial View of 86th St. & Douglas Ave.

Located north of the Hickman Road corridor in the city of Urbandale is the intersection of 86th Street and Douglas Avenue. This intersection moves east- and westbound traffic to the north and south with double left turn lanes. On the northwest side of the intersection is a grocery store, and on the northeast side of the intersection are a bank and various commercial businesses. On the southeast side is a commercial development and on the southwest side is the Urbandale Administration Building and Public Library. Intersection characteristics are shown in Figures 3.16 and 3.17.

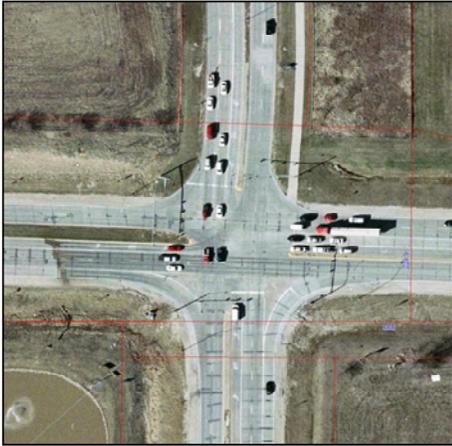
Aerial view of Oralabor Road & State Street

**Figure 3.26. Roadway, traffic, and signal timing characteristics for Oralabor Rd. & State St.**

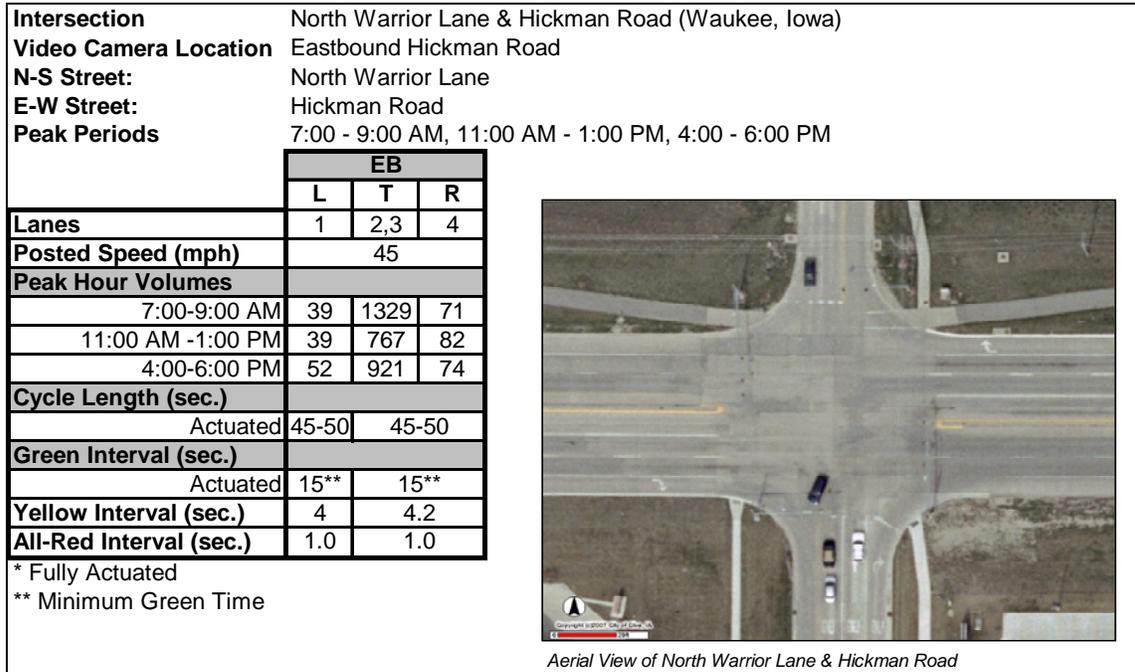
**Figure 3.28. Roadway, traffic, and signal timing characteristics for N. Warrior Ln. & Hickman Rd.**

commercial and light industrial businesses. On the southwest corner of the intersection is a 16-pump Casey's General Store which serves as a morning and afternoon staging area for Waukee school buses. Traffic volume is expected to increase over the next 10 years because of expanding development from the Des Moines area. Intersection characteristics are provided in Figures 3.28 and 3.29.

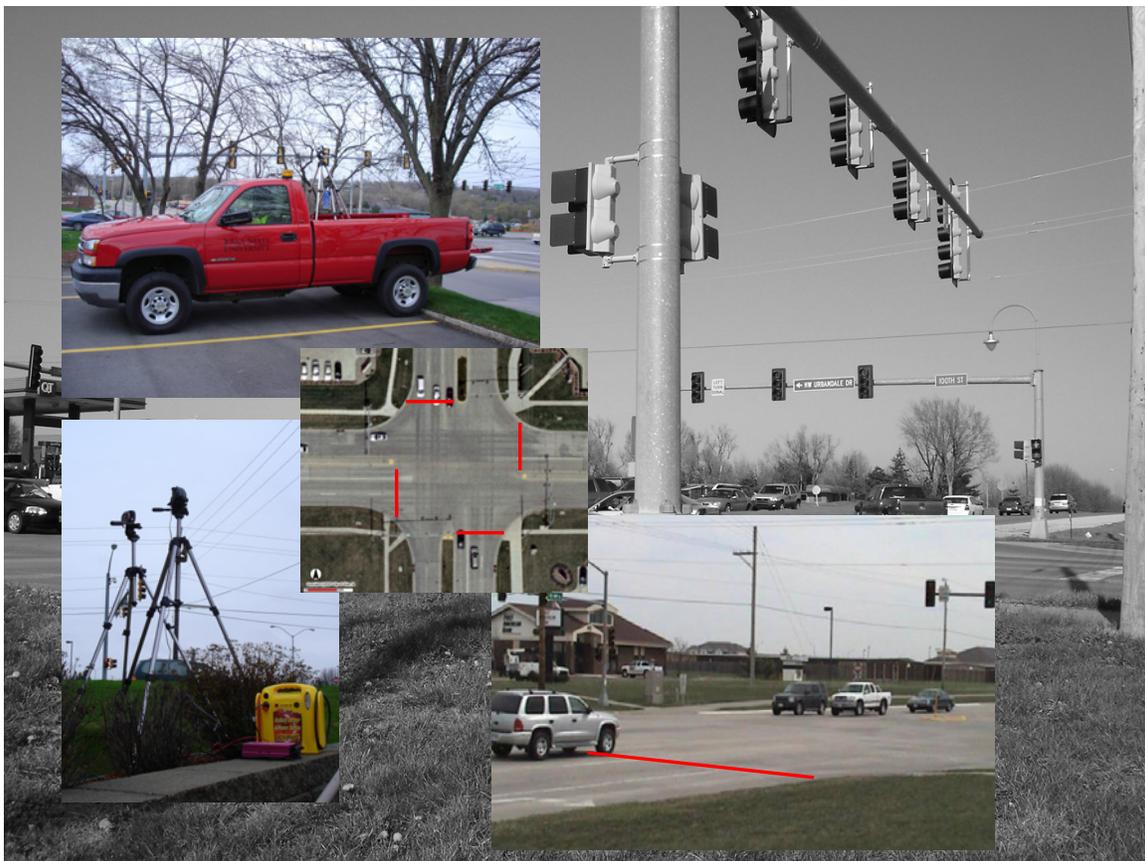
**Figure 3.30. Schematic of data collection**

Violation data for the control intersections were obtained using field data collection. Video of the approach of interest was taken using two DVD-R digital cameras mounted on two tripods in the bed of a pickup truck. A schematic of data collection is shown in Figure 3.30.

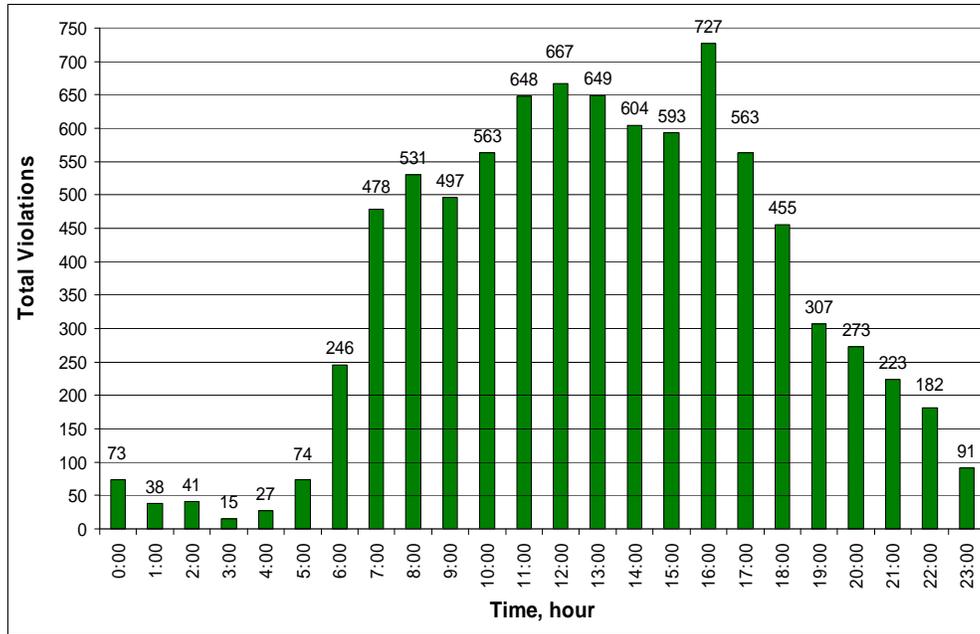
**Figure 3.31. RLR violations by hour of the day**

Data were also evaluated by time of day. Other studies have shown that RLR violations typically occurred during the morning and afternoon peak hours when drivers tended to run red lights (Porter and Berry, 1999). Violations by hour of the day are shown in Figure 3.31. As shown, the highest number of violations occurred between 4:00 and 5:00 p.m., and the second highest number was between 12:00 and 1:00 p.m.

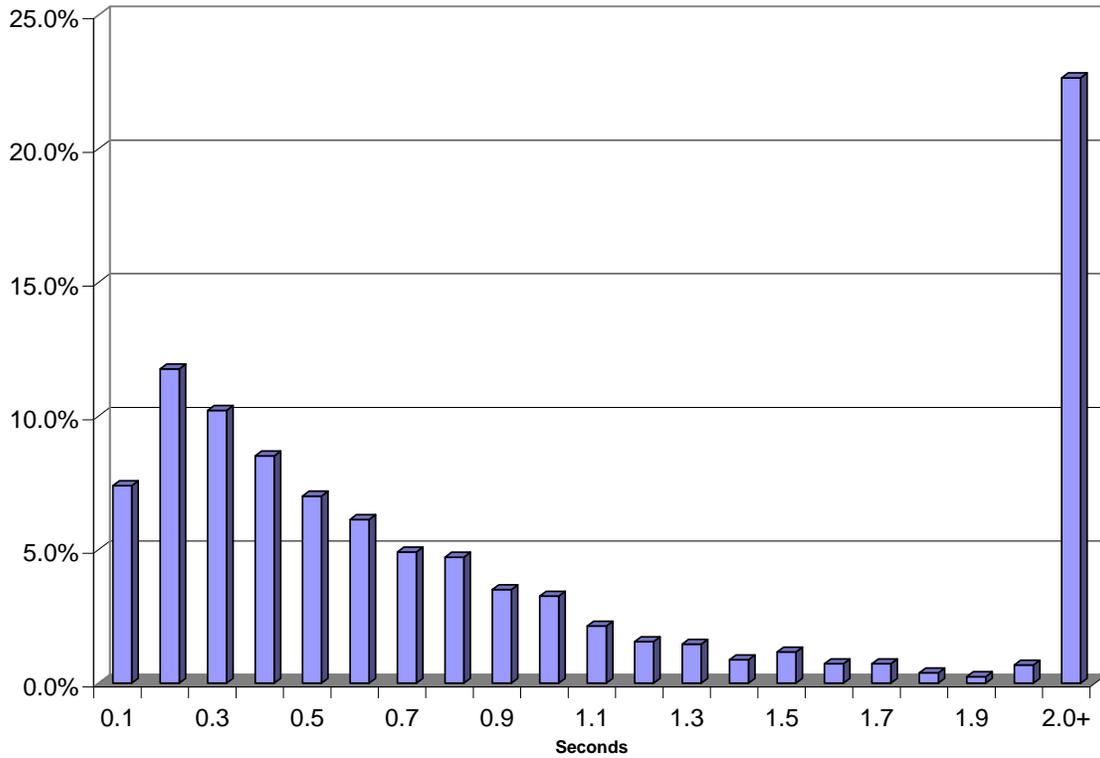
**Figure 3.32. Distribution of time into red for left-turning vehicles**

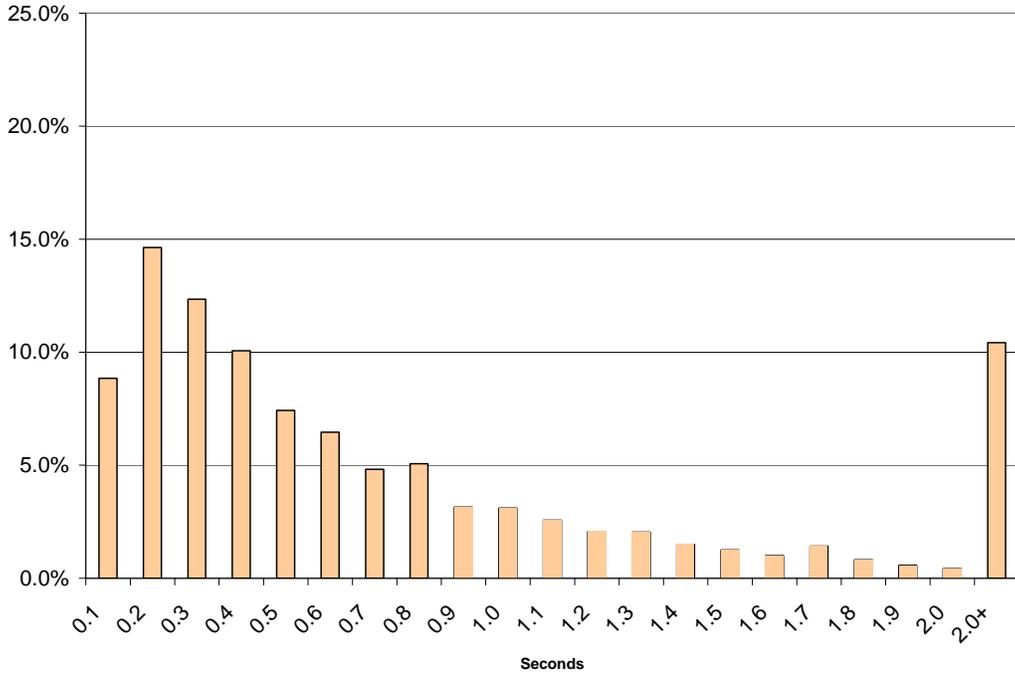
**Figure 3.33. Distribution of time into red for through vehicles**

entered the intersection during the green permitted phase and then ended up completing the maneuver after the signal had changed. As shown, in Figure 3.33, over 10% of through drivers who ran the red light did so two or more seconds into the red. Almost 78% of right-turning drivers who ran the red did so two or more seconds into the red, as shown in Figure 3.34. Vehicles that slowed significantly or stopped before making a right turn on red were not classified as red light runners.

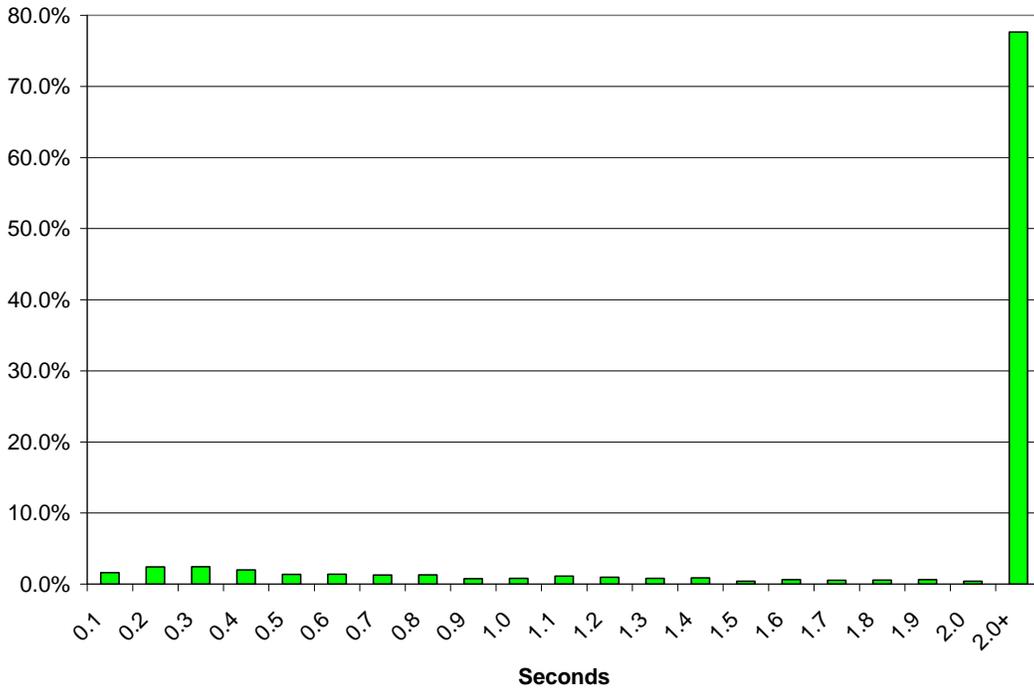
**Figure 3.34. Distribution of time into red for right-turning vehicles**

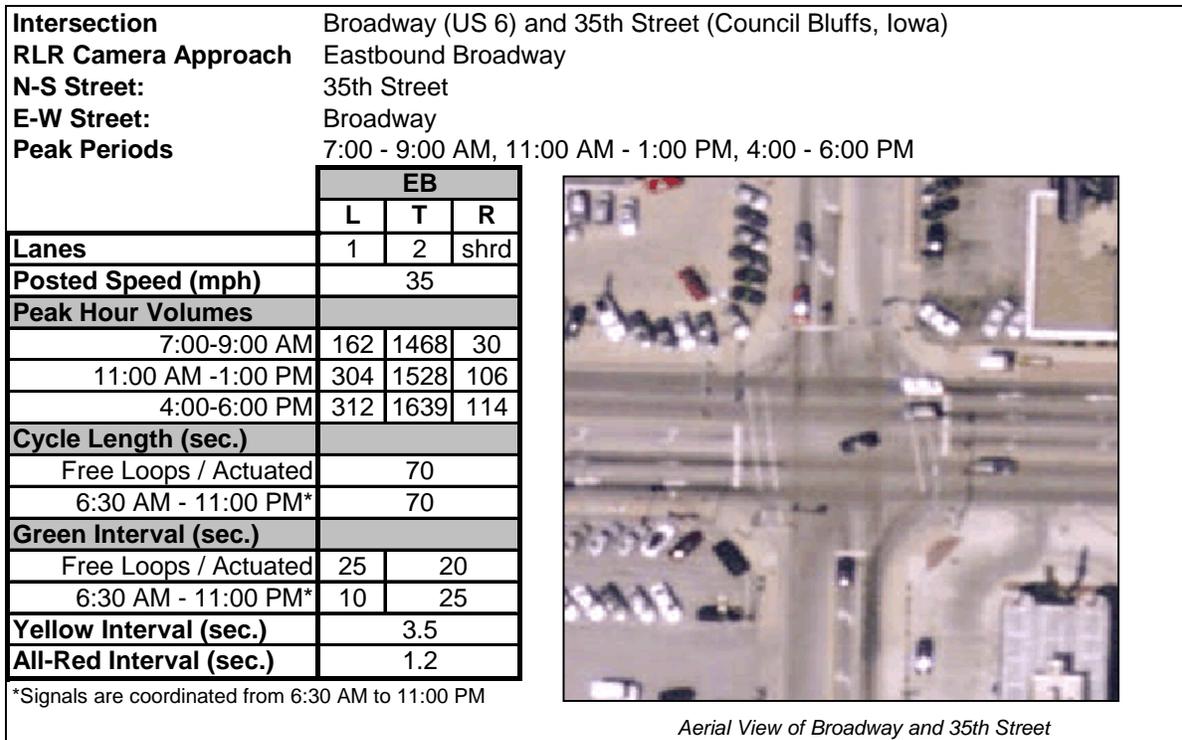
**Figure 4.3. Roadway, traffic, and signal timing characteristics for Broadway and 35th St.**

The intersection of Broadway and 35th Street is located less than one mile east of Interstate 29 and is the first major intersection east of downtown Omaha, NE. Broadway and 35th Street is located in a heavily commercial area. On the northeast side of the intersection is Automart 150, and on the northwest side is Fleming Motor Company. On the southeast side of the intersection is a Sonic and to the southwest is an empty parcel of land. All four businesses have multiple access points on both 35th Street and Broadway. Characteristics are shown in Figures 4.3 and 4.4.

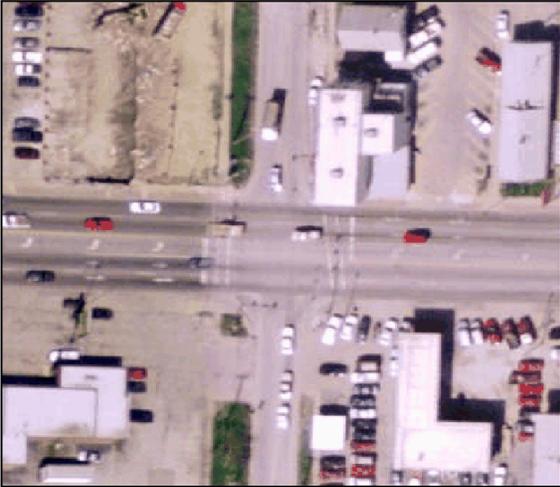
*Aerial View of Broadway and 21st Street*

**Figure 4.5. Roadway, traffic, and signal timing characteristics for Broadway and 21st St.**

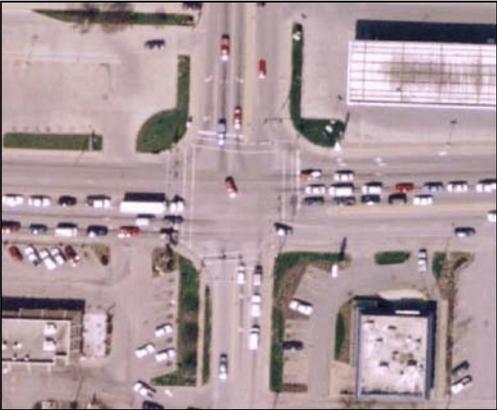
**Figure 4.7. Roadway, traffic, and signal timing characteristics for Broadway and 16th St.**

<b>Intersection</b>	Broadway (US 6) and 16th Street (Council Bluffs, Iowa)					
<b>RLR Camera Approach</b>	Eastbound and Westbound Broadway					
<b>N-S Street:</b>	16th Street					
<b>E-W Street:</b>	Broadway					
<b>Peak Periods</b>	7:00 - 9:00 AM, 11:00 AM - 1:00 PM, 4:00 - 6:00 PM					
	EB			WB		
	L	T	R	L	T	R
<b>Lanes</b>	1	2	3	1	2,3	4
<b>Posted Speed (mph)</b>	35			35		
<b>Peak Hour Volumes</b>						
7:00-9:00 AM	138	1037	75	352	1457	121
11:00 AM -1:00 PM	270	1668	151	507	1664	218
4:00-6:00 PM	292	2052	125	761	1589	153
<b>Cycle Length (sec.)</b>						
Free Loops / Actuated	111 to 126			111 to 126		
6:30 AM - 11:00 PM*	111 to 126			111 to 126		
<b>Green Interval (sec.)</b>						
Free Loops / Actuated	20	27		20	27	
6:30 AM - 11:00 PM*	16	37-50		15	37-51	
<b>Yellow Interval (sec.)</b>	3.5			3.5		
<b>All-Red Interval (sec.)</b>	1.2			1.2

\*Signals are coordinated from 6:30 AM to 11:00 PM

*Aerial View of Broadway and 16th Street*

Burger King and McDonalds—that have high turning volumes during the lunch peak hour. Intersection characteristics are shown in Figures 4.7 through 4.9.

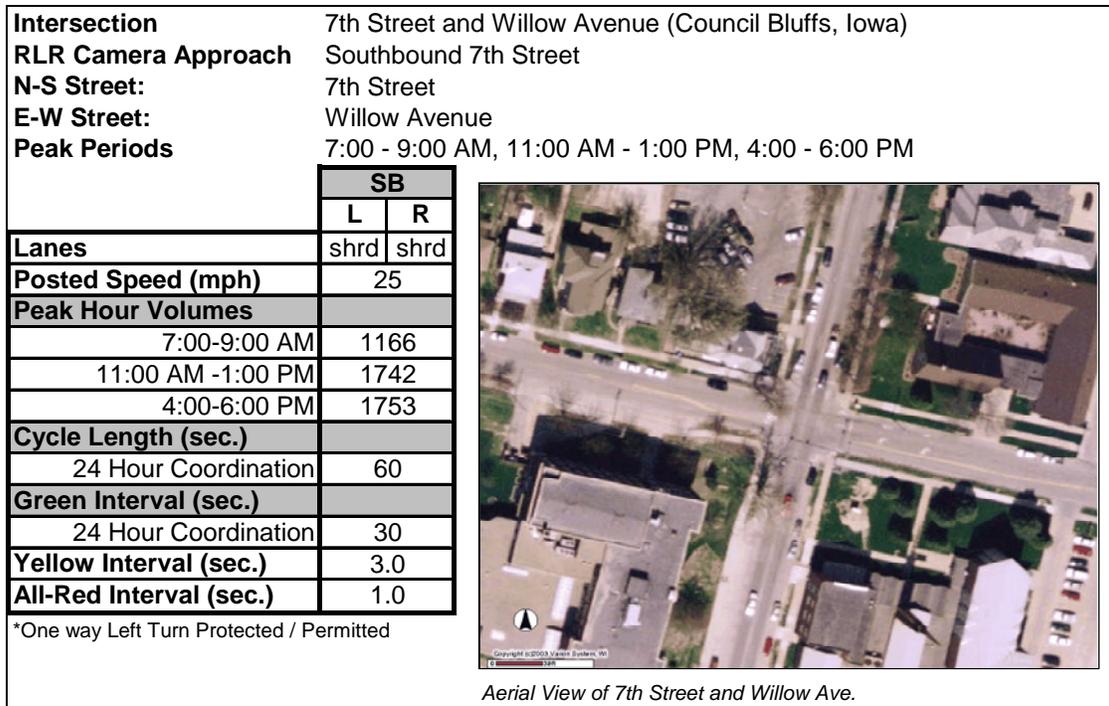
**Figure 4.13. Roadway, traffic, and signal timing characteristics for 7th St. and Willow Ave.**

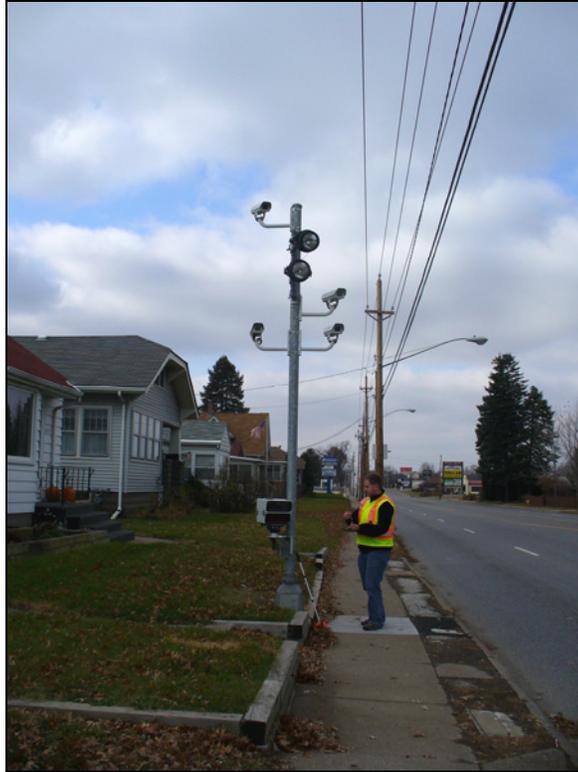
**Figure 5.1. Davenport RLR and automated speed camera system.**

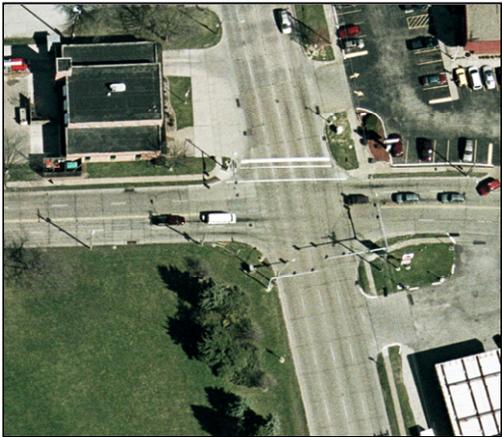
**Figure 5.8. Roadway, traffic, and signal timing characteristics for 35th St. and N. Harrison St.**

<b>Intersection</b>	35th Street and North Harrison Street (Davenport, Iowa)		
<b>RLR Camera Approach</b>	Southbound Harrison Street		
<b>N-S Street:</b>	Harrison Street		
<b>E-W Street:</b>	35th Street		
<b>Peak Periods</b>	7:00 - 9:00 AM, 11:00 AM - 1:00 PM, 4:00 - 6:00 PM		
	<b>SB</b>		
	<b>L</b>	<b>T</b>	<b>R</b>
<b>Lanes</b>	shrd	2,3	shrd
<b>Posted Speed (mph)</b>	35		
<b>Peak Hour Volumes</b>			
7:00-9:00 AM	99	2122	201
11:00 AM -1:00 PM	155	2437	239
4:00-6:00 PM	238	2896	352
<b>Cycle Length (sec.)</b>			
7:00-9:00 AM	110		
11:00 AM - 1:00 PM	110		
4:00-6:00 PM	110		
<b>Green Interval (sec.)</b>			
7:00-9:00 AM	57		
11:00 AM - 1:00 PM	57		
4:00-6:00 PM	57		
<b>Yellow Interval (sec.)</b>	4.0		
<b>All-Red Interval (sec.)</b>	1.0		
*Coordinated with Welcome Way Progression

*Aerial View of 35th Street & North Harrison St.*

Located south of the camera-enforced intersection of Welcome Way and Kimberly Road is the intersection of 35th Street and Harrison Street. Harrison is a one-way southbound street that carries the combined volume of Welcome Way and Harrison Street from where the two roads meet north of this intersection. Located on the both the southeast and southwest of the intersection is a city park. On the northwest side of the intersection is a fire station and on the northeast side is a busy bank that has a driveway less than 30 feet away from the intersection. Thirty-fifth Street is a high-volume arterial that serves many nearby residential areas and terminates at Division Street a couple of miles west of this intersection. Intersection characteristics are shown in Figures 5.8 through 5.10.

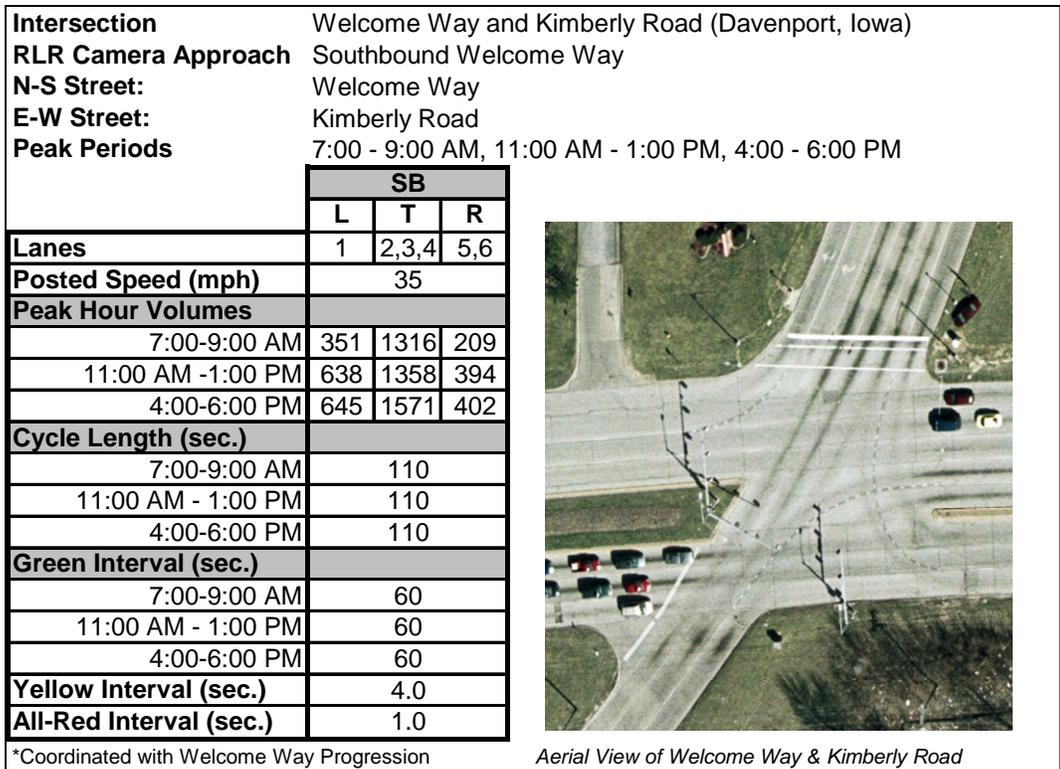
**Figure 5.11. Roadway, traffic, and signal timing characteristics for Welcome Way and Kimberly Rd.**

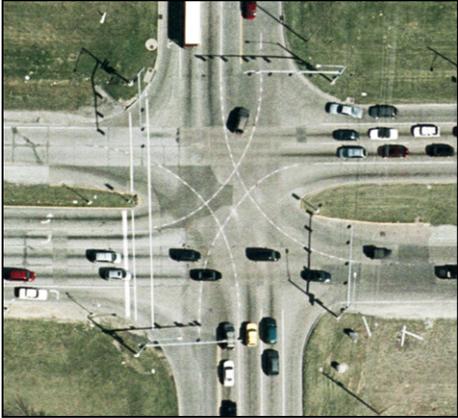
**Figure 5.17. Roadway, traffic, and signal timing characteristics for Kimberly Rd. and Elmore Ave.**

7:00-9:00 AM	100-110			100-110		
11:00 AM - 1:00 PM	100-110			100-110		
4:00-6:00 PM	100-110			100-110		
<b>Green Interval (sec.)</b>						
7:00-9:00 AM	15-45 max			15-45 max

11:00 AM - 1:00 PM	15-45 max			15-45 max		
4:00-6:00 PM	15-45 max			15-45 max		
<b>Yellow Interval (sec.)</b>	4.5			4.5		
<b>All-Red Interval (sec.)</b>	1			1

Aerial View of Kimberly Road & Elmore Ave.

Located on the east side of Davenport, the intersection of Kimberly Road and Elmore Avenue is the first intersection west of Interstate 74 and the city of Bettendorf. Private residences can be found on the west side of the intersection. Commercial developments, including banks and shopping centers, can be found on the east side of the intersection. There is pedestrian traffic on the single crosswalk due to complicated signal timing that makes crossing the intersection a challenge. The traffic engineering department has stated that this is a heavy-volume intersection and congestion happens during both the morning and afternoon peak hours. Multiple signal timing updates happened at this intersection in the past two years, helping improve traffic flow. Intersection characteristics are shown in Figures 5.17–5.19.

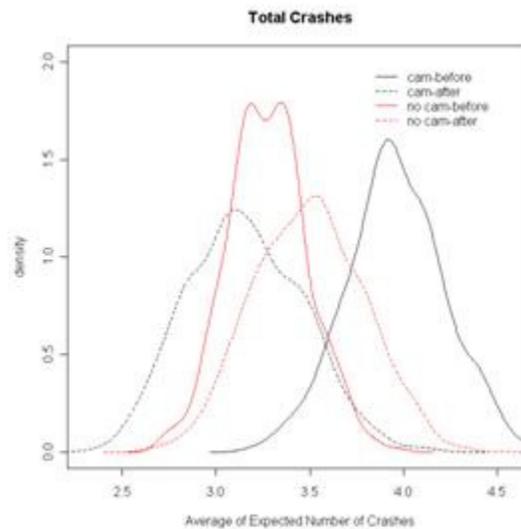
**Figure 6.1. Posterior distributions of the average in total crashes over expected crash frequencies for Davenport**

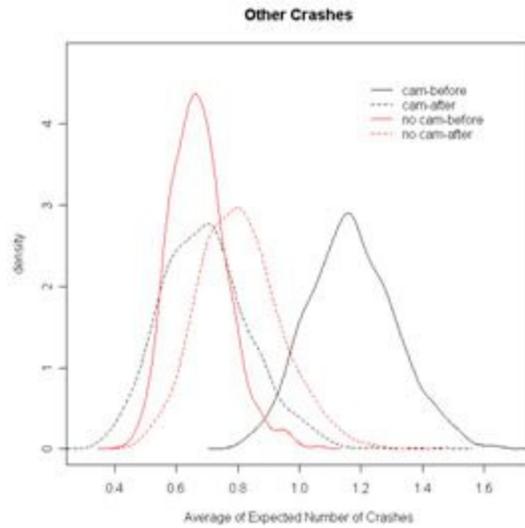
**Figure 6.2. Posterior distributions of the average in RLR-related (non-rear-end) crashes over expected crash frequencies for Davenport**

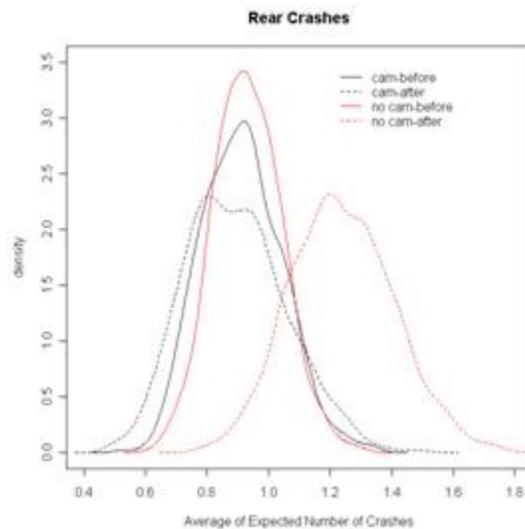
**Figure 6.3. Posterior distributions of the average in RLR-related rear-end crashes over expected crash frequencies for Davenport**

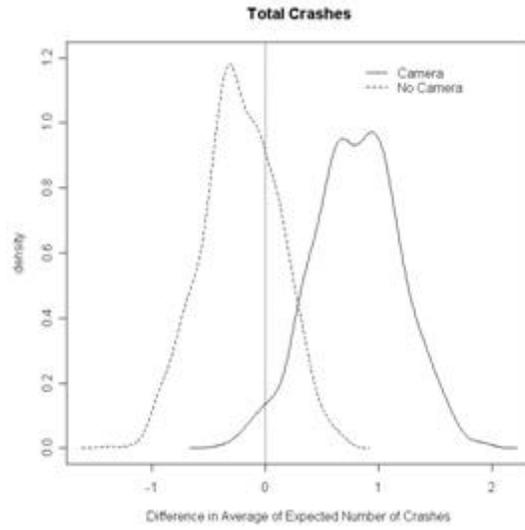
**Figure 6.4. Difference in average of expected total crashes (Davenport)**

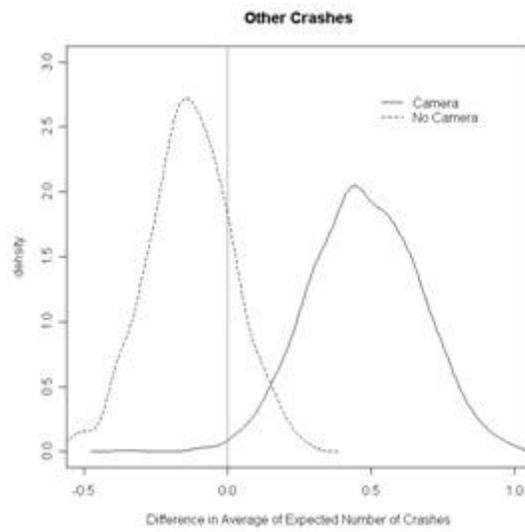
**Figure 6.5. Difference in average of expected RLR-related (non-rear-end) crashes (Davenport)**

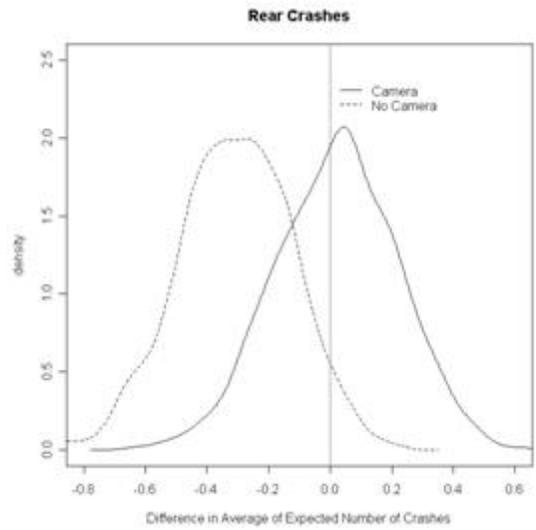
**Figure 6.6. Difference in average of expected RLR-related rear-end crashes (Davenport)**
