Comparison of Roadway Roughness Derived from LIDAR and SFM 3D Point Clouds

Final Report

Sponsored by
Iowa Department of Transportation
(HR-3001 InTrans Project 15-543)

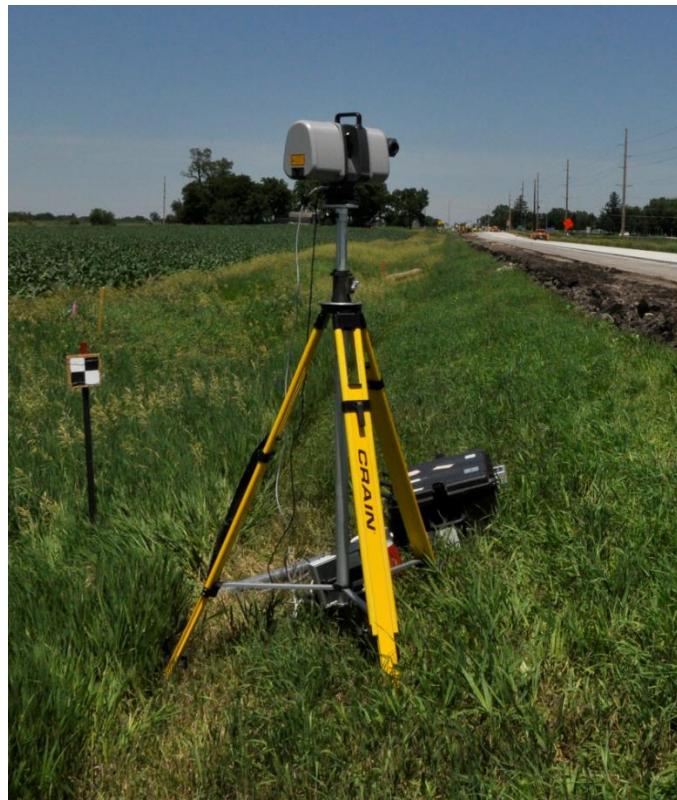
LIDAR systems measure the information (spatial coordinates and color) of a 3D space and store the information in a 3D point cloud. The term LIDAR is generic and includes airborne laser scanning technologies, mobile scanners mounted on vehicles, and stationary laser scanners or stationary terrestrial laser scanners, where the laser scanner is fixed at a station with known coordinates and a geospatially referenced 3D point cloud is constructed based on the distance between the scanner and the detected points. The Trimble CX 3D stationary terrestrial laser scanning system was used in this study to acquire 3D laser scans. The positional accuracy of a single point is 4.5 mm at 30 m and drops to 7.3 mm at 50 m. The distance accuracy is 1.2 mm at 30 m and drops to 2 mm at 50 m. Figure 1 shows the scanner setup.

Figure 1. Trimble CX 3D laser scanner setup

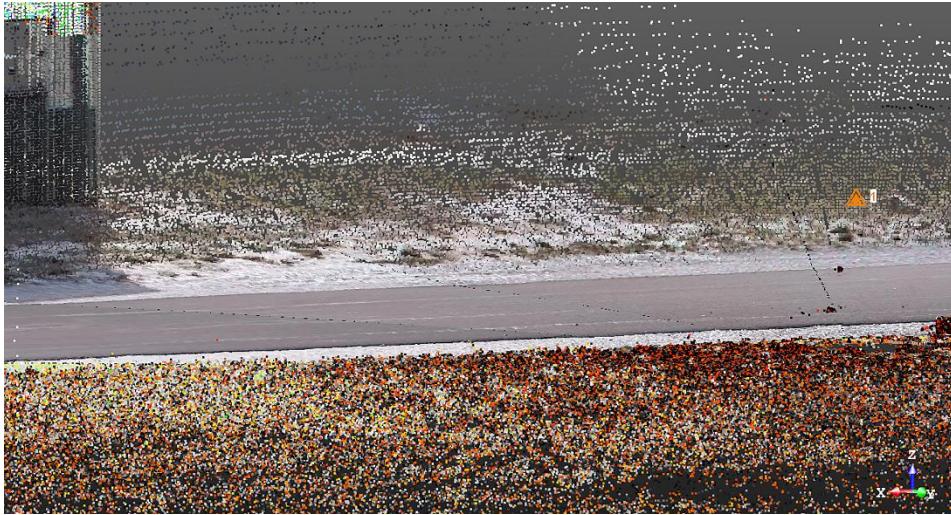
After acquiring the data, the scan is registered in specialized software. Many activities, such as registration and fitting of geometries, can be performed using software packages. Point clouds are registered by identifying common targets (spheres or flat targets, as shown in Figure 2) appearing in the full scans that share a common spatial domain with other scans taken at a different time or at different stations. These targets are used as benchmarks to geospatially reference scans by matching the common target locations in each scan and thus stitching the scans together to produce a full 3D cloud. Figure 3 shows an example of a registered point cloud. The variation in color indicates the material's reflectivity.

Figure 3. Registered point cloud of a new asphalt pavement surface

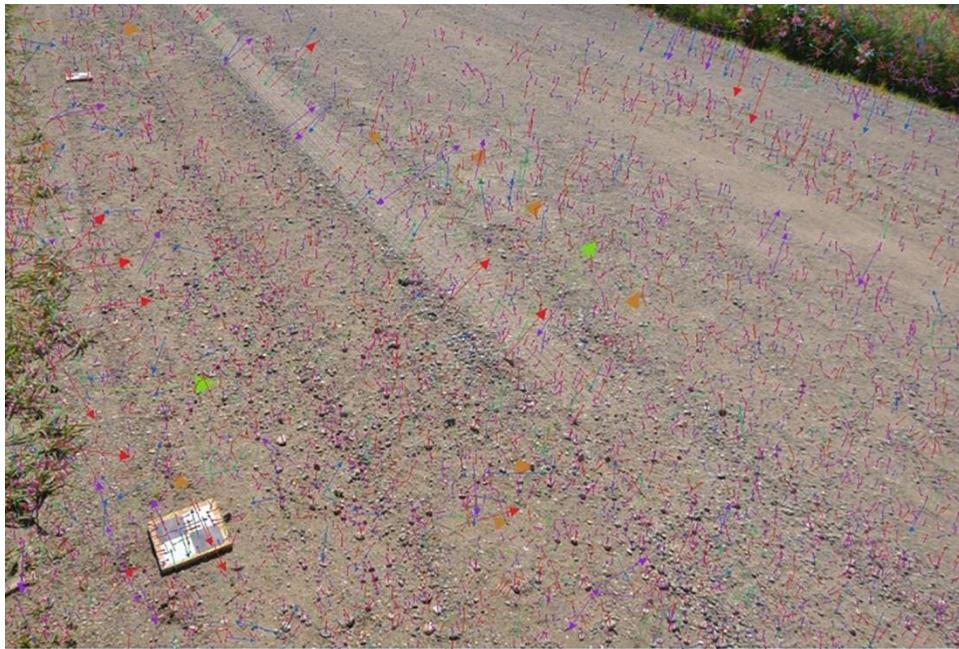
In the first step of SFM computation, the process of scale-invariant feature transform (SIFT) is used on the photographs (Lowe 2004). SIFTing utilizes extrema detection to extract unique key points from photographs using a difference-of-Gaussian function (Figure 4).

Figure 4. SFM key point recognition using a difference-of-Gaussian function (see colored arrows)

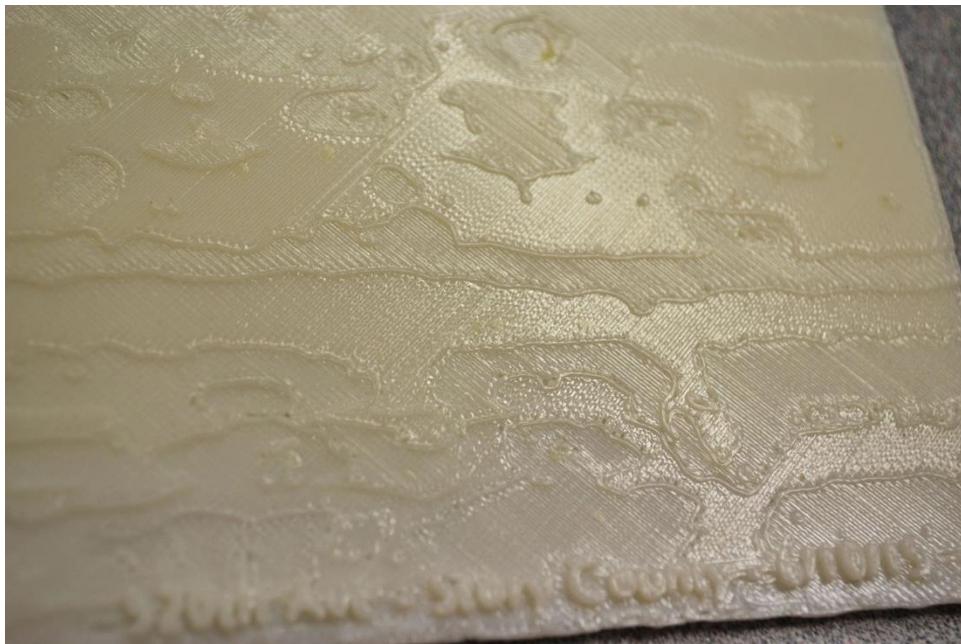
3D-printed road surfaces can be useful in visualization and educational purposes. Initially, the model was printed on a Stratasys Mojo printer with a 170 μm (0.00669 in.) resolution (Figure 9).

Figure 9. 3D-printed model of gravel road from a low-resolution Stratasys Mojo printer

However, most of the road surface features were lost due to the low resolution of the print. The model was then printed on a Stratasys Polyjet printer with VeroBlue material at a 30 μm (0.00118 in.) resolution (Figure 10).

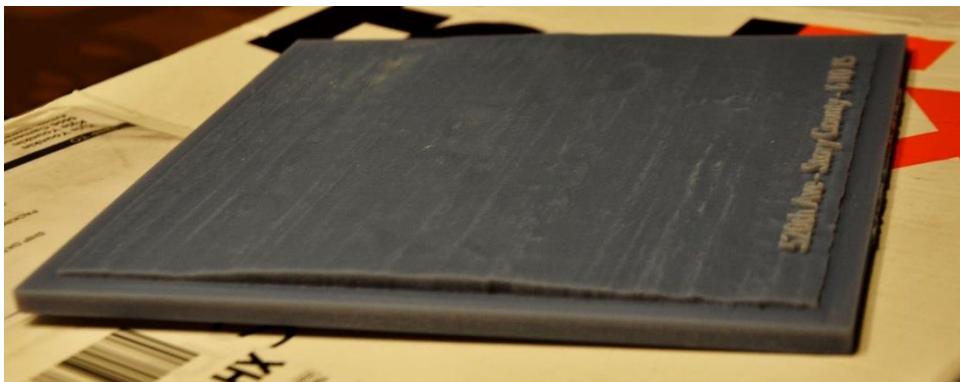
Figure 10. High-resolution 3D-printed model of a gravel road from a Stratasys Polyjet printer

With this high-resolution print, even small surface variations were captured. These models could be used in variety of presentations and workshops on deteriorating unpaved roads across Iowa.

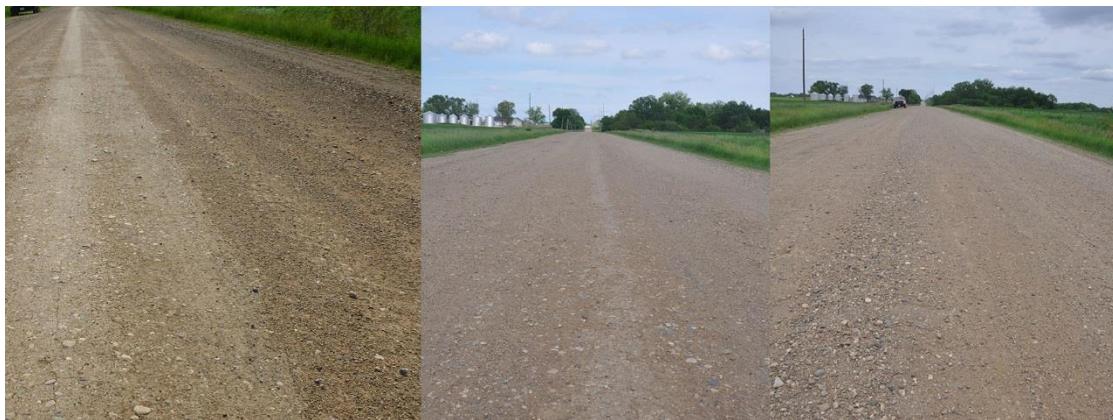
Figure 11. West section of 210th Street at different times: May 28 (left), June 3 (middle), and June 4 (right); blading occurred before May 28 and after June 4

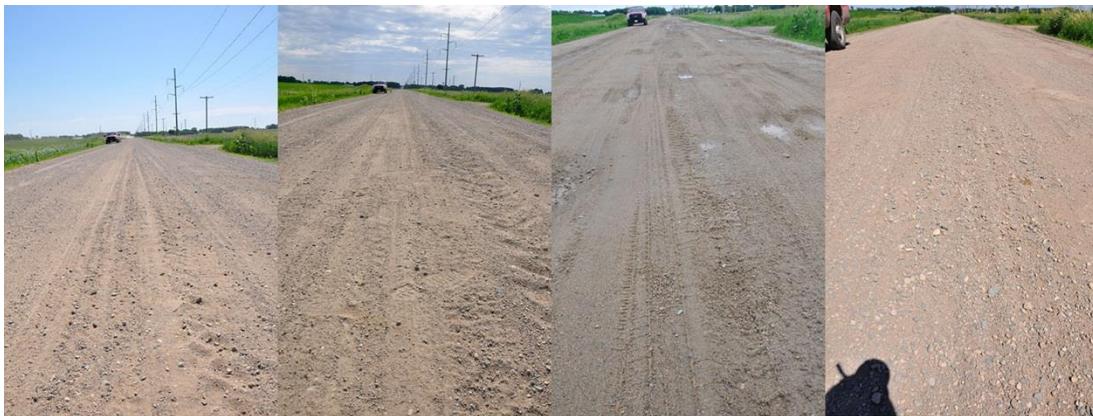
Figure 15. East section of 210th Street at different times: June 5 (left), June 6 (middle-left), June 8 (middle-right), and June 9 (right); blading occurred June 4 and June 15

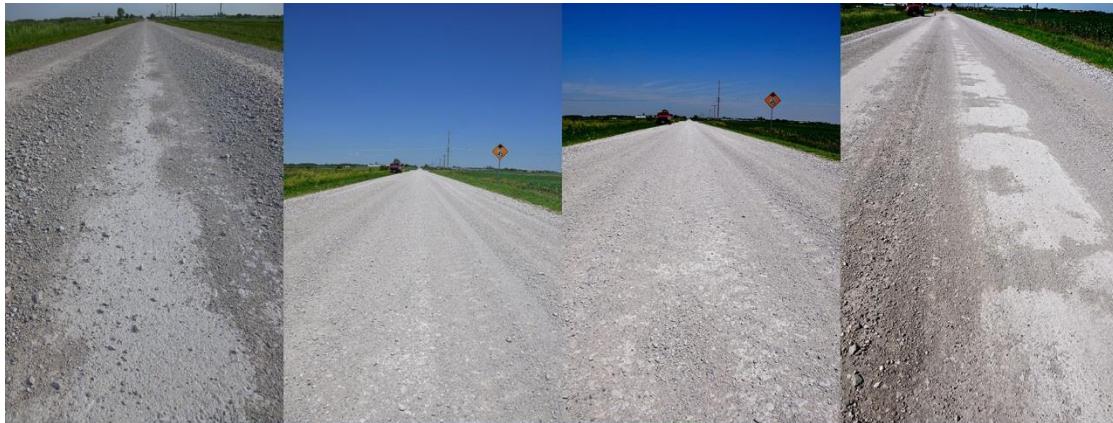
Figure 18. 520th Avenue in Story County at different times: June 1, June 9, June 10, and June 16. Blading occurred June 9 and June 29

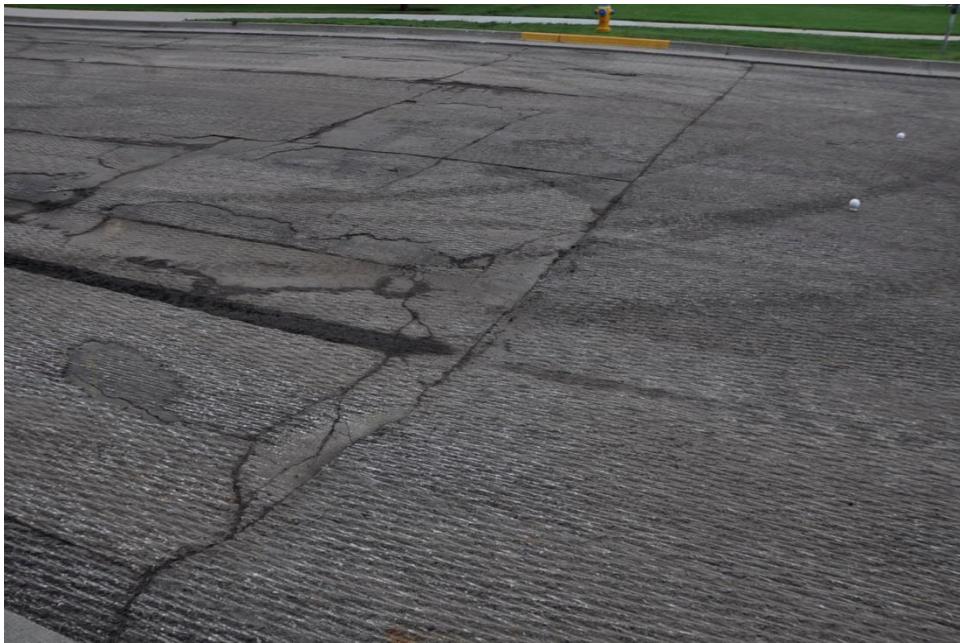
Scans were taken before (Figure 20) and after (Figure 21) the paving of a parking lot located northwest of Wilson Hall on the Iowa State University campus. The parking lot is an asphalt overlay on a milled asphalt surface.

Figure 20. Wilson parking lot before paving

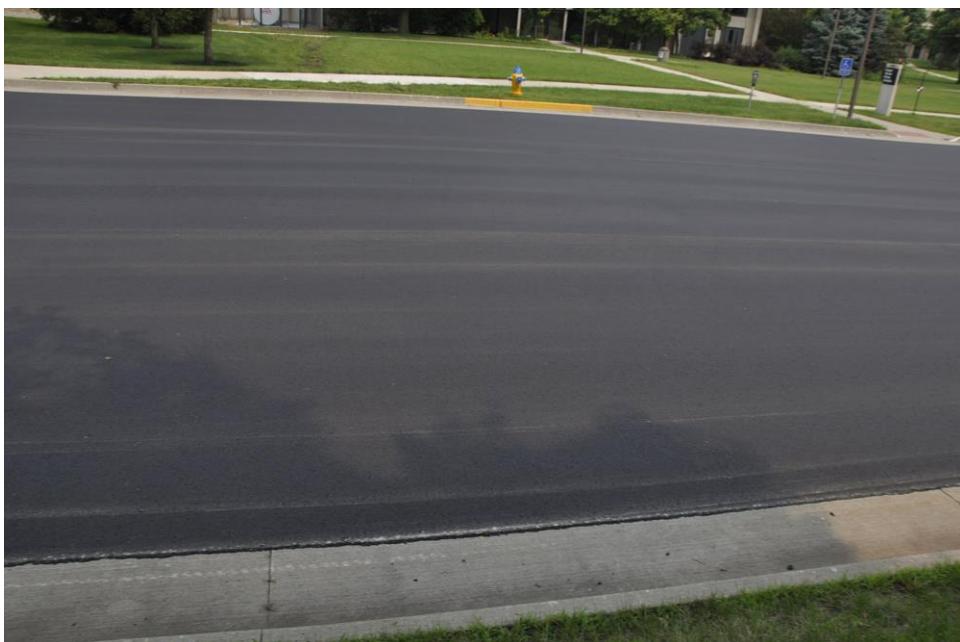
Figure 21. Wilson parking lot after paving

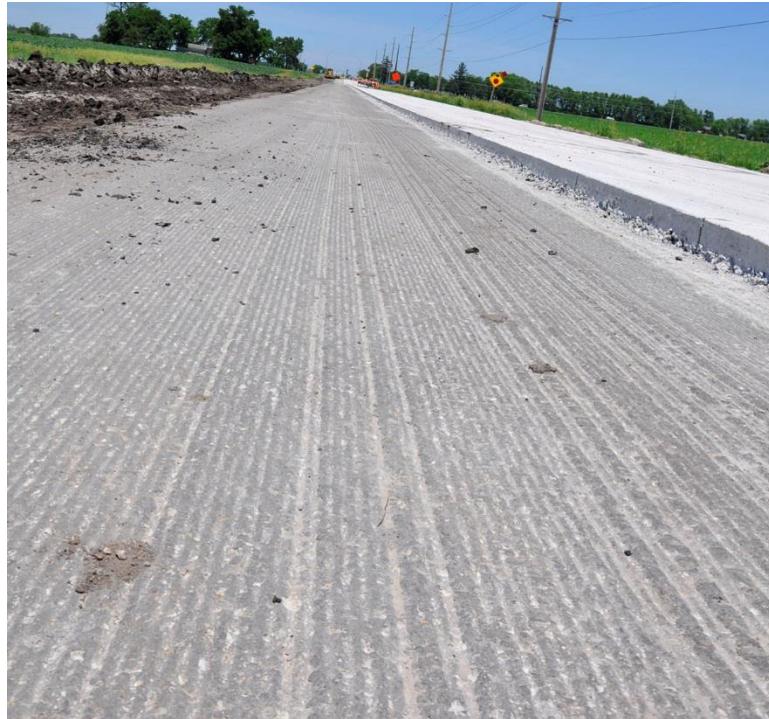
This section is a concrete overlay of a milled roadway surface. The concrete was placed by a slip-form paver. The approximate coordinates of the laser scanner station were $41^{\circ}52'22.10''\text{N}$, $93^{\circ}36'1.47''\text{W}$. Figure 22 shows the milled section before paving, and Figure 23 shows the section's concrete surface after paving.

Figure 22. Milled concrete surface of the south section of Highway 69 before paving

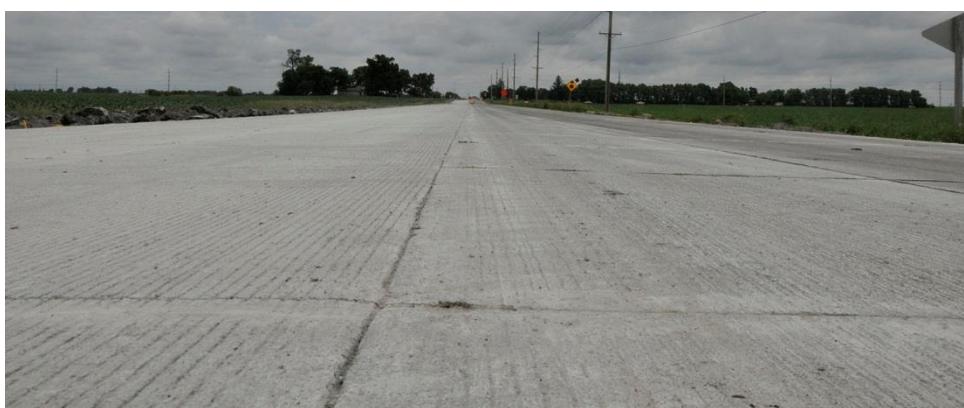
Figure 23. Concrete surface of the south section of Highway 69 after paving

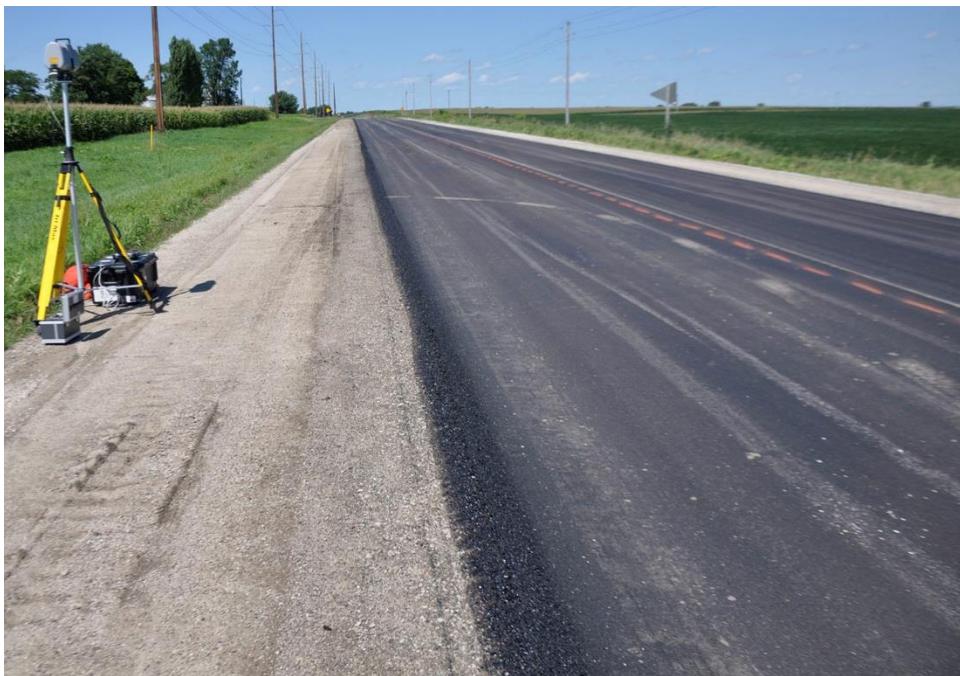
Four scans of this section were taken. The base aggregate, chokestone, intermediate asphalt, and finished asphalt layers were captured. Monuments were also left in place for monitoring of the roadway in the future. The approximate coordinates of the laser scanner station were 41°55'6.01"N, 93°36'36.02"W. Figure 24 shows the intermediate asphalt layer, and Figure 25 shows the finished asphalt layer.

Figure 24. Intermediate asphalt layer of the north section of Highway 69

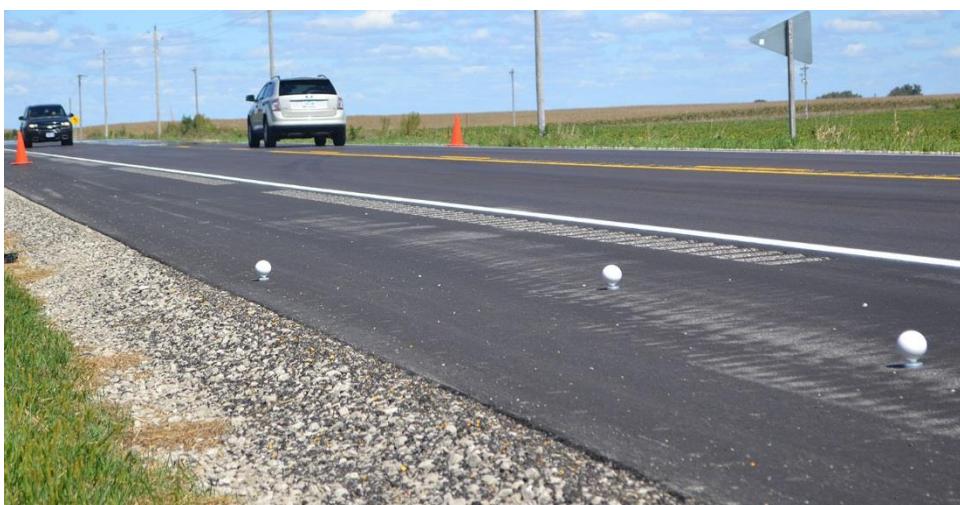
Figure 25. Finished asphalt layer of the north section of Highway 69
