# Effective Shoulder Design and Maintenance

## Final Report June 2007

**Sponsored by**  
the Iowa Highway Research Board  
(IHRB Project TR-531)  
and  
the Iowa Department of Transportation  
(CTRE Project 05-198)

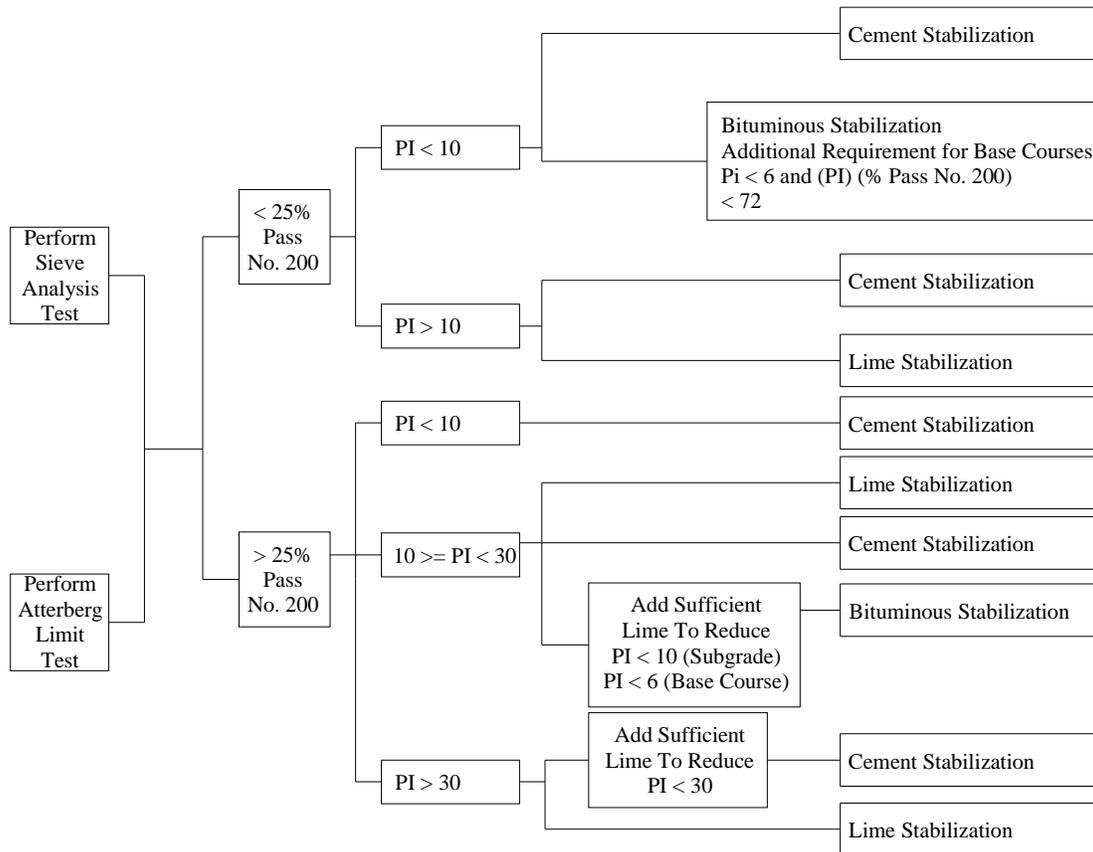
**Figure 3. Selection of stabilizer (Chu et al. 1955)**

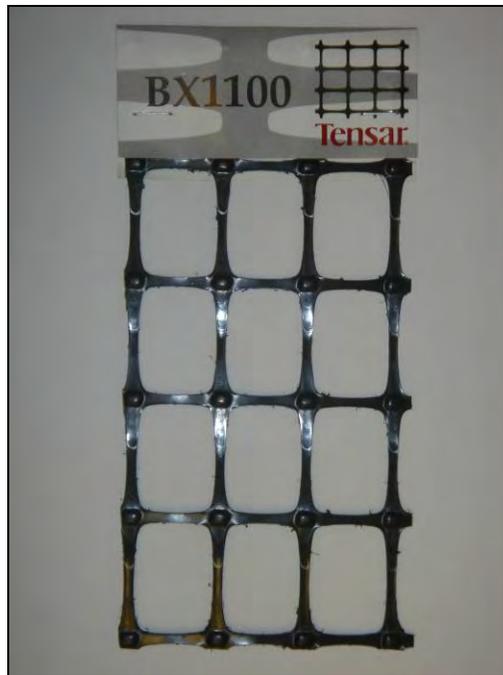
Three fundamental reinforcement mechanisms have been identified involving the use of geogrids: (1) lateral restraint, (2) improved bearing capacity, and (3) tensioned membrane effect. Lateral restraint refers to the interlocking and confinement of aggregate during loading, restricting the lateral flow of the material. This increases the modulus of the base course material, which thus increases the vertical stress distribution applied to the subgrade. Improved bearing capacity is achieved by shifting the failure envelope from the weaker subgrade to the stiffer base course. The tensioned membrane effect is based upon the concept of an improved vertical stress distribution resulting from tensile stress in a deformed membrane. In early research stages, the tensioned membrane effect was believed to govern the reinforcement mechanism. However, later research demonstrated that reinforcement benefits are obtained without significant deformation and that lateral restraint is the primary reinforcement mechanism, followed by the improved bearing capacity concept (U.S. Army Corps of Engineers 2003). Figure 4 shows a biaxial geogrid commonly used for soil reinforcement.

**Figure 4. Tensar BX1100 geogrid (image scale 1:2.5)**

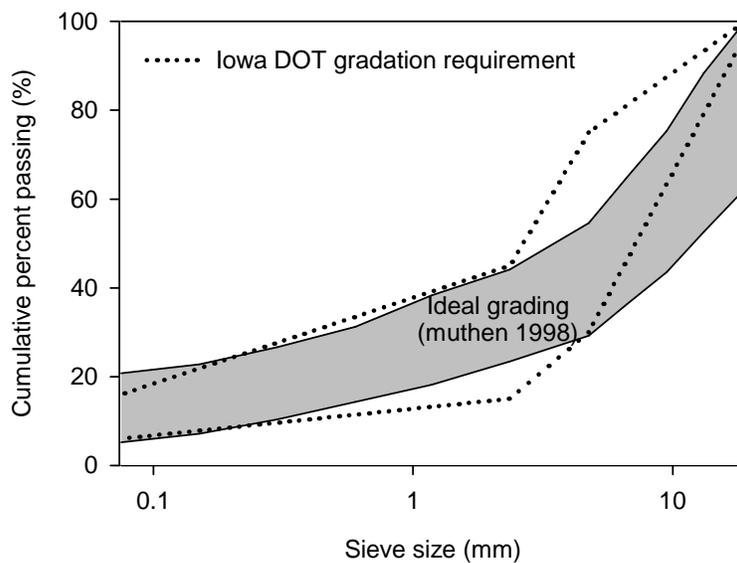
Foamed asphalt works with a range of aggregate gradation. The Iowa DOT gradation requirement for granular shoulders and the gradation requirement for aggregates that can be stabilized with FA, according to Muthen (1998), are shown in Figure 5. The figure indicates that FA is a good candidate for stabilizing granular shoulders in Iowa based on specified gradation. If necessary, grading can be adjusted by adding fines or coarse material so that the final gradation conforms to the gradation envelope. The percentage of fines is recommended to be a minimum of 5%. Generally, both the gradation and the plasticity index (PI) should be determined. Materials with PI greater than 12 should be treated with lime to reduce the PI (Muthen 1998; Lee and Kim 2003).

**Figure 5. Gradation envelope for foamed asphalt mixes (modified from Muthen 1998)**

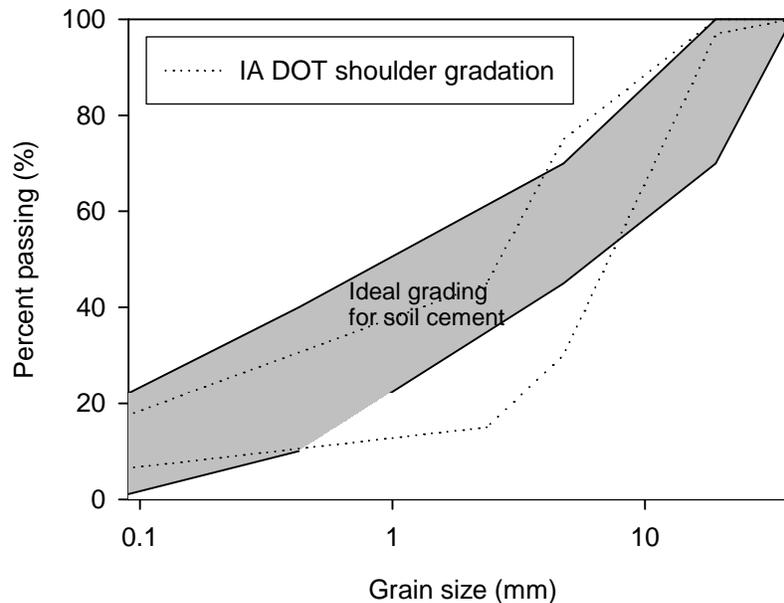
The soil portion of the PC-stabilized soil mixture can be any combination of sand, silt, clay, and gravel. In addition, old granular base roads, with or without their bituminous surfaces, can be recycled to make good soil-cement. However, soils with a granular breaking skeleton and sufficient fines to partly fill the voids without interference from grain-to-grain contact (approximately 10% to 35% of non-plastic fines) require the least amount of cement for adequate hardening (Portland Cement Association 1979; Fang 1990). Figure 6 shows the gradation requirement for a cement-stabilized base course and the Iowa DOT gradation requirement for granular shoulders. A segment of the Iowa DOT shoulder gradation requirement matches the gradation requirement for cement-stabilized base courses. In addition, the percentage of fines (material passing the No. 200 sieve) is within the suggested limits.

**Figure 6. Gradation requirement for cement stabilized base course (modified from Department of the Army, the Navy, and the Air Force 1994)**

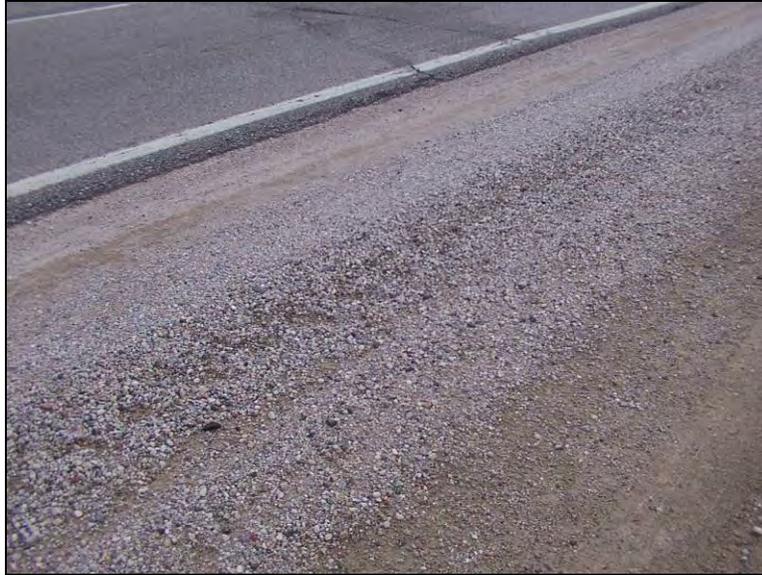
The first shoulder section (milepost 151.95 E.B.) is about 8 ft. wide and is comprised of crushed limestone, as shown in Figure 11. The edge line is 6 in. from the pavement edge. A 2 in. drop-off was measured at this section. Aggregate samples were collected at 0, 24, and 36 in. from the pavement edge, and grain size analysis was conducted. The results of the grain size analysis, shown in Figure 12, indicate that the granular material gets coarser with increasing distance from the pavement. The soil properties of the collected samples are shown in Table 10.

**Figure 11. Shoulder section at U.S. 30 milepost 151.95 E.B., September 2, 2006**

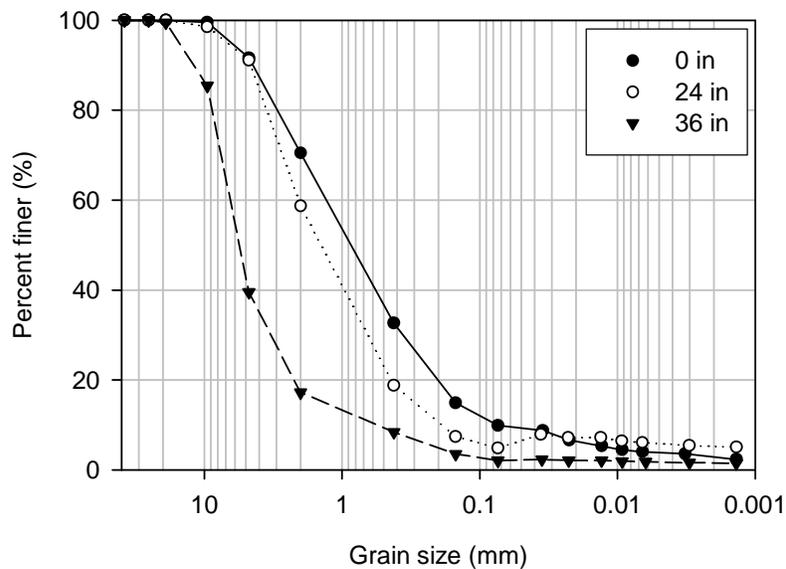
**Figure 12. Grain size distribution of granular shoulder material (M.P. 151.95 E.B.)**

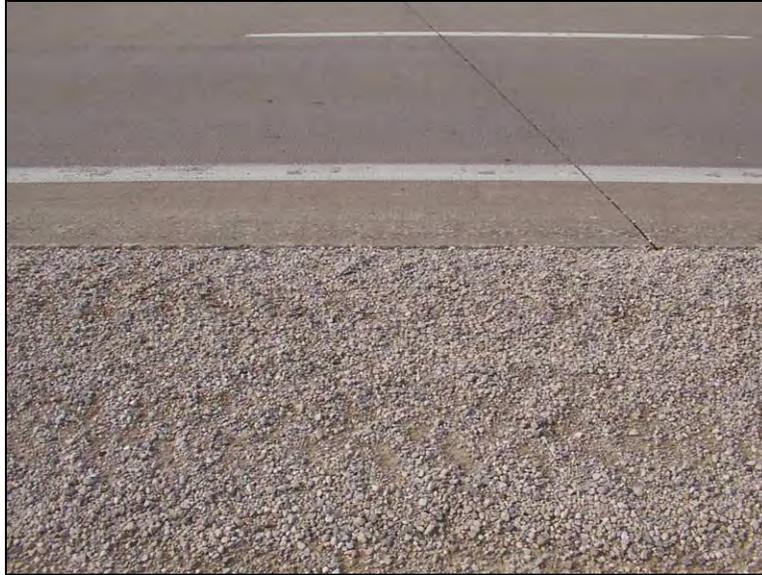
The second shoulder section inspected on U.S. 30 (milepost 156.0 W.B.) was about 8 ft. wide. The edge line is 25 in. from the pavement edge, and, unlike the first section, there is no shoulder drop-off (Figure 13). However, the crushed limestone on the surface was observed to be loose. Aggregate samples were collected for grain size analysis every 1 ft. from the pavement edge up to a distance of 5 ft. The results of the grain size analysis, which are shown in Figure 14, reveal that the percentage of fines increases gradually with distance from the pavement edge. The loss of fines reduces cohesion of the surface layer, resulting in loose, coarse aggregate. If not maintained, this section can undergo longitudinal rutting. The soil properties of the samples collected are shown in Table 10

**Figure 13. Granular shoulder section on U.S. 30 (milepost 156.0 W.B.), September 2, 2006**

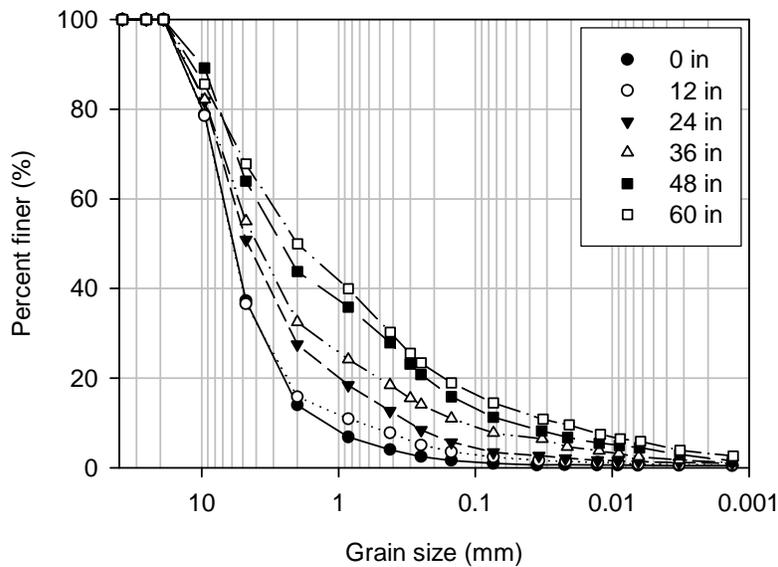
**Figure 14. Grain size distribution of granular shoulder material (M.P. 156.0 W.B.)**

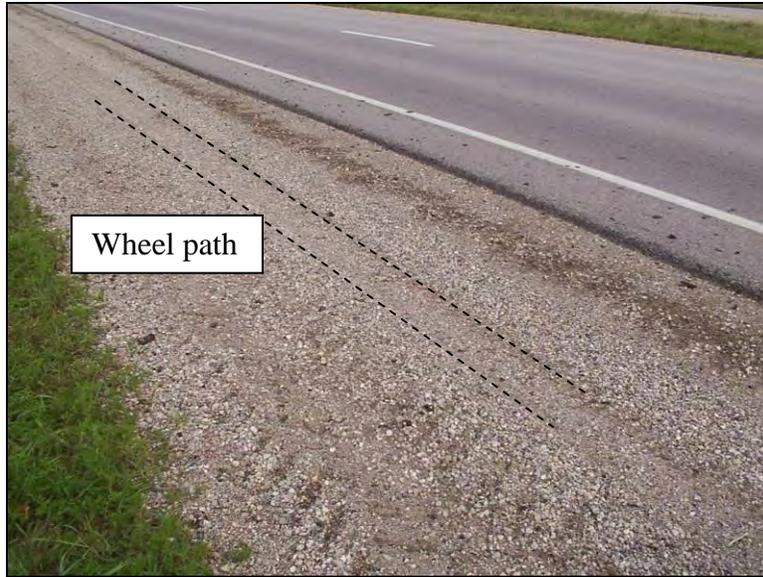
The third shoulder section investigated on U.S. 30 (milepost 160.25 E.B.) was about 8 ft. wide. The edge line is 25 in. from the pavement edge, and the shoulder drop-off was measured to be 2.5 in. (Figure 15). A visible wheel path was noted about 3 ft. from the pavement edge. Further, the area adjacent to the pavement was cleared of surface gravel. This was reflected in the grain size analysis results, which were conducted on samples collected every 1 ft. up to a distance of 5 ft. from the pavement edge (Figure 16). The soil properties of the samples collected are shown in Table 10. The samples collected at 0 and 12 in. have less coarse gravel, whereas the sample collected at 24 in. has coarser gravel, than the sample collected at 36 in.

Figure 15. Granular shoulder section on U.S. 30 (milepost 160.25 E.B.), September 2, 2006

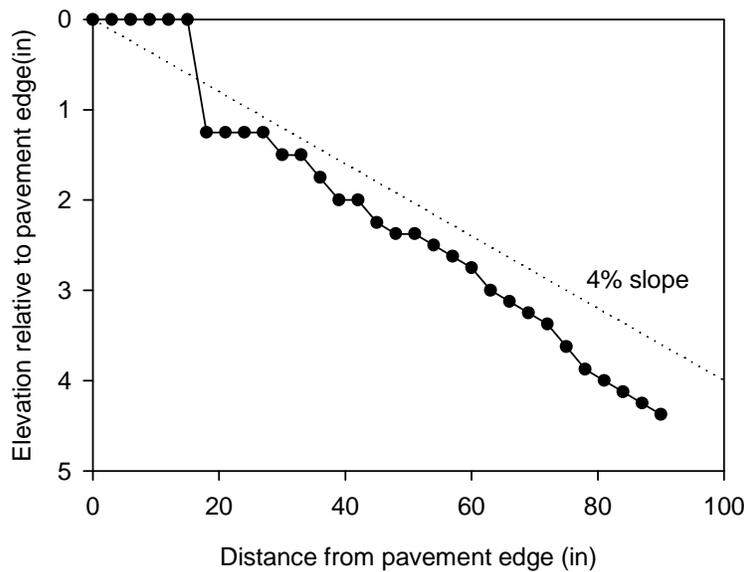
The elevation profile of the shoulder section was determined relative to the pavement elevation (Figure 31). The edge drop-off adjacent to the stabilized area is about 1.25 in. and the overall slope of the section is about 4%, which is in agreement with the Iowa DOT requirement. A DCP test was conducted at 36 in. from the pavement edge (Figure 32). The CBR value for the upper 8 in. is 5, which may be attributed to loose material in the upper layer. The strength increases significantly in the underlying 12 in. (CBR of 83).

**Figure 31. Elevation profile relative to the pavement edge, Hwy 18 W.B.**

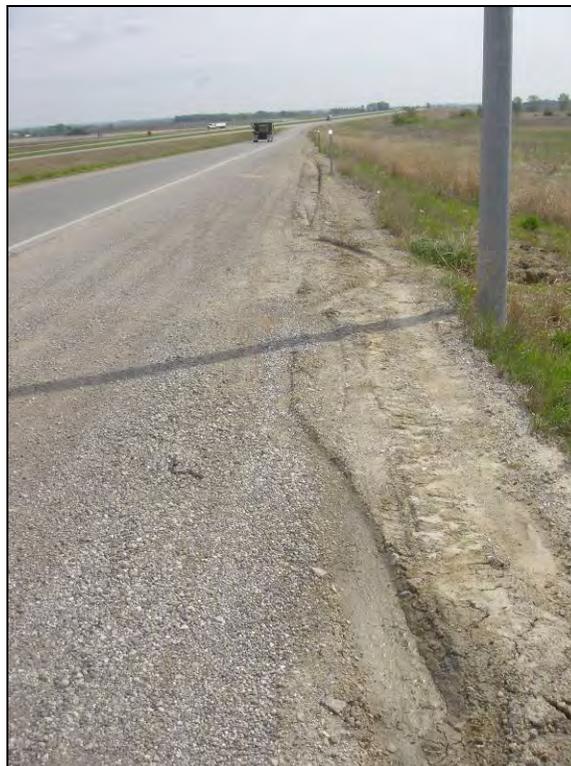
**Figure 39. Shoulder rutting caused by soft subgrade and absence of granular layer on Hwy 65 exit ramp to Hwy 27, May 10, 2006**

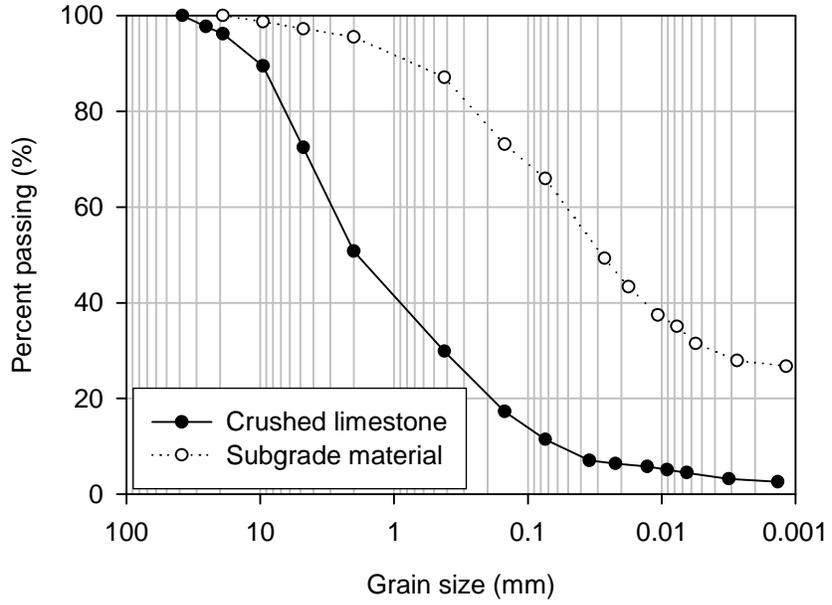
A soil sample was obtained from both the crushed limestone and the subgrade material for grain size distribution analysis (Figure 40). The limestone and the subgrade materials are classified as SP-SM (poorly graded sand with silt) according to USCS (A-1-b according to AASHTO) and CL (lean clay) (A-6), respectively. The elevation profile relative to the pavement edge was determined, as shown in Figure 41. The profile, which extended a distance of 7.5 ft, shows that the maximum shoulder drop-off is 3.5 in. at 9 in. from the pavement edge, and the overall slope of the section is about 4%. Three DCP tests were conducted. The first test was conducted inside the shoulder drop-off at 3 in. from the pavement, the second test was conducted outside the shoulder drop-off at 3.1 ft. from the pavement, and the third test was conducted on the subgrade at 14 ft. from the pavement (Figure 42). The CBR of the granular layer was 62 and 152 at 3 in. and 3.1 ft, respectively. At 14 ft. from the pavement edge, the CBR was about 2.

**Figure 40. Grain size distribution of granular and subgrade layers, Hwy 65 exit ramp to Hwy 27**

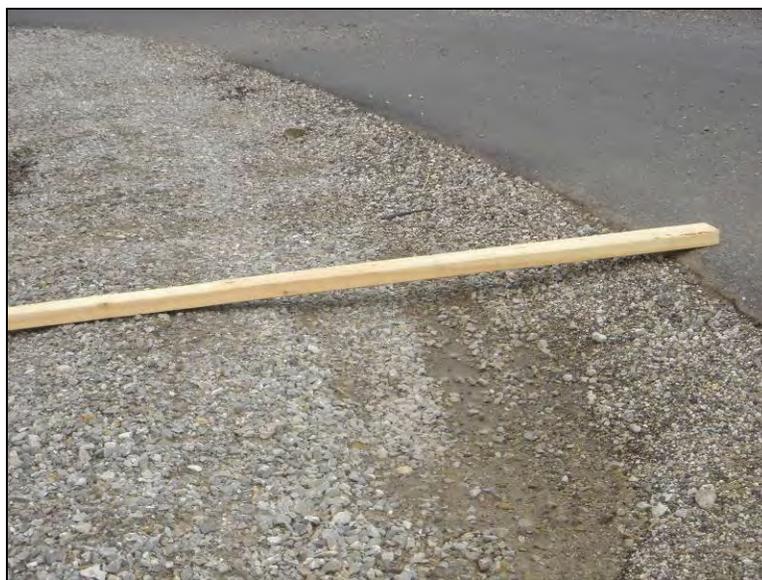
**Figure 44. Cross slope damage at the intersection with Larke Ave. on Hwy 122, July 26, 2005**

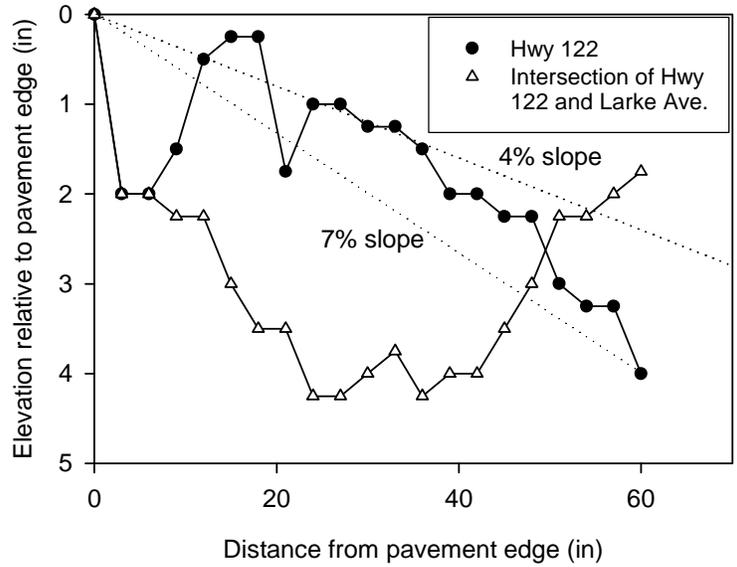
**Figure 45. Elevation profiles relative to the pavement edge, Hwy 122**

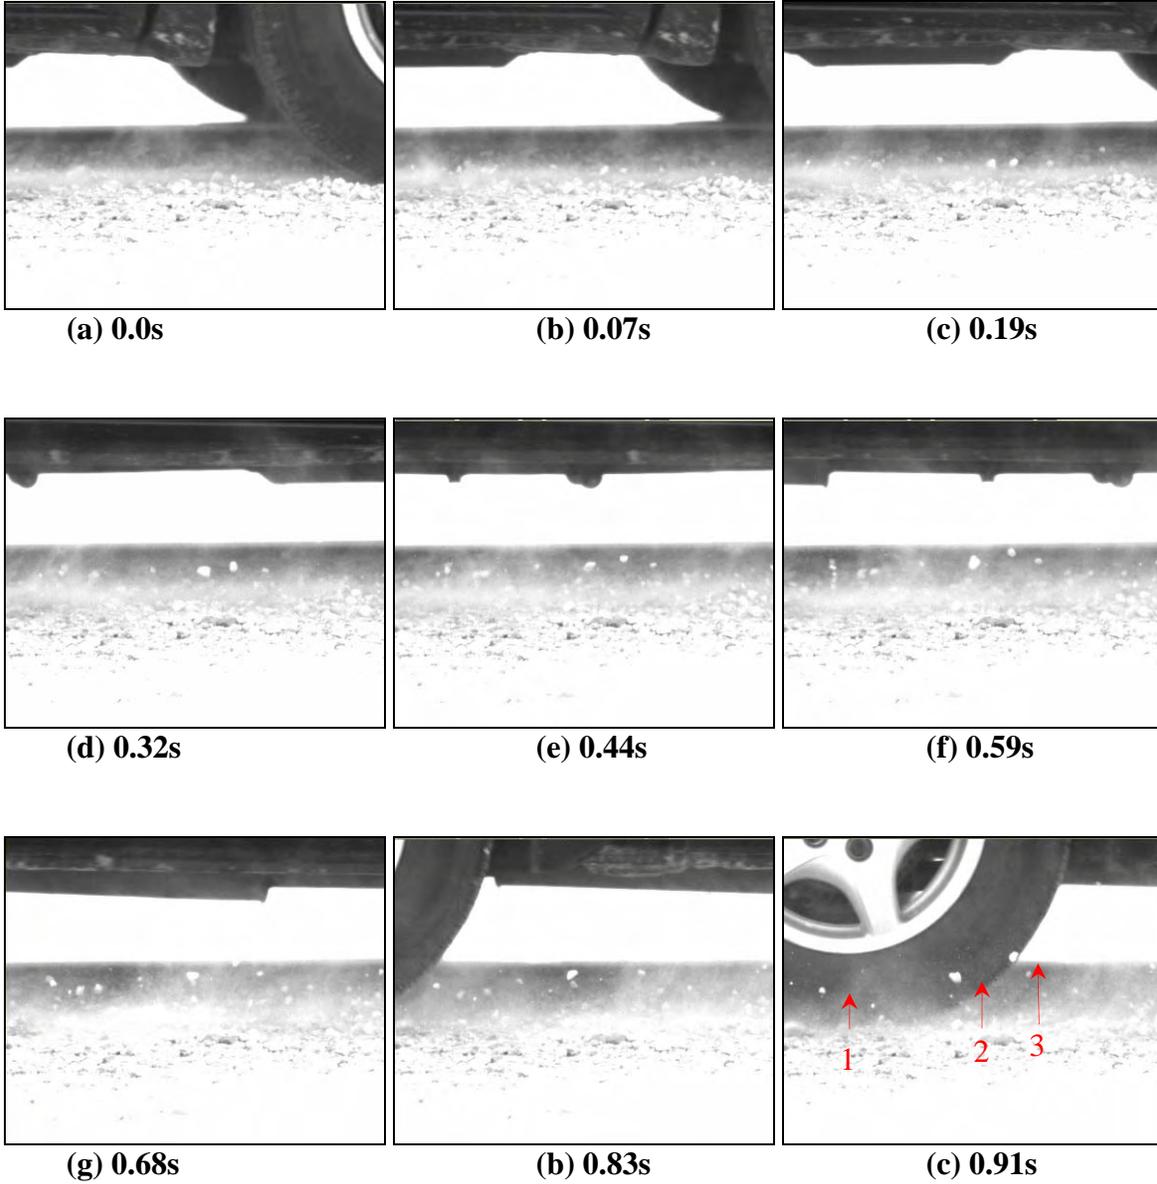
Repeated off-tracking of vehicles will thus eventually clear the shoulder surface of aggregate and cause edge drop-off, which is consistent with the gradation measurements conducted during the field reconnaissance.

**Figure 79. Images captured by a stationary high-speed camera showing aggregate displacement at different times after coming in contact with the tire**

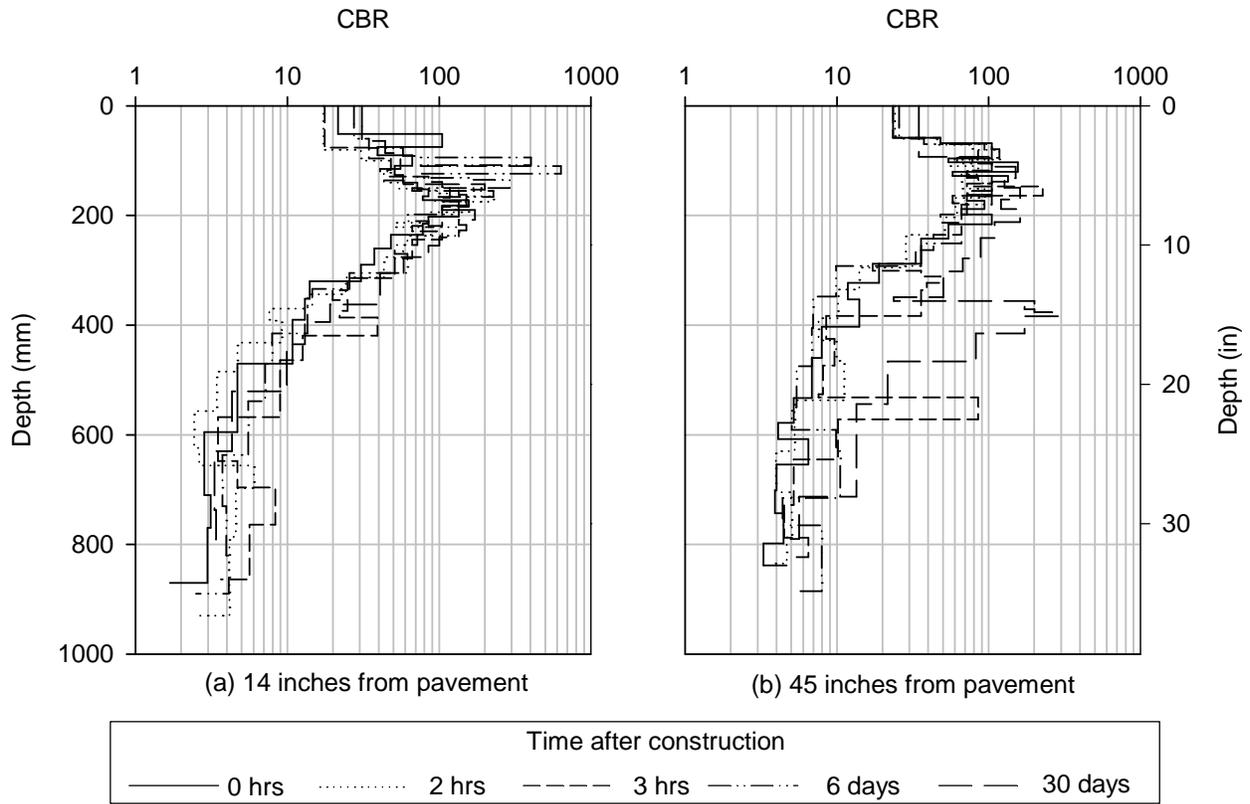
**Figure 87. DCP test results, (a) inside the stabilized area and (b) outside the stabilized area**

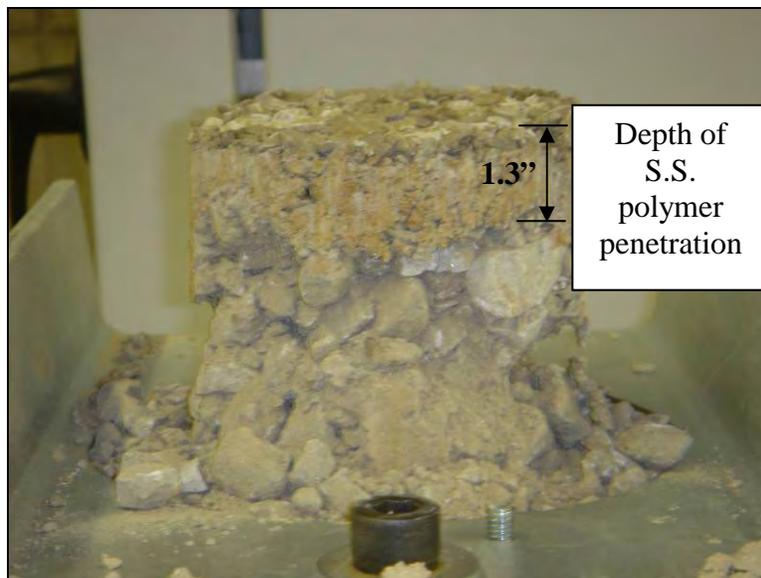
On average, the depth of penetration of the S.S. polymer for sample one (upper bound gradation) was 1.3 in. As shown in Figure 91, the upper 1.3 in. of the extruded sample was cemented together, while the lower portion of the sample was loose. Unlike sample 1, the S.S. polymer penetrated the full depth of the second sample (lower bound gradation) due to its higher permeability.

**Figure 91. Measured penetration depth of S.S. polymer for upper bound gradation**

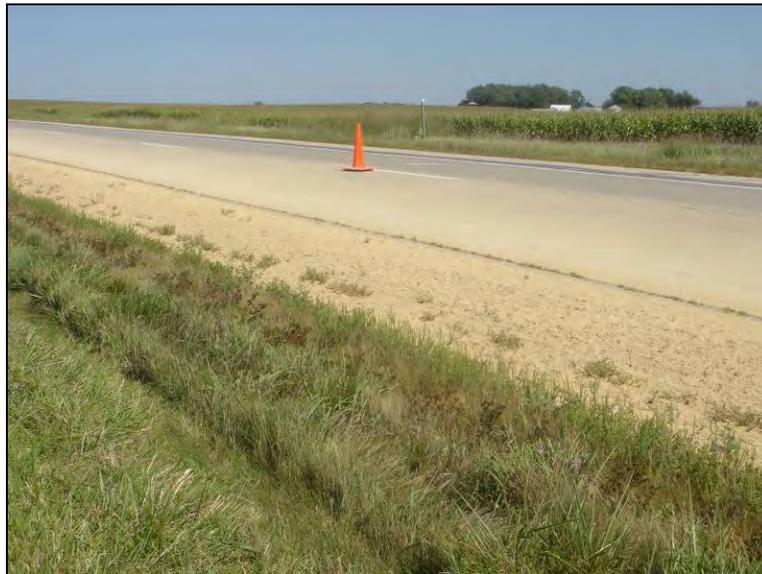
The construction procedures included mixing about 3% to 4% class C fly ash with the granular material prior to placing the FA (Figure 95). Full-depth reclamation of existing shoulder materials with FA and fly ash was conducted to a depth of 10 in. using a reclaimer, as shown in Figure 96. The reclaiming drum was 8 ft. wide. Water was added to the reclaimed foamed asphalt via a water truck that followed the road reclaimer to achieve moisture content near the optimum for compaction. Compaction of the FA was accomplished using a vibratory pad foot followed by a smooth drum roller. Two days after construction, the FA surface was sealed using a seal coat (chip seal), as shown in Figure 97.

**Figure 95. Fly ash added to the granular material on I-35 milepost 150 northbound, September 1, 2005**

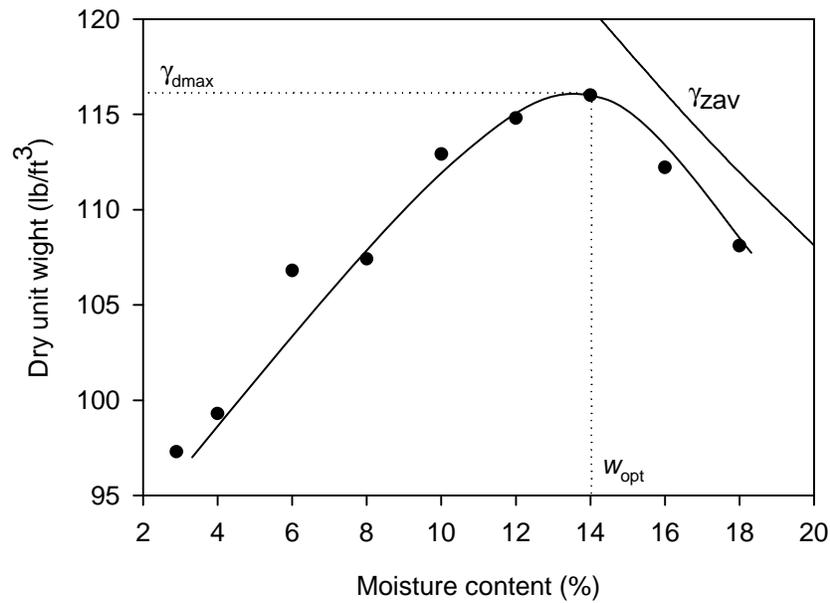
**Figure 98. Optimum moisture content and maximum dry density determined by standard Proctor test, I-35 milepost 150 northbound**

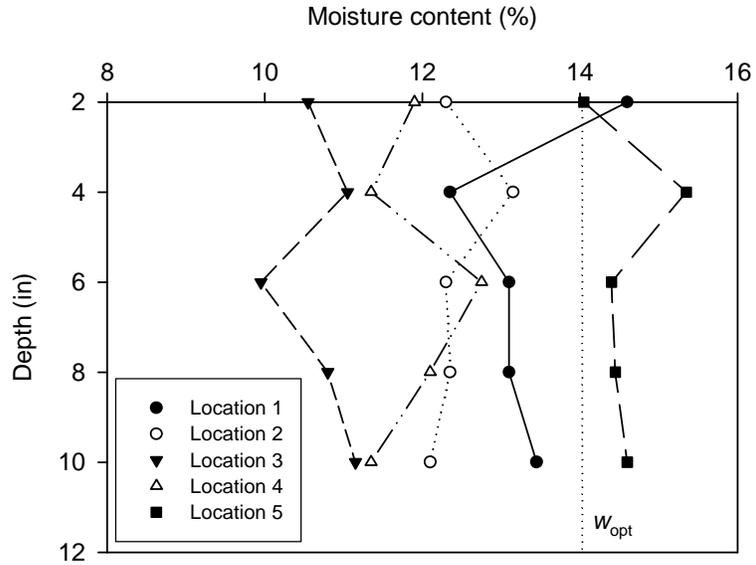
contents at locations 1 through 4 were on the dry side of optimum moisture content (1% to 2% below optimum), while at location 5 the field moisture contents was on the wet side (about 1.5% above optimum). When compared to the maximum dry density obtained by the standard Proctor test, the relative compaction in the field varied from 95% to 100% compaction. At two locations, the percent compaction exceeded 100%. DCP tests were conducted before and after compaction of the FA and at 6 and 40 days after reconstruction (Figure 101). The data collected at 40 days was excluded because the DCP could not penetrate beyond a depth of 3.9 in. The results show that immediately after compaction the CBR value increased from 0.4 to 14 for the upper 12 in. Additional strength gain was observed after 6 days, as the CBR value increased to 59. This shows that FA was successful in increasing the short-term strength of reclaimed material.

**Figure 99. Variation of field moisture content with depth along the shoulder section, I-35 milepost 150 northbound**

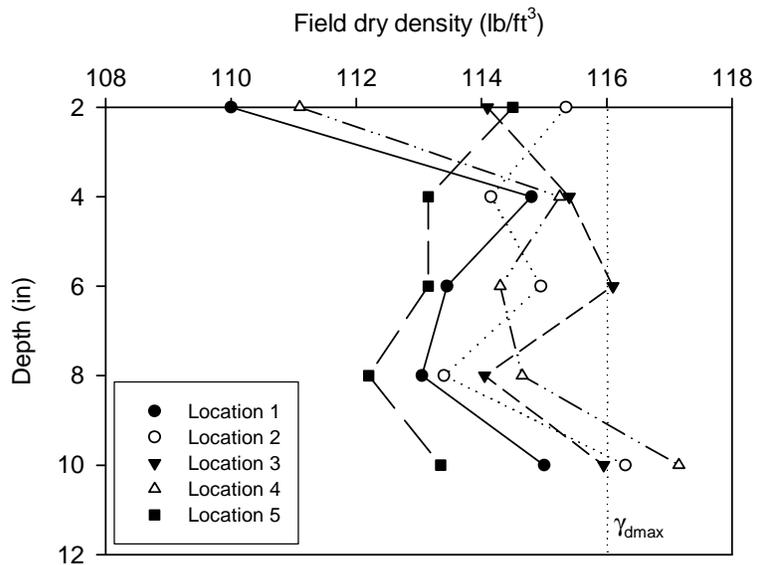
**Figure 100. Variation of field dry density with depth along the shoulder section, I-35 milepost 150 northbound**

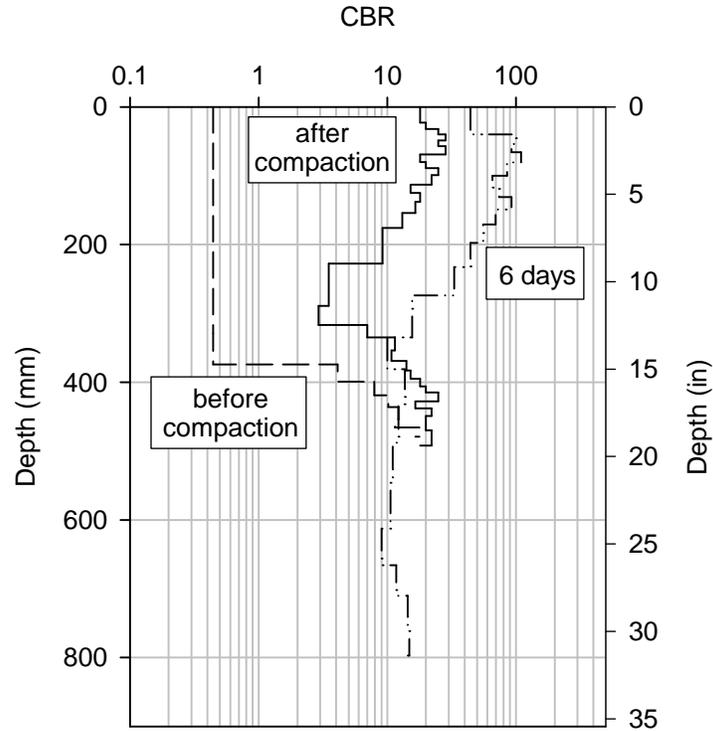
**Figure 101. DCP test results showing strength gain with time, I-35 milepost 150 northbound**

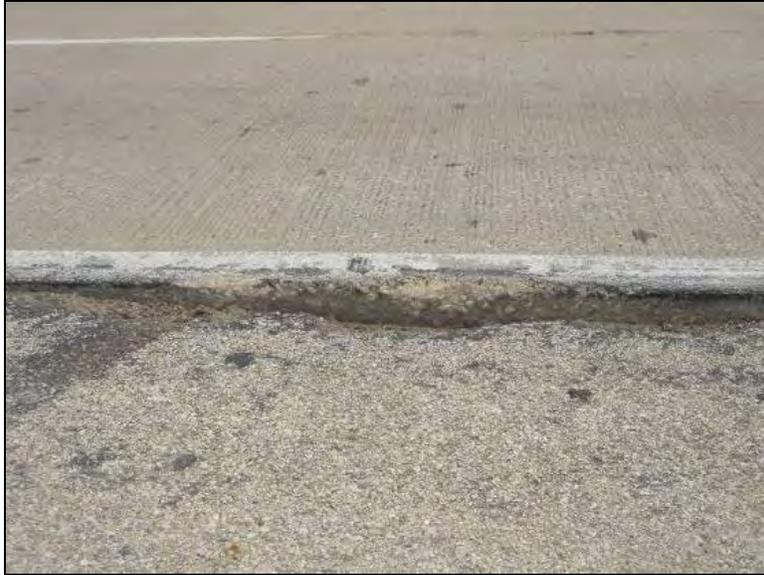
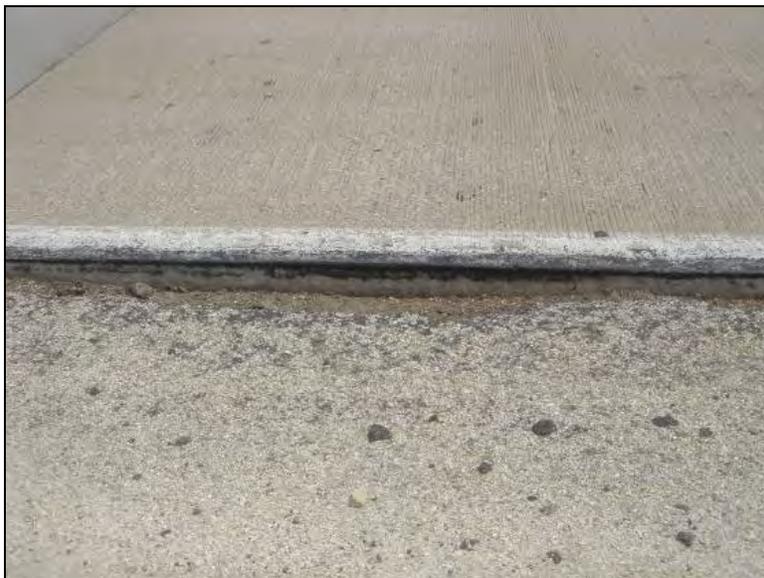
The test section was inspected after 10 months from the reconstruction date. It was observed that the test section failed along the pavement edges. Due to this failure, and as shown in Figure 102, edge drop-offs varying from 3 to 5 in. were formed. Along the horizontal curved road sections (in particular milepost 150, northbound lane), where vehicle off-tracking is likely, edge drop-offs had developed in a number of places. Thus, the area adjacent to the pavement edge was patched, as shown in Figure 103. Foamed asphalt was successful in improving the shoulder's short-term performance, as evidenced by the increase in CBR values. However, this stabilization technique failed to withstand loads imposed by off-tracking vehicles at the pavement edge. Inspection of the seal coat after 12 months from reconstruction did not result in any indications of seal coat failure, such as delaminating or substantial snow plow damage.

**Figure 102. Edge drop-off caused by failure of foamed asphalt-stabilized section, July 25, 2006**

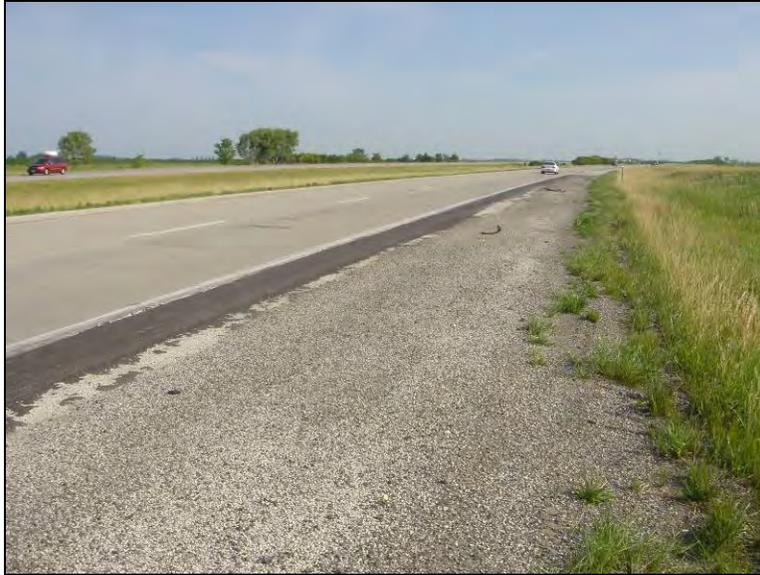
**Figure 103. Asphalt patch placed on the deteriorated shoulder adjacent to a horizontal curve, I-35 milepost 150 northbound, July 7, 2006**

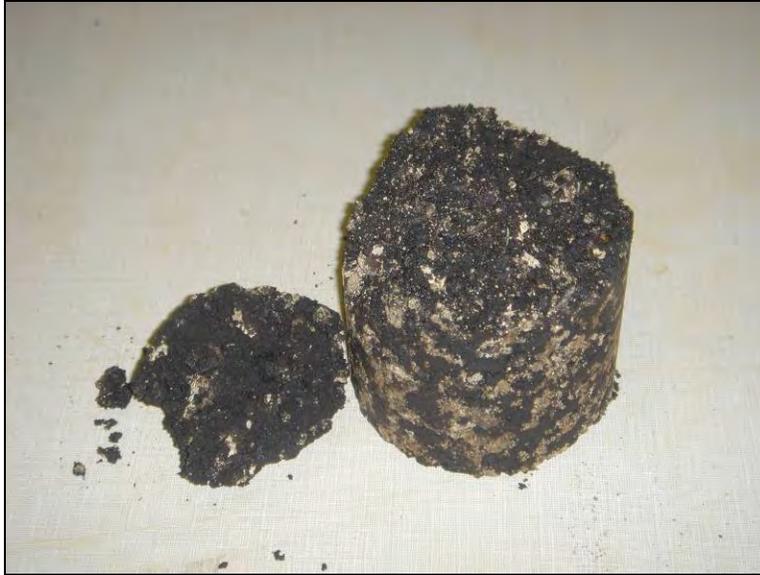
**Figure 105. Failure of foamed asphalt stabilized sample during wet-dry testing**

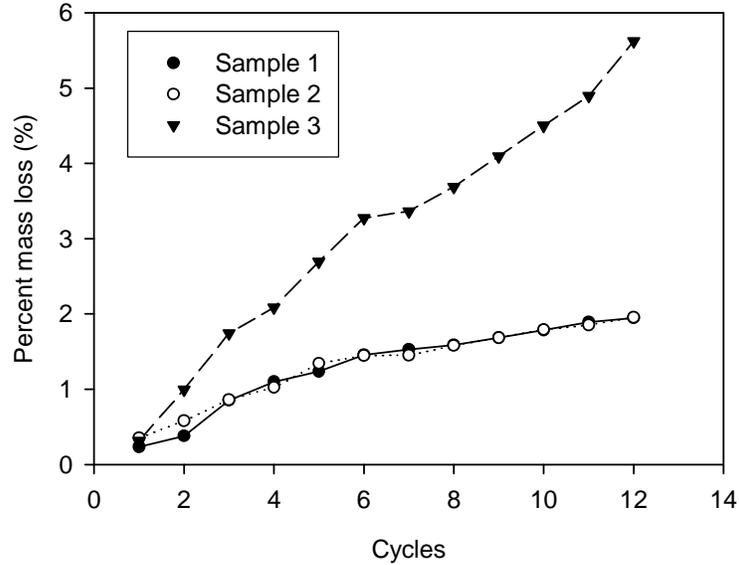
**Figure 107. Percent mass loss during freeze-thaw cycles**

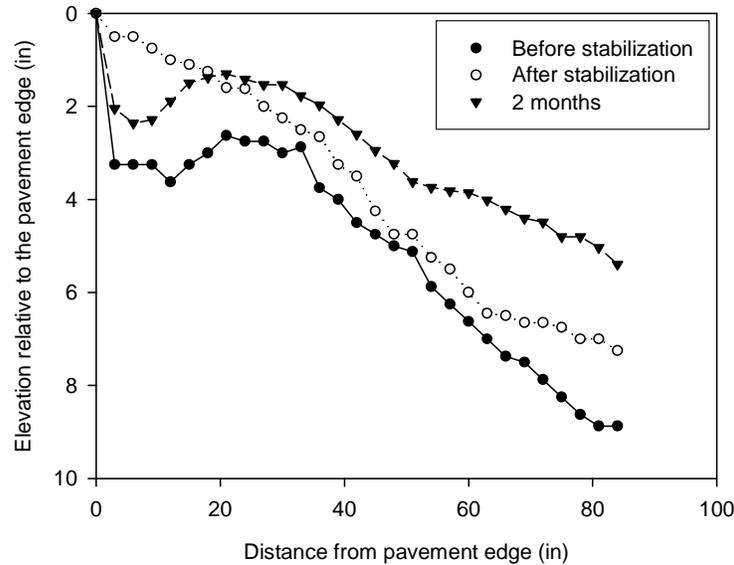
**Figure 116. Elevation profile relative to the pavement edge, Hwy 18 milepost 202.50 W.B.**

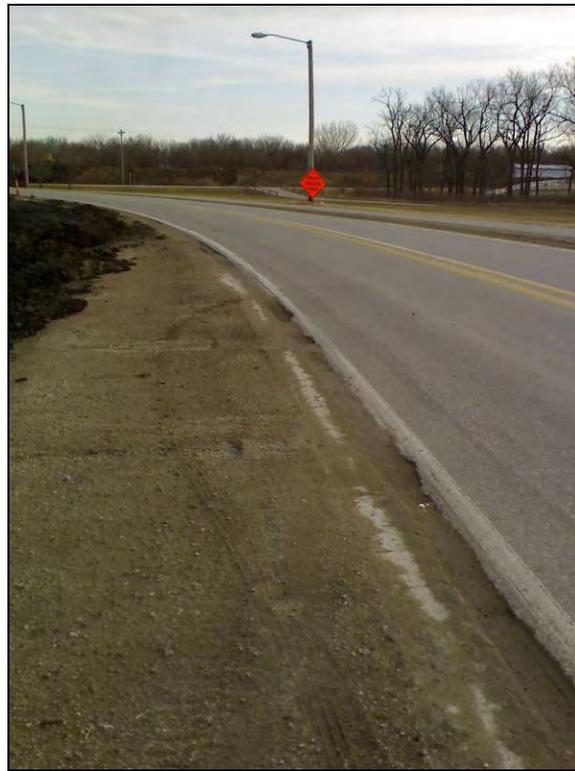
**Figure 130. Significant edge drop-off observed after four months on 16th St. Ames, IA, December, 2007**

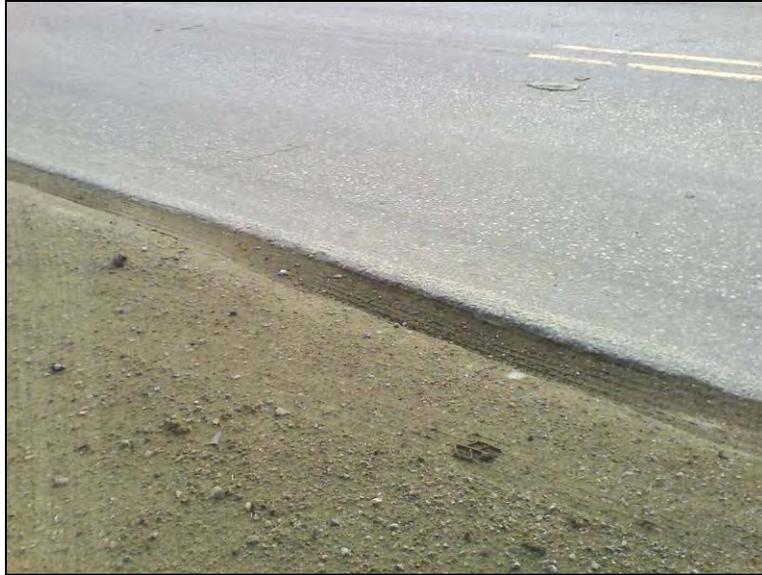
**Figure 131. Three-inch edge drop-off adjacent to pavement after eight months, May 18, 2007**

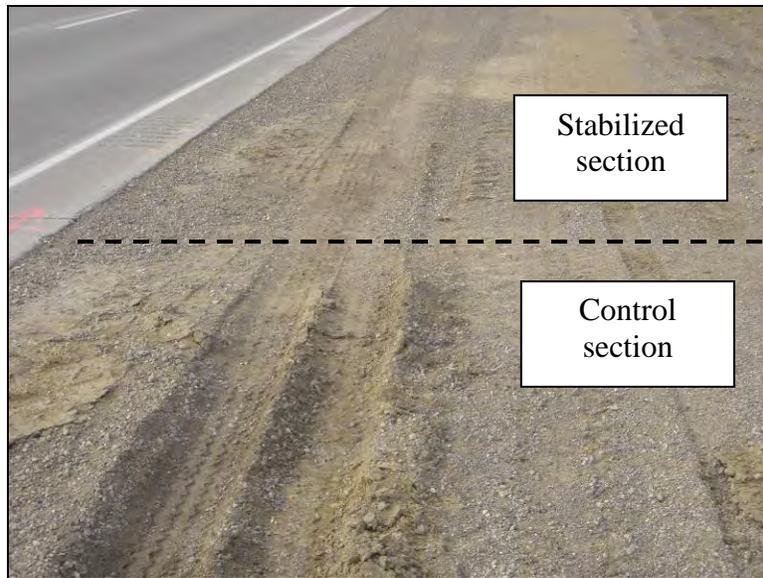
**Figure 158. Higher rut depth observed along the control section after one month from shoulder reconstruction, November 23, 2005**

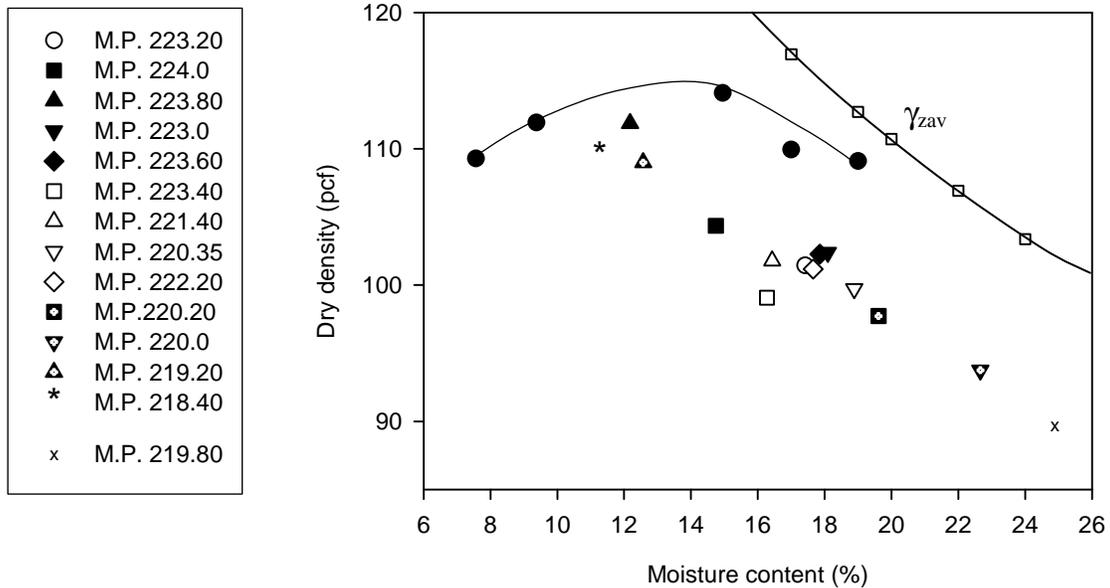
**Figure 169. Moisture-density relationship for subgrade material**

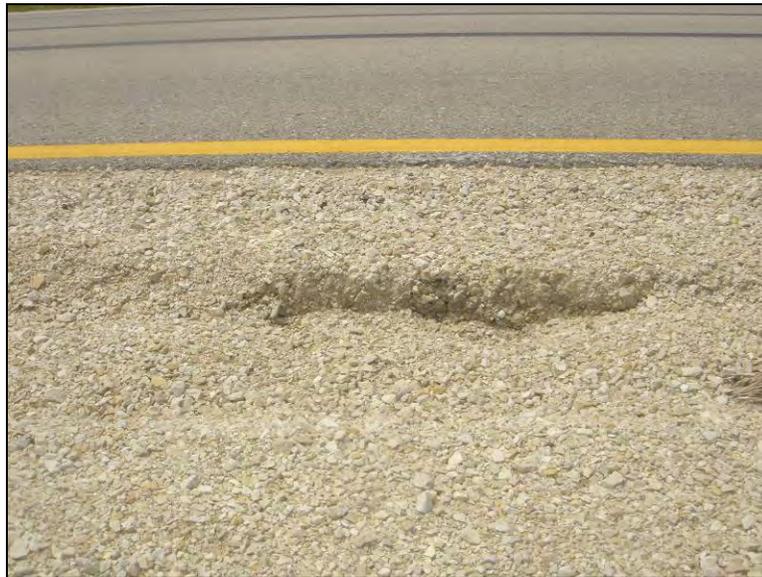
**Figure 181. Development of shoulder rutting one month after shoulder construction, July 25, 2006**

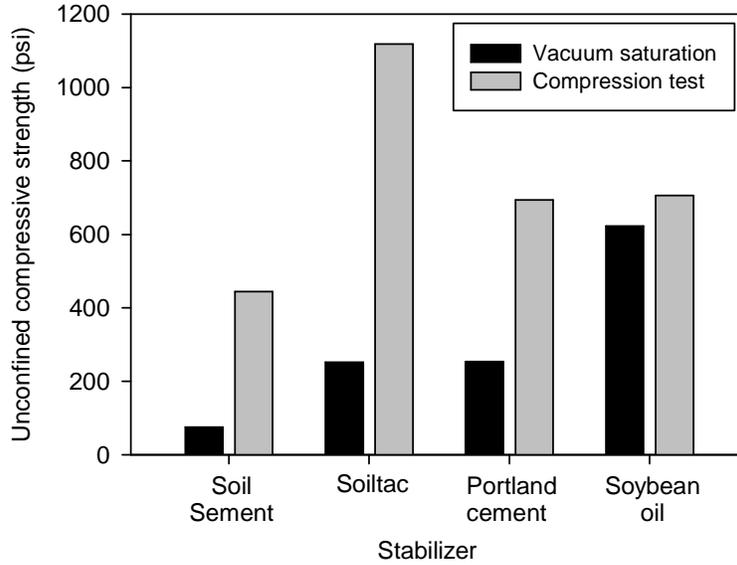
**Figure 194. Summary of compressive strength results**

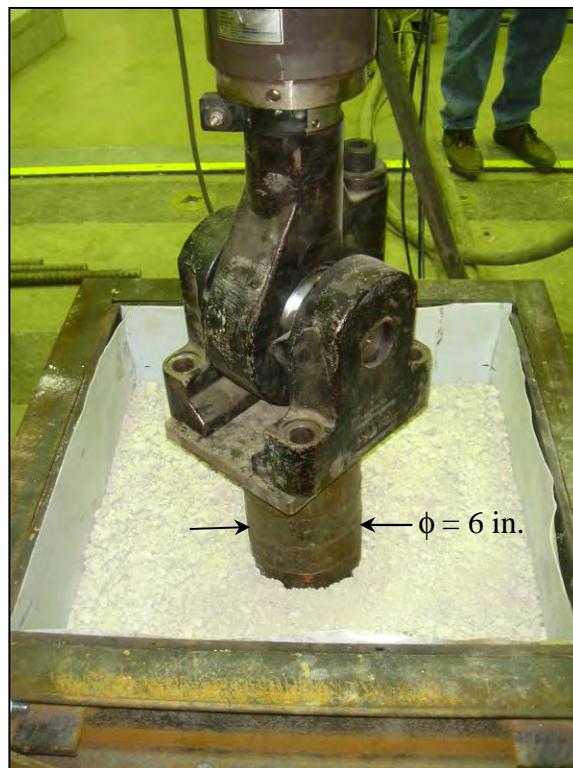
**Figure 198. Applying cyclic loading to the soil using a 6 in. plate**

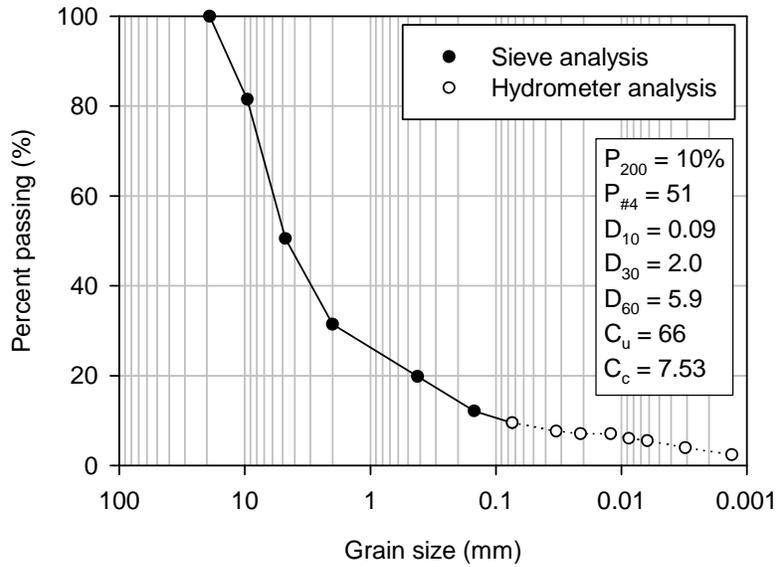
**Figure 201. Grain size distribution analysis for the granular material used in the laboratory box testing**

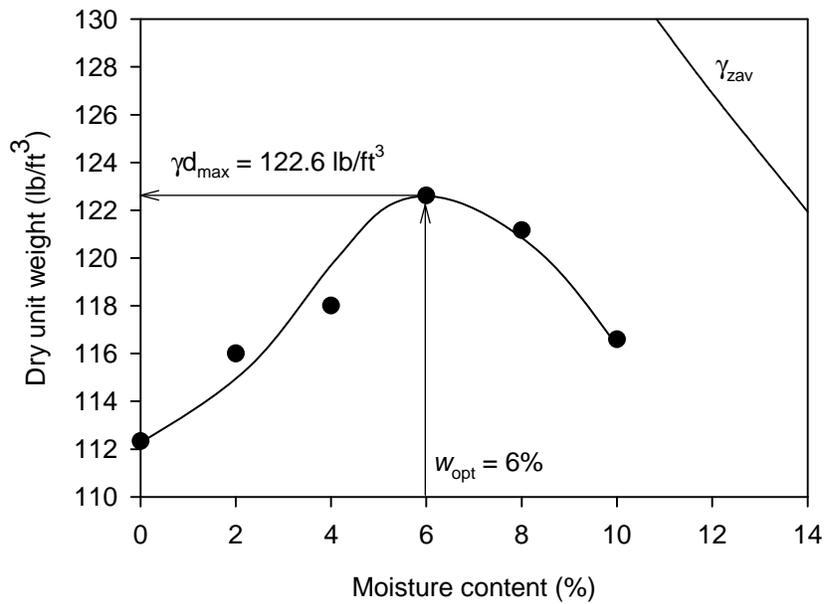
**Figure 202. Relationship between moisture content and dry unit weight for the granular material used in the laboratory box testing**

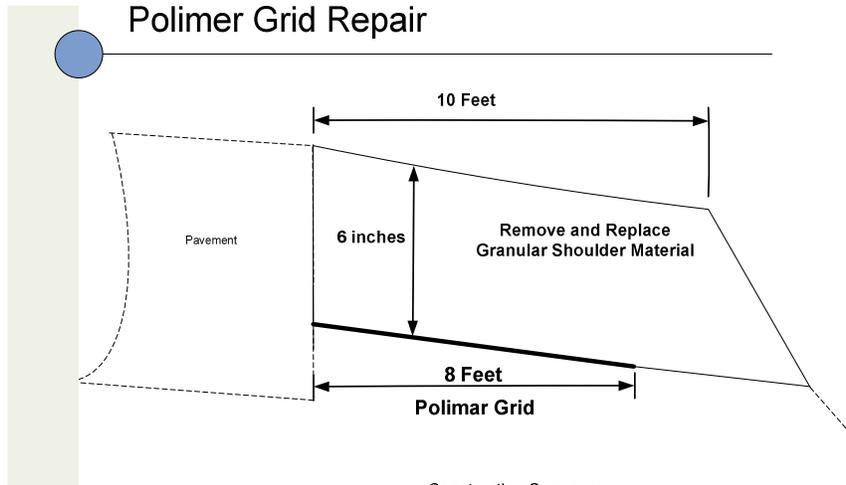
- Construction Sequence
1. Remove & store existing aggregate
  2. Place polimer grid
  3. Replace / re-compact aggregate
  4. Add aggregate & bring to grade
