# Effective Shoulder Design and Maintenance

## Final Report June 2007

**Sponsored by**  
the Iowa Highway Research Board  
(IHRB Project TR-531)  
and  
the Iowa Department of Transportation  
(CTRE Project 05-198)

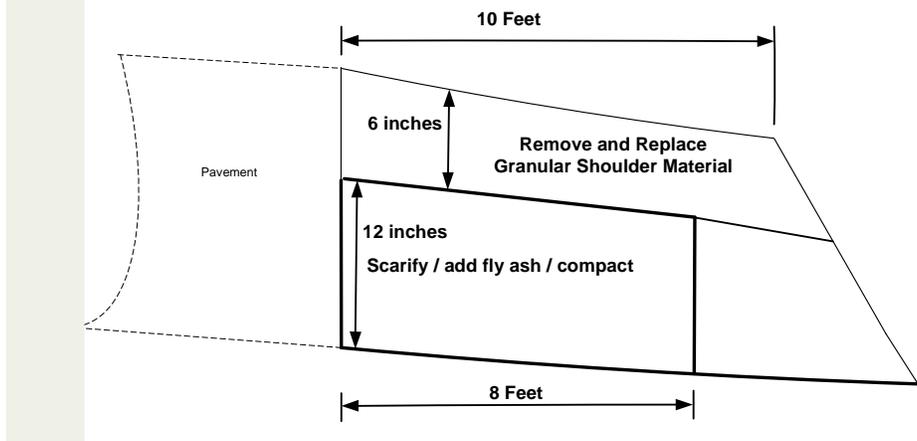
- Construction Sequence
1. Remove & store existing aggregate
  2. Scarify one foot deep with fly ash and compact
  3. Replace / re-compact shoulder aggregate
  4. Add aggregate & bring to grade

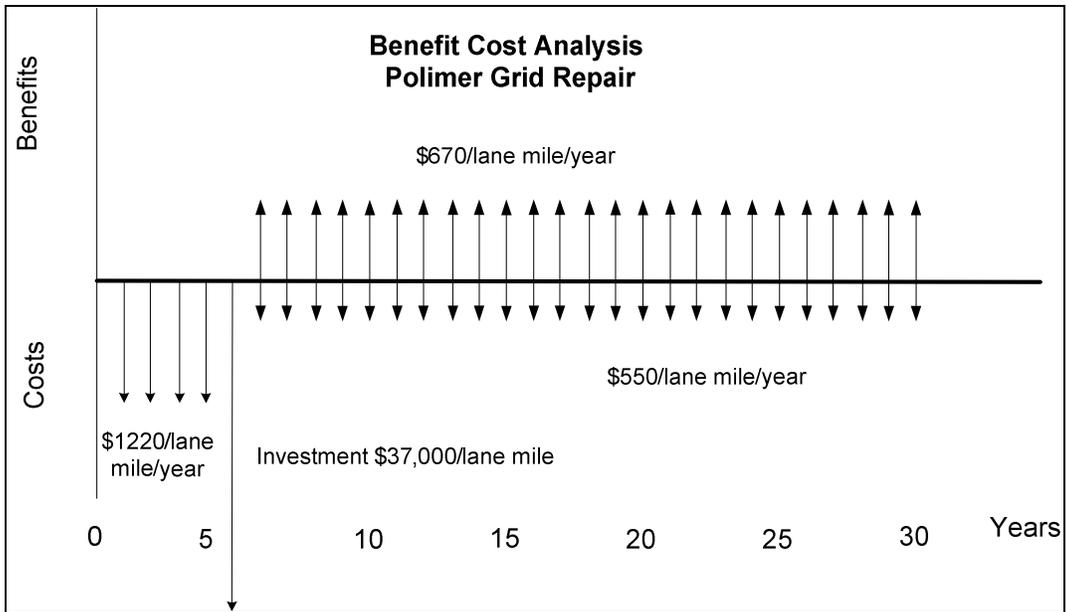
**Figure 248. Benefit-cost analysis for polymer grid repair**

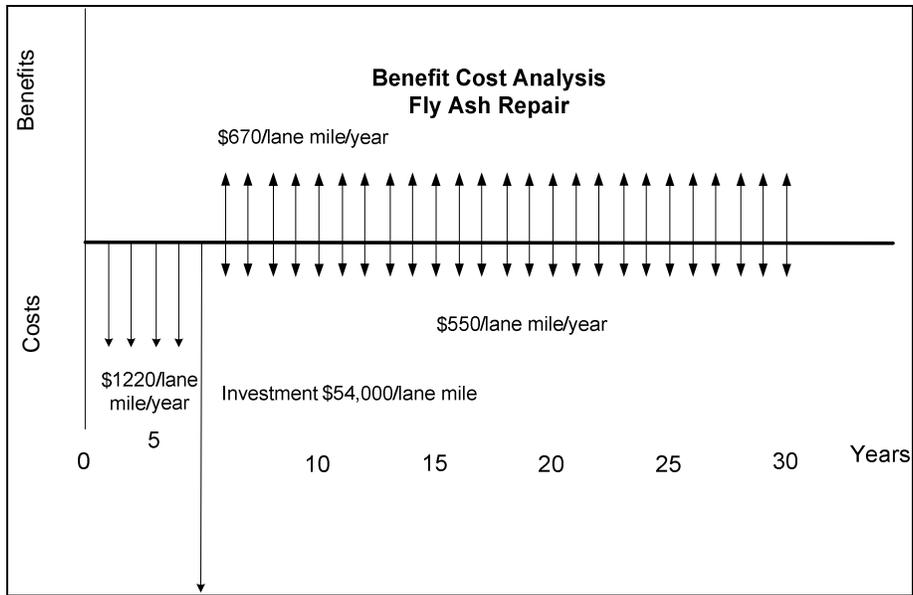
**Figure 250. Benefit-cost analysis for fly ash repair**

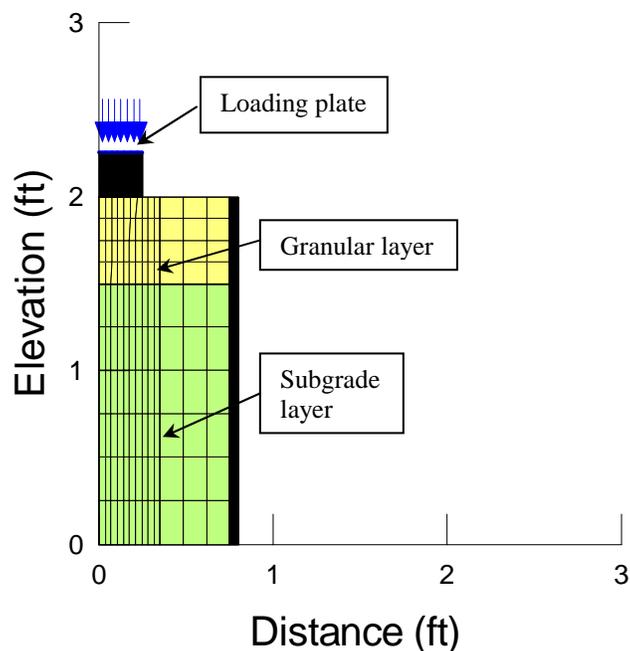
Figure C.1. Finite element model of the laboratory box

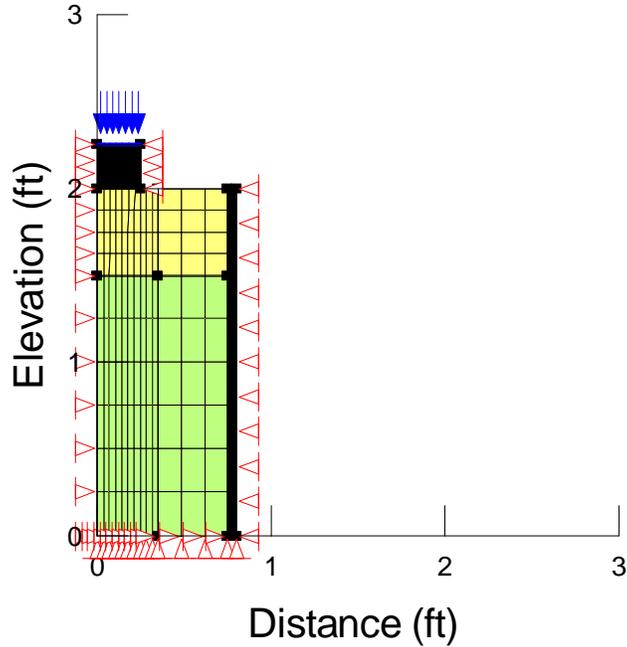
**Figure C.2. Boundary conditions of the finite element model**

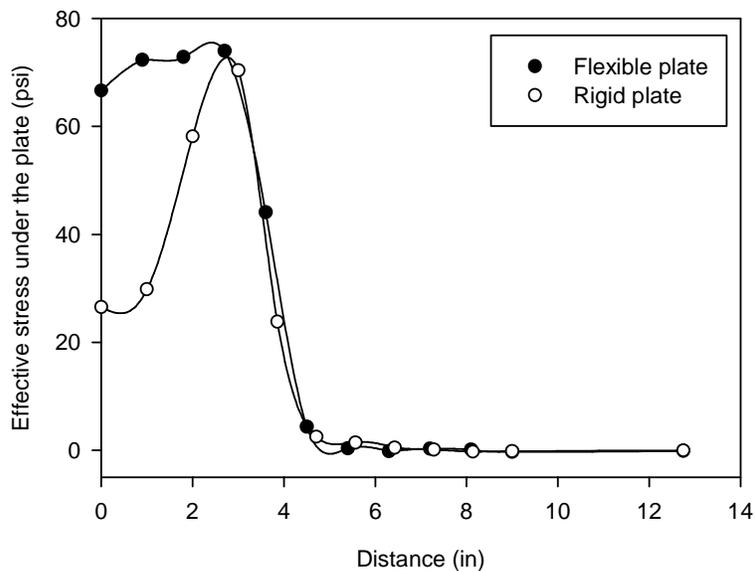
**Figure C.7. Effective stress distribution under flexible and rigid plates**
