# Investigation of Steel-Stringer Bridges

tech transfer summary

Investigation of Steel-Stringer Bridges: Superstructures and Substructures

Iowa Highway Research Board (TR-522)  
Iowa Department of Transportation  
(CTRE Project 04-184)

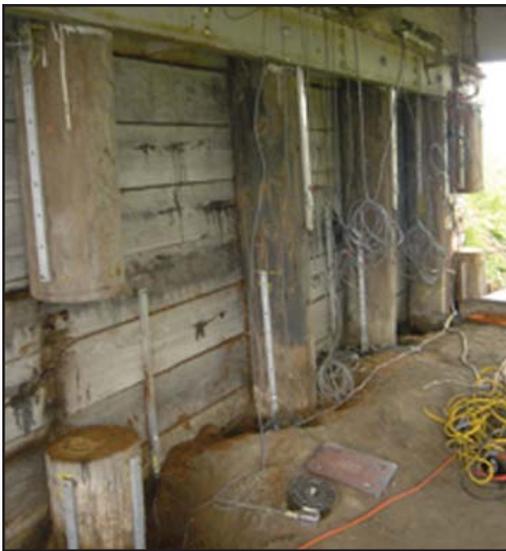
*Humboldt County bridge with sections removed from three piles*

Destructive evaluation was performed at one bridge where three out of the seven supporting timber piles at one abutment were consecutively removed to simulate pile deterioration. After removing each pile, the bridge was load tested to measure pile loads and strains on intact piles. The data were used to determine the stress in each pile and thus predict the variation of load distribution with different degrees of pile damage. To determine the feasibility of repairing localized deteriorated sections in timber piles, one of the removed pile sections was repaired using a splicing technique, and the percent restoration of pile capacity was measured.

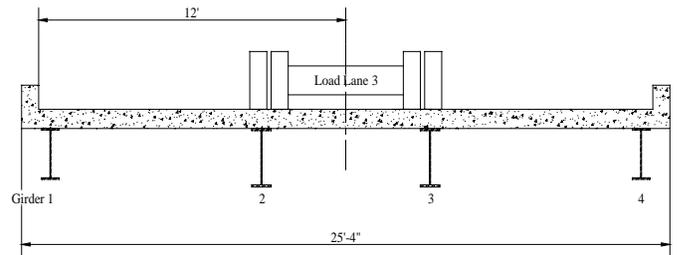
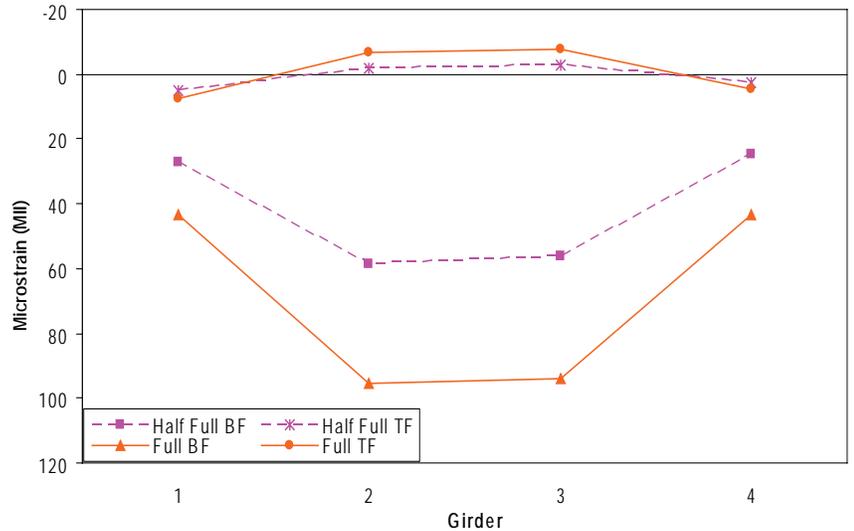
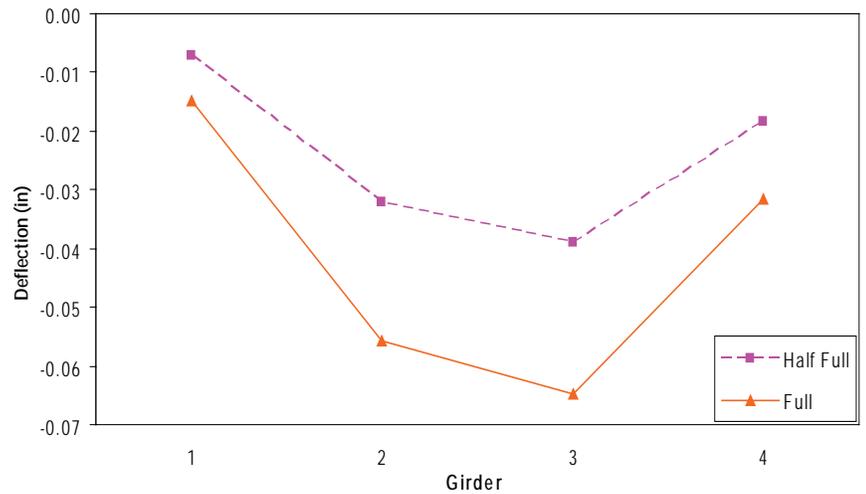
**a. Lane 3 Loading**

**b. Strain Profile**

**c. Deflection Profile**

*Strain and deflection results for 33.3-foot bridge in Carroll County, Iowa*

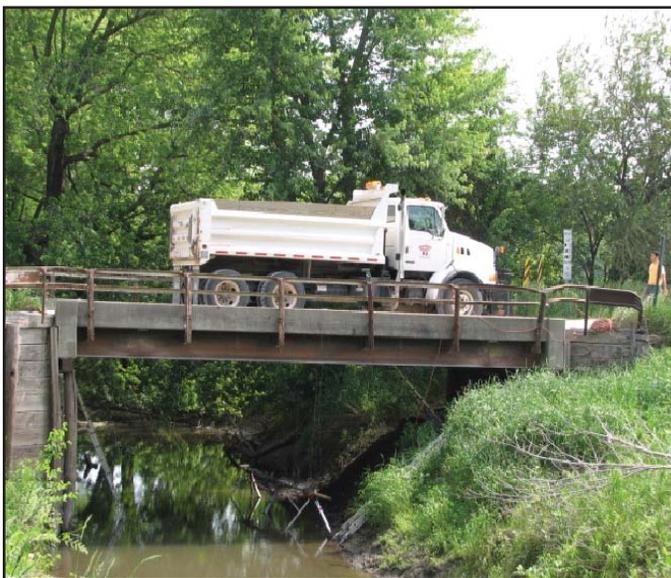
Testing of the Mahaska County bridge

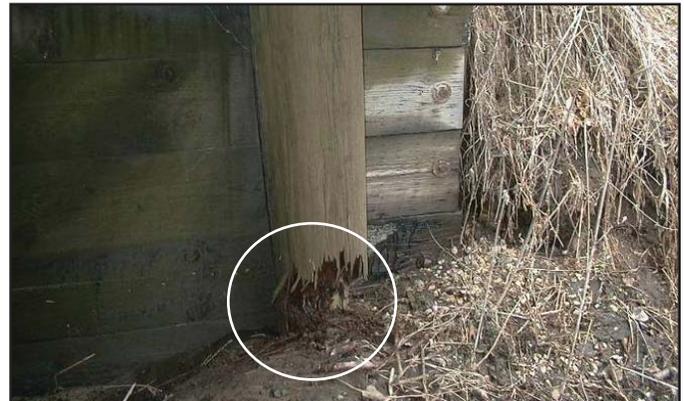
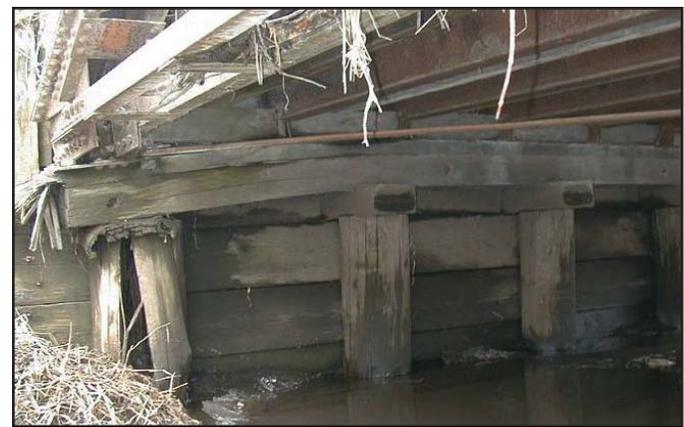
Biological deterioration resulting in reduction in pile cross section (top) and complete deterioration of a pile section causing failure of pile cap (bottom)

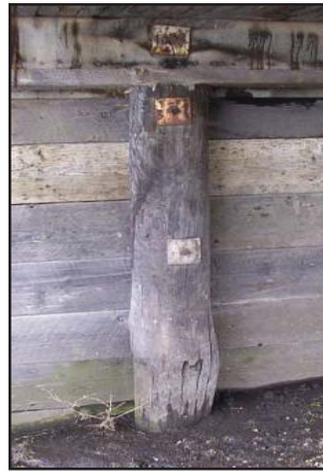
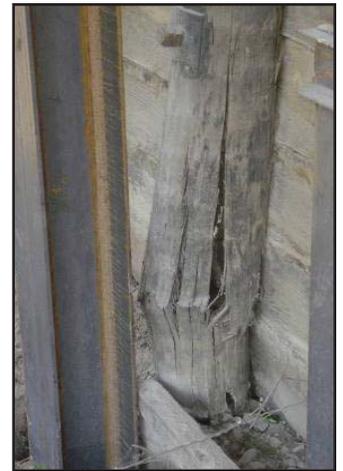
*Compression failure of deteriorated pile section caused by overloading leading to bulging of timber fibers (left) and mushrooming of the pile section (right)*

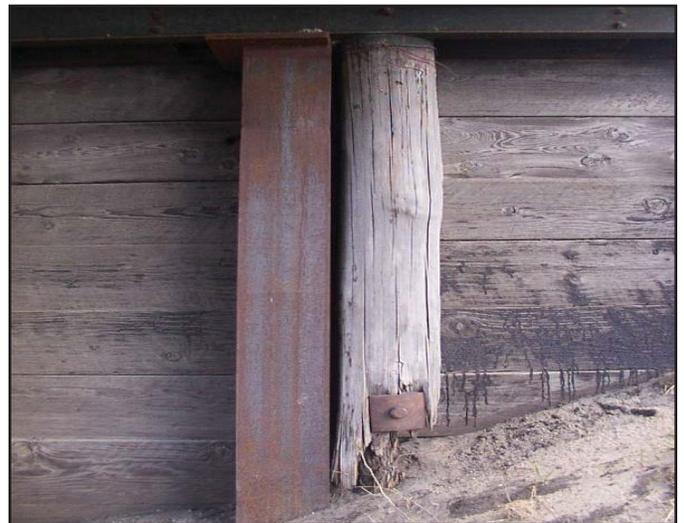
*Steel pile driven adjacent to a defective timber pile*

Several substructure repair techniques are being implemented in Iowa. These techniques include (1) addition of a timber or steel pile adjacent to the defective pile when the deterioration of that pile exceeds 50%, and (2) construction of a new substructure system (i.e., replacing all existing piles) when advanced deterioration is widespread in more than one pile, threatening the integrity of the bridge. These repair techniques are considered major maintenance.

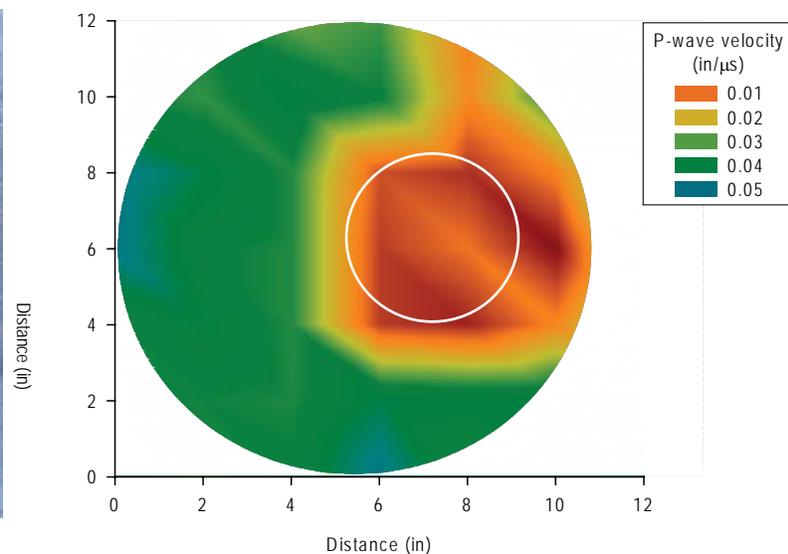
*Two-dimensional tomography image revealing the timber pile internal condition*

A nondestructive ultrasonic stress wave technique was used to develop cross-sectional tomography images of timber piles for the purpose of evaluating internal defects. Stress waves are generated from an impact on the side of the pile. By measuring the wave travel time through a pile in the radial direction, the wave propagation speed can be calculated, which can be used as a predictor of the internal condition of the pile. Multiple stress wave measurements at different radial orientations, together with an image reconstructing technique, were used to produce two-dimensional tomography images of internal timber pile deterioration.

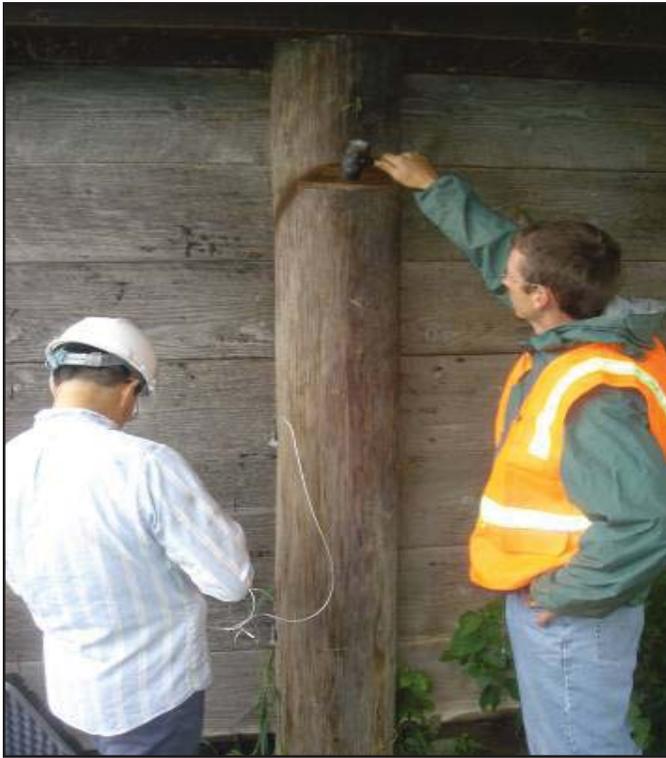
*Pile integrity test: impacting the pile to generate a compression wave*

Determining the pile length is critical in calculating the residual capacity of timber piles. Pile integrity tests were performed at one bridge to estimate the pile length or detect major cracks below the ground level. This method is based on vertically impacting the pile and measuring the time for the reflected compression wave to reach an accelerometer. The pile integrity method can estimate the length of the pile within approximately 15% of the actual length (Wightman et al. 2003).

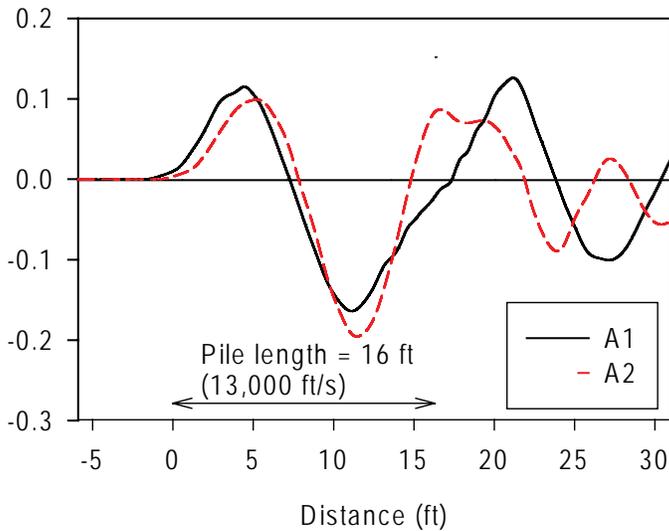
*Pile integrity test results, with pile toe estimated to be 16 feet below ground level (measured wave speed = 13,000 feet/second)*

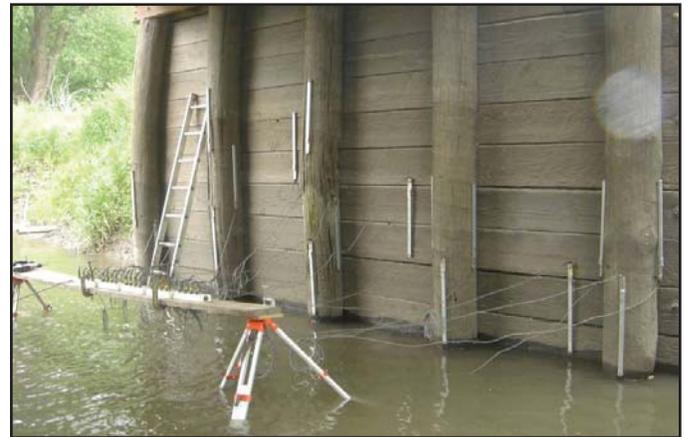
*Bridge abutment instrumented with strain gauges*

Substructure static load tests were conducted at five bridges, and the strain responses of the abutment piles and backwall were measured using strain gauges with gauge lengths varying from 12 to 24 inches. Due to the non-homogeneity of wood as well as localized deteriorated zones along the pile, the exposed portion of each pile was instrumented with more than one strain gauge to capture pile behavior at both strong and weak sections.

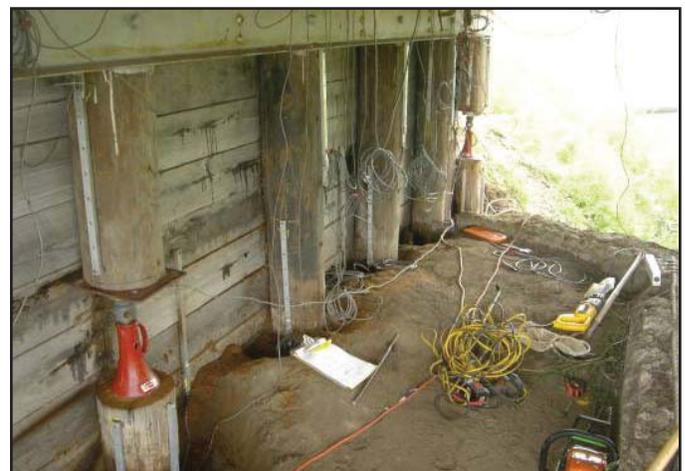
*Pile sections removed to simulate timber pile deterioration*

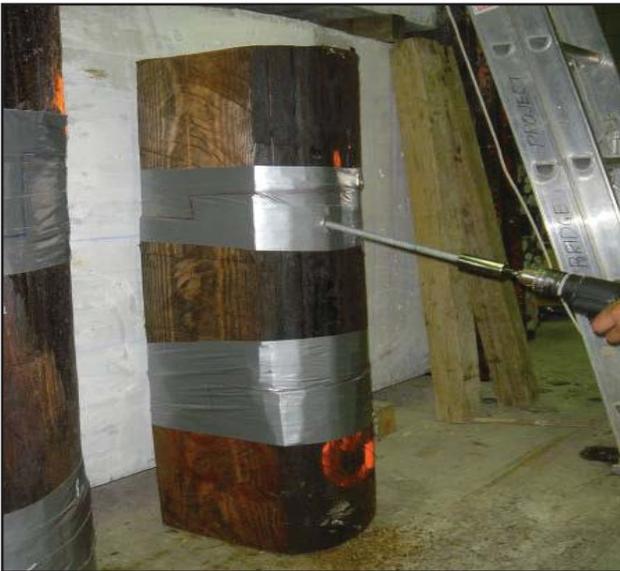
*Timber pile repair using mechanical splicing*

The selected repair methods were (1) mechanical splicing, (2) replacing the damaged section with a new section with a fiber reinforced polymer (FRP) wrap, and (3) using epoxy material with FRP wrap.

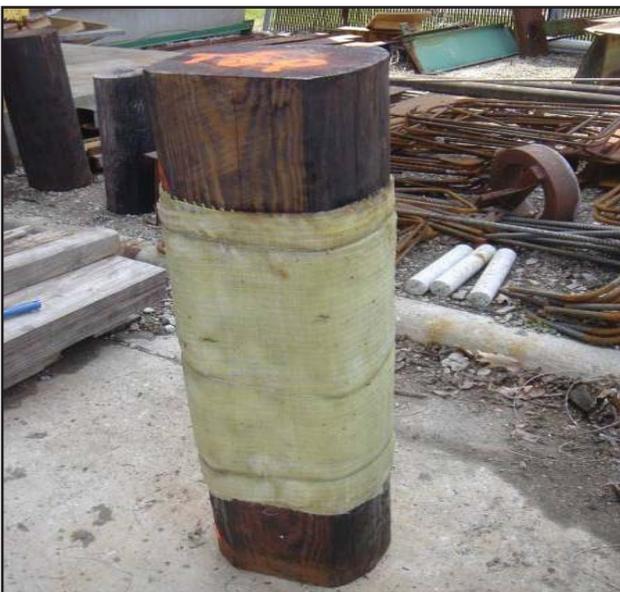
*Timber pile repair using fiber reinforced polymer (FRP) wrap*

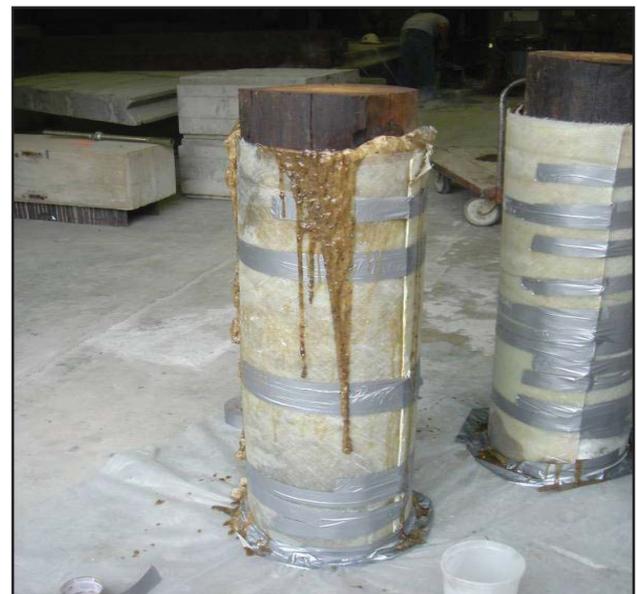
*Timber pile repair using epoxy filler with FRP shell*
