Stabilization Procedures to Mitigate Edge Rutting for Granular Shoulders – Phase II

tech transfer summary

January 2011

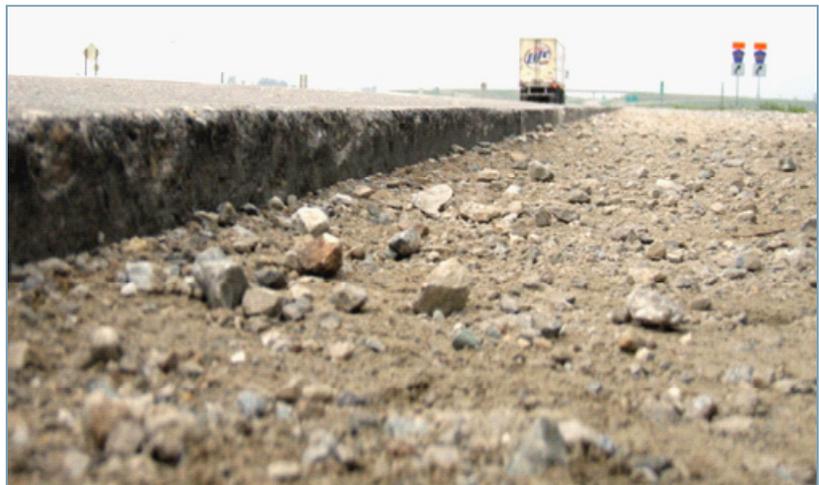
Shoulder drop off along the pavement edge on Highway 18

Several conditions coincide to cause edge ruts in granular shoulders. Air movements (generated by traffic) blow fine particles away from the pavement edges, which would otherwise serve as binders to hold the shoulder materials together and resist rutting. When vehicles go off-track and drop off the edge of the pavement, they displace the larger, remaining particles.

The drainage from the pavement surface is concentrated at the edge, softening the shoulder materials, and exacerbating the displacement process. The deeper binding materials that haven't been blown away are compacted by off-tracking vehicles into a hard crust one to three inches below the pavement edge.

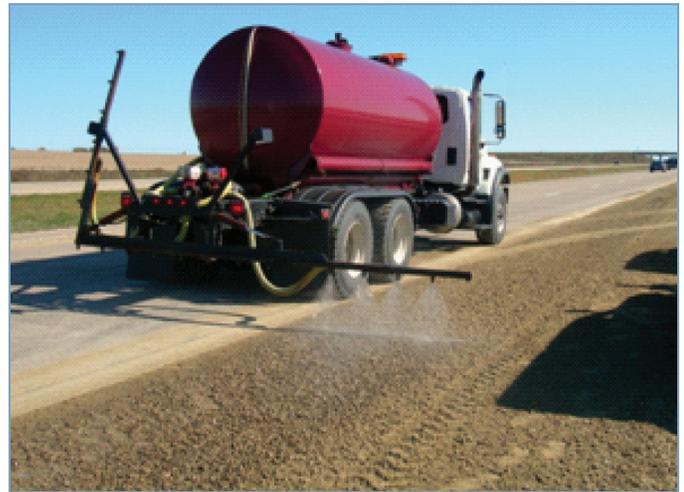
Spraying calcium chloride on shoulder surface

Calcium chloride and magnesium chloride are applied as liquid salt solutions that suppress dust and stabilize by retaining moisture. Base One is a liquefied silica and soda ash emulsion that binds and stiffens certain soils and granular materials. DUSTLOCK is a trade name for a soybean soapstock and it was used because maintenance personnel in District 2 had a previous positive experience using the same product applied to the shoulder of US 18 near Garner on July 25, 2000.

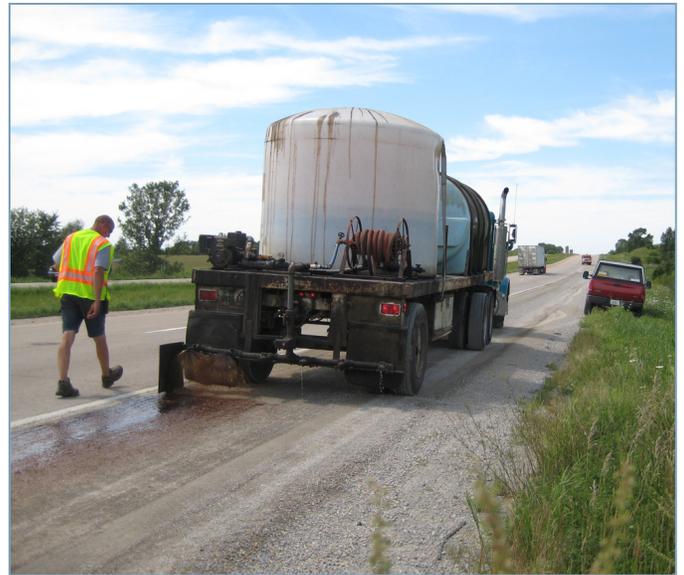
Spraying DUSTLOCK on Test Section V

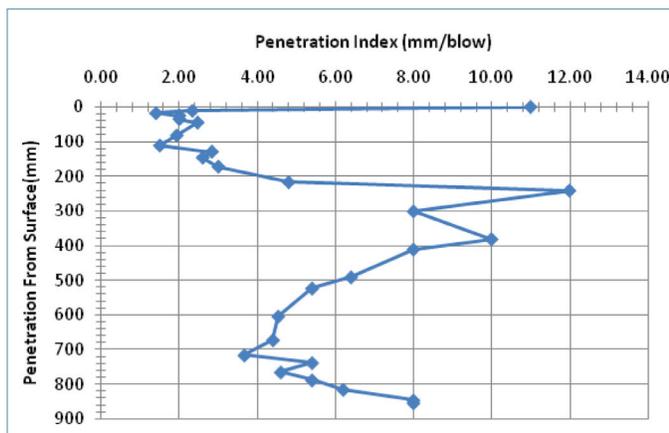
DCP test results

A field investigation was conducted throughout District 2 to document the conditions at these problematic sections. The investigation included conducting dynamic cone penetrometer (DCP) tests, collecting samples of the shoulder aggregate, and taking elevation profiles and site photos.

Using the DCP field data, California Bearing Ratio (CBR) plots of the problematic shoulders were developed for each location. Elevation profile data from each location was plotted to illustrate the shoulder's elevation progressing away from the pavement's edge. For each location, the results of laboratory testing for grain size and Atterberg limits were summarized.

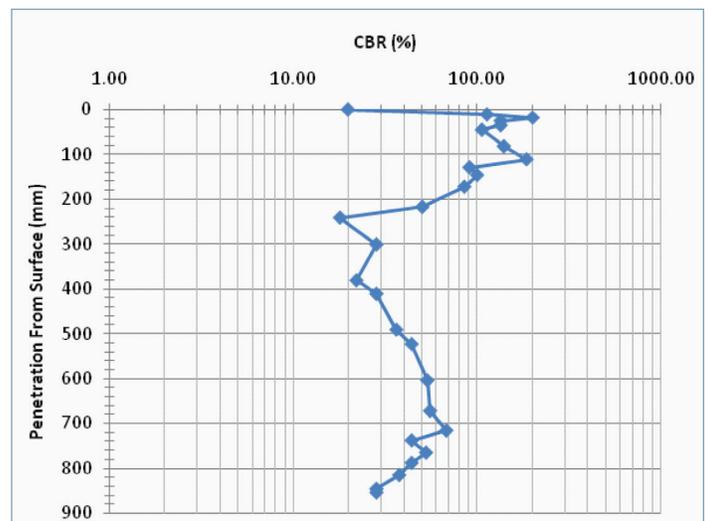
CBR measurements

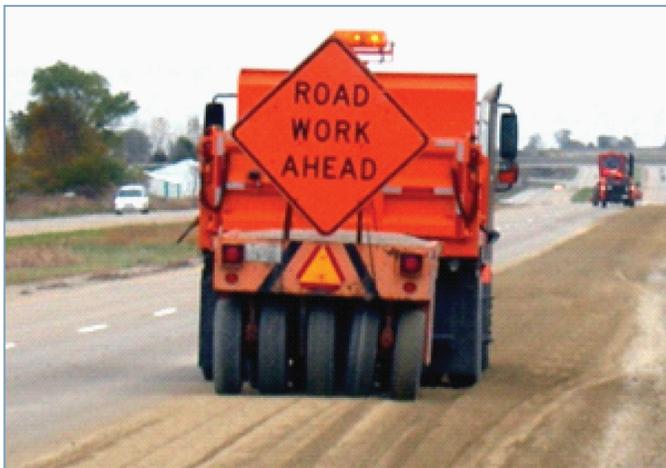
Pull-behind compactor takes too much time to safely turn for additional passes

In particular, it would be necessary to have a pneumatic compactor that could operate bi-directionally. Typically-available, pull-behind compactors do not allow enough passes to be made quickly enough when consideration is given to the time required to safely turn the units, especially on limited access highways.

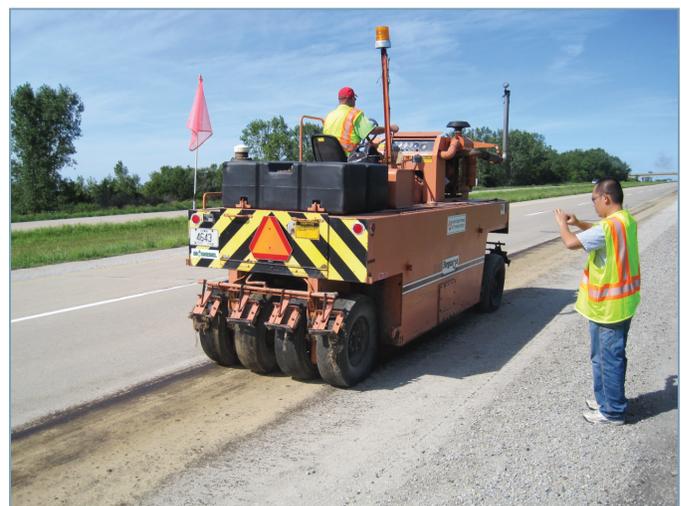
Bi-directional compactor allows enough passes to be made quickly enough to compact and stabilize reclaimed material

- Consider greater use of bi-directional rollers when shoulder repairs and maintenance require heavy compaction. The Iowa DOT's current self-propelled pneumatic rollers will likely be satisfactory for many such applications.

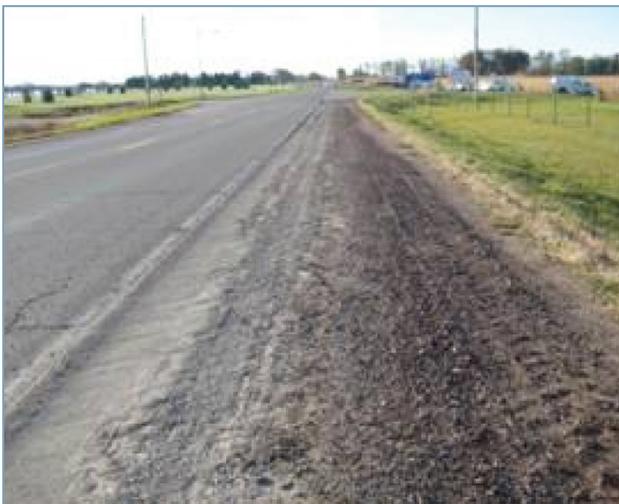
DUSTLOCK performance on stable granular shoulder material

- DUSTLOCK appears to wear well in locations where the shoulder material provides a stable base and vehicles do not off-track to the extent that they do on the US 20 test section. In areas of heavy off-tracking, preliminary indications are that stabilizing the shoulders reduces the number of maintenance cycles to half of what they would be without the stabilizer.
- The laboratory test method for investigating stabilizer performance appeared to be a reasonable effort that provided some information about stabilized material behavior in confined situations. However, the method would have to be combined with a test similar to an asphalt rut test to detect instability for unconfined circumstances.

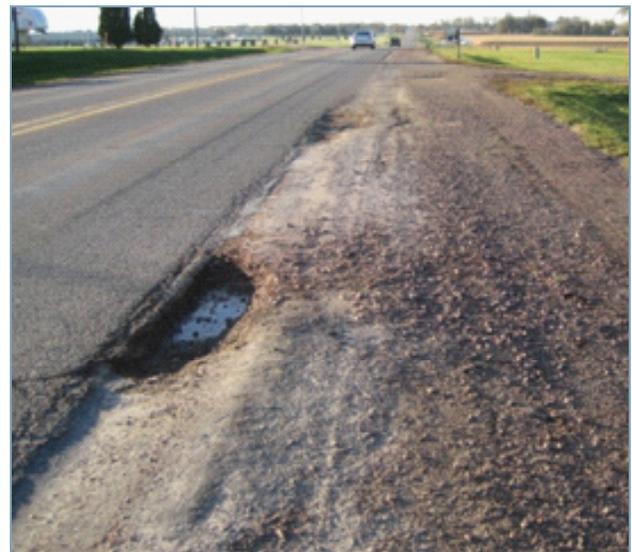
DUSTLOCK performance on unstable granular shoulder material
