Evaluation of the Buena Vista IBRD Bridge:
A Furthering of Accelerated Bridge Construction in Iowa

Iowa Highway Research Board
(IHRB Project TR-605)
Iowa Department of Transportation
(InTrans Project 08-342)

tech transfer summary

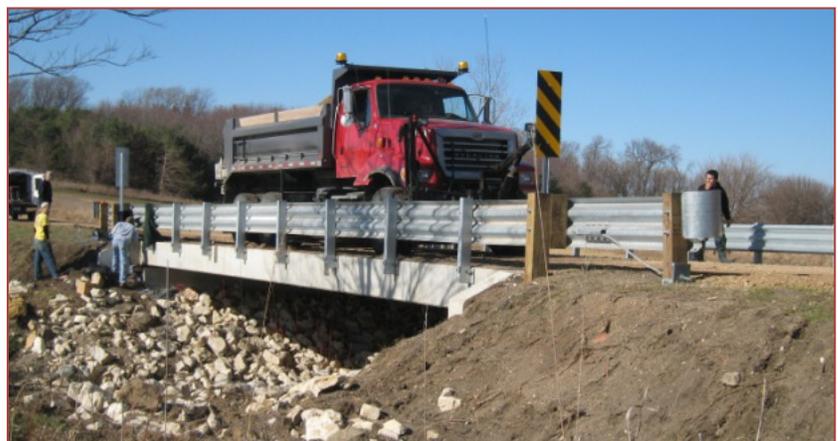
Load testing the completed, single-span, 50 ft (center to center of supports), Buena Vista County IBRD bridge

Upon completion of the bridge in 2009, it was instrumented and load tested using two county trucks loaded with gravel. Approximately one year later, instrumentation was

- The maximum bridge deflection measuring during testing was 0.259 in. Normalizing this value for the different between test truck weights and the weight of design trucks, this value becomes 0.479 in., which is significantly less than code requirements.

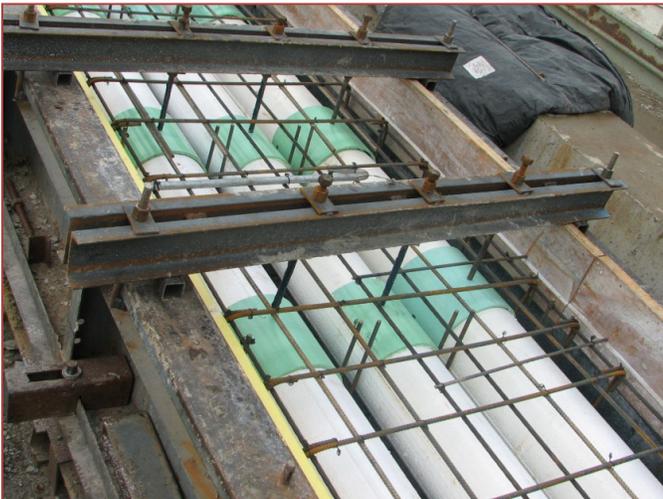
Fabrication form setup for one of the seven precast/prestressed box girders/beams with Styrofoam cylinders used to create the voids

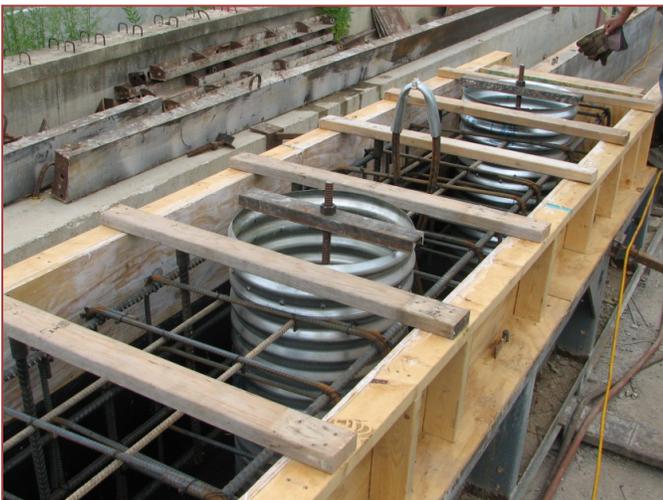
Construction of abutment cap formwork showing one of the beam lift loops near one end of the form and two of the corrugated metal pipe (CMP) pile connection openings

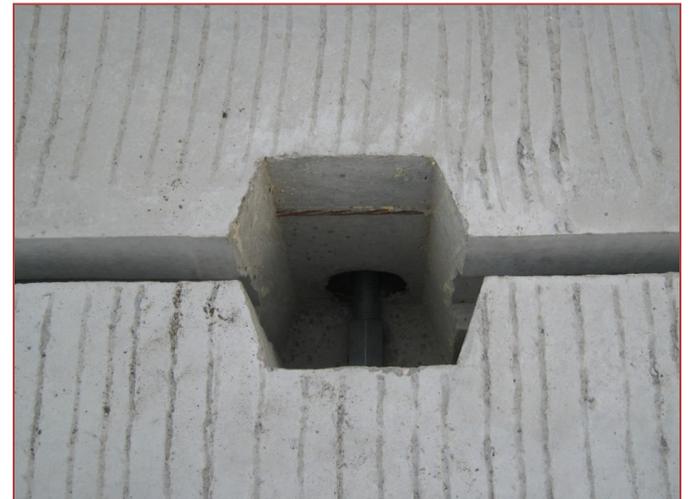
Tie rod block outs in final precast beams for tightening the interior tie rods once bridge components are in place on site

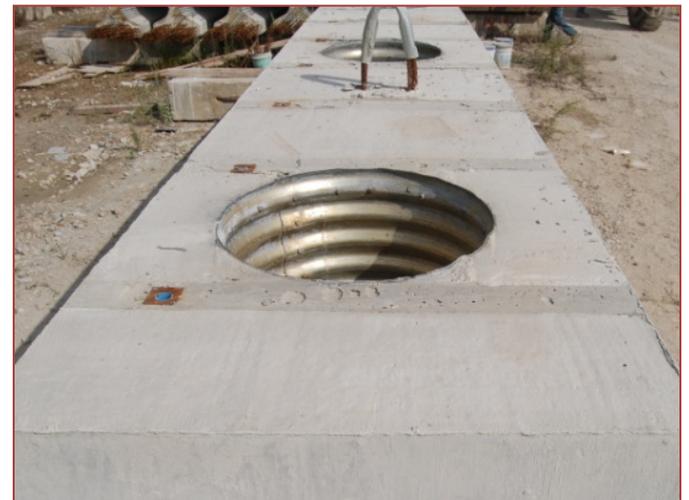
One of the two precast abutment caps showing pile connection openings, guardrail post anchor rod extension openings along the edge, and one beam lift loop

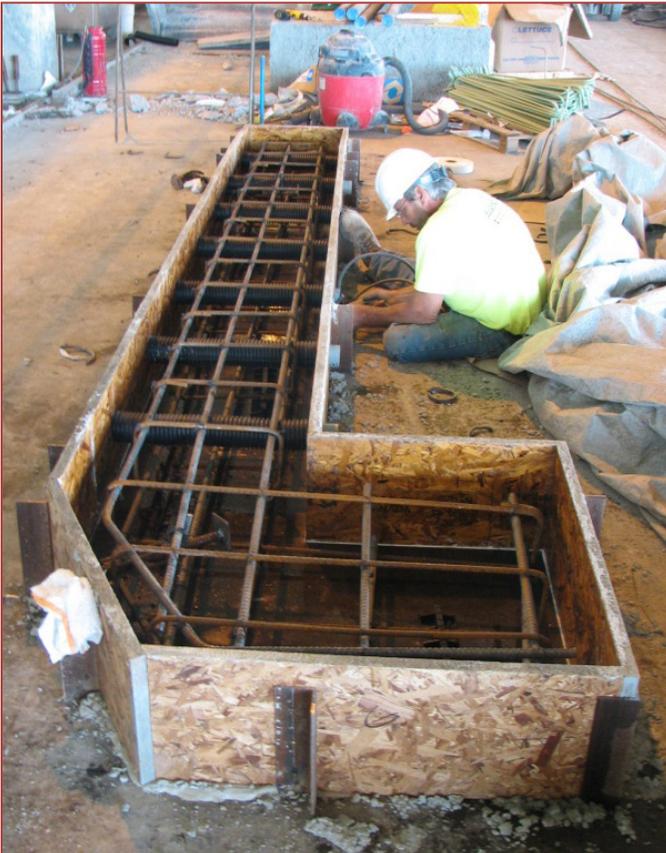
Construction of formwork to precast four back wingwalls, with this being the first ABC project in Iowa to use them

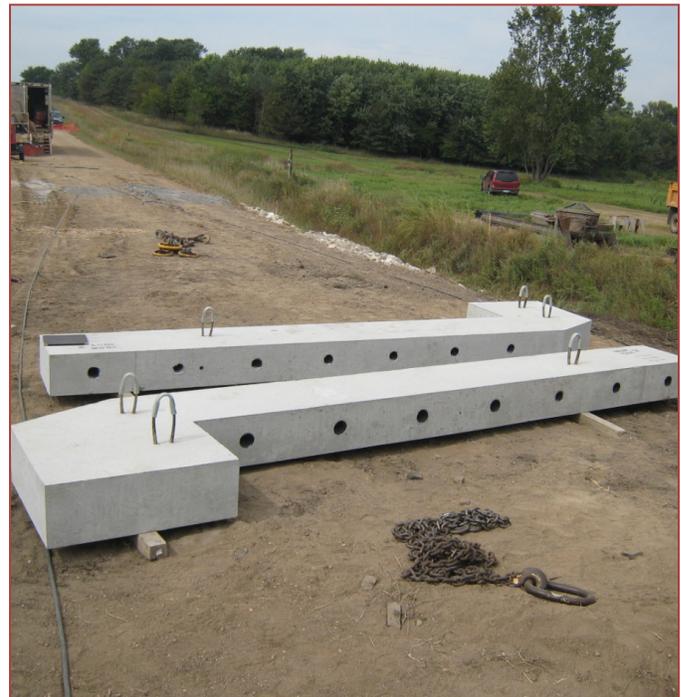
Two of the four back wingwalls, each with three lifting loops and seven anchor rod openings

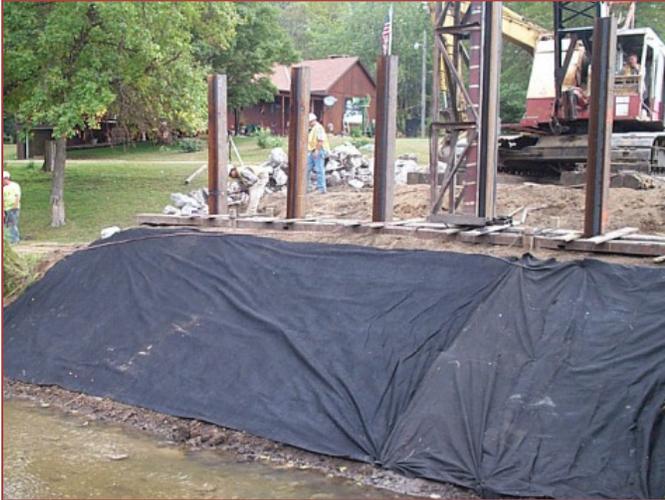
Driving piles with close attention to locations and tolerances using templates to position the five piles correctly

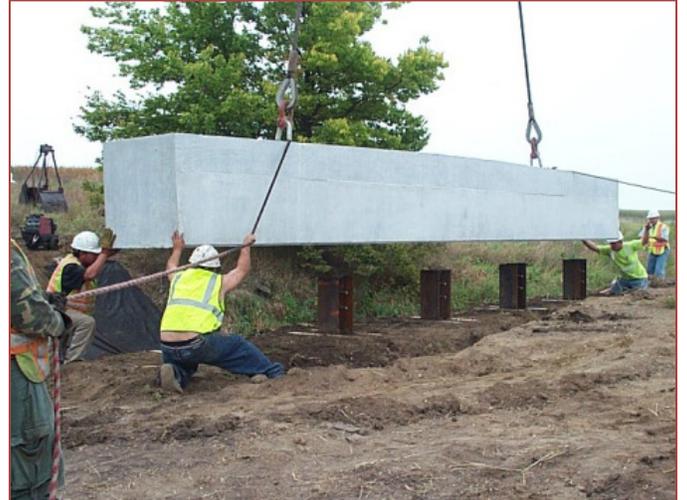
Installing west abutment cap onto pilings before cutting off the lift loops and filling CMP voids with concrete

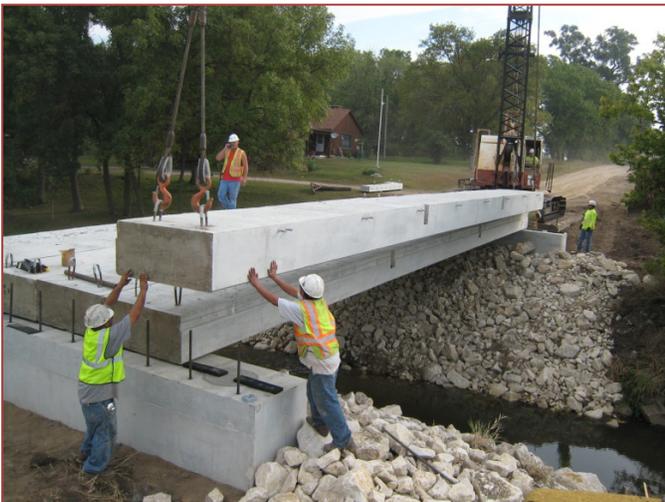
Positioning exterior beam after extension of anchor rods along the edge of abutment caps and middle beam placement

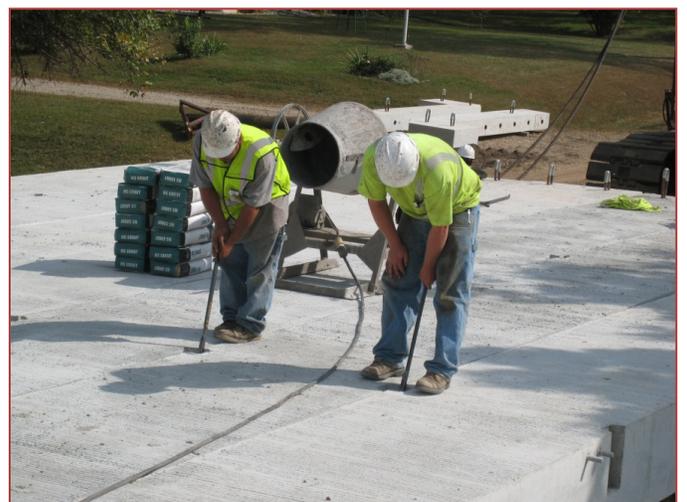
Tightening transverse tie rods before filling block outs with epoxy grout

- Very small differential movement occurred between adjacent box beams. In 2009, the maximum value measured was 0.021 in. while in 2010 it was significantly less (.0027 in.). The hand-tightened transverse tie rods and grout-filled joints provide good lateral load transfer between adjacent units.

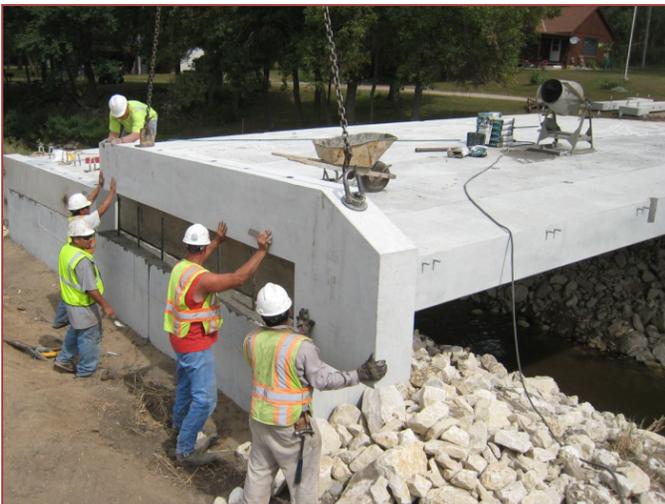
Placement of second back wingwall onto anchor rods and epoxy grout bed on west end of bridge

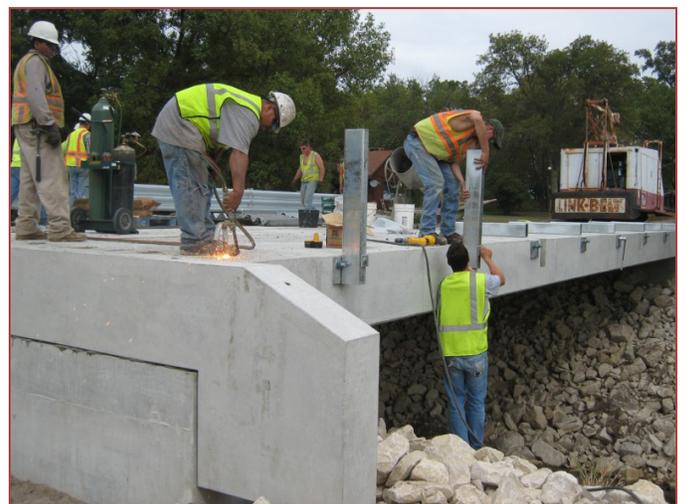
Installation of guardrail posts on south side of bridge
