Timber Abutment Piling and Back Wall Rehabilitation and Repair

Iowa Highway Research Board
(IHRB Project TR-616)
Iowa Department of Transportation
(InTrans Project 10-372)

tech transfer summary

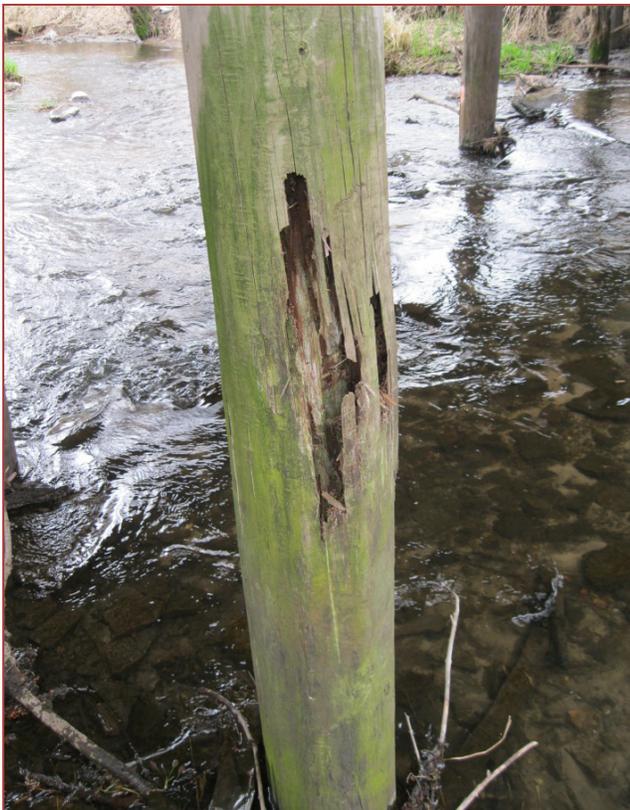
Sample damage and decay at demonstration project

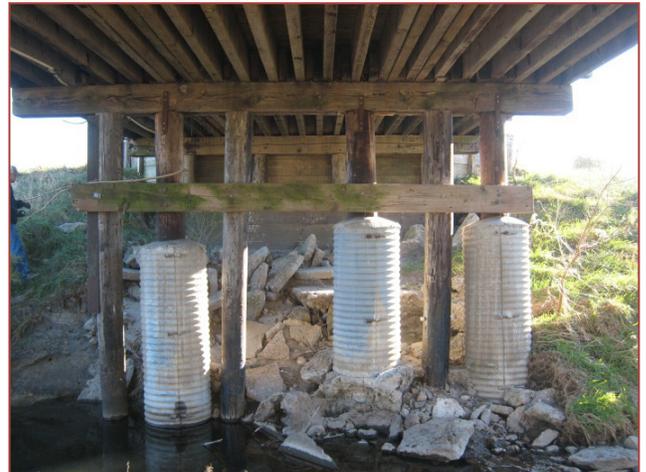
One variation of casts created from corrugated metal pipe (CMP) and concrete infill

At the first of these bridges, corrugated metal pipe was used to create a form around the decayed or damaged portions of the pile, which was filled with concrete, thereby creating a cast and providing additional stiffness.

The near-term performance of this method appears to be adequate to maintain a functioning bridge. However, given this method of repair has not been observed over the long-term, conclusions regarding its indefinite performance cannot be made.

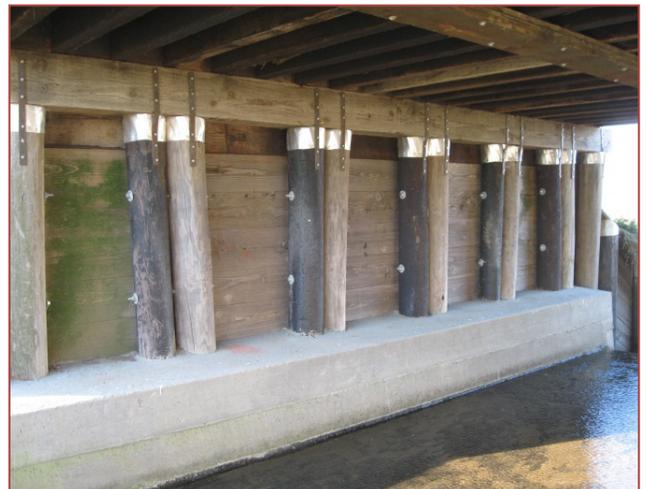
One variation of new concrete sills and pile caps

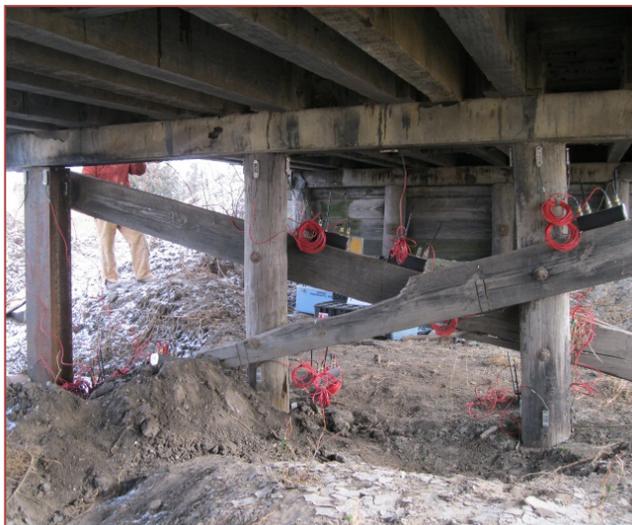
Instrumentation at one of the four bridge test sites

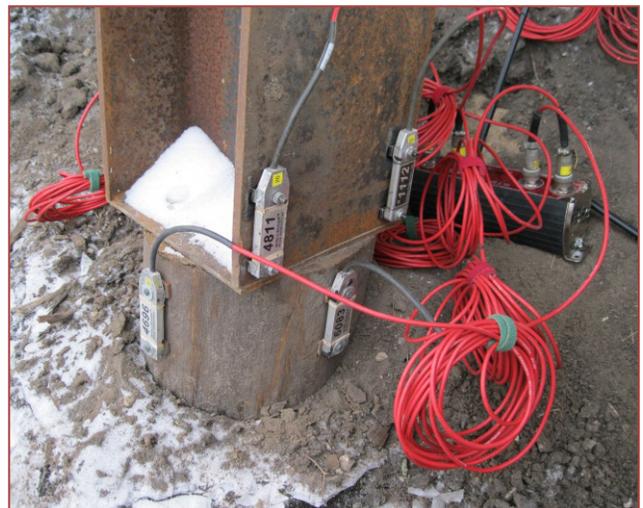
Instrumentation at steel post connection to existing pile

The first solution that was laboratory tested involved modifying the existing method of posting with a steel H-pile or the like allowing for vertical adjustment at the connection between the existing timber pile and new steel post; the connection detail proved to be a promising solution.

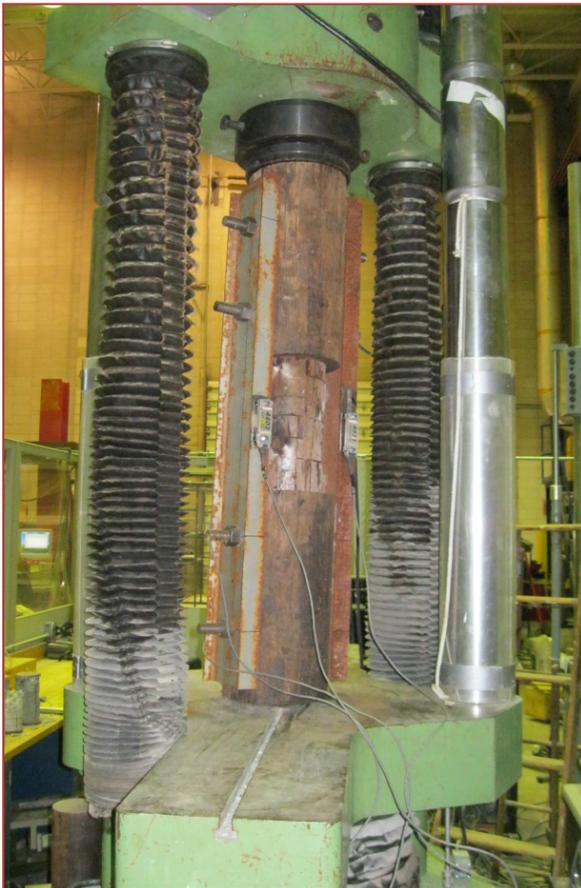
Timber sistered with steel was one of the two solutions that was laboratory tested

The second strengthening system entailed adding steel “sisters” to a decayed or damaged pile. Each sister was bolted to the pile opposite of each other and extended beyond the simulated section loss.

In the end, the “sisters” only aided in the strengthening when failure in the remaining portion of the pile was imminent, although it is assumed that modification to the connection details would engage the sisters earlier in the loading process.
