Effective Structural Concrete Repair Volume 3 of 3

Evaluation of Repair Materials for Use in Patching Damaged Concrete

March 2004

Iowa DOT Project TR - 428

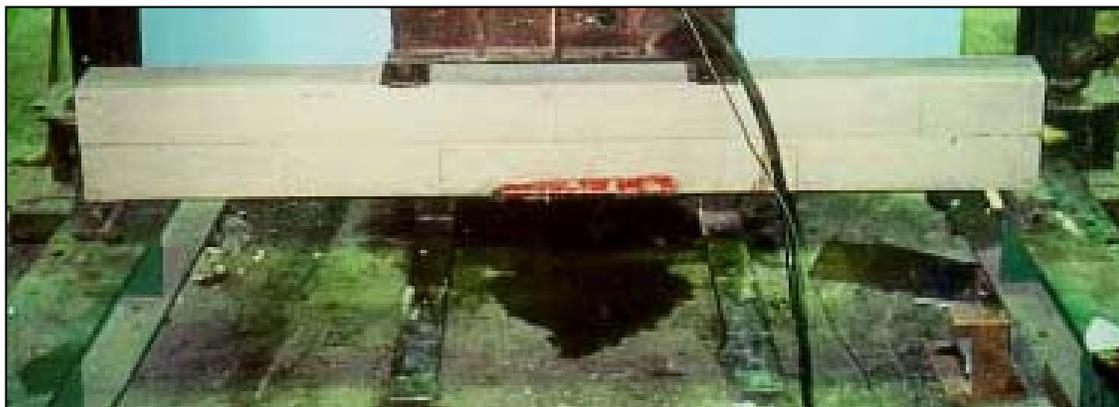
Figure 3.1 Damaged beam after repair material is added.

The flexural test used in this study involved loading simulated impact damaged concrete beams that were repaired with different repair materials. The purpose of this portion of the study was to determine the flexural strength of the repaired beams and the strength of the bond between the repair patch and the concrete beam. These beams were used to determine the stiffness of the beams with different repair materials and to predict cracking loads. Figure 3.1 shows a typical beam used in this test.

Beams tested were 6 in. x 12 in. x 8 ft in their original undamaged condition. There were 2-#4 (1/2 in. diameter), 40 ksi steel bars running longitudinally and setting on 1 1/2-in. chairs to ensure standard cover. The beams were cast in standard metal forms in six different pours. The concrete (Table 3.2) used was an Iowa Department of Transportation (Iowa DOT) bridge mix C4, which contains 3/4-in. aggregate and 5-7% air entrainment.

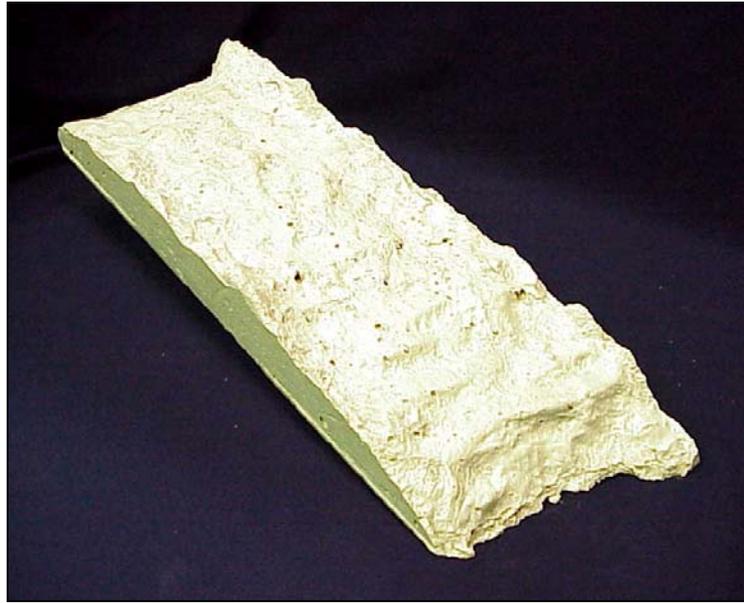
Figure 3.2 Plaster of paris insert.

To simulate impact damage and to make the damage as uniform as possible, plaster of paris inserts were cast. Each insert, whose center line was aligned with the center line of the beam, was 18-in. long by 1 1/2-in. deep at its deepest cross-section, and feathered at the ends (Figure 3.2). To make each insert uniform, a 6-in. wide concrete beam was used as a model. The model beam was prepared by chipping away an 18-in. long by 1 1/2-in. deep section with 1/4-in. peaks with a chipping hammer.

Once the beam was prepared, two 2 x 4's were used as the forms for the insert. The 2 x 4's were held in place at their ends by two wood clamps. The inside surface of each 2 x 4 and the damaged concrete were coated with form oil so that the insert would not stick to the concrete. To make each batch of plaster of paris uniform, each batch was mixed in two

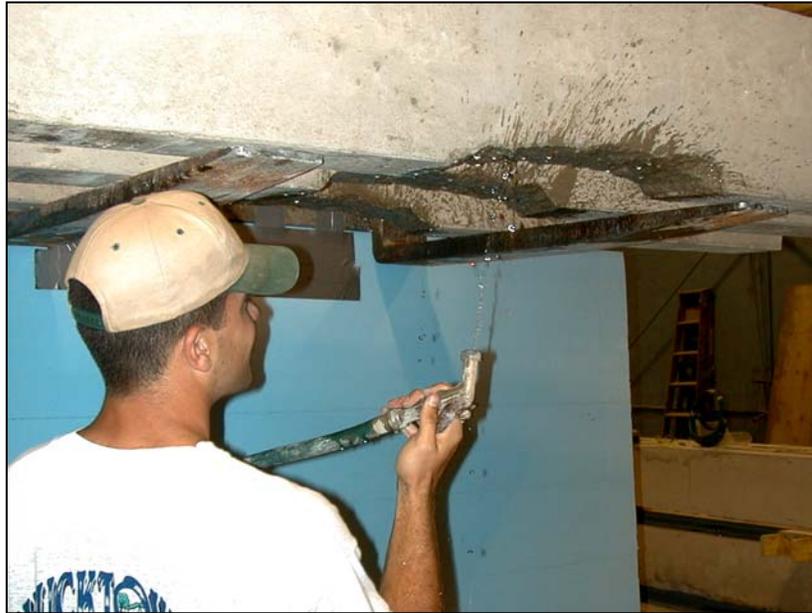
Figure 3.3 Wetting the damaged surface of a beam specimen.

thick paste as the latex admixture was activated. It was tempting to add additional water in the first two minutes of mixing, but it was not recommended. Small amounts of water, as little as a couple of drops, can significantly change the consistency of the repair material once mixing has begun. The damaged surface of the beam was splashed with water again before the repair material was applied.

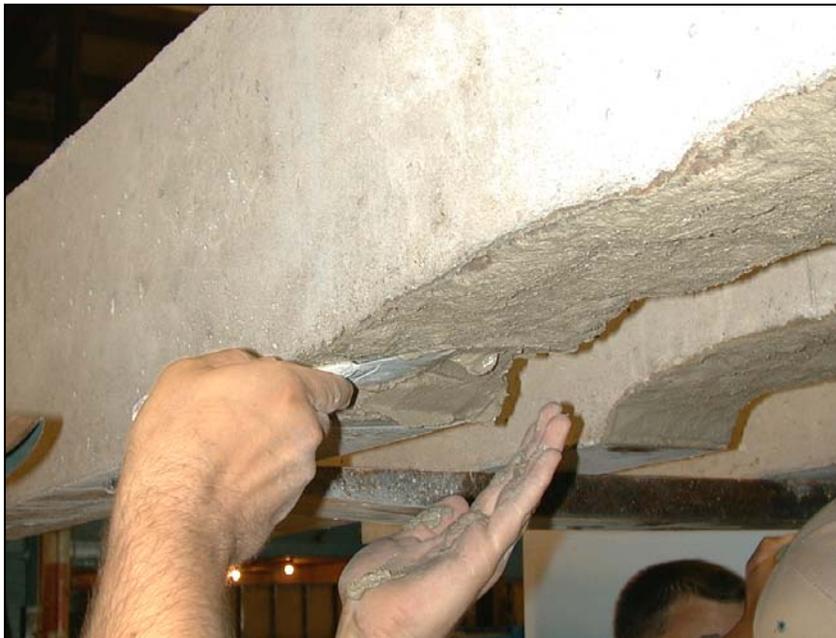
Figure 3.4 Application of repair Material A with a putty knife.

minutes, but applying lifts less than an hour apart is not recommended. Material A is a thixotropic material, which means that if agitated, it will return to a plastic state. When the material returns to a plastic state, the working time of the material is increased, and the material has a tendency to peel off the beam. The manufacturer recommends scoring the bottom of each lift to promote bond to the next lift. This was difficult to do because of the thixotropic nature of the material. The surfaces were lightly brushed between lifts to remove some material that had not fully hardened; it took four lifts to repair each beam. It was possible to repair three beams and cast the 12-3-in. diameter cylinders with two bags of material, but there was a significant amount of waste in each batch mixed because of the short pot life and the amount of material that fell onto the ground. It took four lifts to repair each beam.

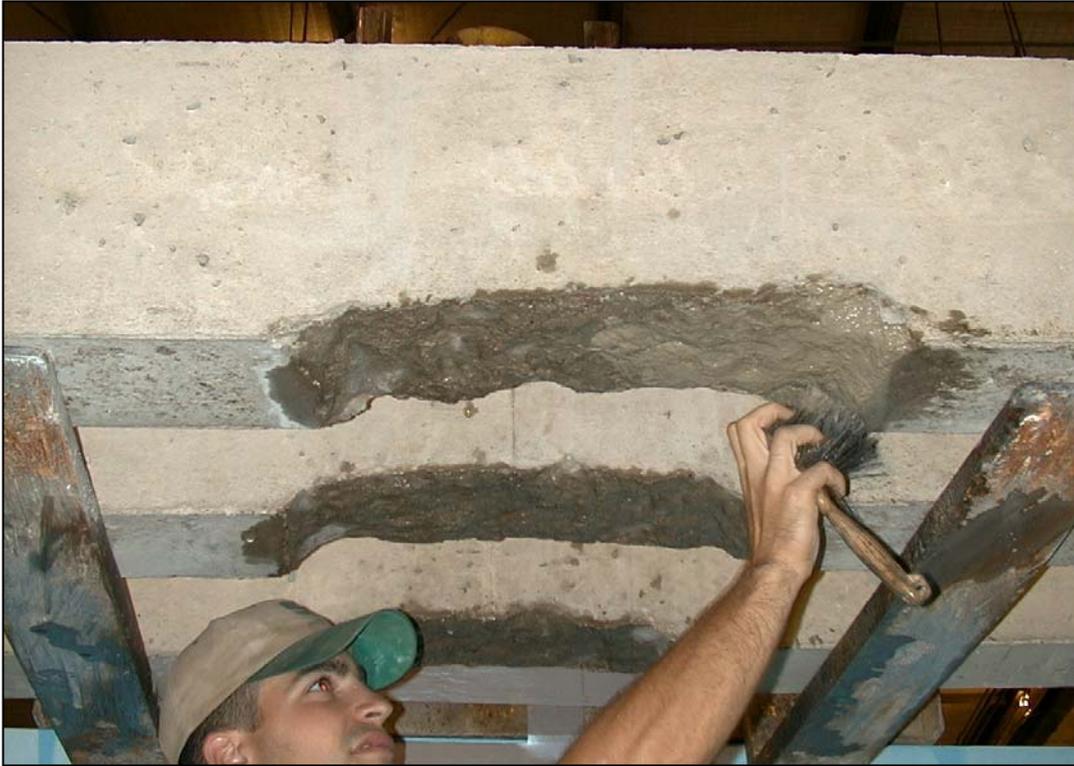
Figure 3.5 Worker applying scrub coat with a brush.

B was much darker and thicker than Material A and had a thick oatmeal consistency, whereas Material A was grittier. As shown in Figure 3.5 the surface of each damaged beam was dampened and a scrub coat was applied. Without a scrub coat many of the repair materials did not adhere to damaged section of the beam.

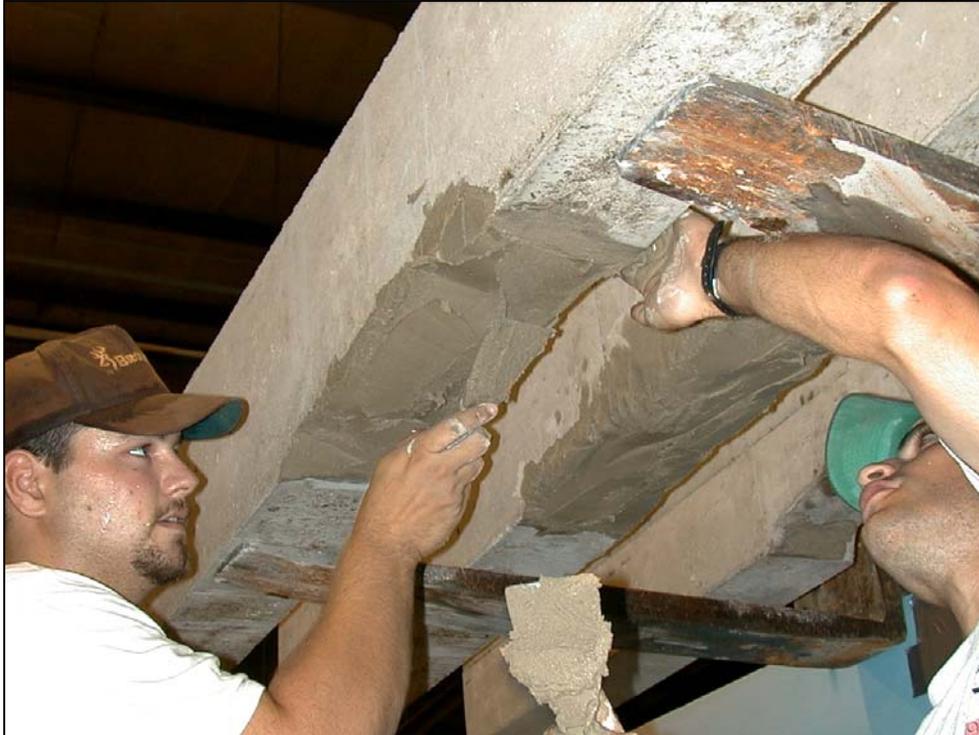
Figure 3.6 Application of repair Material B.

It was possible to apply Material B in 1-in. lifts, as it adhered to the concrete surface very well. Figure 3.6 shows workers applying a lift of repair material. It was possible to work with Material B for more than 40 minutes. Because of the longer pot life, better bond, and higher lifts, there was much less material wasted with Material B than with Material A. One bag repaired 3 beams and all of the cylinders.

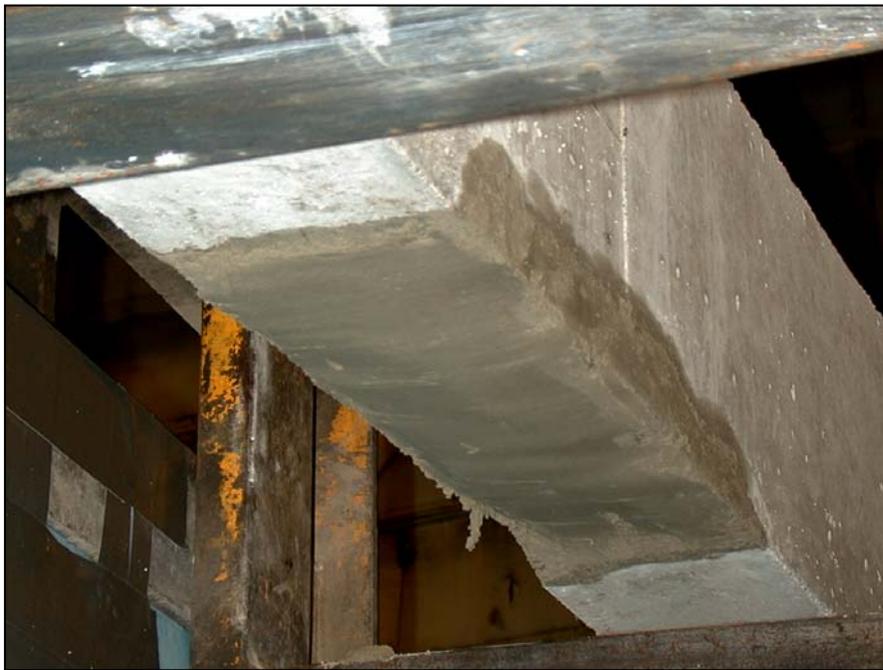
Figure 3.7 Finished patch on a repaired beam specimen.

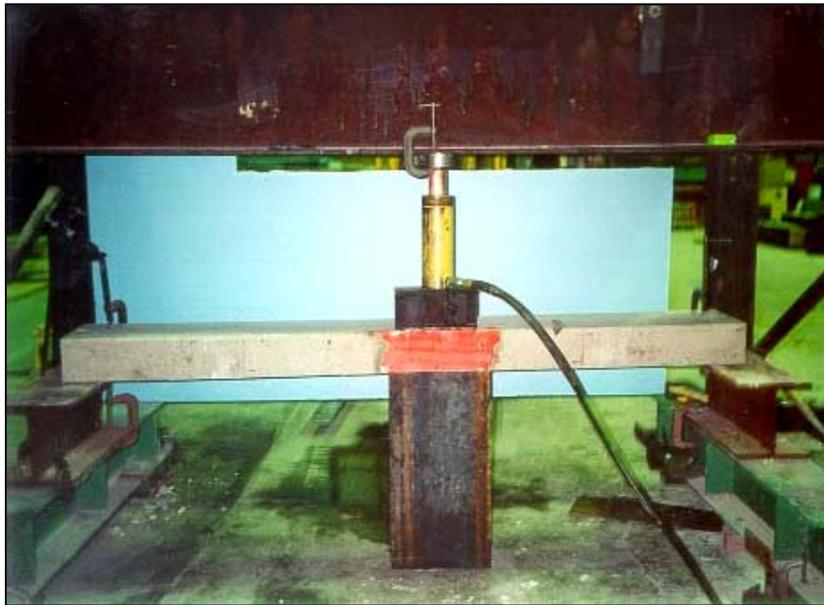
Figure 3.8 Push out shear test setup for one beam specimen.

loading point coupled with the force applied to the patch subjects the bond between the concrete beam and the repair material to shear. A 20 kip hydraulic cylinder was used to apply load to a 12-in. long W6 steel beam whose bottom flange was cut to a 1-in. width which in turn applied the load to the patch. Care was taken to make sure that the load applied to the patch was purely vertical to insure that the resulting stresses were purely shear stresses.

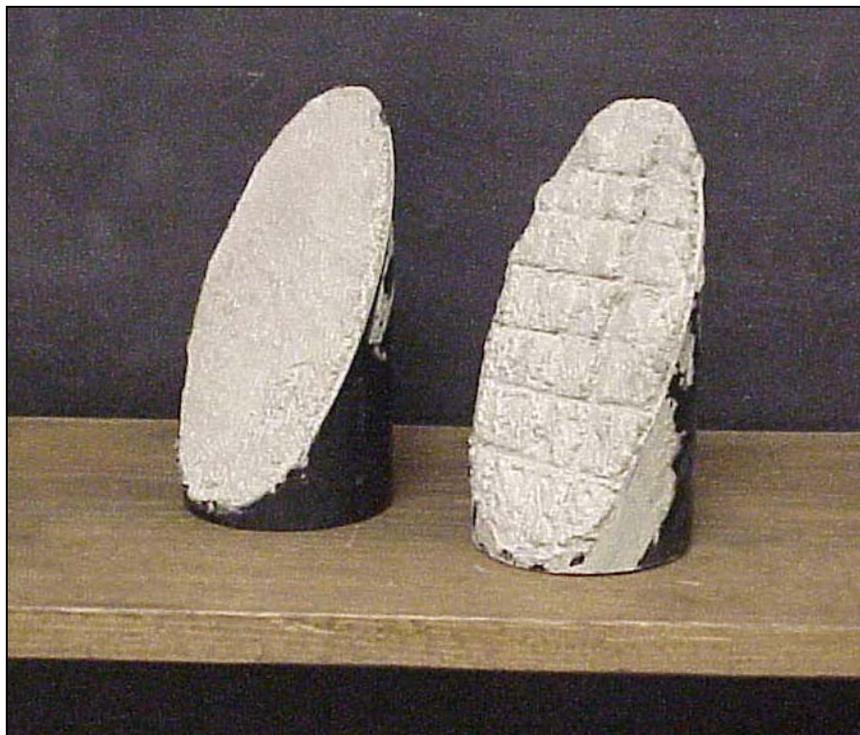
Figure 3.12 Wedge cylinder sample bonding surface.

with a trowel to simulate the roughened surface of a damaged beam. A waffle type pattern (cylinder on the right in Figure 3.12) was scored into the future bond surface with the edge of a concrete trowel. Workers tried to keep the grooves as uniform as possible from wedge to wedge. The hardest part of the etching process was etching the feathered end of the wedge. When large pieces of aggregate were in the feathered end, they were removed and the entire process was repeated. The lack of aggregate near the feathered end of the wedge may cause the feathered end of the wedge to be weak. To eliminate this variable in the local strength of the wedge samples, the repaired cylinders were placed in the test machine with the concrete wedge at the bottom and the repair material wedge at the top. The cylinders were covered with visqueen and cured in the laboratory for one week. The first repair cylinders were made 25 days after casting the wedges.

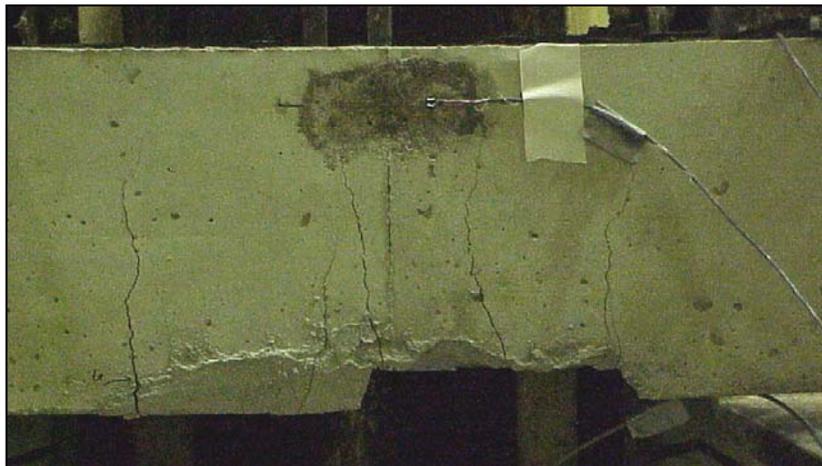
Figure 4.2 Material A damaged patch.

Shown in Figure 4.2 is a damaged beam repaired with Material A. Material A had the lowest compressive strength (4,400 psi) and modulus of elasticity (2×10^6 psi) of any of the materials tested. The theoretical cracking load determined using Method 1 was close to the average experimental value; the theoretical cracking load determined using Method 2 was higher. Even though there is a difference in the cracking loads, the deflection of the beam is predicted quite accurately in the uncracked region. Once the beam had cracked, it was stiffer than predicted. Method 2 did a better job predicting the behavior of the beams. This was due to the large difference in the modulus of elasticity of the repair material and that of the concrete. At the ultimate load, the bond between the beam and the Material A failed. Large chunks of the patch fell out at failure.

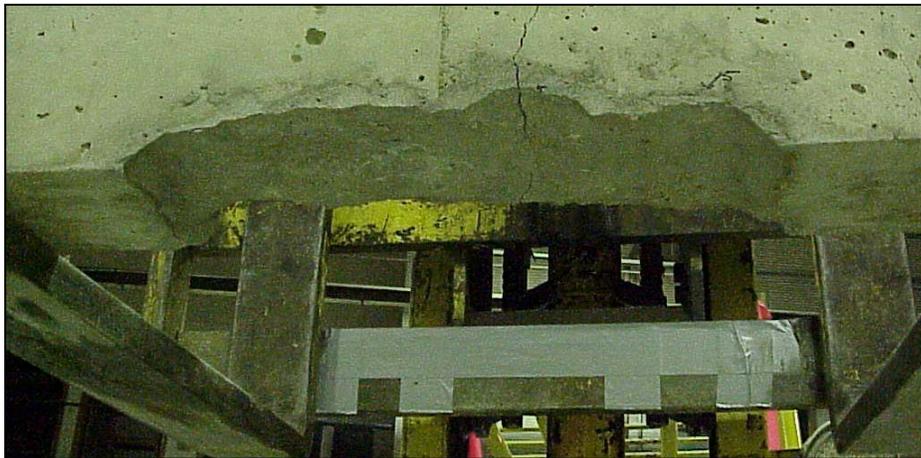
Figure 4.4 Complete Material D patch failure.

Again the modulus of elasticity of the repair material was nearly identical to that of the concrete repaired, and the behavior, both cracking load and uncracked stiffness, were predicted very well by both methods. Shown in Figure 4.4 is the complete patch failure. Material D fell off of the beam at a lower load than other repair materials. The failure was along the interface and there was little to no warning. Unfortunately, all Material D patches failed similarly.

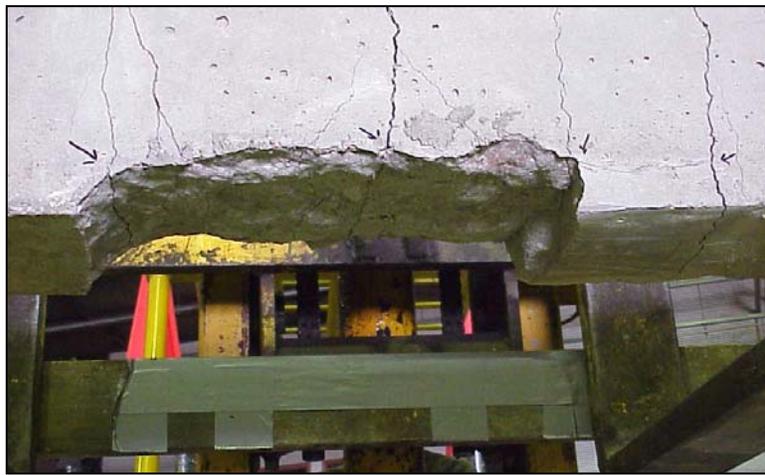
Figure 4.5 Material E patch failure along the bond line.

determined by Method 2, is within 10% of the actual value. Material E debonded from the beam at ultimate load easier than the other repair materials. Like many of the Material D patches, the patches fell out of the beam very cleanly. The other repair materials would fall out of the beams after a light tapping with a hammer. The Material E patches would often fall out at a relatively low load. Twice the patch fell out before the reinforcement in the beam yielded. A typical Material E patch failure is shown in Figure 4.5.

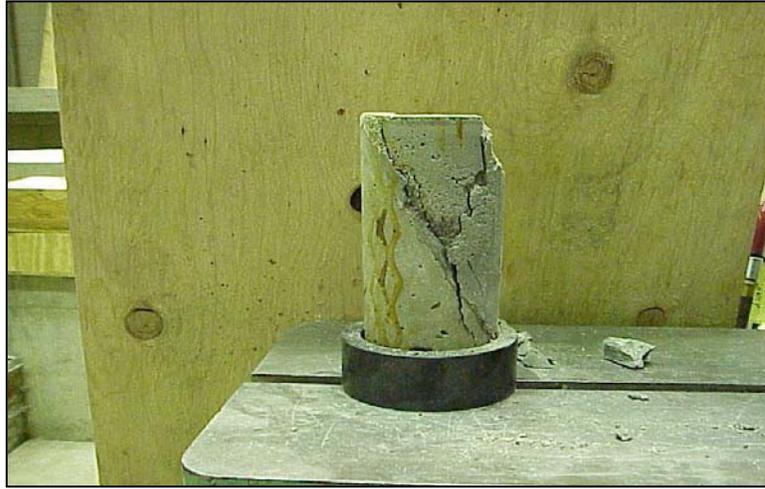
Figure 4.8 Typical compressive wedge cylinder failure.

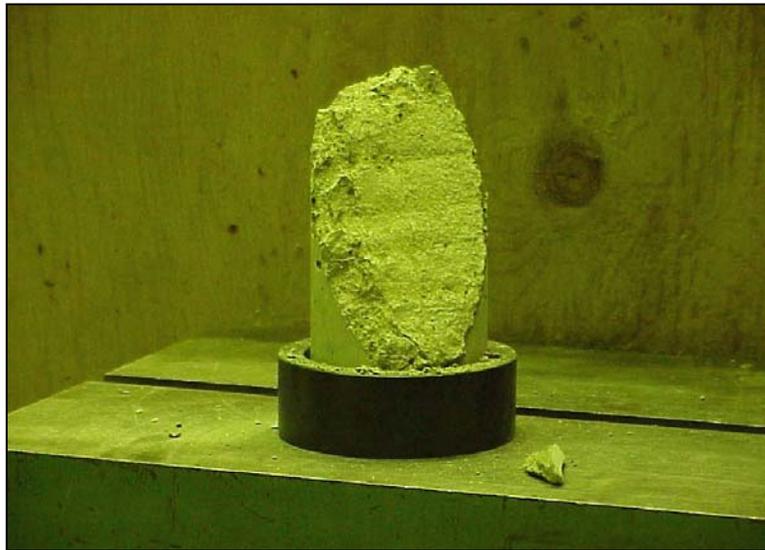
Figure 4.9 Typical shear wedge cylinder failure.
