Thin Maintenance Surfaces

Phase Two Report with Guidelines for Winter Maintenance on Thin Maintenance Surfaces

Sponsored by
the Iowa Department of Transportation

Final Report • January 2003

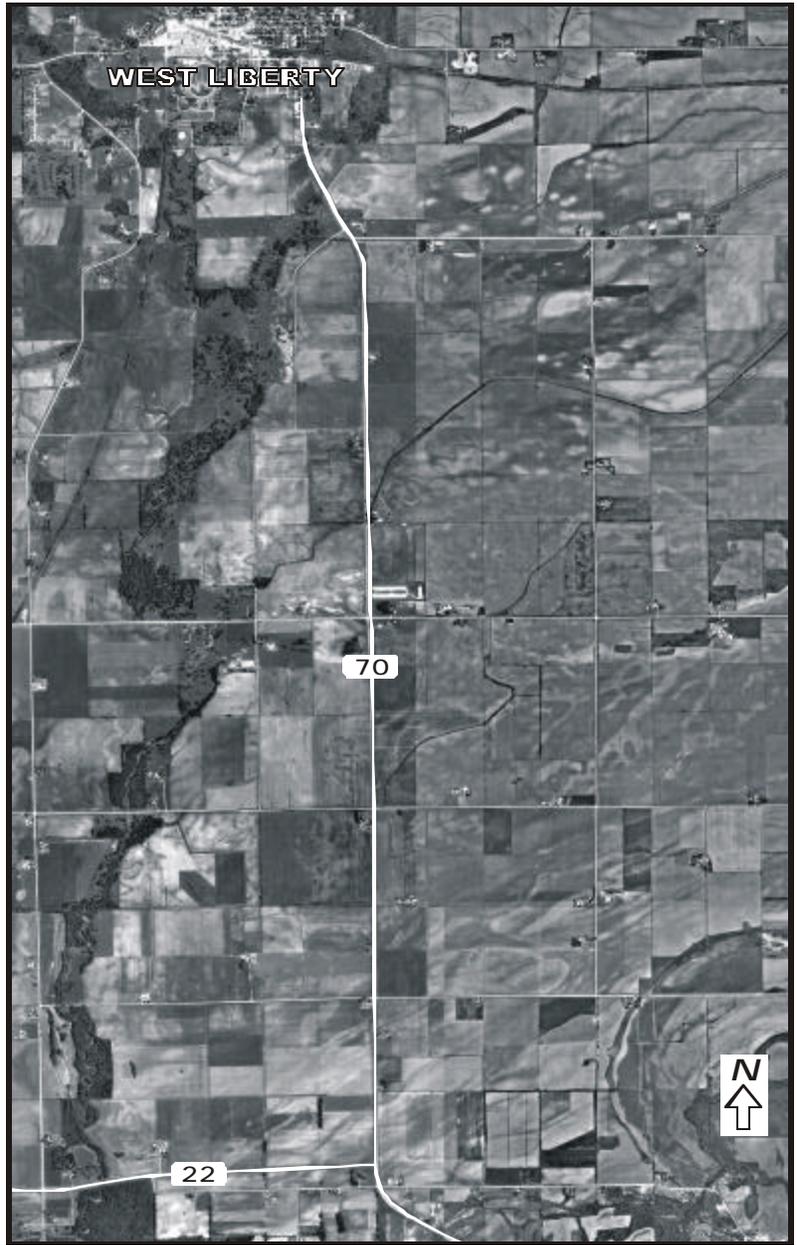
Figure 30. Aerial View of Micro-Surfaced Section of Highway 70

Figure 30 shows the section of Highway 70 that was micro-surfaced in 1999. The road runs north-south from West Liberty to Highway 22. The site was visited and photographed on May 5, 2000. Figure 31 shows a typical view of the road surface. From this, it is apparent that some sort of vibratory scraping has occurred on the road surface, possibly due to a plow blade scraping the surface. This is shown more clearly in Figure 32. Figure 33 shows in close up a region where such scraping has occurred. Again, the scraping is consistent with being formed by a scraping plow blade during winter maintenance operations.

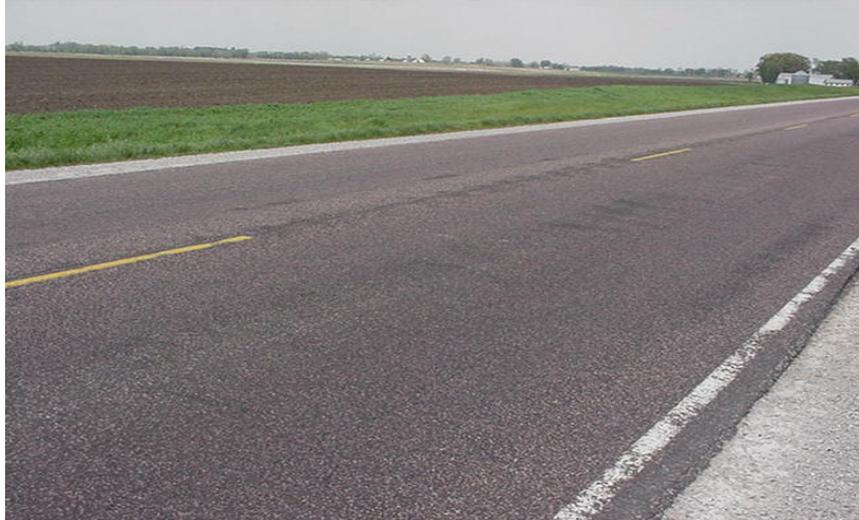
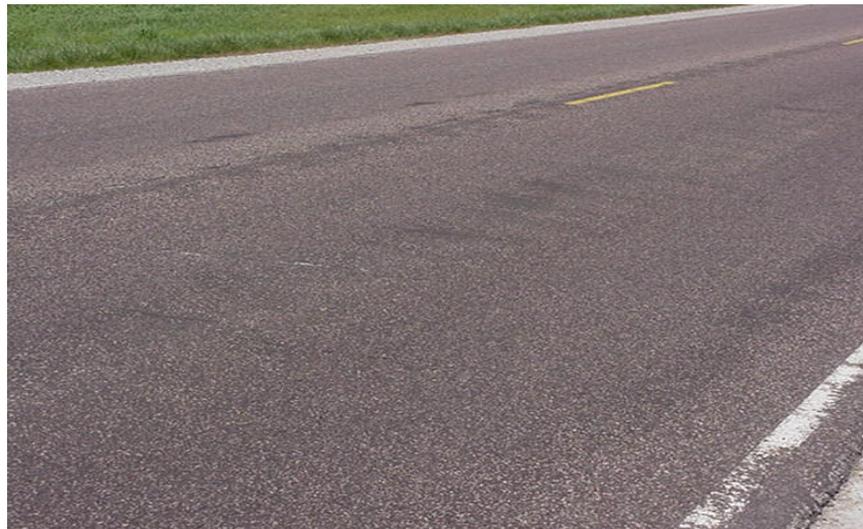
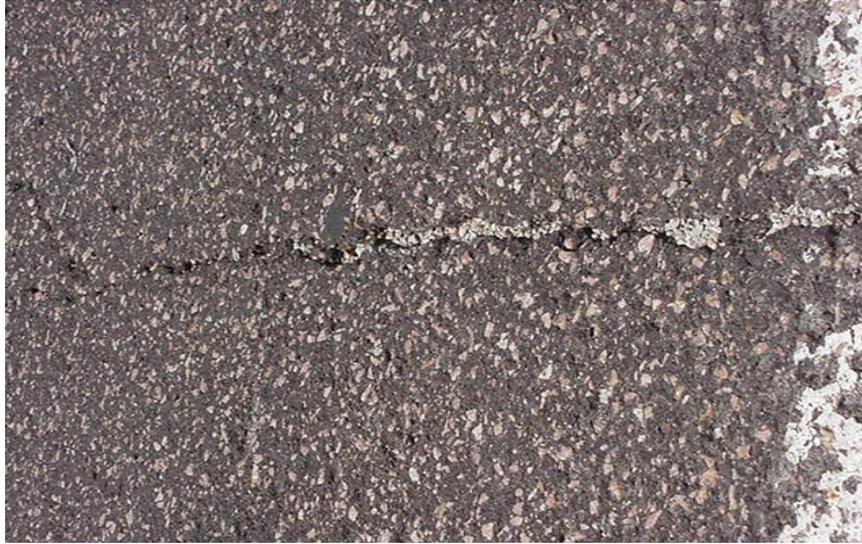
Figure 32. View of Vibratory Scraping that Has Already Occurred on the Roadway

Figure 33. Close-up View of Vibratory Scraping on the Roadway

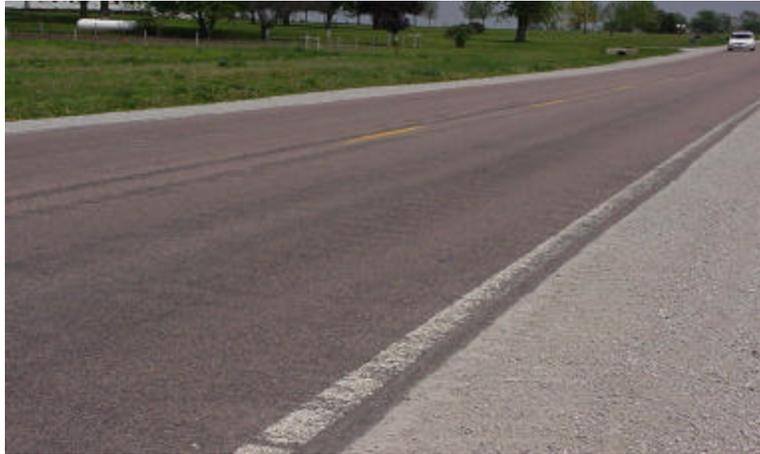
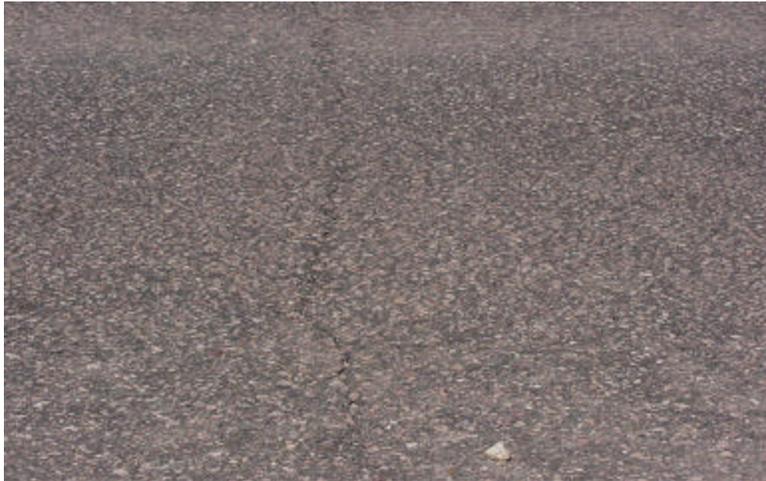
The resurfaced section of Highway 927 visited in this study runs east-west between Walcott and I-280, as shown in Figure 34. This site was also visited and photographed on May 5, 2000. Figure 35 shows the same sort of vibratory scraping marks that were seen on Highway 70, although these are perhaps more pronounced. Figure 36 shows a close-up view of the road surface, and there is some evidence of scraping wear on the surface (especially toward the top of the photograph). This scraping would be consistent with having been caused by a plow during winter maintenance operations.

Figure 35. View of Vibratory Scraping on Highway 927

Figure 36. Close-up View of Some Sort of Scraping Wear on the Roadway Surface

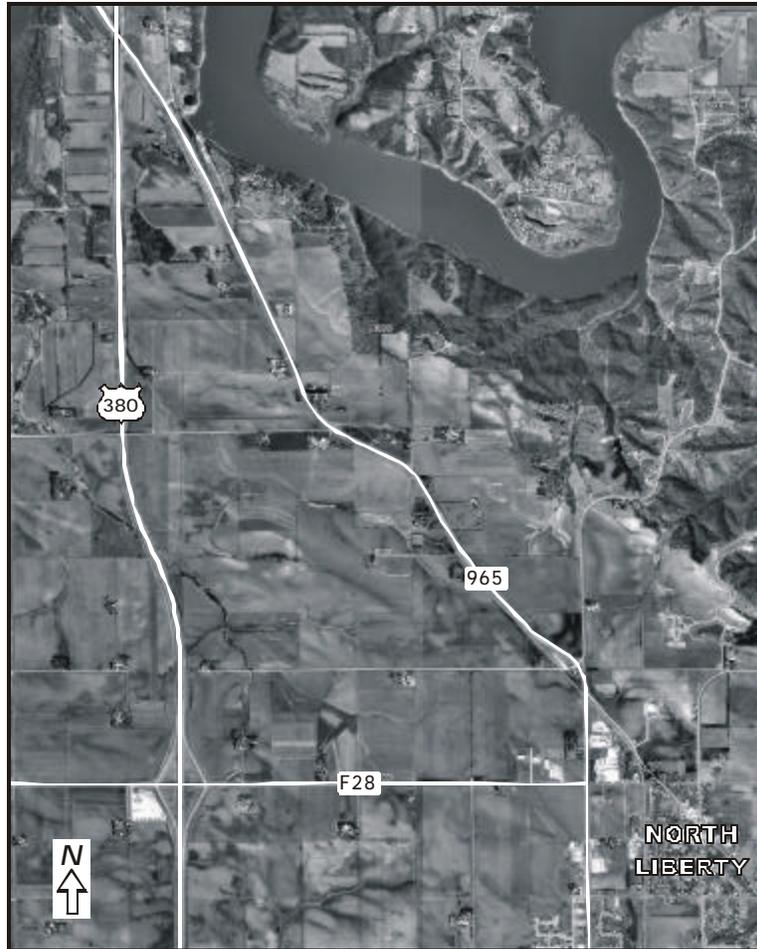
Figure 37. Aerial View of Section of Highway 965 Treated with Slurry Seal

The section of Highway 965 that had been treated with Slurry Seal runs approximately northwest-southeast, as shown in Figure 37. This site was visited and photographed on May 31, 2000. Figure 38 shows the typical condition of the road surface. As can be seen in Figure 39 the road surface is not in particularly good condition. Cracks have come through the treatment, and in places, it appears to have come away from the pavement completely. Although it cannot be clearly stated that this damage was due to scraping by a plow, Figure 40 suggests some scraping damage in particular close to the fog line. However, such scraping damage is minor in comparison with the otherwise poor shape of the treatment.

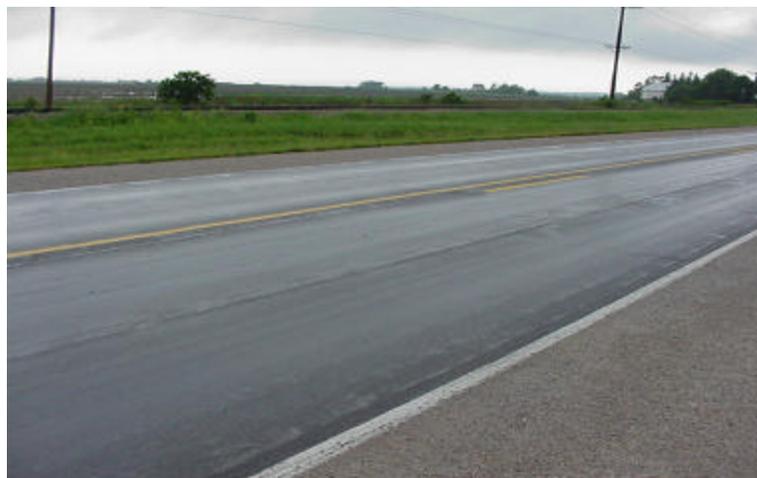
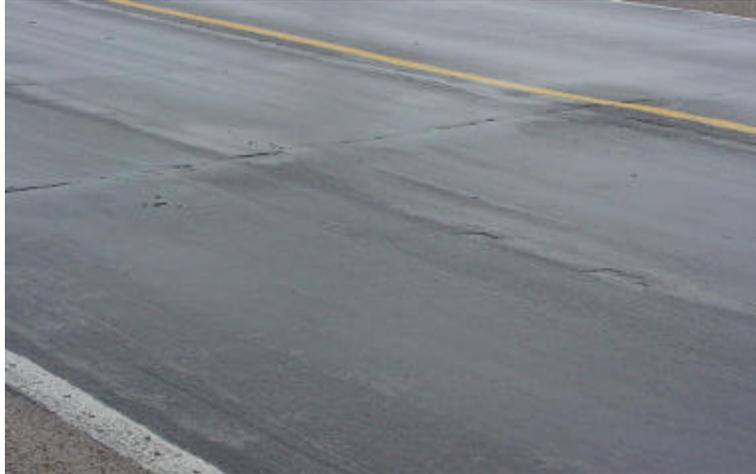
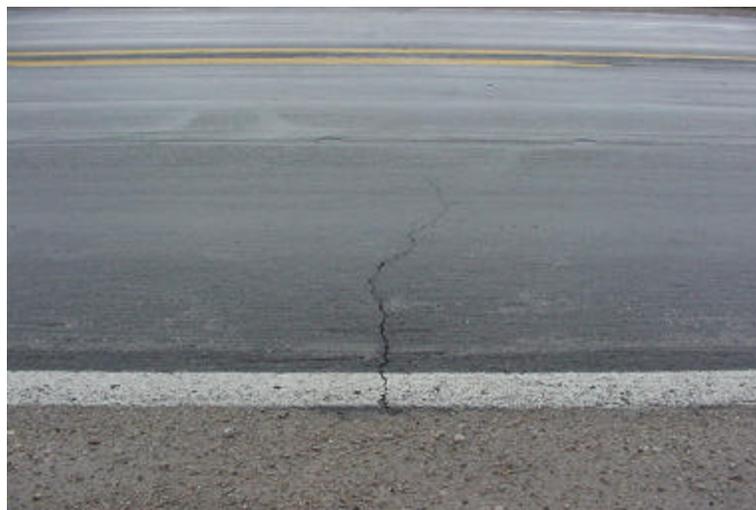
Figure 39. Closer View of Roadway Surface Showing It Is Not in Good Condition

Figure 40. Close-up View of Some Scraping of the Roadway Surface and Overall Poor Condition of the Roadway

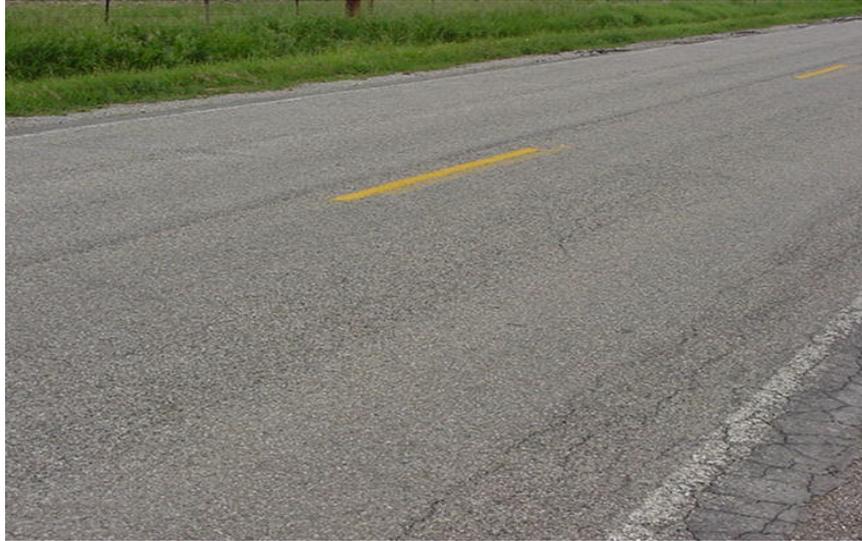
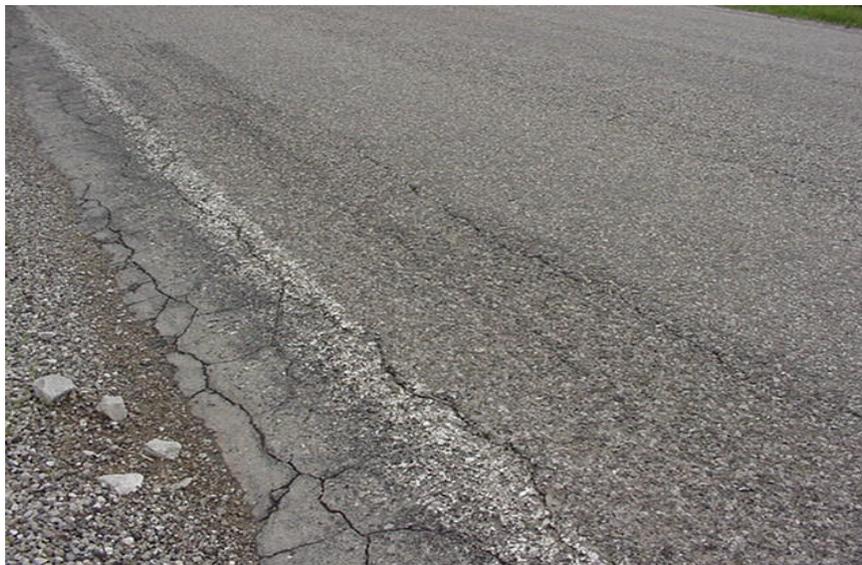
Figure 41 shows the section of Highway 131 that had been treated with seal coat, which runs south from US 30, before turning east into Belle Plaine. This site was also visited and photographed on May 31, 2000. A typical section of the road is shown in Figure 42. Significant cracking is apparent, especially close to the fog line and into the shoulder area. Figure 43 shows the cracking in this edge region more closely. Again, it does not appear that this cracking is due to scraping by a plow, although there are what appear to be scrape marks present. However, such scraping damage is minor in comparison with the damage due to cracking.

Figure 43. Close-up View of Cracking Along Edge
