Field Testing of Railroad Flatcar Bridges Volume I: Single Spans

Final Report
August 2007

Sponsored by
the Iowa Department of Transportation
and
the Iowa Highway Research Board (Project TR-498)

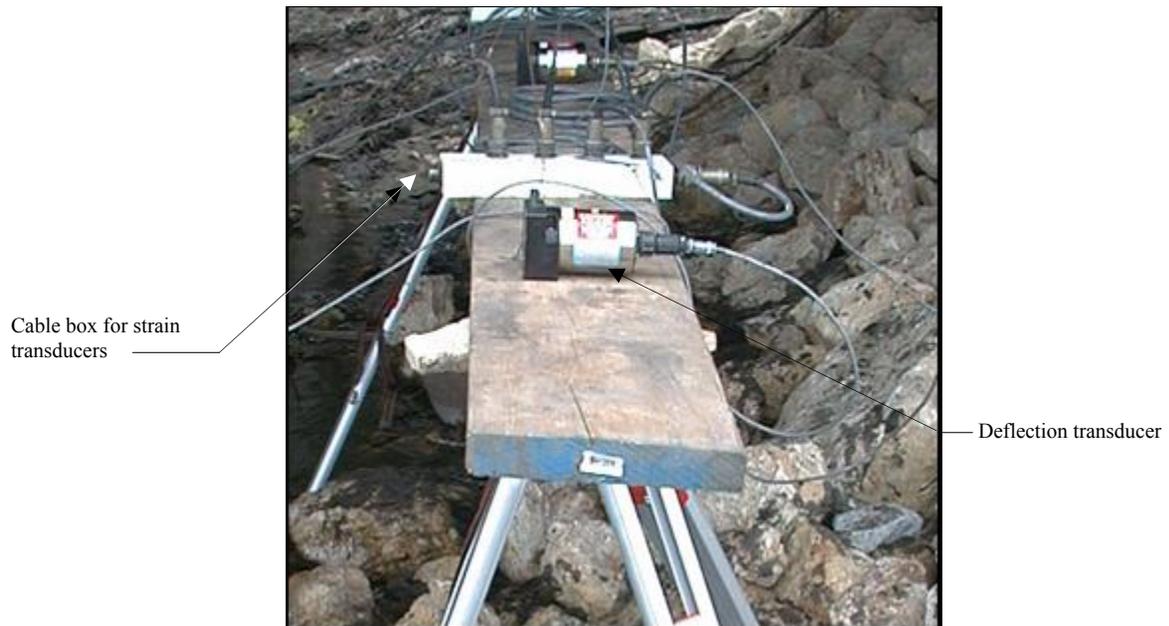
Figure 2.11. Instrumentation used on BCB2

b. Deflection transducer for the exterior girder at the 1/4 span

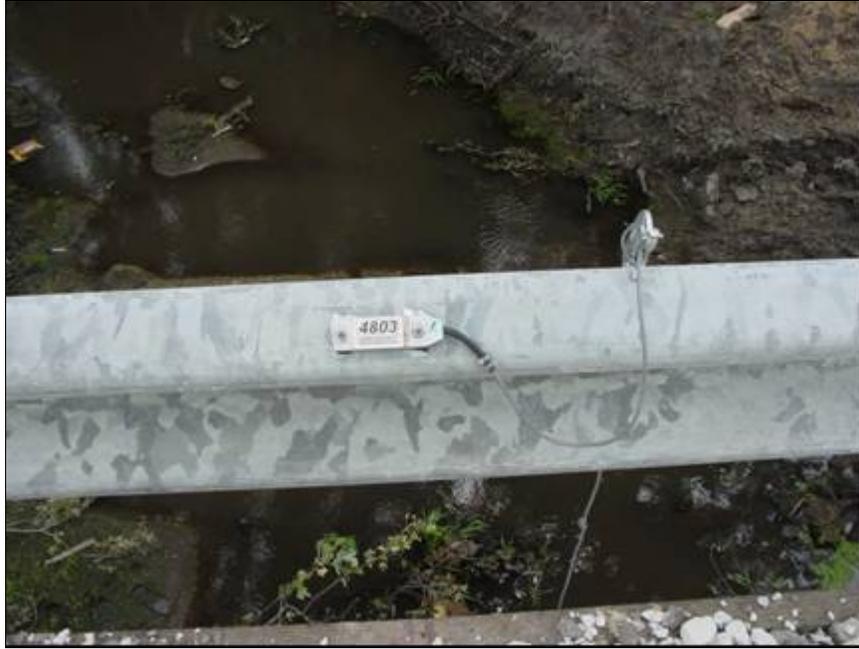
Figure 2.12. Strain transducers used on BCB2

a. Strain transducer at midspan on the south guardrail

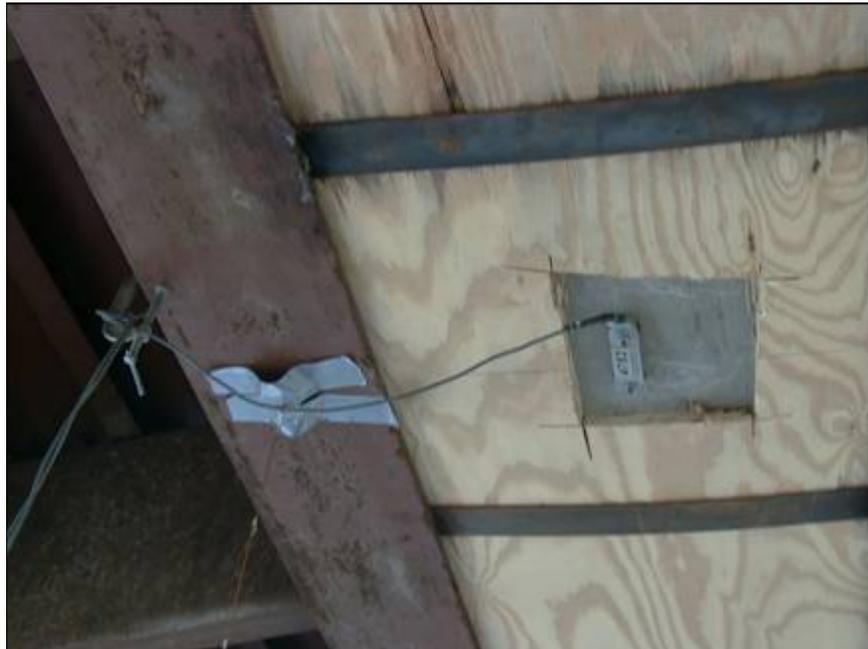
b. Strain transducer on the concrete LFC

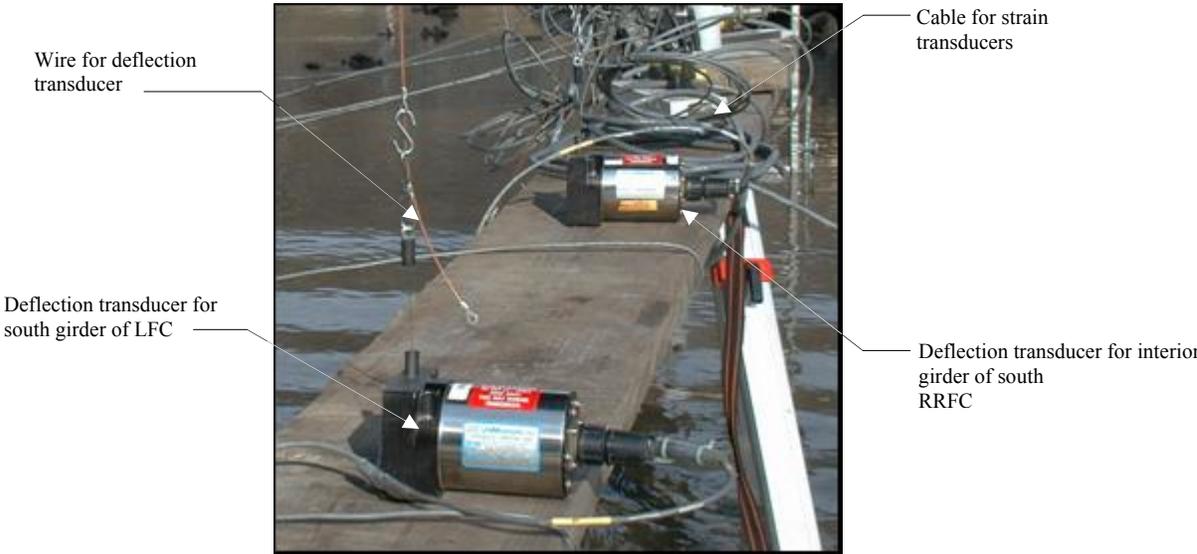
Figure 3.11. Deflection transducers used on DCB

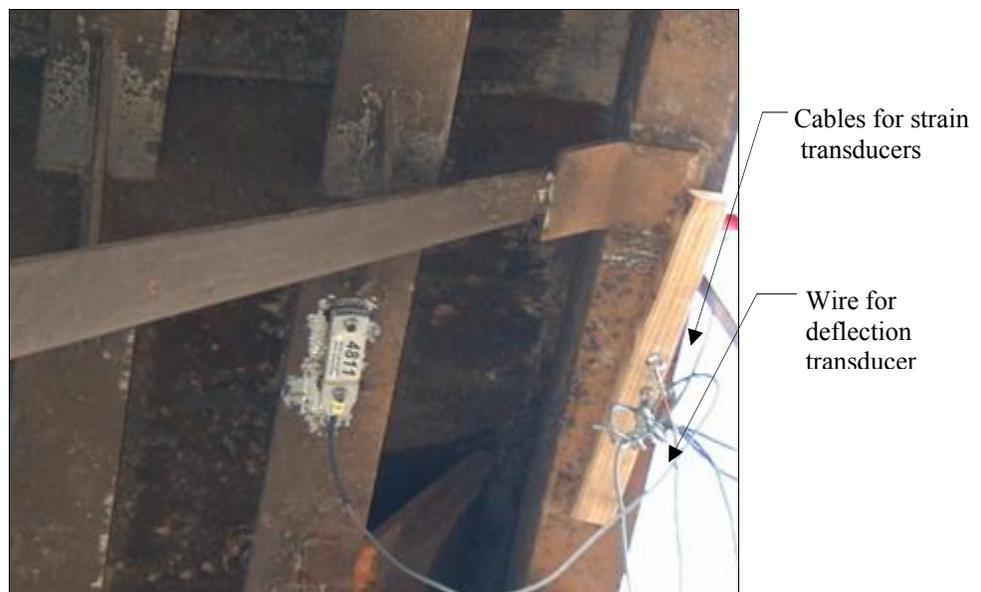
Figure 3.13. Photographs of strain transducers used on DCB

a. Strain transducer 13 on a secondary member

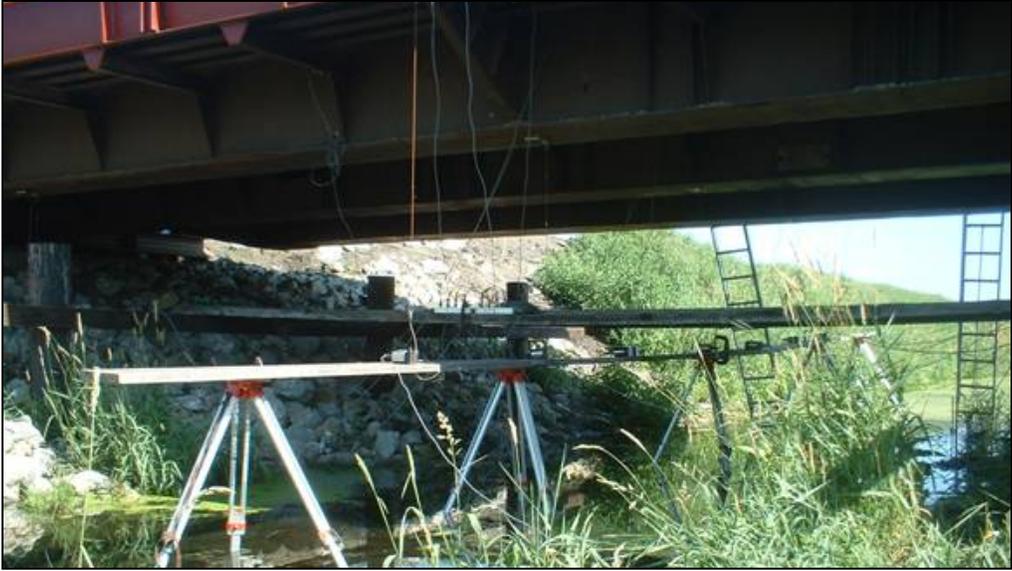
a. Installed deflection instrumentation on the WCB2
