Field Testing of Railroad Flatcar Bridges Volume II: Multiple Spans

**Final Report
August 2007**

the Iowa Department of Transportation
and
the Iowa Highway Research Board (Project TR-498)

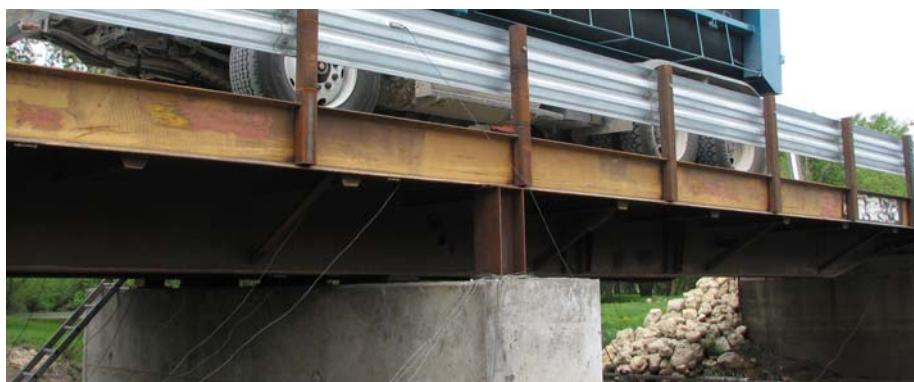
Figure 3.4. BCB5 pier support conditions

b. I-shaped Support at Exterior Girder
