Evaluation of Long-Term Field Performance of Cold In-Place Recycled Roads:

Summary Report

Final Report
May 2007

Sponsored by
the Iowa Highway Research Board
(IHRB Project TR-502)
and
the Iowa Department of Transportation
(CTRE Project 03-160)

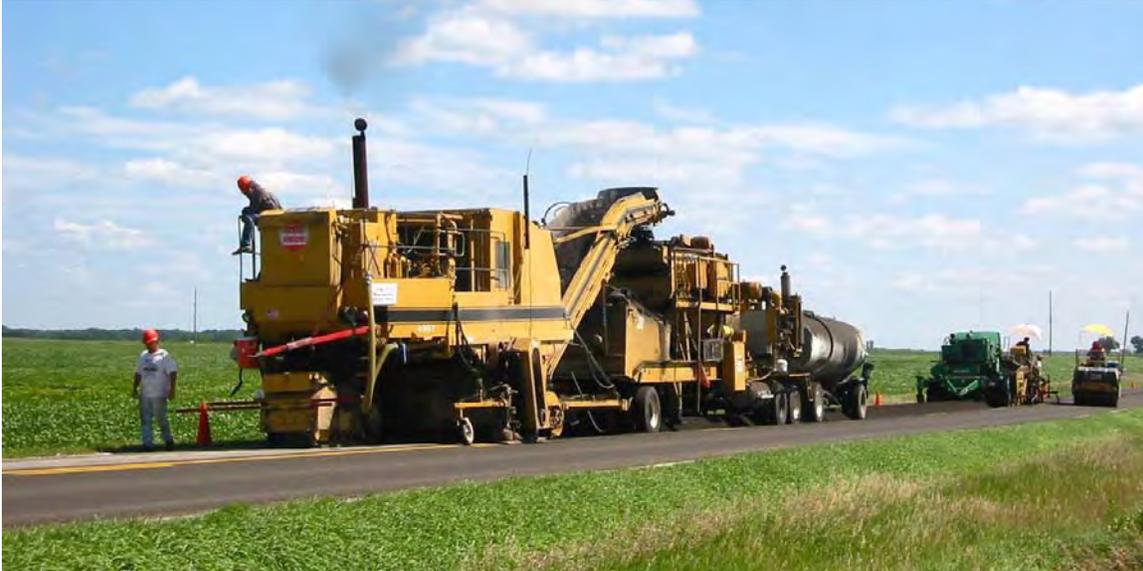
Figure 2. Picture of a typical CIR recycling train

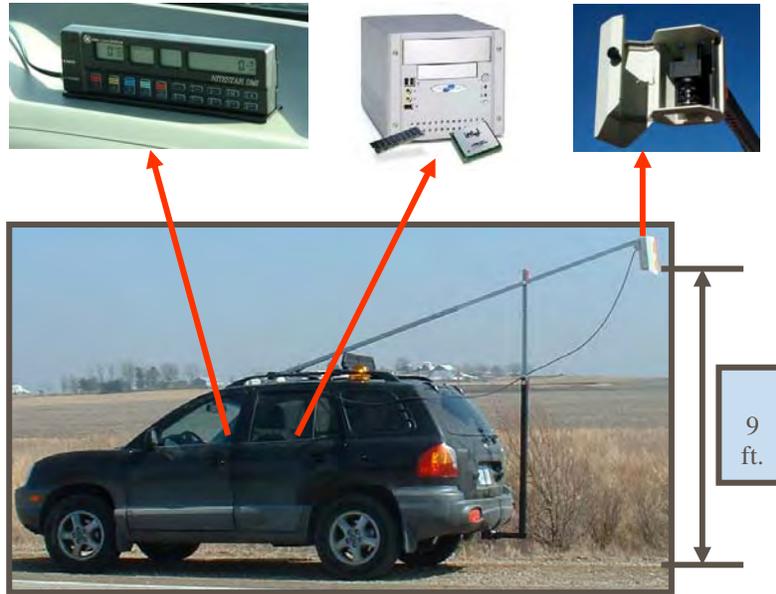
(a) Configuration of automated image collection system

(i) Length of longitudinal crack

(ii) Area of alligator cracking

(b) Screen shots demonstrating manual crack measuring process

Figure 4. Field distress measurement system

Images of field distresses for the sample were digitally captured by University of Iowa researchers (Lee and Kim 2006) and analyzed using a partially automated, technician-assisted procedure. As shown in Figure 4 (a), images were digitally captured using a vehicle-mounted digital camera that was computer-synchronized with the vehicle's speed to capture overlapping images of the road at highway speed. The images were then analyzed on a personal computer, where the operator traced cracks using a mouse and outlined areas of other distresses. Distresses included transverse, longitudinal, block, and alligator cracking; patching; raveling; and bleeding.

To determine crack severity, the operator estimated crack width by scaling. The resulting measurements were then processed to calculate a pavement condition index (PCI) according to the method outlined by (Shahin and Walther 1990). Figure 4(b) provides sample screen shots that demonstrate the crack measurement process. While this approach was more automated than the approach used in the 1996 study (Jahren et al. 1996), the University of Iowa research team conducted a side-by-side comparison of the two methods and found that they produced equivalent results (Lee and Kim 2006). Rut measurements were taken at 50 ft. intervals by the University of Iowa researchers using a dipstick measuring device on a 4 ft. straightedge.
