Feasibility of Forming Transverse Joints with Joint Forming Devices

tech transfer summary

Evaluation of Transverse Joint Forming
Methods for PCC Pavement

Iowa Highway Research Board (TR-532)

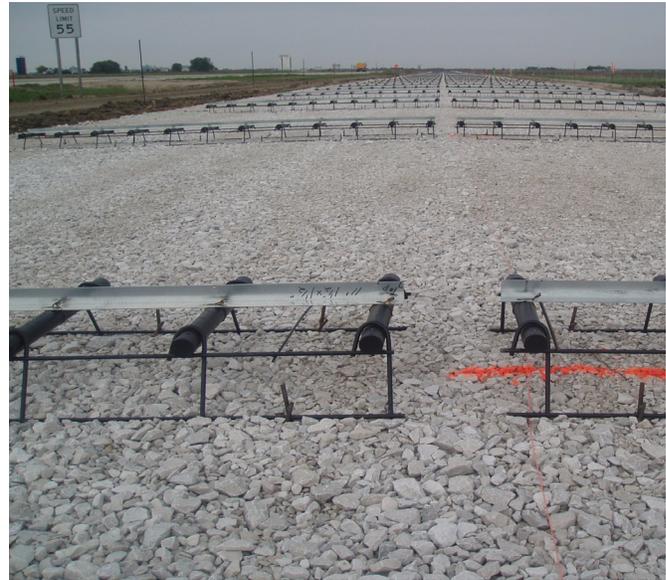
Cross-section of joint-forming device on top of the dowels

The joint-forming devices tested each consisted of a galvanized, L-shaped piece of metal placed in the area of the dowel basket to form the joint.

Six separate installations of six joints each (a total of 36 joint-forming devices) were made. The joint formers were placed either below the dowel baskets or on top of the dowels. The joint formers placed on the base were secured with dowel basket pins on approximately 610 mm centers along the joint formers. The pins were driven behind the L-shaped metal of the joint-forming devices (away from the paver) to prevent the metal from being overturned during paving. The joint formers above the dowels were secured with wire ties to the dowels themselves at 305 mm intervals to prevent rollovers.

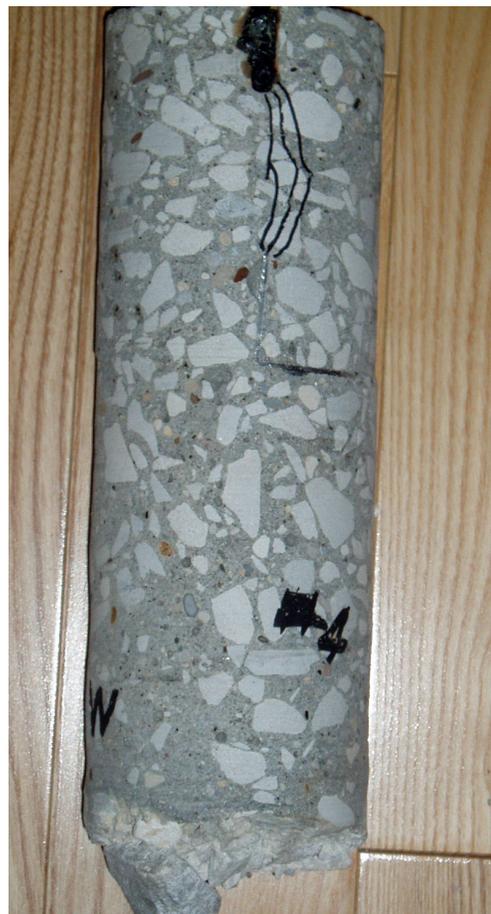
Core sample showing a crack extending from the joint former

Monitoring began immediately. Prior to paving, measurements were taken to reference the relative location of the joint-forming devices in each joint. Paving over the test sections took place over two days, and no alignment problems were observed. Photographs were also taken from various points around each test site before, during, and after the concrete was poured. Similarly, pavement condition data were recorded during the paving process and after the concrete had set enough to walk on (approximately one day after pouring). Over the following two weeks, each test section was checked for transverse cracks. During this time, weather data indicated scattered rain showers and mild temperatures (peaking in the high 70s °F), as is expected during spring paving. On final monitoring survey six months after paving, no transverse cracks had yet developed, apart from one centerline crack.
