Structural Characterization of UHPC Waffle Bridge Deck and Connections

Final Report
July 2014

Sponsored by
Iowa Highway Research Board
(IHRB Project TR-614)
Iowa Department of Transportation
(InTrans Project 09-362)

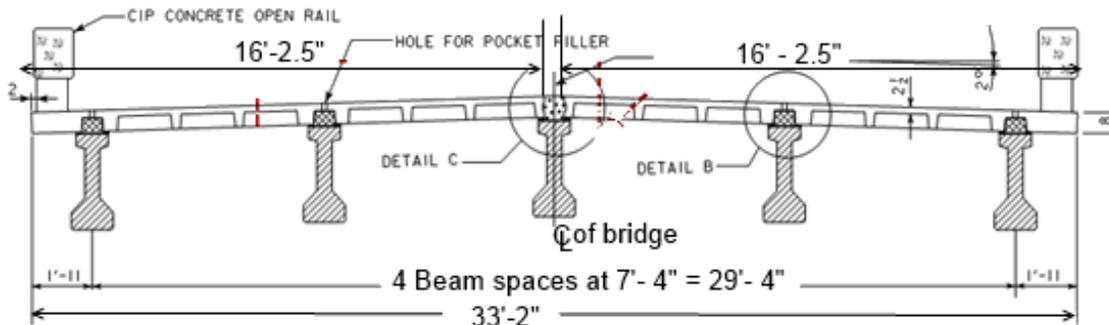
Figure 2.2. Cross-section of the UHPC waffle deck bridge designed for Wapello County Bridge in Iowa

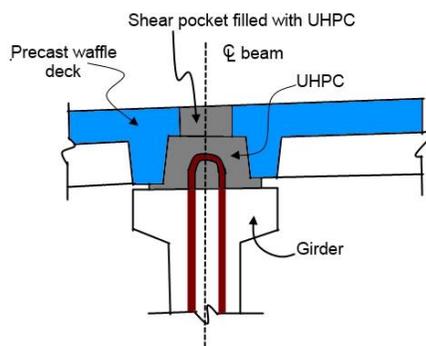
1. **Shear Pocket Connection:** This connection is formed between the girder and the waffle deck panel using shear pockets. In this connection, a shear hook from the girder is extended into the shear pocket and the shear pockets in the waffle deck panel are filled with UHPC (see Figure 2.3). This will cause the girders and the waffle deck to act in a composite manner.

Figure 2.3. Shear pocket connection details between girder and waffle deck panel

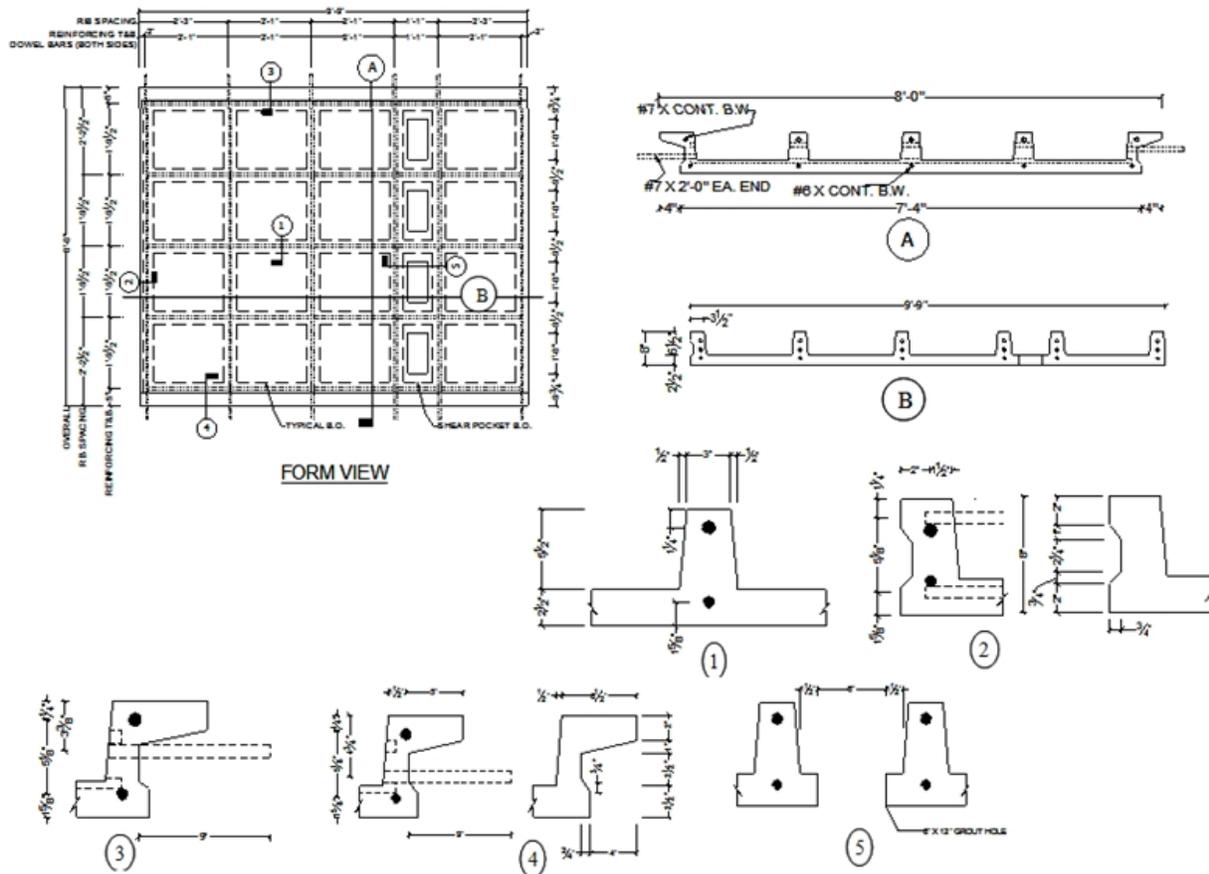
The UHPC waffle panels were designed with conventional mild steel reinforcement primarily to resist the transverse flexural moments (i.e., for moments induced about the bridge longitudinal axis) in accordance with the current AASHTO slab deck design provisions (AASHTO 2007). This resulted in Grade 60, No. 7 ($d_b = 0.875$ inch, where d_b is the diameter of the bar) and No. 6 ($d_b = 0.75$ inch) mild steel reinforcement located at 1.25 inches from the bottom surface and at 1.625 inches from the top surface of the panel, respectively. In the longitudinal direction, the panels were detailed with Grade 60, No. 7 and No. 6 mild steel reinforcement at 2.125 inches from the bottom surface and at 2.375 inches from the top surface, respectively. All the reinforcement was provided along panel ribs in both directions. Figure 2.7 shows the cross-section and reinforcement details of a typical waffle deck panel designed for the prototype bridge.

Figure 2.7. Reinforcement details of the UHPC waffle deck test panels

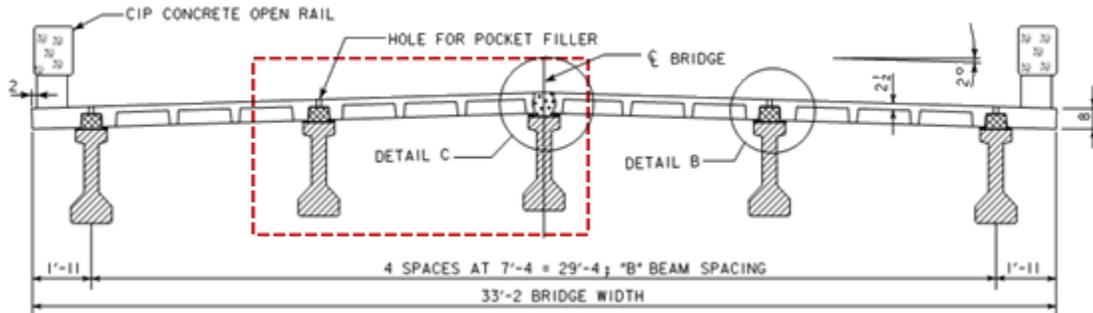
Figure 2.8 Cross-section details of the proposed UHPC waffle deck bridge in Wapello County

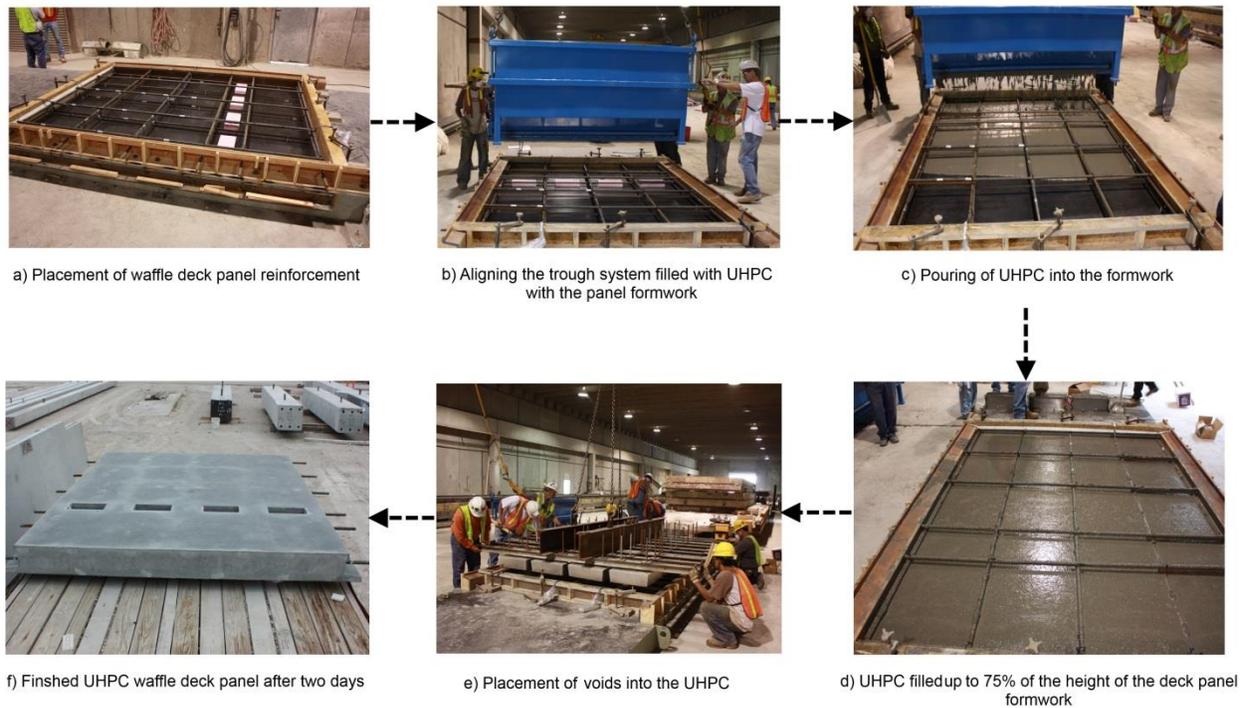
Figure 2.9. Construction sequence used for the UHPC waffle deck panels at the precast plant

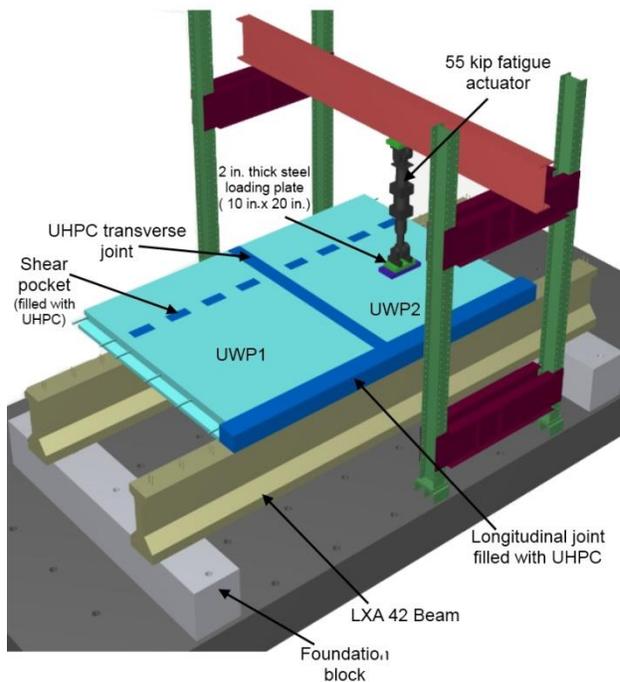
A schematic of the test setup used for the UHPC waffle deck system is shown in Figure 2.10, which was established to closely replicate the critical regions of the field structure in the laboratory. As noted earlier, the setup represented an end section of the prototype bridge encompassing the center and intermediate girders, including the connections at those locations. The UHPC deck panels were supported on two 24-foot long prestressed concrete girders having cross sections of girder type LXA 42, which were simply supported at the ends on concrete foundation blocks as shown in Figure 2.10. The foundation blocks were posttensioned to the strong floor of the laboratory using a total of four 1-inch diameter high-strength threaded rod to prevent them from experiencing any lateral movement during testing. The girders were established by cutting a 48-foot long LXA 42 prestressed concrete girder, which was used by the Iowa DOT as a standard girder in the past. The girders were placed on the foundation blocks at a center-to-center distance of 7 feet 4 inches between them as expected in the prototype bridge. They were supported on rollers at one end and pinned at the other end. After the girders were set in place, the waffle deck panels were placed on the girders with 1.25 inches of the longitudinal ribs at the connection in contact with each girder as expected in the field.

a) Schematic of laboratory test setup

Figure 2.10. Schematic of the setup used for testing of the UHPC waffle deck panel system

panel and the other was at the center of the transverse joint between the deck panels (see Figure 2.10). The critical locations for the tests were determined using a 3-D finite element analysis model of the test specimen in ABAQUS software (ABAQUS 2008). For each test location, a service load test, a fatigue test, an overload test, an ultimate load test, and a punching failure test were conducted. The overload was defined as a factor of the service level load, which will cause very minimal damage to panel or joint. The ultimate load was defined as a factor of the service load, which will cause a significant cracking or failure of the panel and joints. All the service, overload, and ultimate load tests were performed using monotonic increments of loads, and these tests were paused during loading to the target values for visual inspection of any damage to the test system, including formation of cracks. The applied load values for service load tests were arrived at based on the current AASHTO standard truck wheel load. For the fatigue load test, the system was subjected to 1,000,000 cycles at a constant frequency of 2 Hz. This test was paused twice during the tests, and the same maximum load was applied in a quasi-static manner to evaluate any progressive damage to the system.

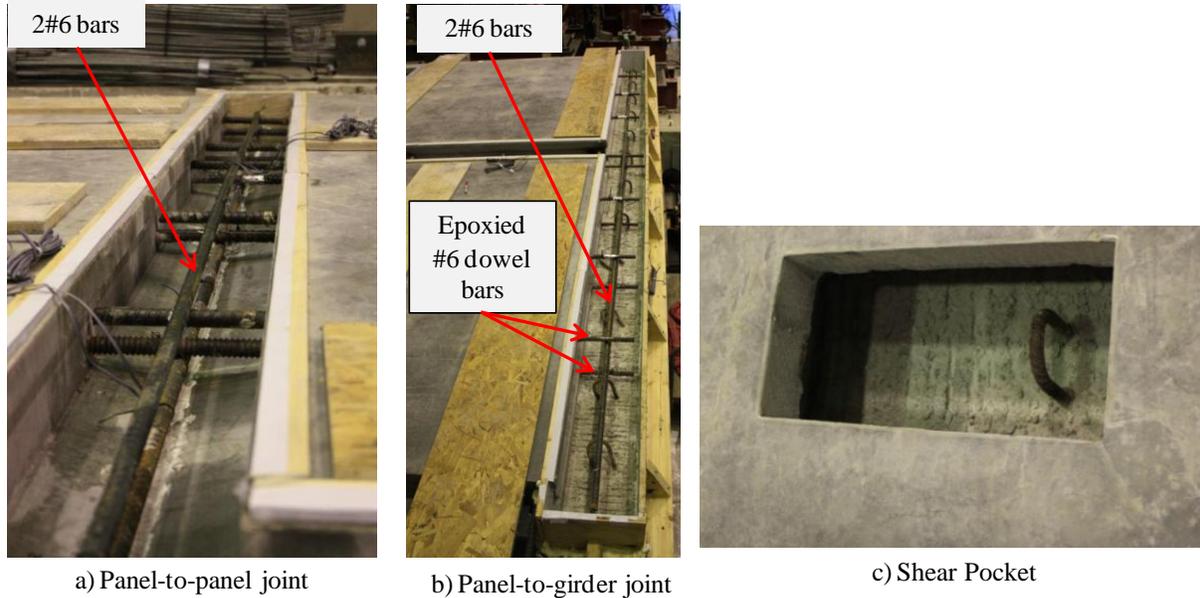
Figure 2.11. Details of the reinforcement provided in various joints

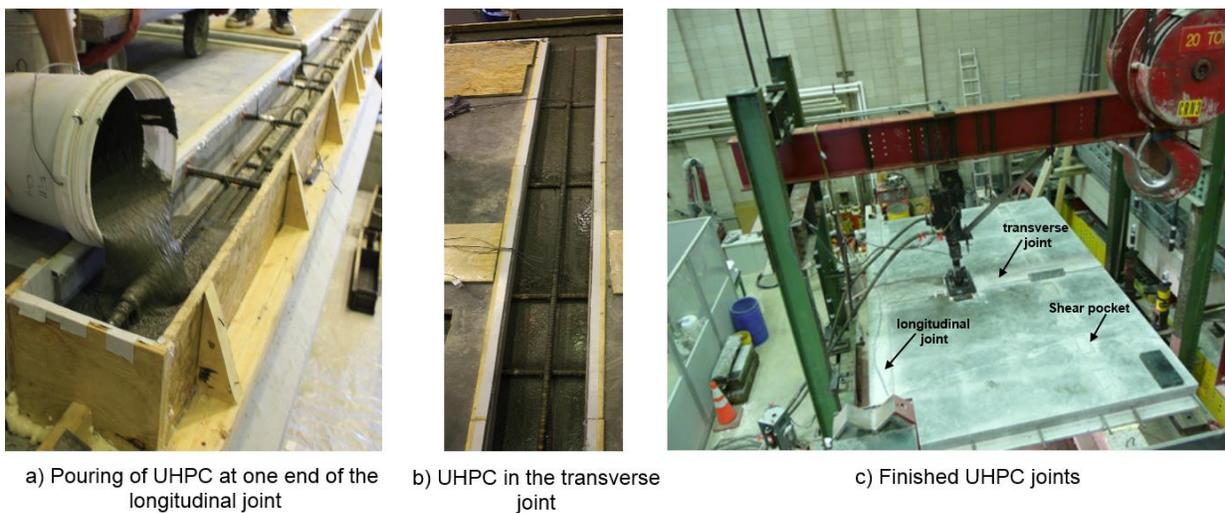
Figure 2.12. Construction of UHPC joints in the ISU laboratory

The UHPC was poured from one end of the longitudinal joint (panel-to-girder joint), and it was allowed to travel along the entire length of the joints (see Figure 2.12). After casting, all UHPC joints were covered with form plywood to minimize any moisture loss. The test cylinders were also subjected to the same curing conditions as the joints. They were tested in regular intervals to monitor the strength gain with time. Table 2.3 shows the details of the UHPC strength gain with time. The 28-day compressive strength of UHPC in the joints was less than typical strength of 26 ksi used in the deck panels but more than the required design strength of 15 ksi. This was expected because the UHPC in the joints was not subjected to any heat treatment. The test preparation work began immediately upon completion of the joints. The plywood was removed after 3 days, and the testing got under way 34 days after casting of the UHPC joints. A ± 55 kip capacity fatigue rated hydraulic actuator, mounted to a steel reaction frame as shown in Figure 2.10 was used to apply the load to the test unit. The frame was posttensioned to the strong floor of the laboratory using four 1.25-inch diameter high-strength bars. A 10 inch by 20 inch steel plate was used at the loading end of the actuator to simulate a truck wheel load on the panel for all testing.

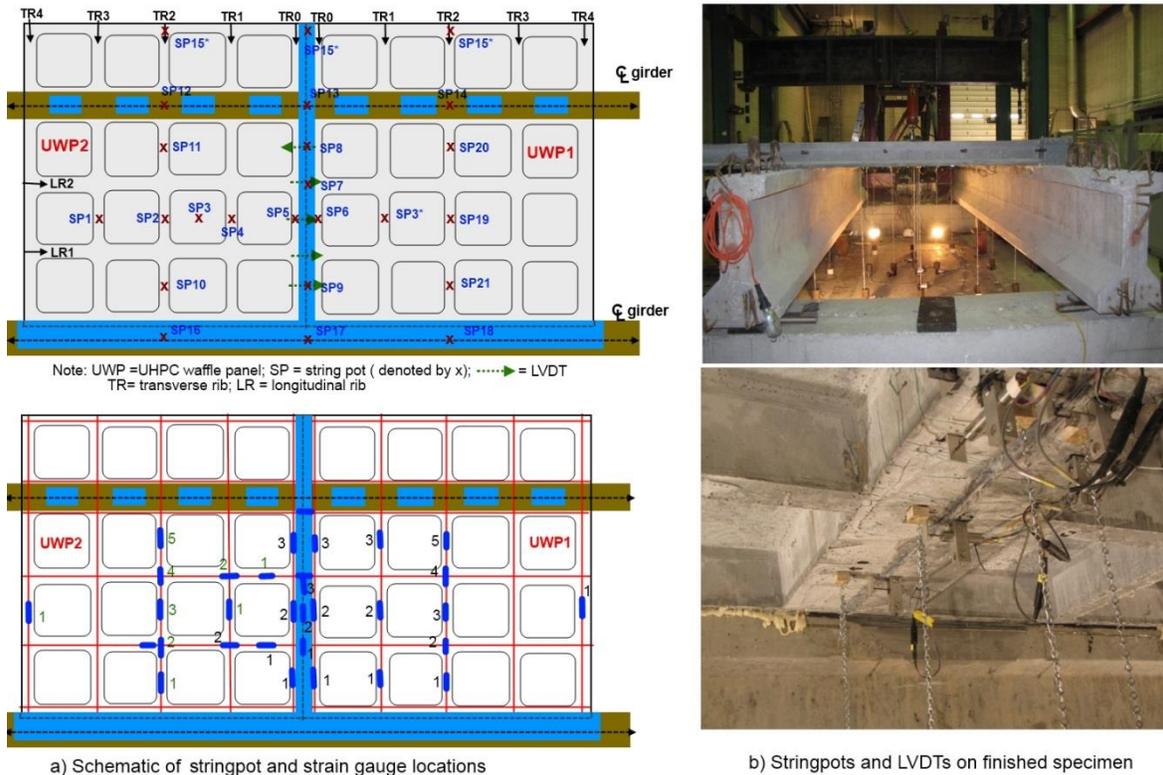
The LVDTs were placed along the panel-to-panel joint region to capture any possible gap opening along the transverse joint during testing. They were also used down the depth of the panels to measure average strains and neutral axis depth during loading (see Figure 2.13). Also, the width of the flexural cracks along the transverse ribs was monitored during testing using LVDTs. A number of embedded strain gauges were used to measure the strain demands in the reinforcement along the transverse and longitudinal ribs of the panels and in the reinforcement placed within the joints. The No. 6 ($d_b = 0.75$ inch) dowel bars epoxied into the side face of the deck panels were also gauged to monitor the strain demands on these bars during testing. Figure 2.14 and Figure 2.15 show the locations of the strain gauges mounted on the bottom and top deck reinforcement, respectively. During the test, the data from all gauges and displacement devices were recorded using a computer-based data acquisition system.

Figure 2.13. Schematic of the displacement transducers mounted to the test unit

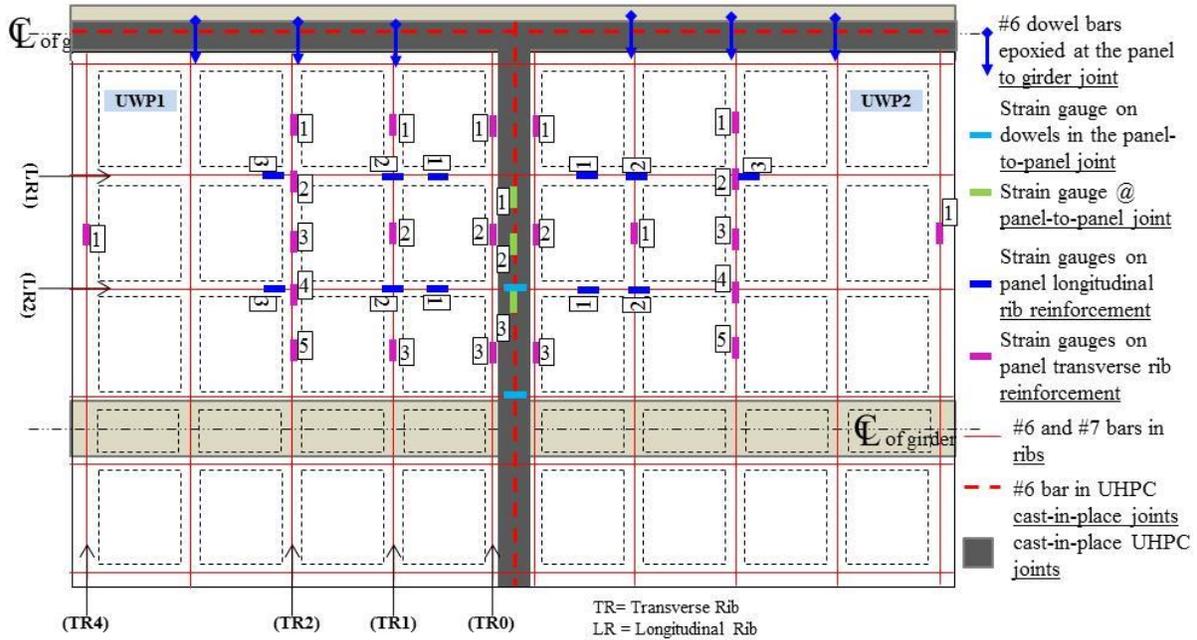
Figure 2.14. Location of strain gauges used on the bottom deck reinforcing bars

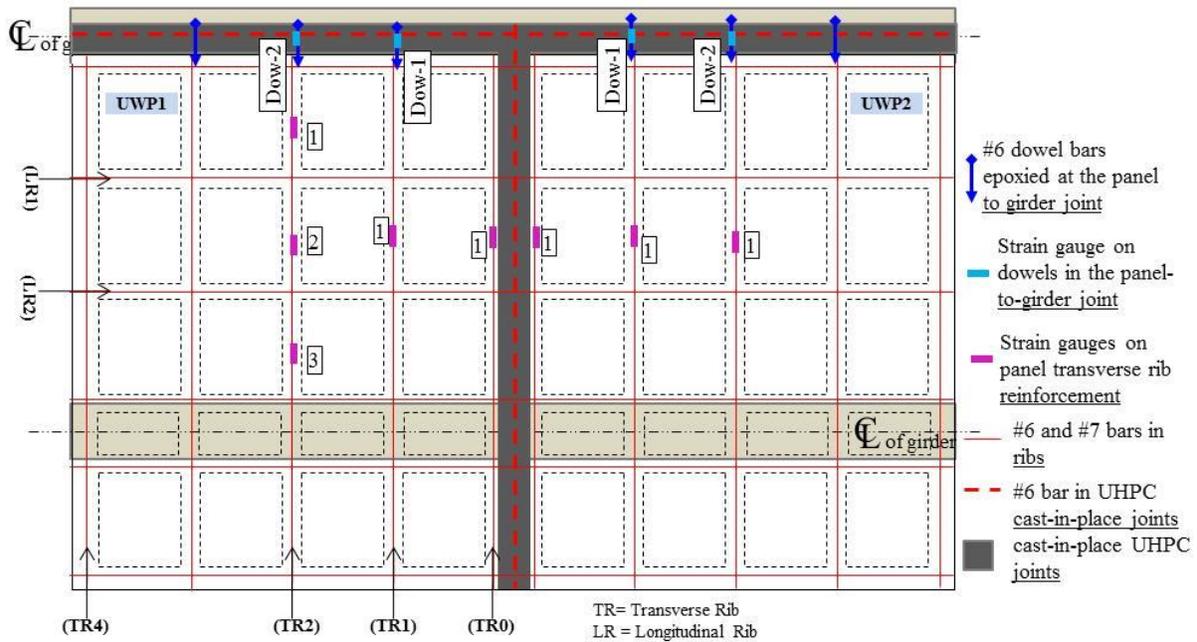
Figure 2.15. Location of strain gauges on the top deck reinforcing bars and dowel bars

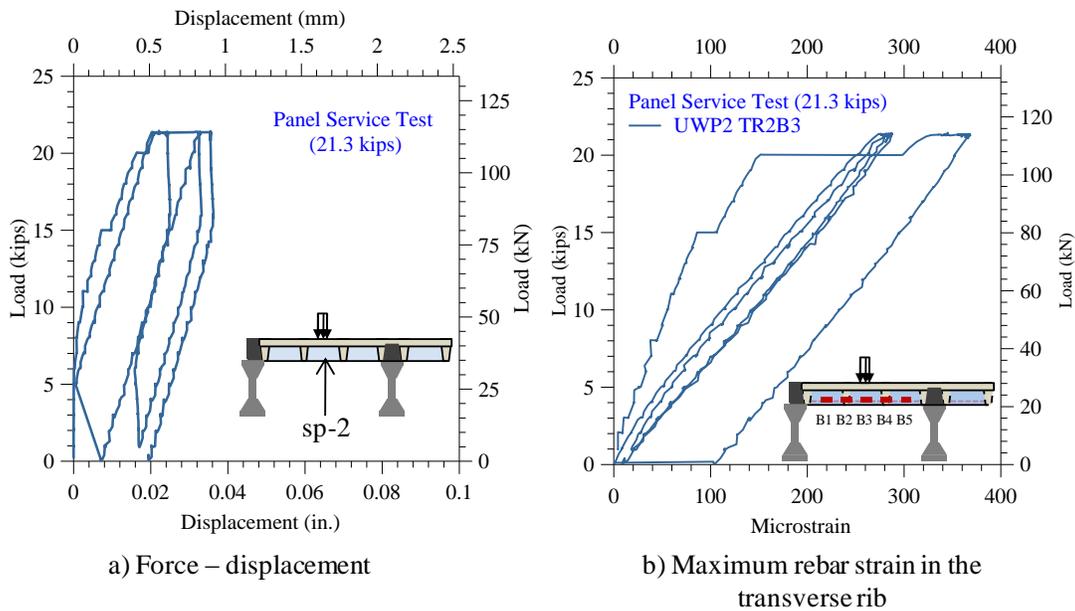
The peak recorded strain in the bottom reinforcement of the center rib running in the transverse direction is shown in Figure 2.16b, which reached a maximum strain of only $375 \mu\epsilon$, or 18% of the yield strain. The strain variations along the length of the bottom reinforcement in the transverse rib TR2 of panel UWP2 and the panel-to-panel joint are shown in Figure 2.17 and Figure 2.18, respectively. The maximum tensile strain in the joint reinforcement was $40 \mu\epsilon$, indicating no damage to the joint region. A single crack having a width less than 0.002 inch was observed on the transverse rib under the load and is identified in Figure 2.19. In comparison to traditional normal concrete, it is important to realize that the material behavior of UHPC is quite dependent on the crack width. Hence, it may not be appropriate to use the AASHTO crack width provisions to qualify the serviceability and durability considerations for the behavior of UHPC structural members. Because of the lack of any specific UHPC bridge design serviceability criteria available in the literature, the crack width limits suggested for UHPC to control the fiber pullout criteria are used to comment on the implication of the crack developed in this test. Based on the AFGC 2002 recommendations, the fiber pullout and strength degradation in UHPC initiate when a crack width reaches 0.0118 in. (0.3 mm) (see Figure 2.20). This limit is nearly more than six times the observed crack width during the service test, confirming that the overall behavior of the precast waffle deck system was outstanding. In addition, it is noted that the test results also confirmed that the system performance satisfied the deflection and crack width requirements recommended for the serviceability condition by AASHTO (AASHTO 2007).

Figure 2.16. Measured force-displacement response and peak rebar strain from gauge B3 at the center of the transverse rib TR2 of panel UWP2

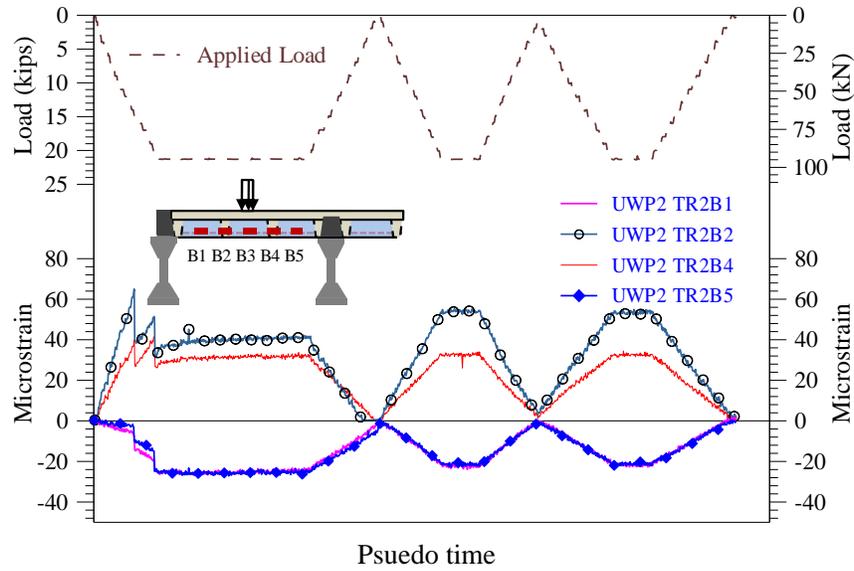
Figure 2.17. Measured strains along the bottom reinforcement of the transverse rib TR2 of panel UWP2

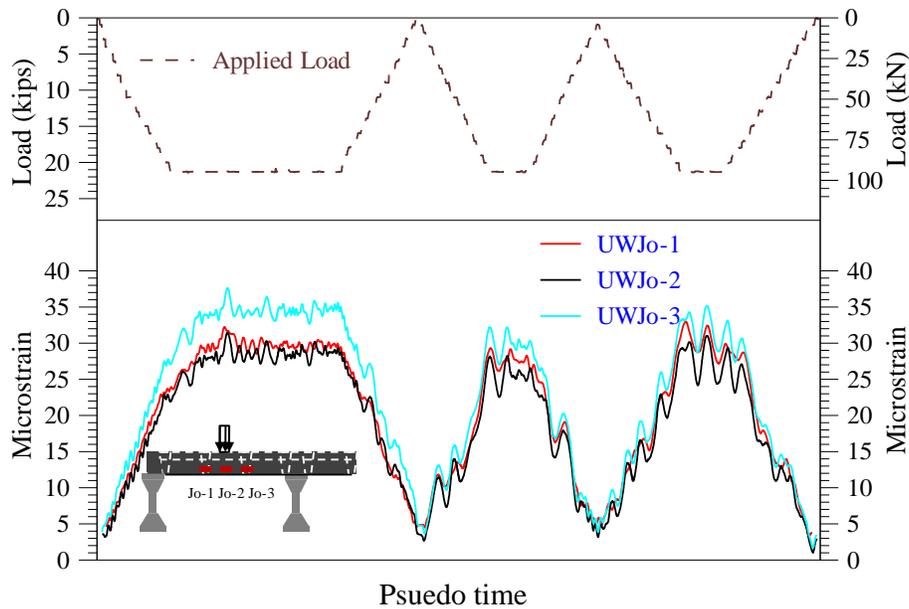
Figure 2.18. Measured strains along a bottom reinforcement of the panel-to-panel joint

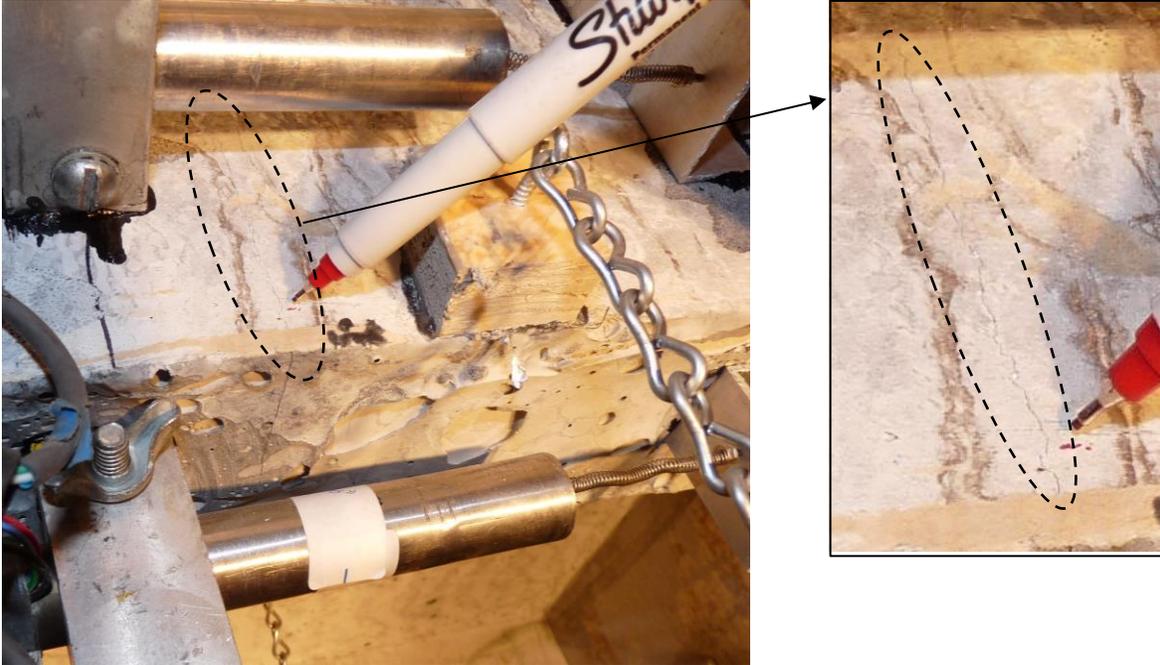
Figure 2.19. A hairline crack in the UWP2 panel transverse rib TR2 at 21.3 kips

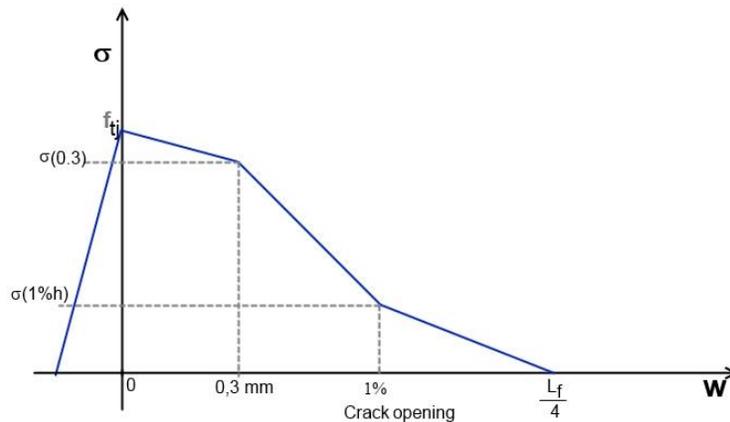
Figure 2.20. A relationship proposed for the UHPC tensile strength variation as a function of crack width (AFGC 2002)

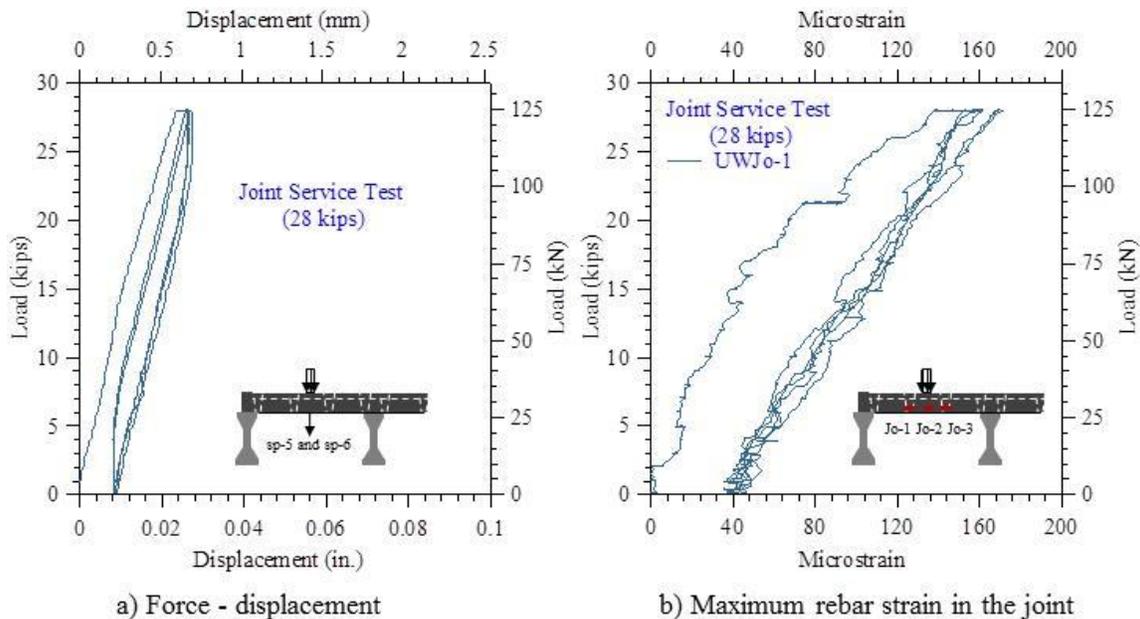
the center of the joint is shown in Figure 2.21a. Again, a linear response was obtained with a maximum deflection reaching only 0.022 inch during the first load cycle. This deflection corresponds to $L/4000$, which is 20% of the specified AASHTO limit of $L/800$ (see Section 9.5.2 in AASHTO [2007]) for continuous spans with pedestrian traffic under the serviceability condition.

The load vs. strain plot for the gauge recorded for the maximum strains and the strain variation along a bottom reinforcement in the joint are shown in Figure 2.21b and Figure 2.22, respectively. The peak recorded strain in the joint bottom reinforcement was $17 \mu\epsilon$, indicating significant reserve capacity of the joint. The strain variations obtained for the bottom reinforcement in the transverse rib TR2 of panels UWP2 and UWP1 are shown in Figure 2.23 and Figure 2.24, respectively. Both figures show comparable strain demands, indicating that the applied joint load was evenly distributed to both panels. Figure 2.25 shows the variation of strains at the center of the rib across the transverse ribs of panel 1, indicating their relative contribution. No cracking was observed at 21.3 kips load. At the peak load of 28 kips, however, a single hairline crack having width less than 0.002 inch was observed on the transverse ribs forming the joint (see Figure 2.26). Given that this crack is significantly smaller than 0.0118 in. (0.3 mm) (see Figure 2.20) corresponding to initiation of fiber pullout and strength degradation of UHPC in tension, it was concluded that the overall behavior of the transverse joint subjected to service load was outstanding. The test results also indicated that the system performance satisfied the deflection and crack width requirements recommended for the serviceability condition by AASHTO (AASHTO 2007).

Figure 2.21. Measured force-displacement response and peak rebar strain at the center of the joint at the service load

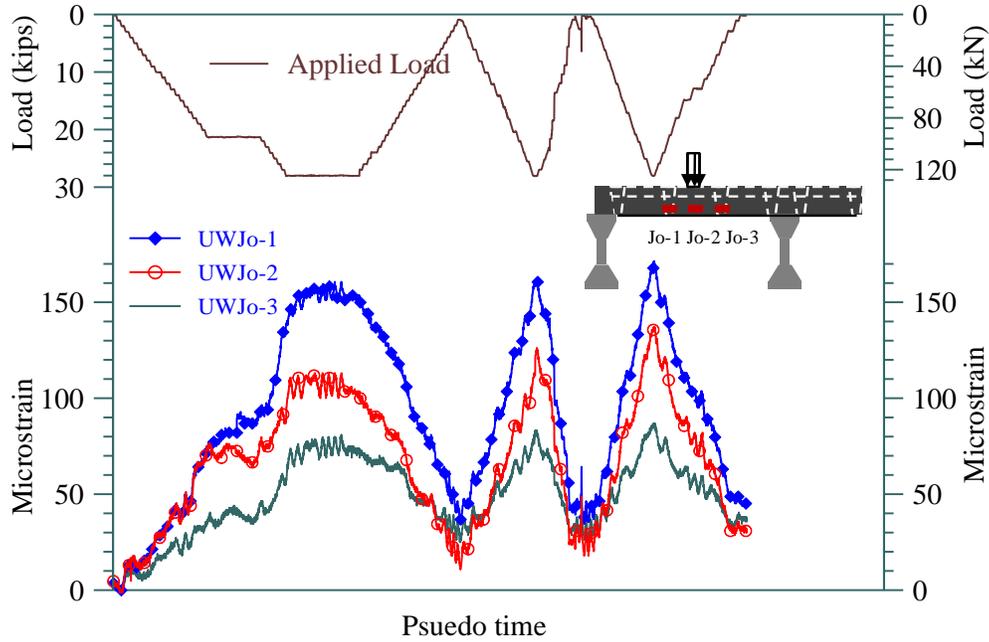
Figure 2.22. Measured strains along the bottom reinforcement of the joint during the service load test

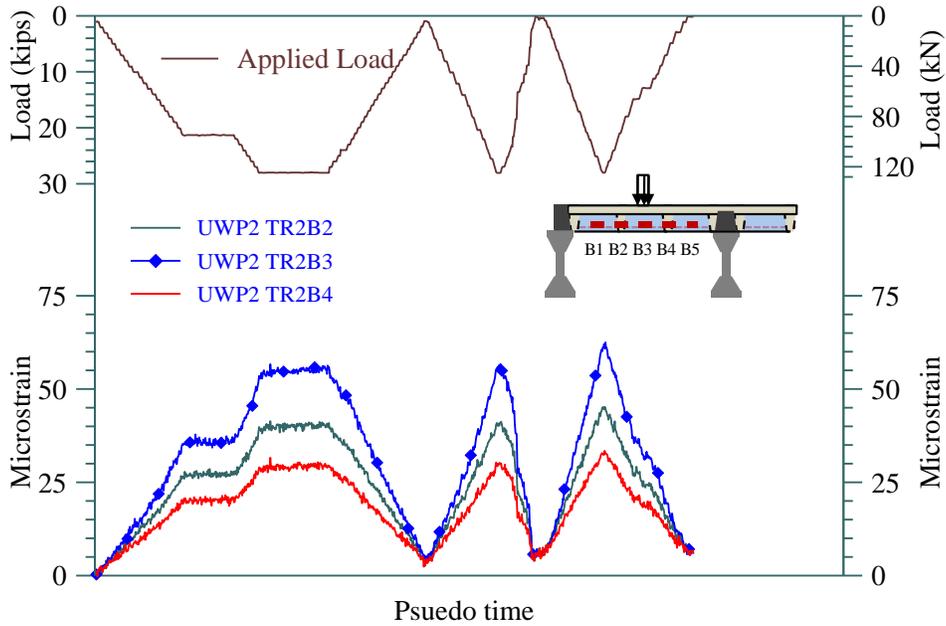
Figure 2.23. Measured strains in the bottom reinforcement of the transverse rib (TR2) along the length of panel UWP2 at service load

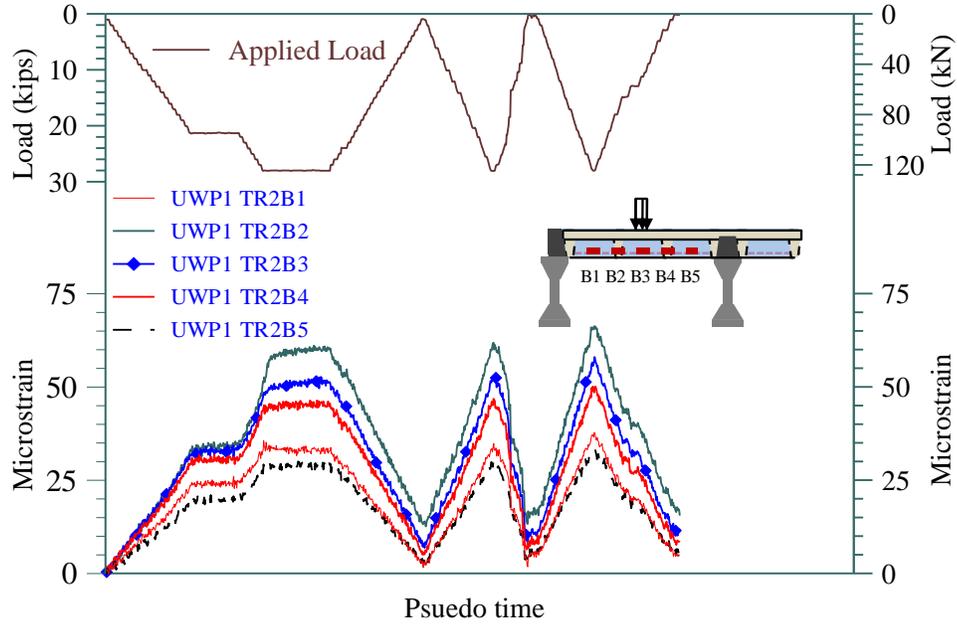
Figure 2.24. Measured strains in the bottom reinforcement of the transverse rib (TR2) along the length of panel UWP1 at service load

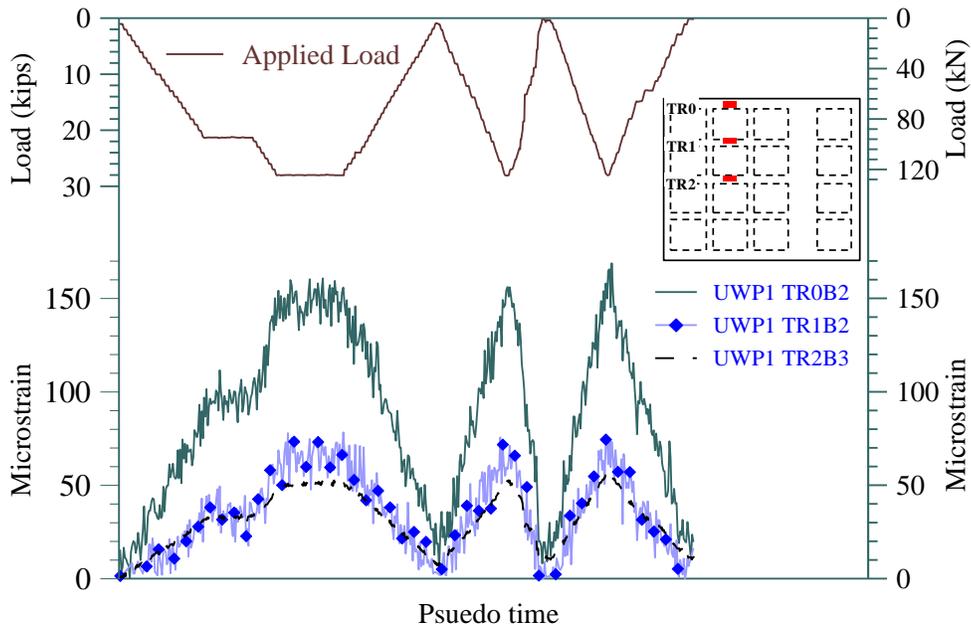
Figure 2.25. Measured strains at the center of the panel across the transverse ribs of UWP1 at service load

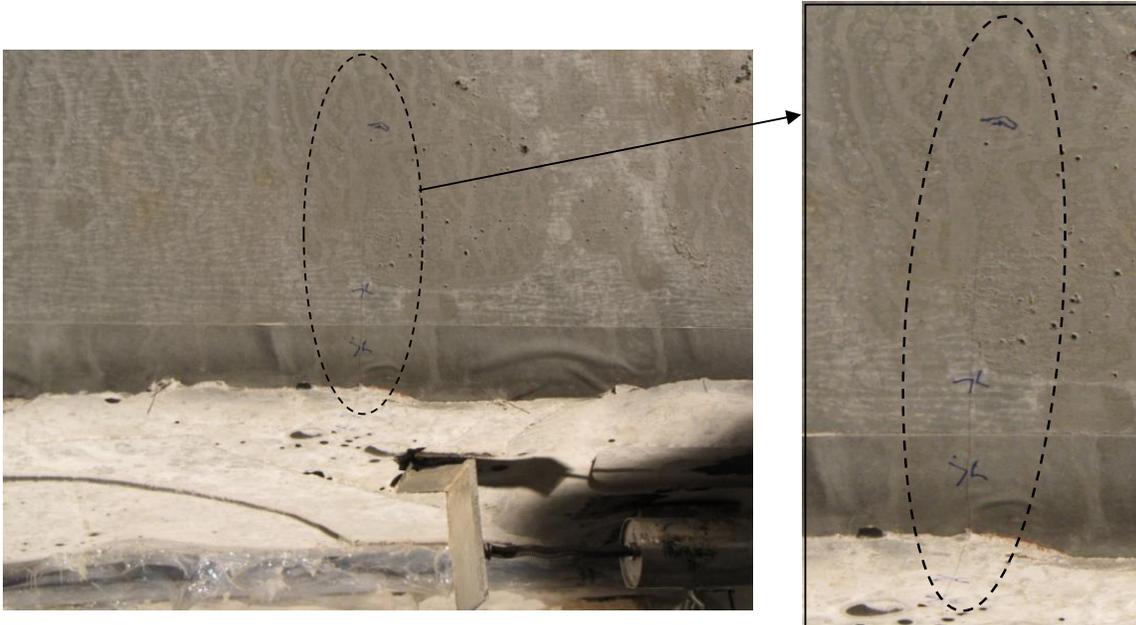
Figure 2.26. A hairline crack formed at the center of underside of the transverse joint at 28 kips

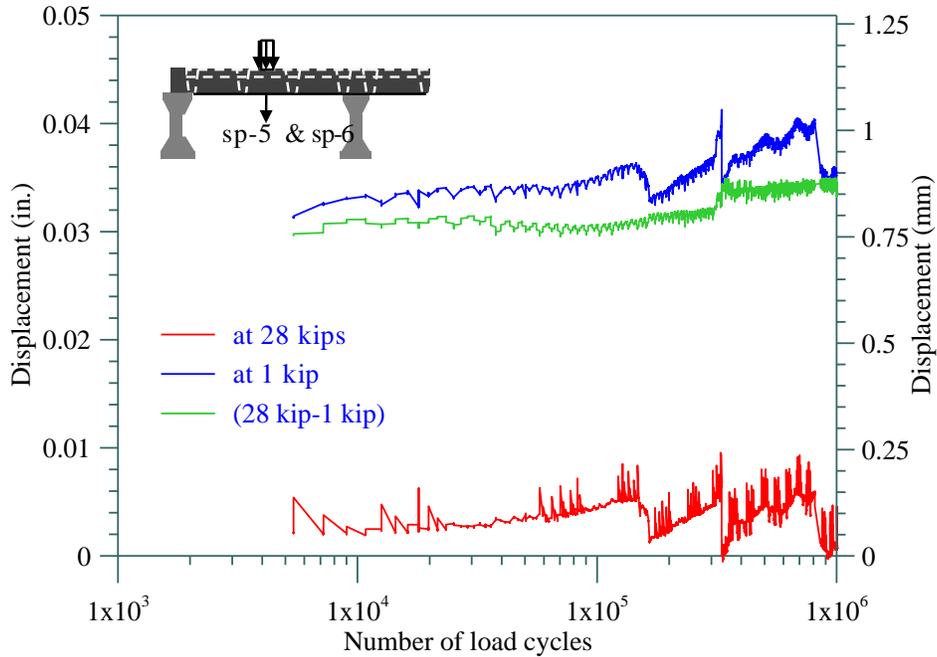
Based on the recorded data, the displacements recorded at the center of the joint at 28 kips and 1 kip are plotted as a function of the load cycle during the fatigue loading in Figure 2.27. It is apparent that the gauge data experienced drift due to ambient condition and other reasons during the test. When the displacement corresponding to the load increment of 27 kips (i.e., 28 kips–1 kip) was examined, however, it was clear that this displacement remained almost constant throughout the test and the change in the displacement reading is largely due to noise observed at 1 kip. With the variation of the displacement being very small and limitations with the sensitivity of the string potentiometers occurring, it is concluded that the UHPC did not experience any fatigue damage.

Figure 2.27. The variation of the peak displacement at the center of the joint during the joint fatigue test

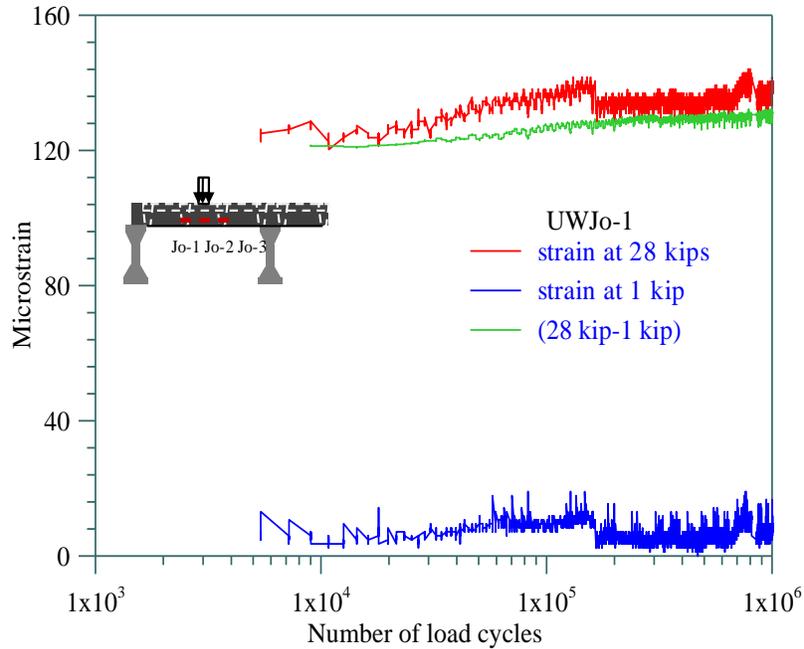
Figure 2.28 shows the strains recorded by the gauge mounted to the joint transverse reinforcement located at the center of the joint as a function of the load cycle. Although the drifts in measured data are apparent, the change in strain remained almost constant at a value of $135 \mu\epsilon$ as the load increased from 1 to 28 kips. This variation is comparable to the peak strain of $170 \mu\epsilon$ recorded during the service load test. Except for the noise in the data, the crack width in the transverse joint was nearly constant over the entire fatigue test and is shown in Figure 2.29.

Figure 2.28. The variation of the peak strain in the bottom joint transverse reinforcement during the joint fatigue test

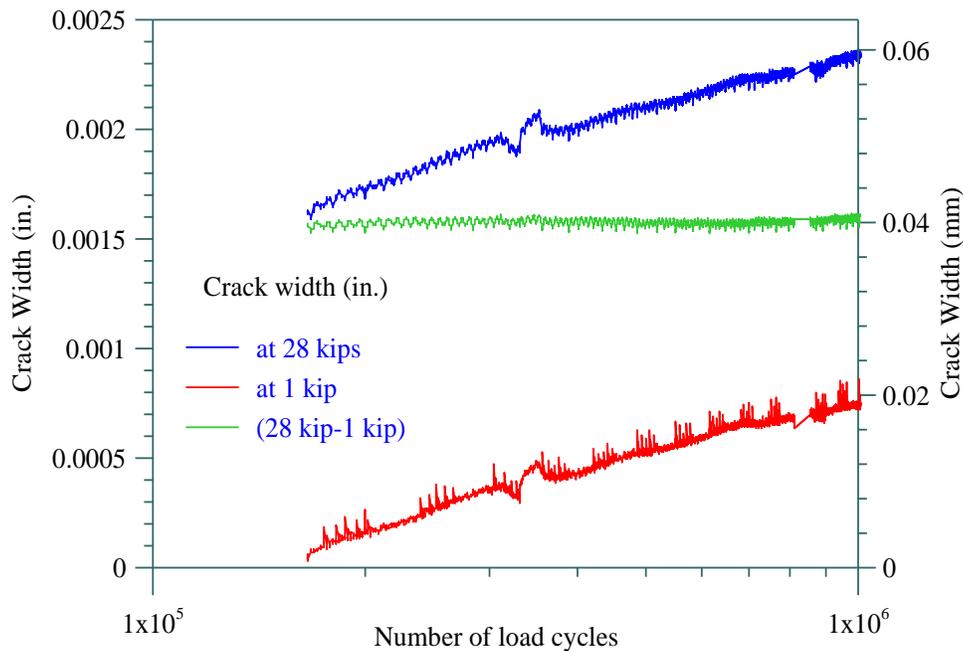
Figure 2.29. The variation of the crack width in the transverse joint with number of load cycles

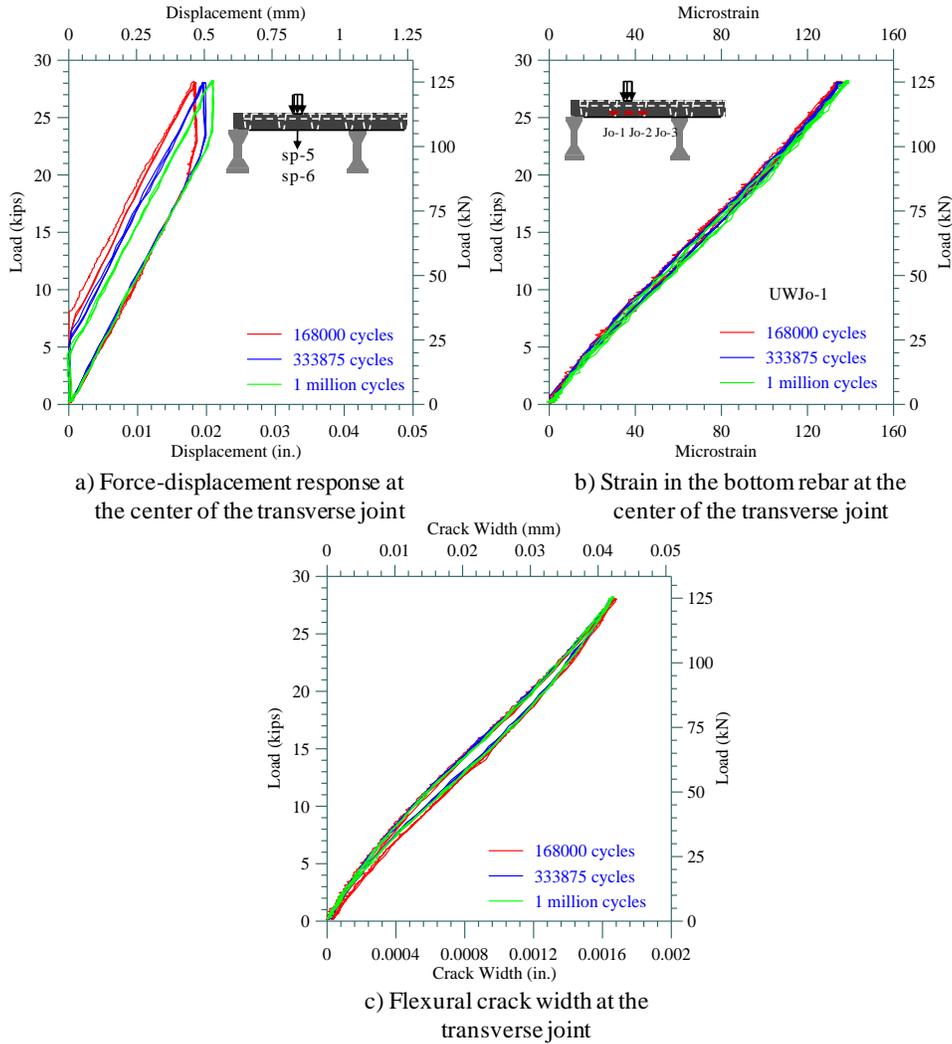
For the static load tests performed at the end of 168,000, 333,875 and 1,000,000 cycles, the load-displacement, peak strain in the bottom reinforcement in the joint, and crack width in transverse ribs forming the joint during the intermediate static load tests are presented in Figure 2.30. The

initial secant stiffness at the peak load of panel-to-panel joint at the end of 168,000, 333,875 and 1,000,000 cycles of loading is 1,166.7 kip/inch, 1,135.6 kip/inch, and 1,139.2 kip/inch, respectively, which compares closely with the stiffness of 1,105.5 kip/inch established during the service load test and shows a variation of less than 5%. It can be seen from these figures that the joint or the UHPC waffle deck system did not experience any significant fatigue damage after subjected to 1,000,000 cycles of amplified service load.

Figure 2.30. Measured responses of the waffle deck system from the static service load tests conducted during the joint fatigue test

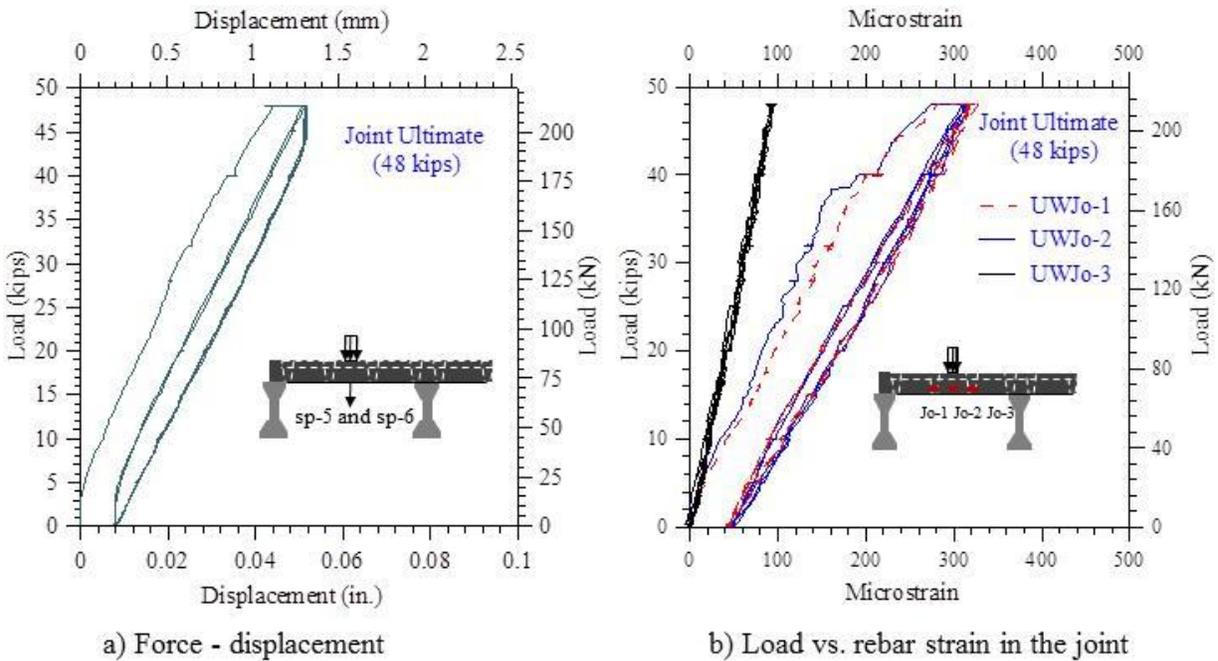
test was defined as 48 kips. Similar to the service load test, the joint was subjected to three load cycles at this load level to ensure the stability of the force-displacement response of the system. The load-deflection curve established at the center of the joint for this test is shown in Figure 2.31a. The transverse joint exhibited a linear force-displacement response even for this test, with insignificant damage and a maximum deflection of 0.05 inch. This deflection corresponds to $L/1760$, which is 46% of the AASHTO serviceability limit of $L/800$ (see Section 9.5.2 in AASHTO [2007]) for continuous span bridges with pedestrian traffic.

Figure 2.31. Measured force-displacement response and peak rebar strain at the center of the joint at the overload load of 48 kips

The strain variations along the bottom reinforcement in the joint as a function of the applied load are shown in Figure 2.31b. The peak strain in the joint region bottom reinforcement was $330 \mu\epsilon$, which is only about 15% of the yield strain of the reinforcement. The strain variations in the bottom reinforcement in the transverse rib TR2 of the panels UWP2 and UWP1 are shown in Figure 2.32 and Figure 2.33, respectively. Figure 2.34 shows the variation of the strain at the center of the rib across the transverse ribs of panel UWP1, indicating their relative participation in resisting the load. A series of hairline cracks were observed in the central region of the joint and are shown in Figure 2.35. The maximum crack width measured along the transverse ribs forming the joint was 0.003 inch, which can be seen in Figure 2.36.

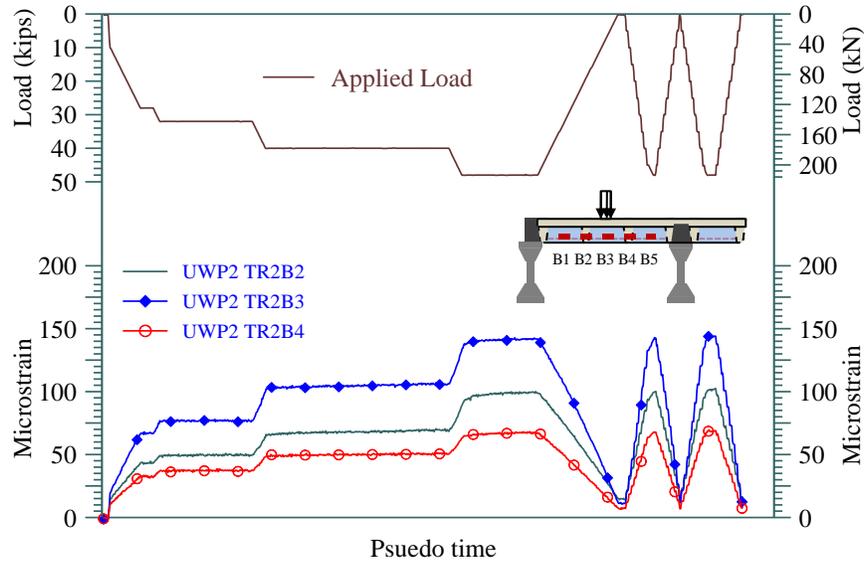
Figure 2.32. Measured strains in the bottom reinforcement of transverse rib TR2 along the length of panel UWP2 at the overload load

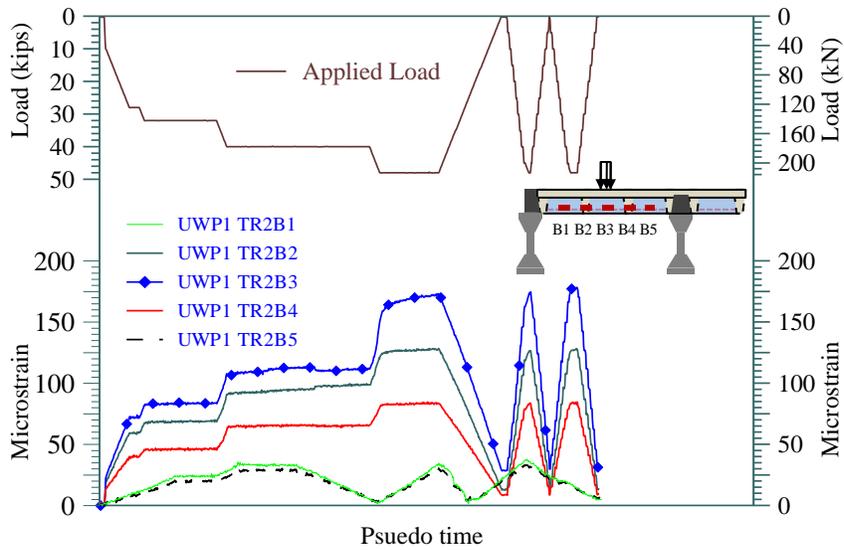
Figure 2.33. Measured strains in the bottom reinforcement of transverse rib TR2 along the length of panel UWP1 at the overload load
