Structural Characterization of UHPC Waffle Bridge Deck and Connections

Final Report
July 2014

Sponsored by
Iowa Highway Research Board
(IHRB Project TR-614)
Iowa Department of Transportation
(InTrans Project 09-362)

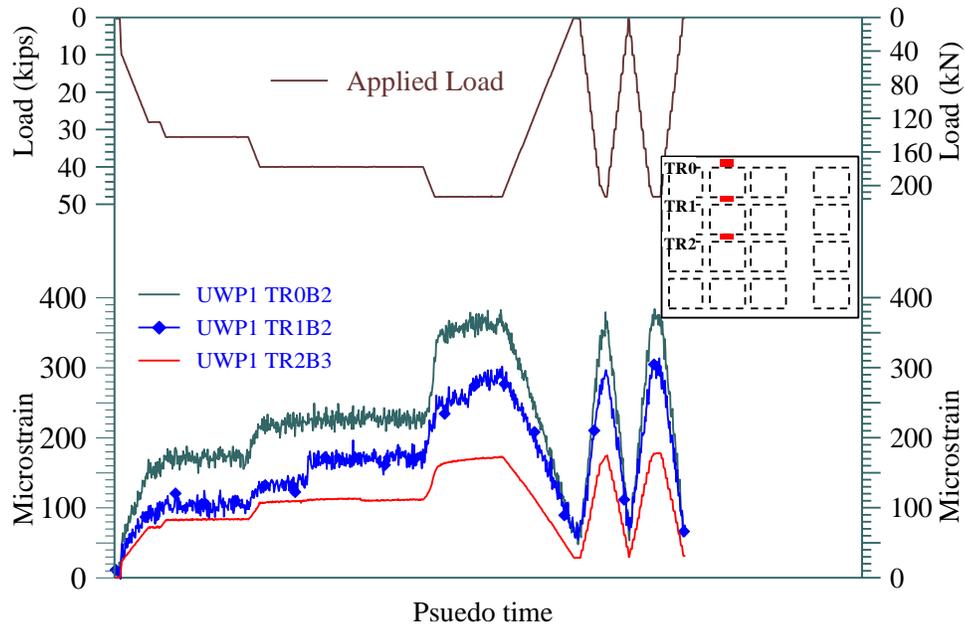
Figure 2.34. Measured strains at the center of the panel across the transverse ribs of panel UWP1 at joint overload load

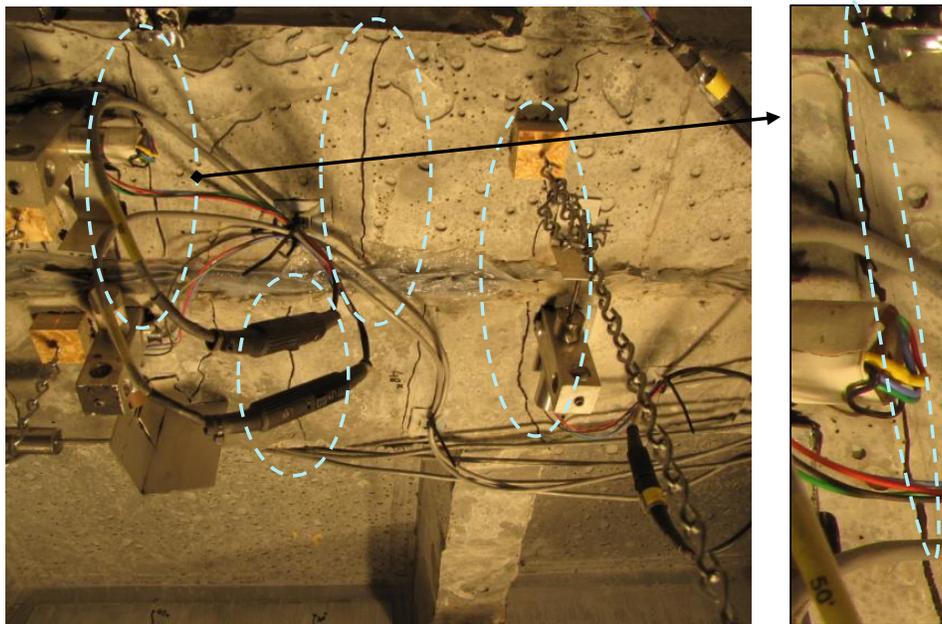
Figure 2.35. Hairline cracks formed at the center of underside of the transverse joint at the overload load of 48 kips

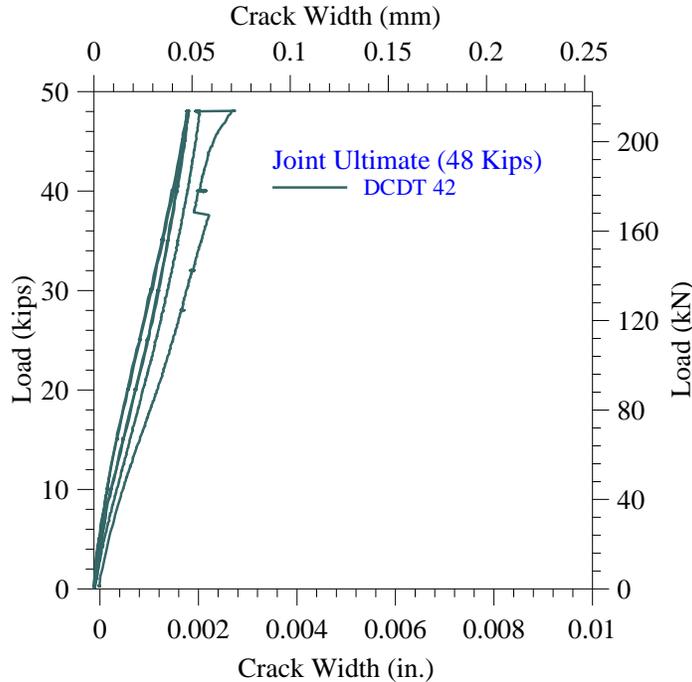
Figure 2.36. The variation in the width of the most critical flexural crack in the transverse ribs forming the transverse joint

The strain variations along the bottom reinforcement in the joint as a function of the applied load are shown in Figure 2.31b. The peak strain in the joint region bottom reinforcement was $330 \mu\epsilon$, which is only about 15% of the yield strain of the reinforcement. The strain variations in the bottom reinforcement in the transverse rib TR2 of the panels UWP2 and UWP1 are shown in Figure 2.32 and Figure 2.33, respectively. Figure 2.34 shows the variation of the strain at the center of the rib across the transverse ribs of panel UWP1, indicating their relative participation in resisting the load. A series of hairline cracks were observed in the central region of the joint and are shown in Figure 2.35. The maximum crack width measured along the transverse ribs forming the joint was 0.003 inch, which can be seen in Figure 2.36.

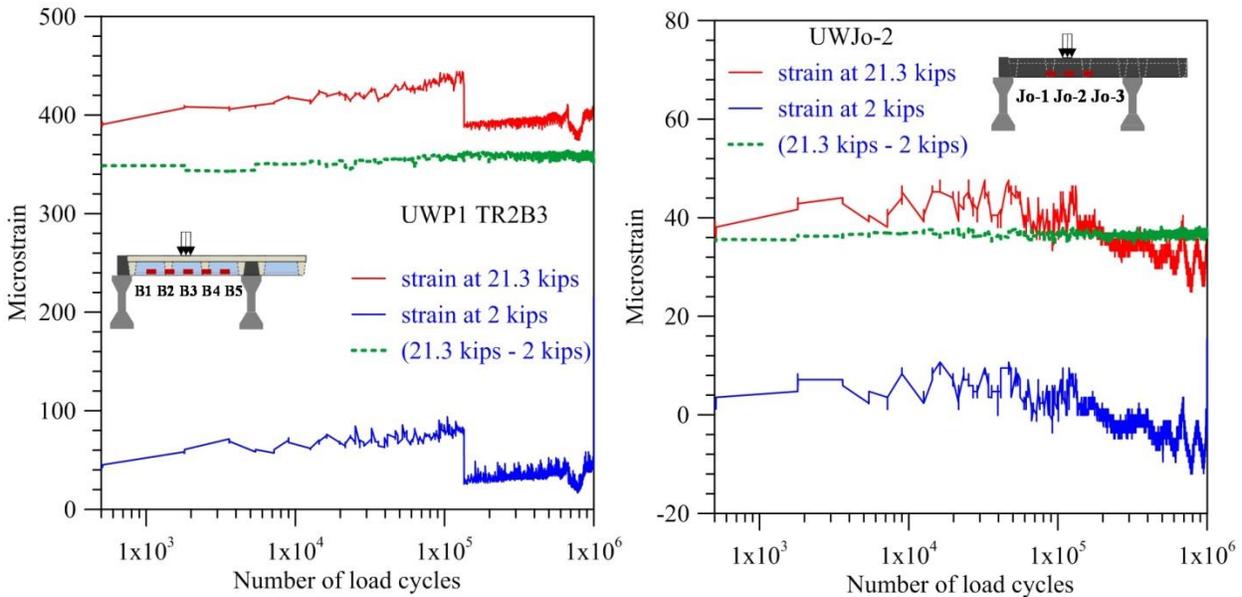
a) Peak rebar strain in the transverse rib b) Peak rebar strain in the transverse joint

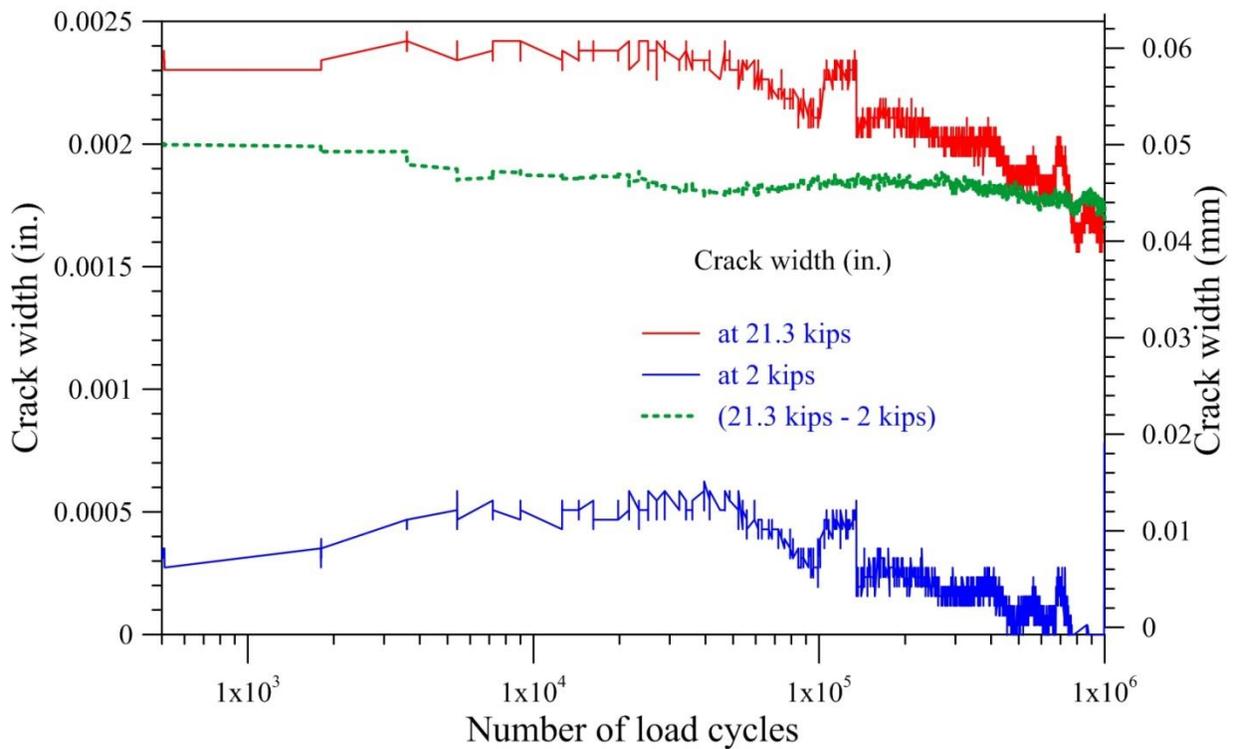
constant over the entire fatigue test and is shown in Figure 2.39. This data varied between 0.0018 inch and 0.0023 inch or within a range of 0.0005 inch, which is close to the sensitivity of the LVDTs used to measure the crack width. For the static load tests performed at the end of 135,000, 670,000 and 1,000,000 cycles, the load displacement, peak strain in the bottom reinforcement in the transverse joint, and crack width in transverse rib TR2 of panel UWP1 during the intermediate static load tests are presented in Figure 2.40. The initial secant stiffness of the panel at the peak load after 200, 135,000, 670,000, and 1,000,000 cycles of loading was 708.05 kip/inch, 667.71 kip/inch, 637.72 kip/inch, and 653.34 kip/inch, respectively. These values compare closely to each other and show variations of within 8% of the average stiffness value. From these observations and Figure 2.40, it is clear that the joint or the UHPC waffle deck system did not experience any significant fatigue damage even after subjected to 1,000,000 cycles at an amplified level of the service load.

Figure 2.39. The crack width variation in transverse rib TR2 of panel UWP1 during panel fatigue test

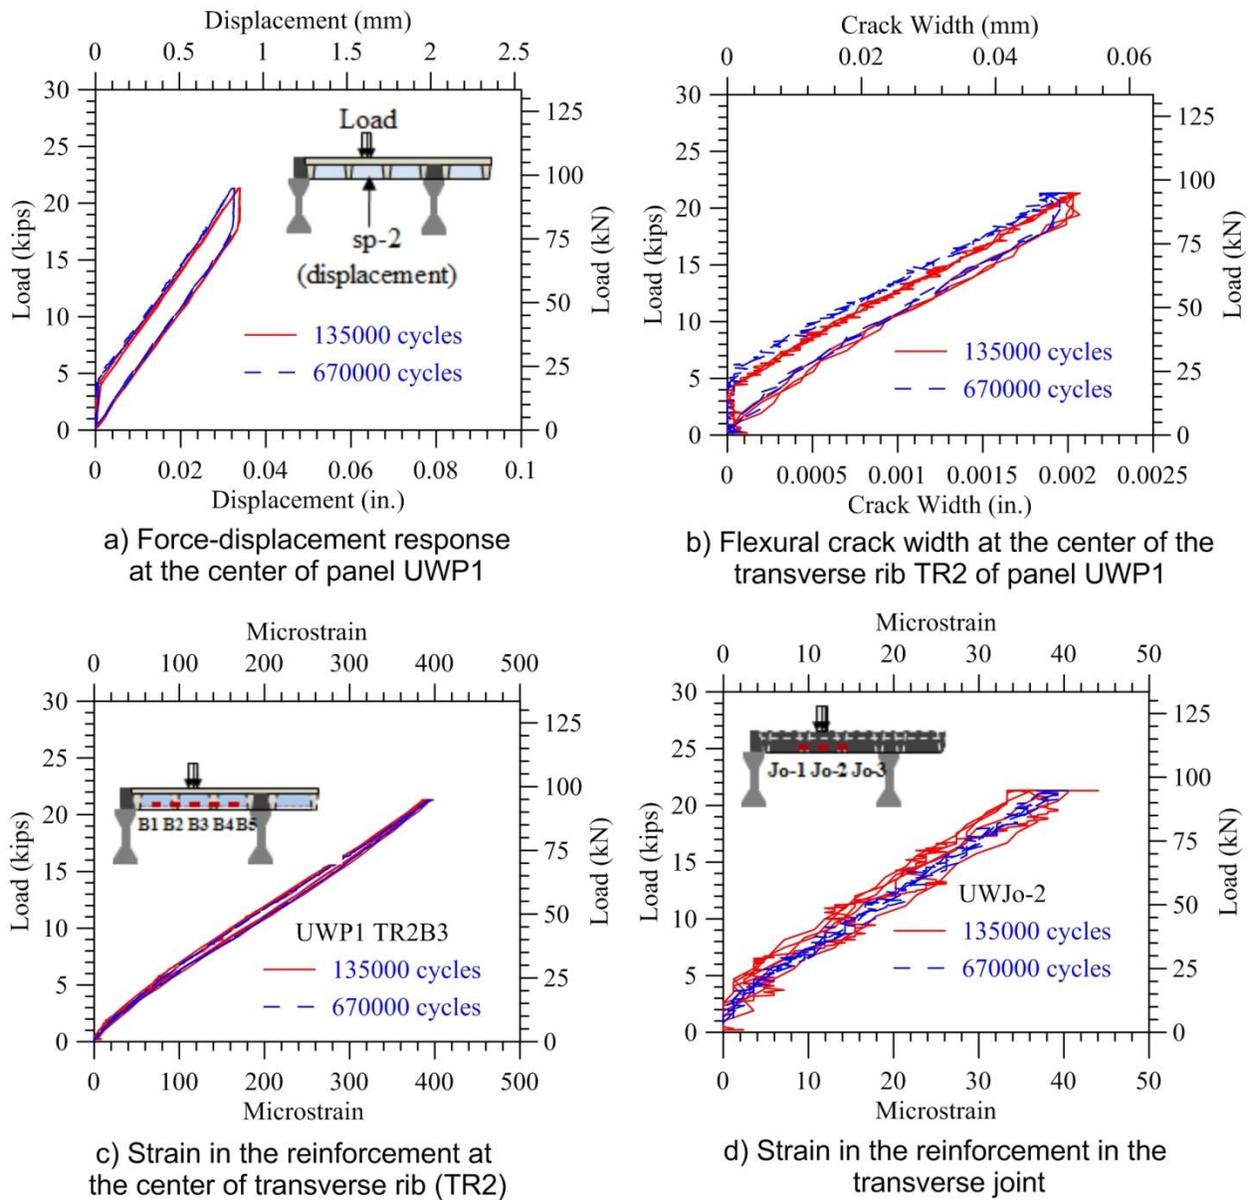
Figure 2.40. Measured responses of the waffle deck system for static service load tests conducted during the panel fatigue test

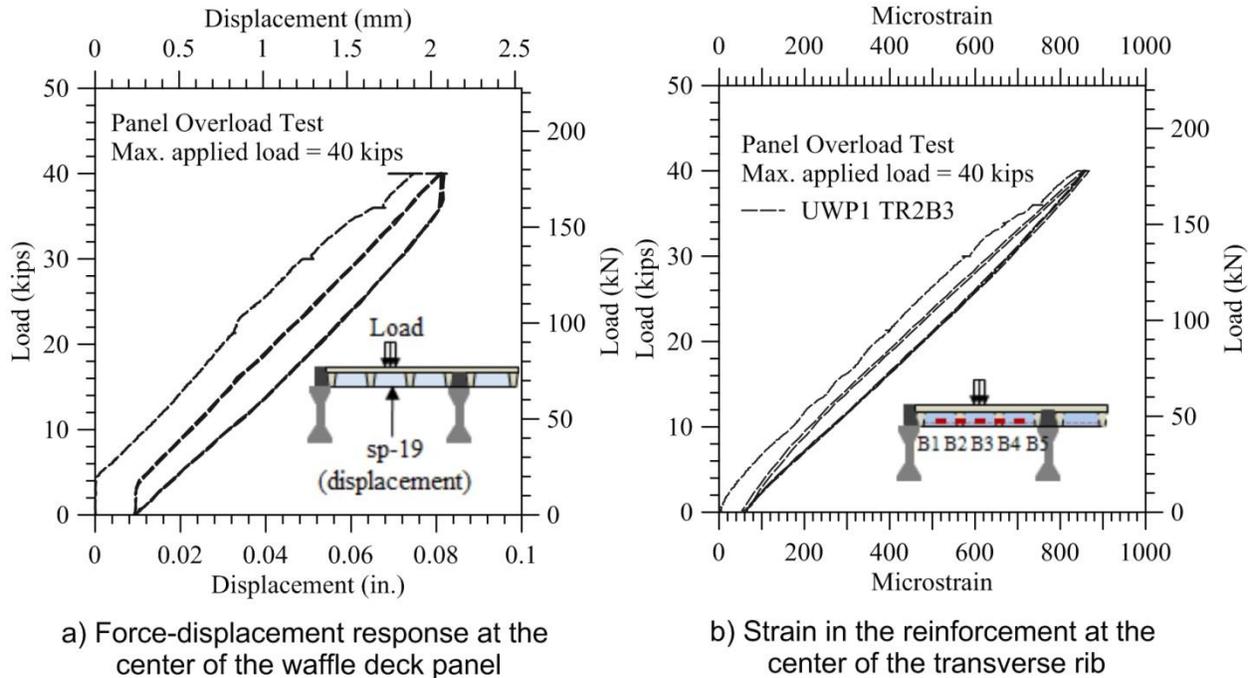
established at the center of panel UWP1 for this test is shown in Figure 2.41a. The panel exhibited a linear force-displacement behavior response with insignificant damage. A maximum deflection of 0.08 inch was measured at the center of panel UWP1. This deflection corresponds to $L/1100$, which is 73% of the AASHTO-specified serviceability limit of $L/800$ for continuous spans with pedestrian traffic.

Figure 2.41. Measured force-displacement response and peak rebar strain at the center of the transverse rib of UWP1 at the overload load of 40 kips

The variation of the most critical strain in the bottom reinforcement of the transverse rib TR2 of panel UWP1 as a function of the applied load is shown in Figure 2.41b. The peak strain in the bottom reinforcement of transverse rib TR2 was only 880 $\mu\epsilon$, which is only about 43% of the yield strain of the reinforcement. The strain variations in the bottom reinforcement placed in the transverse rib TR2 of panel UWP1 and the joint are shown in Figure 2.42 and Figure 2.43, respectively. Three to four hairline cracks were observed on both transverse ribs (TR1, TR2, and TR3) and longitudinal ribs (LR1 and LR2) of panel UWP1 (see Figure 2.44). A hairline crack was seen on the bottom surface of UWP1 (between ribs TR2 and TR3) at the peak load (see Figure 2.44a). The maximum crack width measured along the transverse rib TR2 in UWP1 was 0.008 inch, and its variation with the applied load is shown in Figure 2.45. Figure 2.46 shows the strain demand on the dowel bar in the panel-to-girder joint during the panel overload load test. It is clear that the dowel bars were engaged in load transfer when the 35-kips load was applied at the center of the panel.

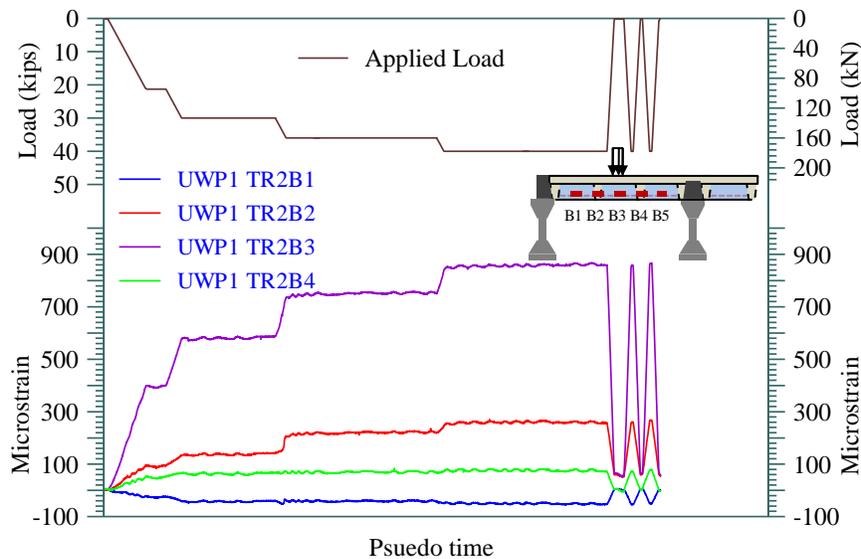
Figure 2.42. Measured strains in the bottom reinforcement of the transverse rib along the length of UWP1 during the overload load test

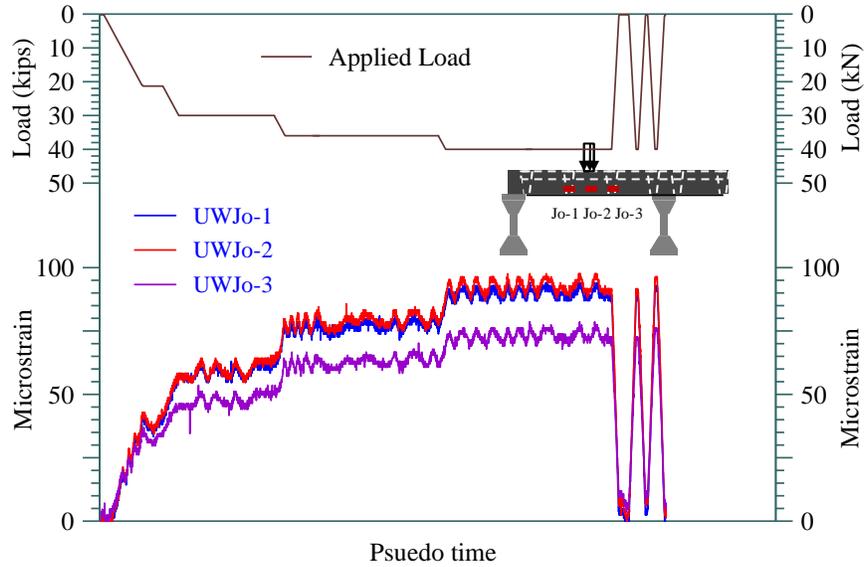
Figure 2.43. Measured strains in the bottom reinforcement of the joint along the joint length during the overload load test

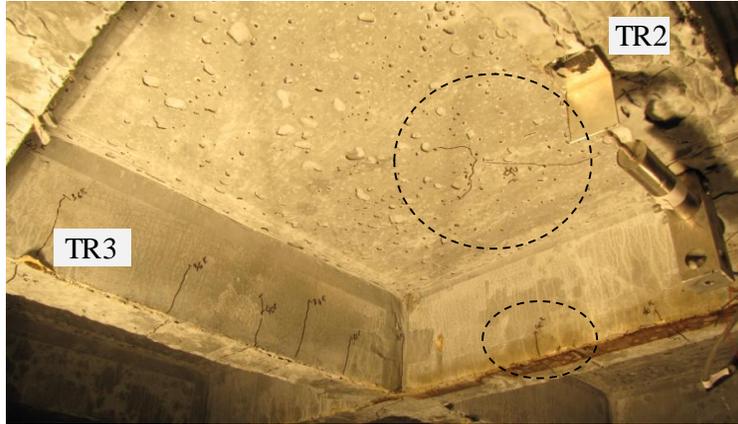
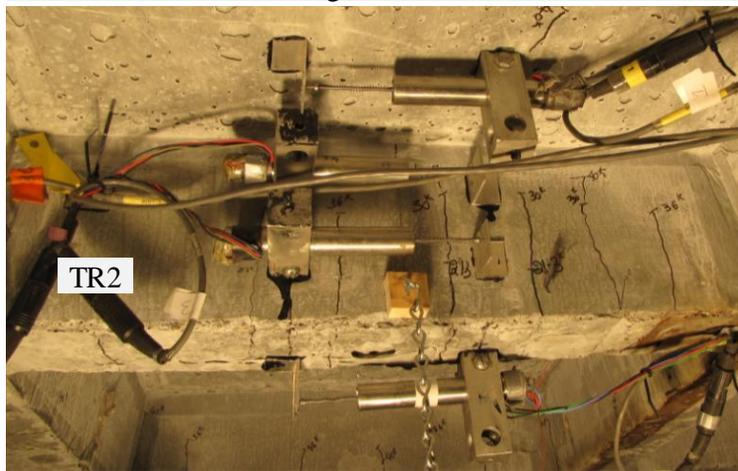
a) Cracking on the bottom surface of the slab and on a longitudinal rib

b) Cracking along transverse rib TR2 of UWP1

Figure 2.44. Hairline cracks developed on panel UWP1 at an overload load of 40 kips

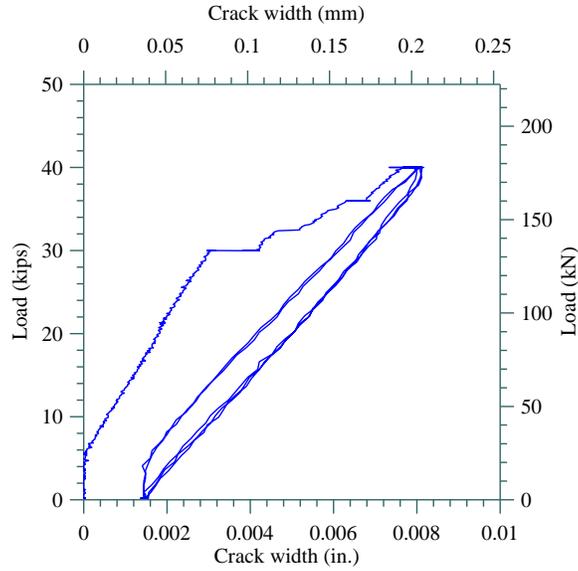
Figure 2.45. Measured crack width in transverse rib TR2 of UWP1 during the overload load test

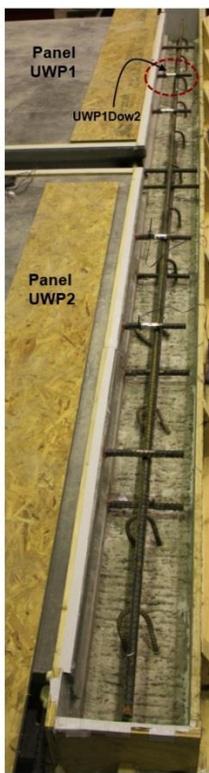
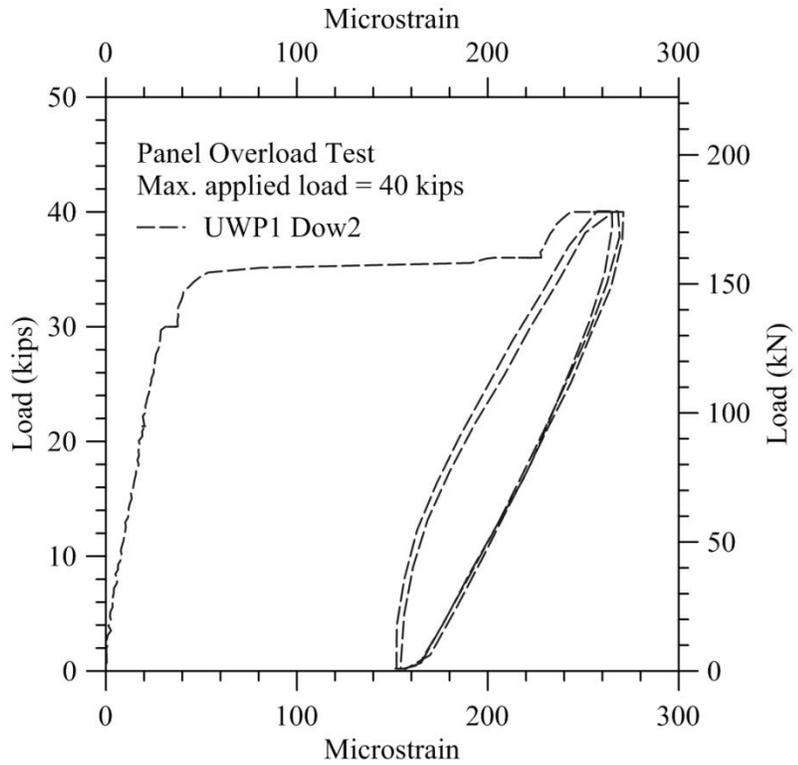
a) Strain gauges on the dowel bars in Panel-to-girder joint

b) Strain in the dowel bar (shown in Figure a) in the panel-to-girder joint

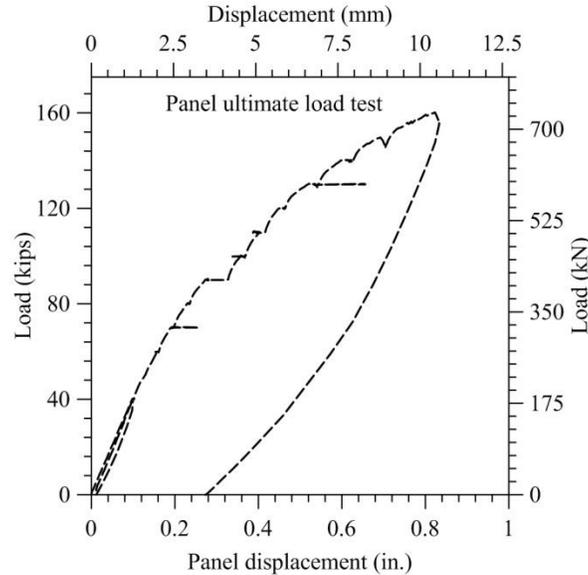
Figure 2.47. Measured force-displacement response of waffle deck system

The panel exhibited a linear force-displacement behavior response up to about 80 kips. A maximum deflection of 0.82 inch was measured at the center of panel UWP1 (center of transverse rib TR2) as the load was increased to 160 kips. The peak strain measured in the bottom reinforcement of transverse rib TR2 at the maximum load was around $1,600 \mu\epsilon$, which is about 76% of the yield strain of the reinforcement. A significant amount of cracking was observed on both the transverse ribs (TR1, TR2, and TR3) and longitudinal ribs (LR1 and LR2) of panel UWP1. The maximum crack width measured along the transverse rib TR2 in UWP1 was 0.08 inch. When the load was removed, the deck panel had a residual displacement of 0.28 inch.

The ultimate load test was carried out to investigate the adequacy of the precast deck system and its connections under ultimate load conditions. The ultimate load referred to in this study was arrived at based on the recommendations from the Iowa DOT personnel. A total load of 160 kips, equivalent to 10 times the AASHTO truck service load, was applied at the center of panel UWP1. The load-deflection curve established at the center of this panel during testing is shown in Figure 2.47.

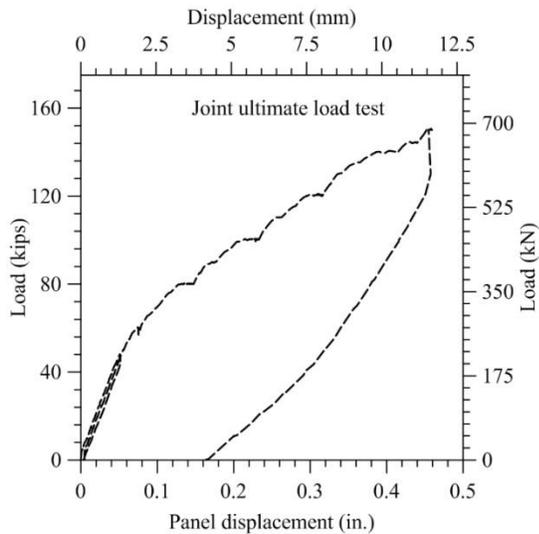
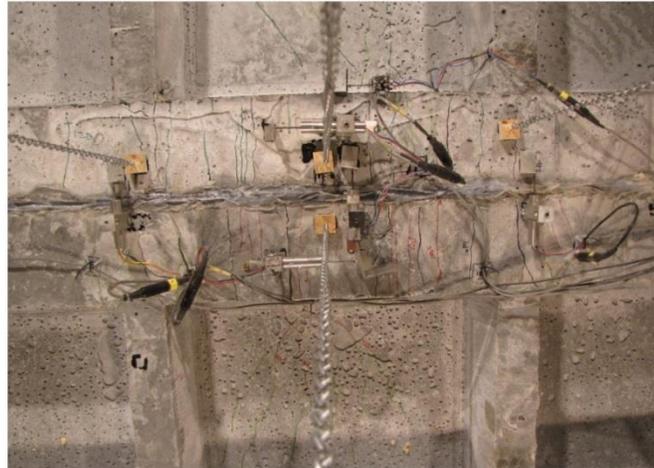
A total load of 160 kips, equivalent to 10 times the AASHTO truck service load, was applied at the center of the transverse joint. The load-deflection curve established at the center of the panel-to-panel joint is shown in Figure 2.48a. The peak strain measured in the bottom reinforcement of transverse rib TR2 was around $1,475 \mu\epsilon$, which is about 70% of the yield strain of the reinforcement. At the end of the test, numerous cracks were formed in transverse ribs of the joint (see Figure 2.48b). The maximum load applied was controlled by the shear cracking initiation in the prestressed girders.

a) Force-displacement response

b) Cracks in the transverse joint at 150 kip load

Figure 2.48. Measured force-displacement response and cracking at the center of the panel-to-panel joint under ultimate loads

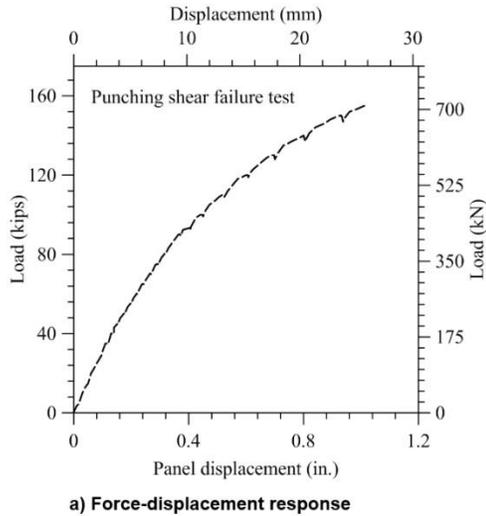
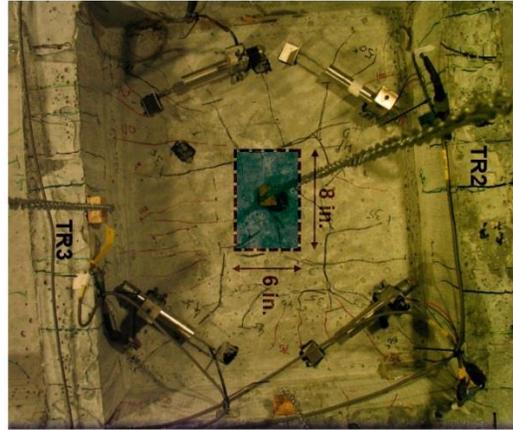
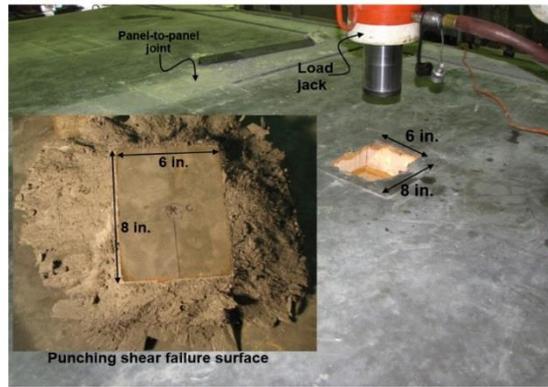
In this test, a wheel load was applied at the center of the waffle deck cell bounded by transverse and longitudinal ribs TR2, TR3, LR1, and LR2. Load was applied at increments of 5 kips on the waffle deck panel, using a 200-kip actuator. The 10-inch by 20-inch plate at the loading end of the actuator was replaced with a 6-inch by 8-inch steel plate to cause the punching shear failure in the panel between the ribs. A possible punching shear failure with a 10-inch by 20-inch plate was not expected to develop within the capacity of the system. As the loading increased, numerous radial cracks on the bottom surface of the panel between the ribs, along with flexural cracks in both transverse and longitudinal ribs, were formed. The measured load-displacement response at the center of the cell is shown in Figure 2.49a. The crack pattern on the bottom surface of the waffle deck was as expected for a typical punching shear failure mode, and it is shown in Figure 2.49b. The waffle deck failed suddenly at a maximum load of 154.6 kips, leaving behind a well-defined 6-inch by 8-inch hole (i.e., the same size as the steel plate placed at the top of the deck) at the center of the cell. The punching shear failure surface had approximately a 45-degree slope down the depth of the panel, as shown in Figure 2.49c. The measured average punching shear strength was around 1.068 ksi, which is equivalent to $6.62\sqrt{f'_c}$ (psi). This punching shear failure capacity is nearly 2.3 times the estimated value using the American Concrete Institute (ACI) equation recommended by Harris and Wollmann (2005).

Figure 2.49. Measured load-displacement behavior and failure surface during punching shear failure test of the waffle deck system

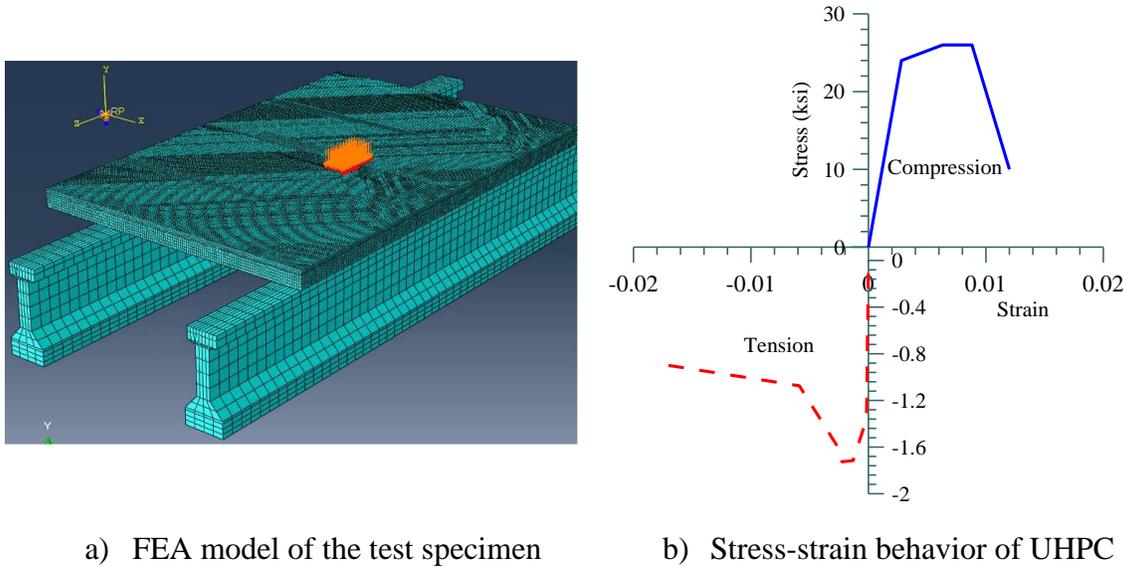
girders were modeled using kinematic constraints. The meshed assembly of the test specimen FEM is shown in Figure 2.50a.

Figure 2.50. Test specimen discretization and material behavior of UHPC used in FEA software (ABAQUS)

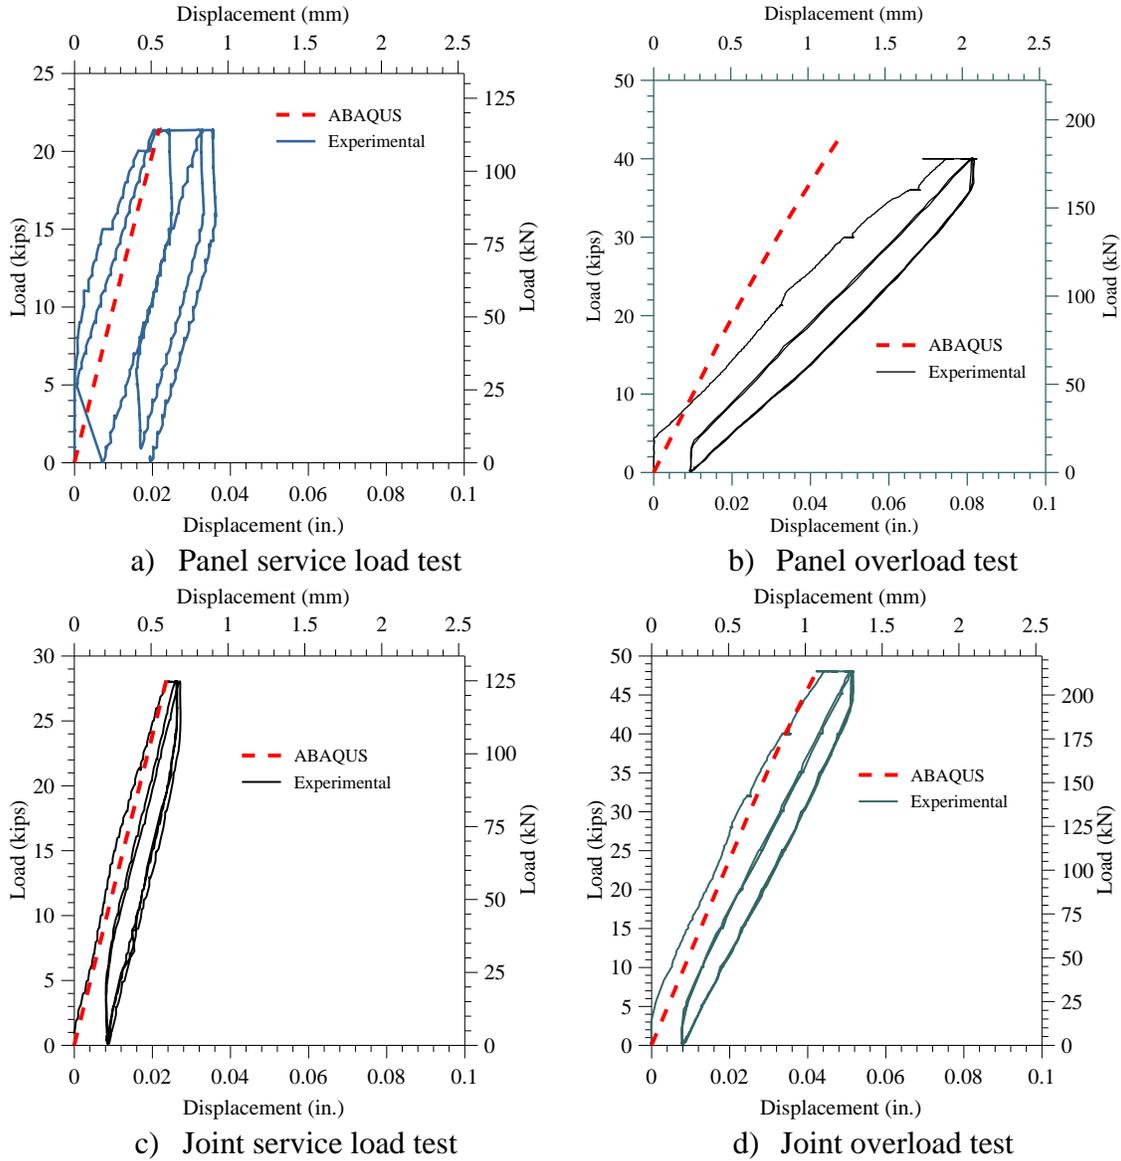
Figure 2.51. Comparison of experimental and ABAQUS force-displacement responses

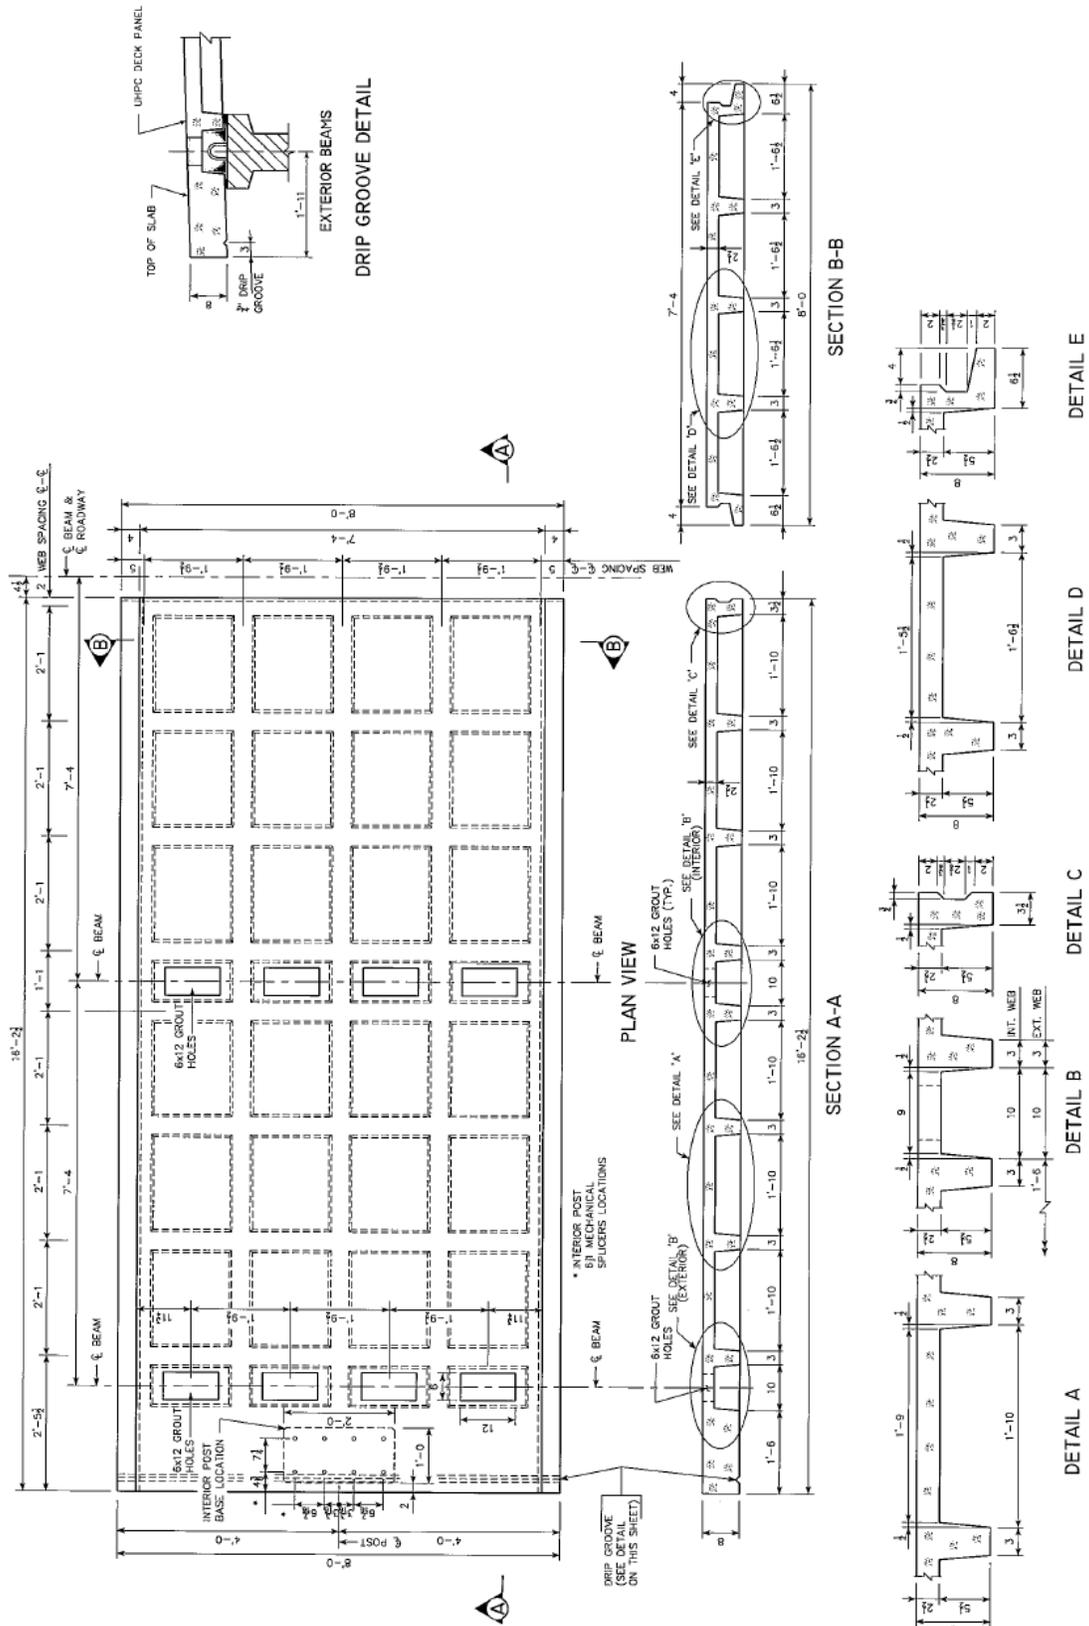
Figure 3.1. Deck panel geometry and cross-section details

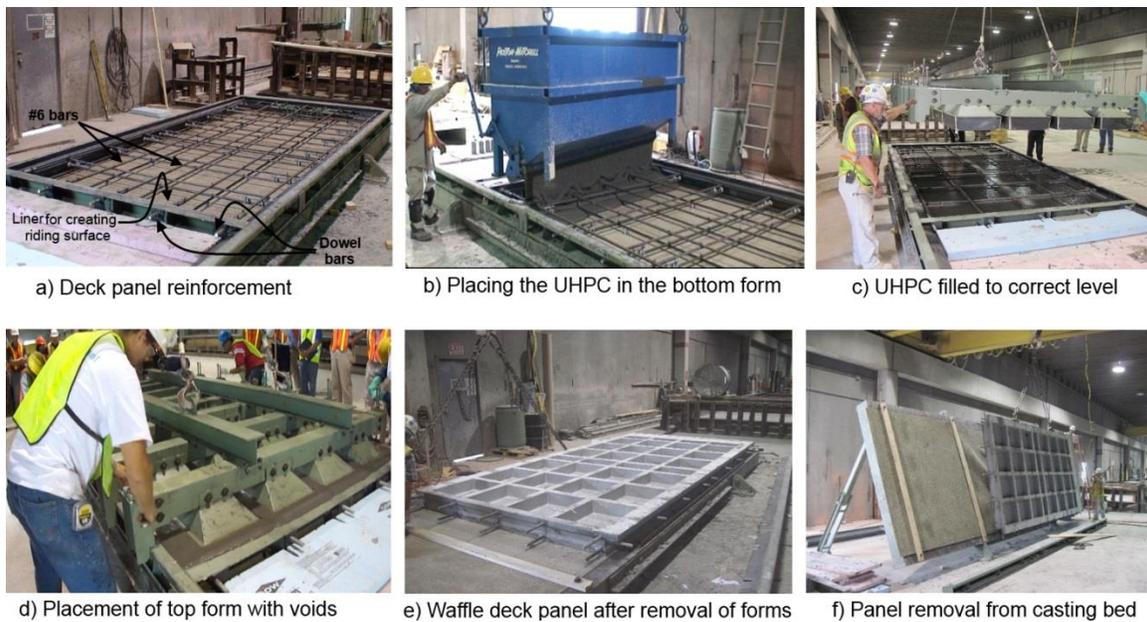
Figure 3.4. Construction of the UHPC waffle deck panel for the demonstration bridge

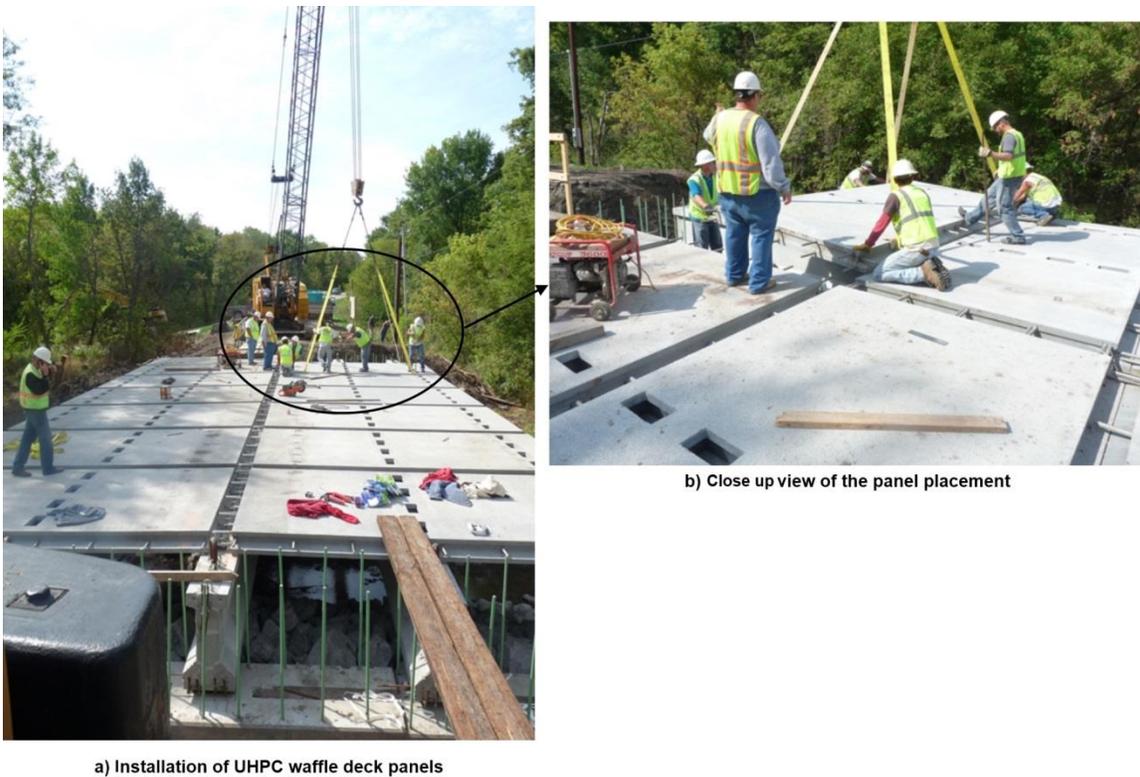
Figure 3.5. Placement of UHPC waffle deck panels on the prestressed girders

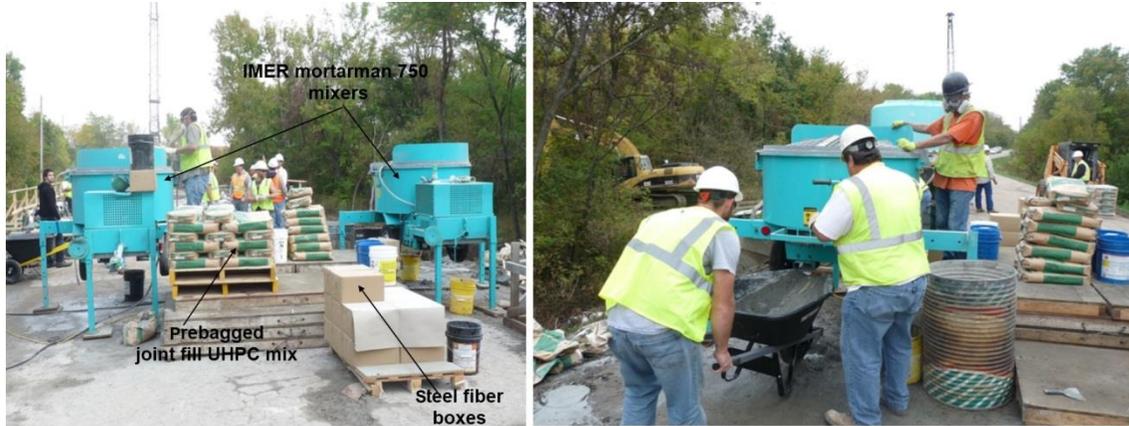
Figure 3.8. Batching of UHPC joint fill using IMER Mortarman 750 mixers at the bridge site

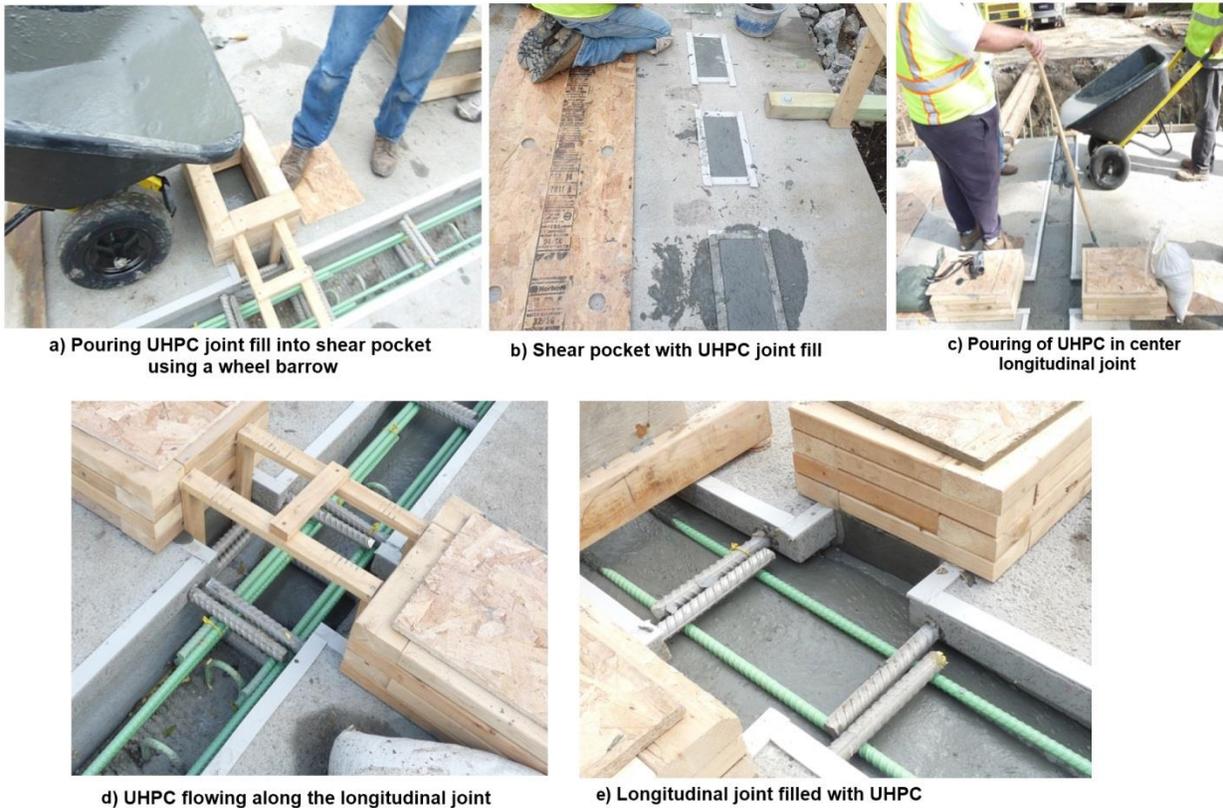
Figure 3.9. Filling of joints with in situ UHPC and completed joints

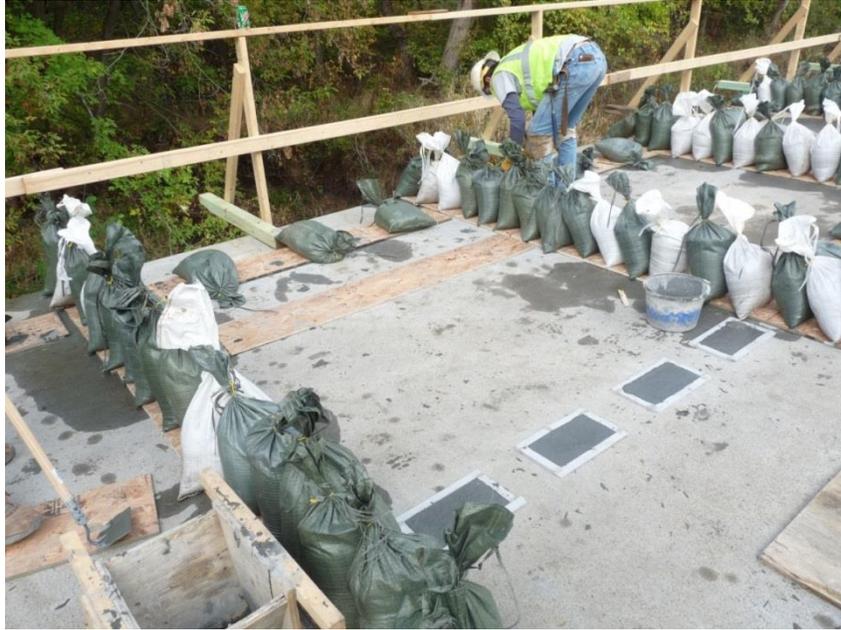
Figure 3.10. Finished transverse joints (panel-to-panel joint) covered with plywood

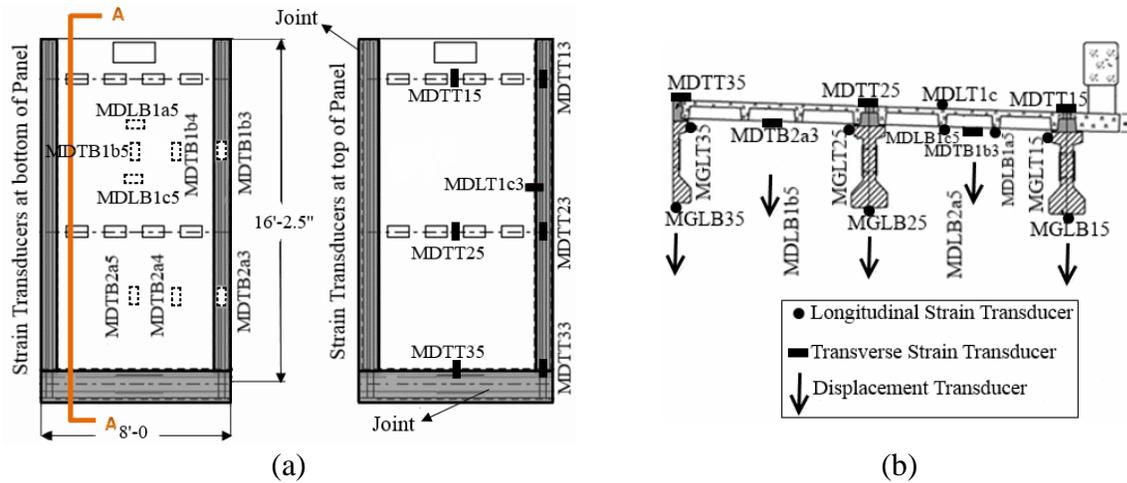
Figure 4.3. Location of transducers at the mid-span panel: (a) Top and bottom of deck; (b) Cross-section view

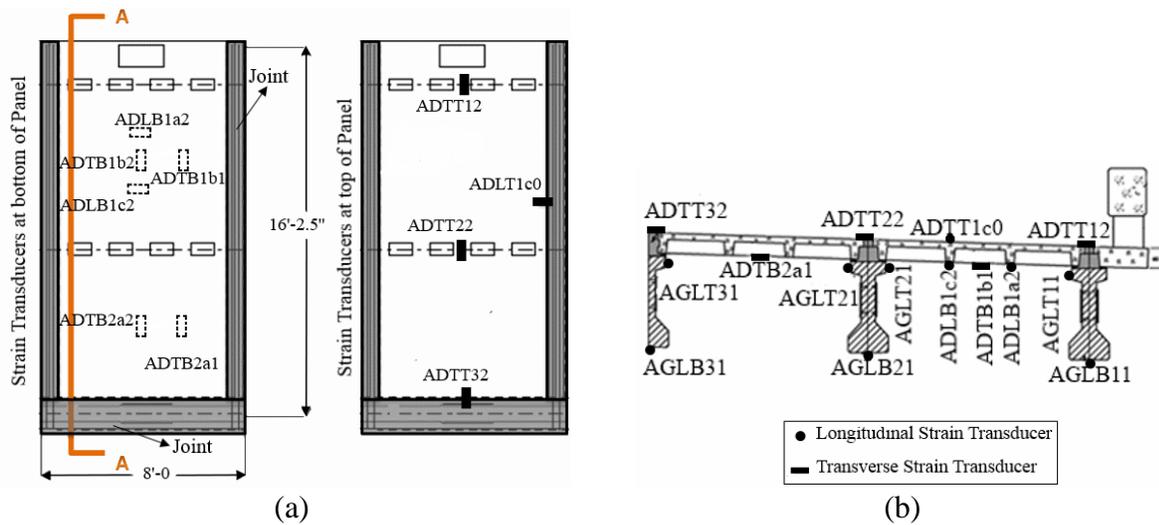
Figure 4.4. Location of transducers at the panel adjacent to abutment: (a) Top and bottom of deck; (b) Cross-section view

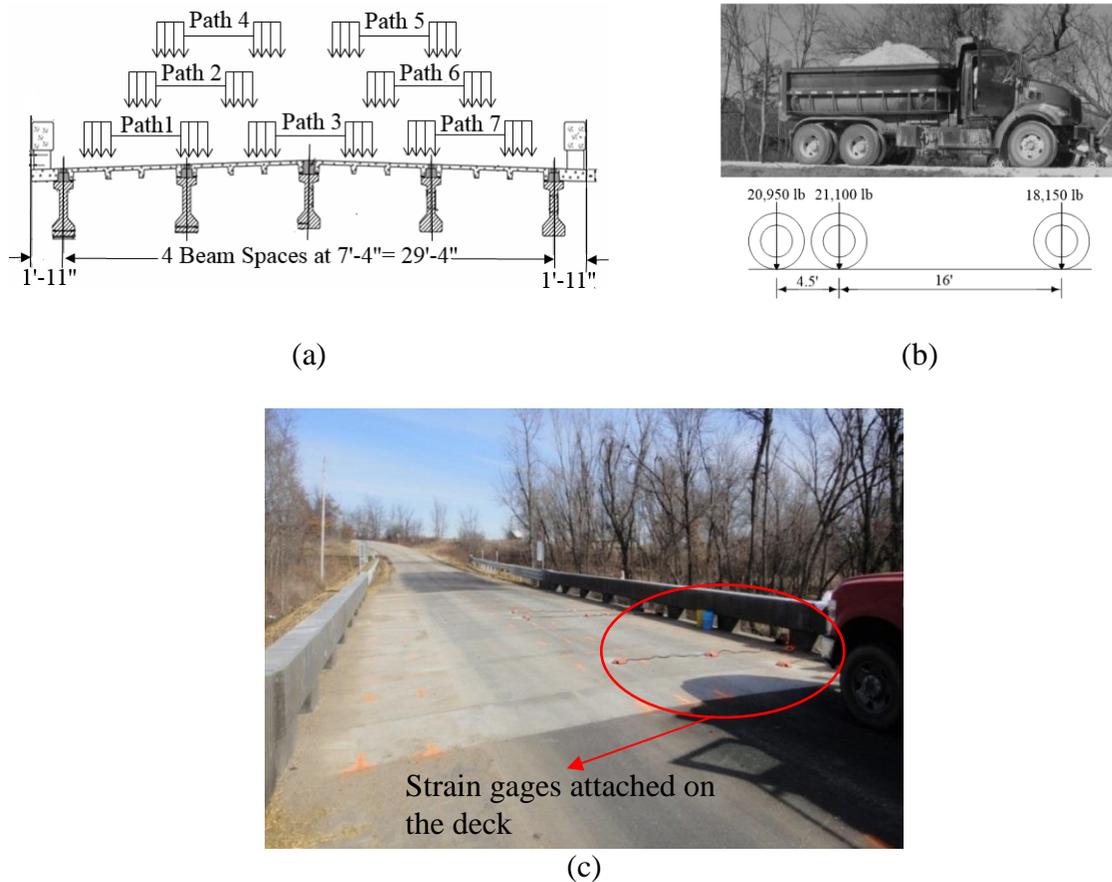
Figure 4.6. Loading: (a) Schematic layout of bridge loading paths; (b) Truck configuration and axle load; (c) Load paths marked on bridge deck

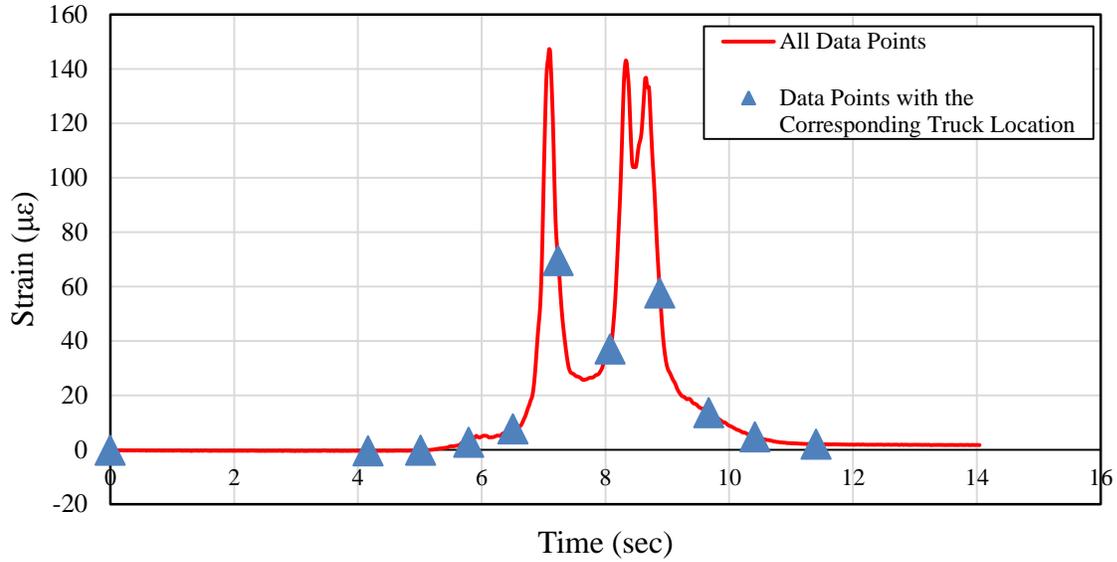
Figure 4.7. Measured transverse strains at the bottom of mid-span panel vs. time for MDTB1b5 transducer
