Structural Characterization of UHPC Waffle Bridge Deck and Connections

Final Report
July 2014

Sponsored by
Iowa Highway Research Board
(IHRB Project TR-614)
Iowa Department of Transportation
(InTrans Project 09-362)

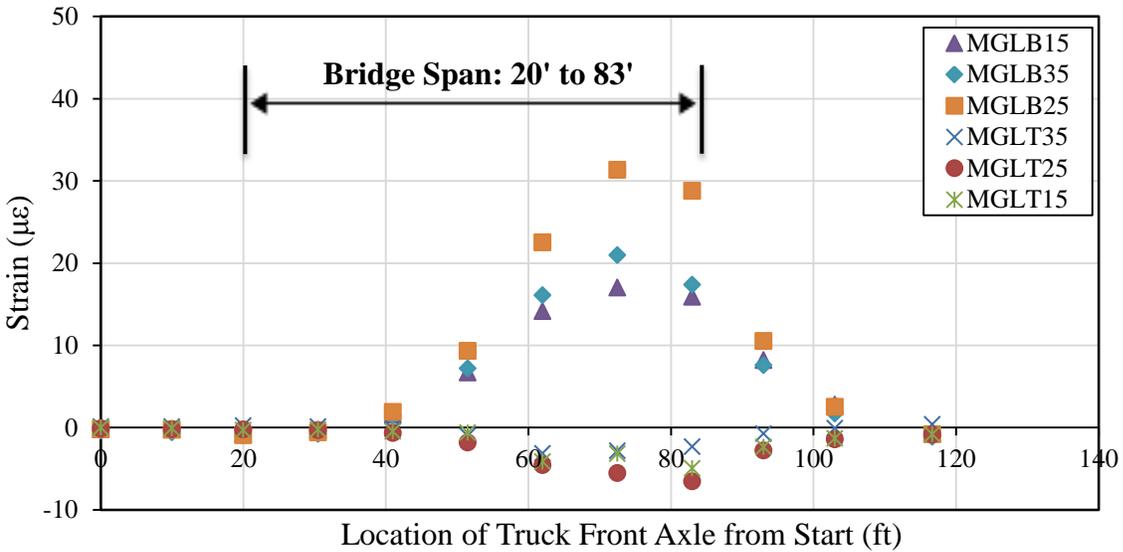
Figure 4.8. Girder top and bottom longitudinal strain at mid-span for load path 2

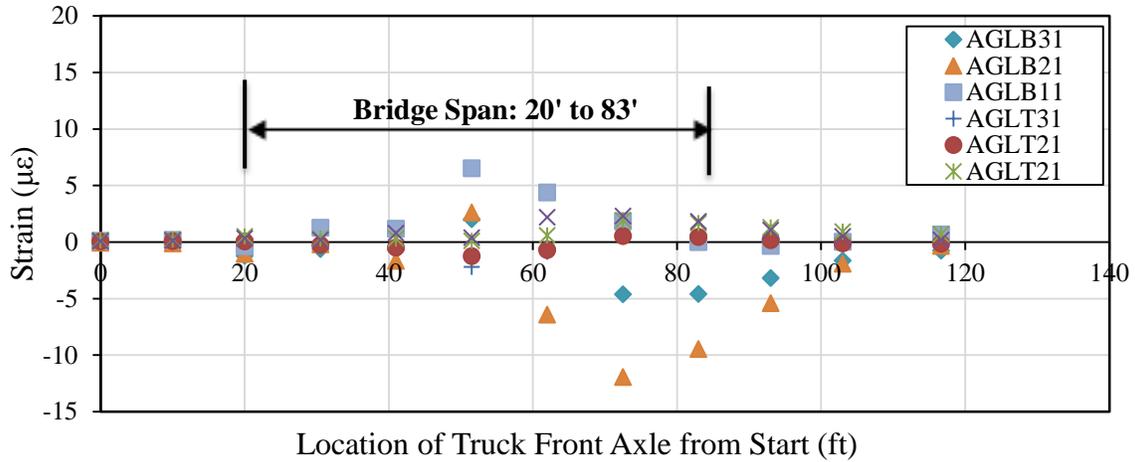
Figure 4.9. Girder top and bottom longitudinal strain near abutment for load path 2

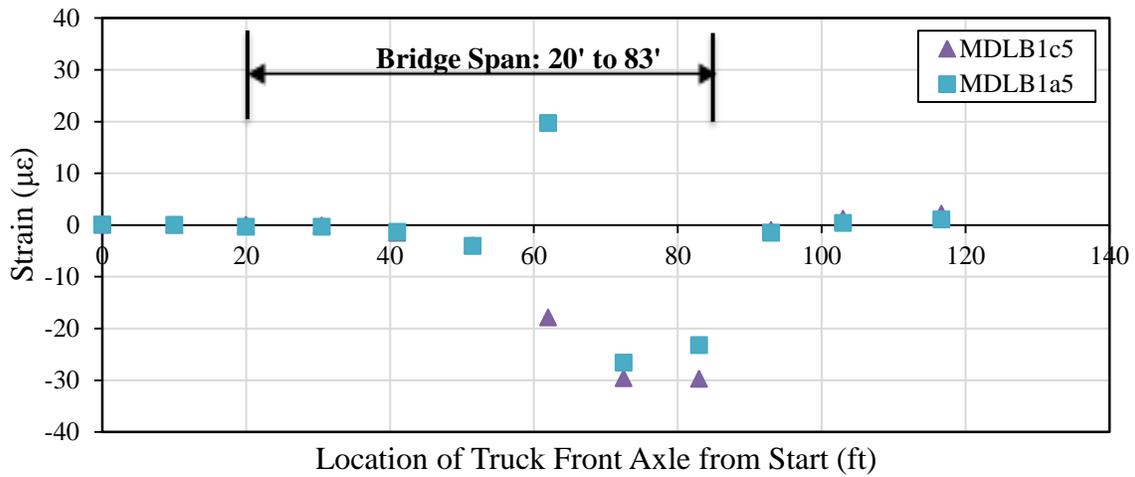
Figure 4.10. Longitudinal bottom strains at mid-span panel for load path 2

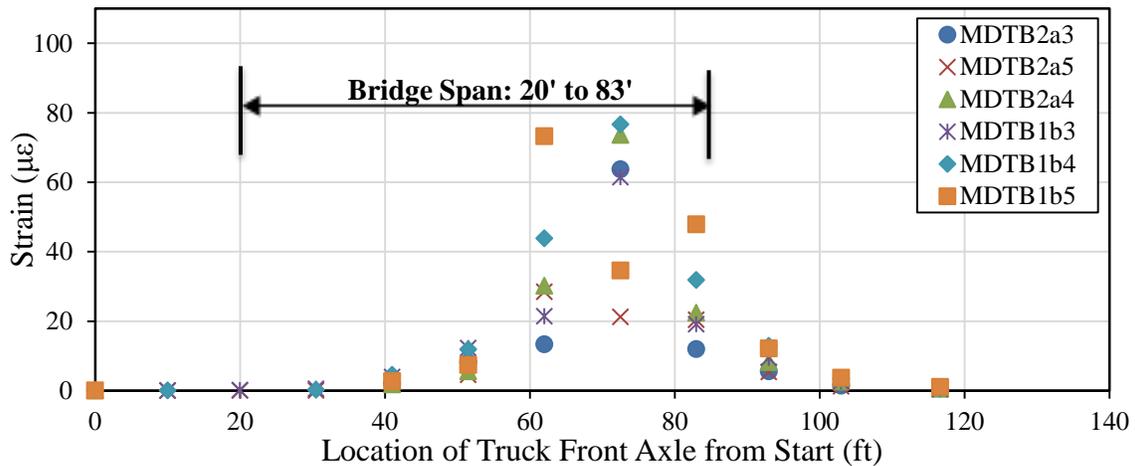
Figure 4.11. Transverse bottom strains at mid-span panel for load path 2

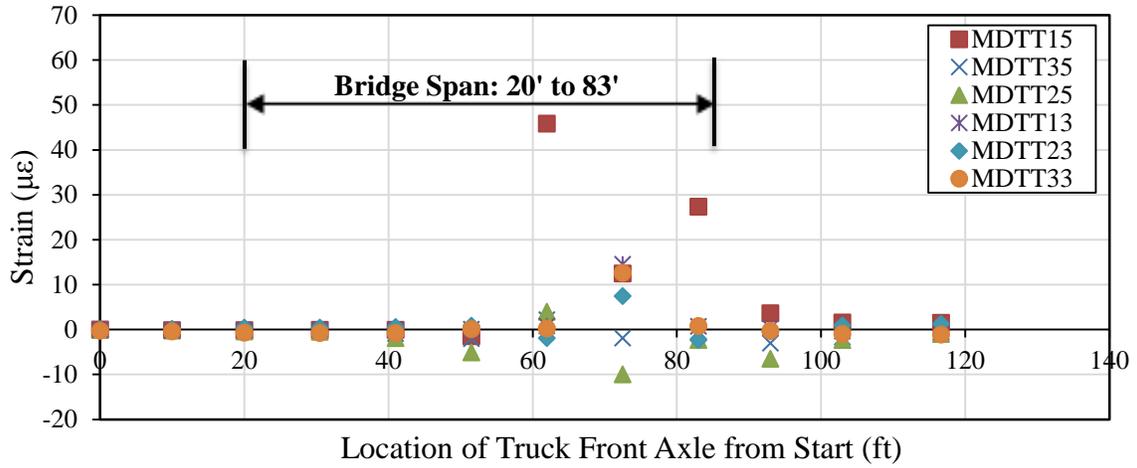
Figure 4.12. Transverse top strains at mid-span panel for load path 2

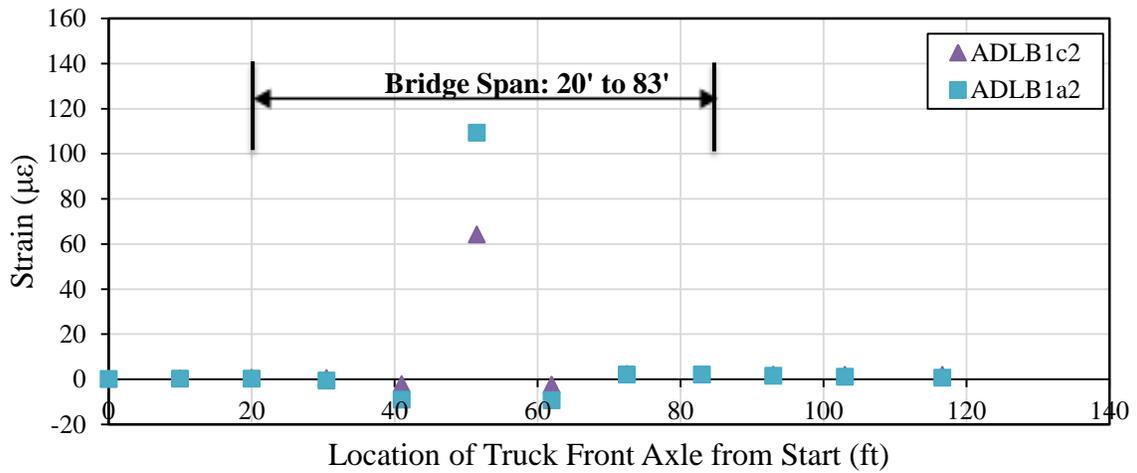
Figure 4.13. Longitudinal bottom strains at end panel for load path 2

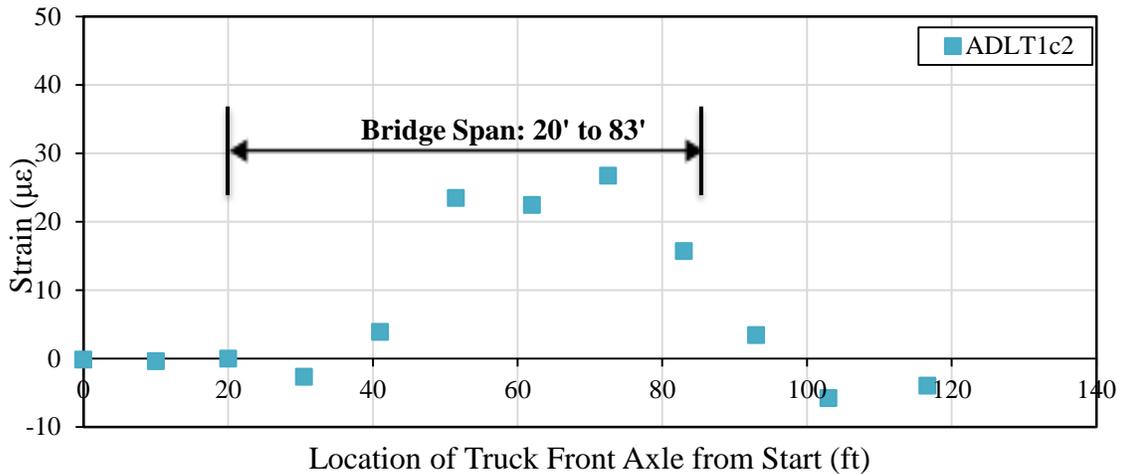
Figure 4.14. Longitudinal top strains at end panel for load path 2

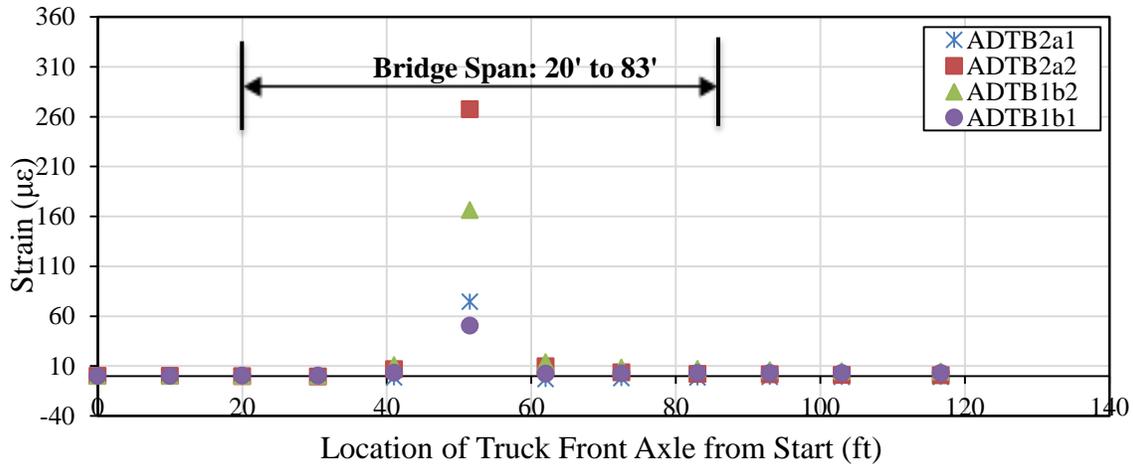
Figure 4.15. Transverse bottom strains at end panel for load path 2

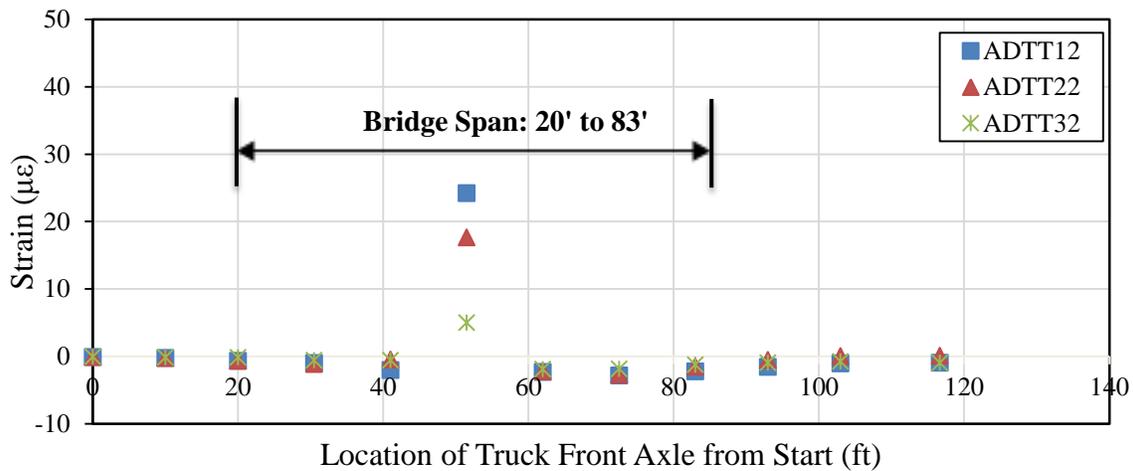
Figure 4.16. Transverse top strains at end panel for load path 2
