Monitoring and Evaluation of a Plate Girder Bridge

Terry J. Wipf, Brent M. Phares, Lowell F. Greimann, Douglas Wood

Iowa State University

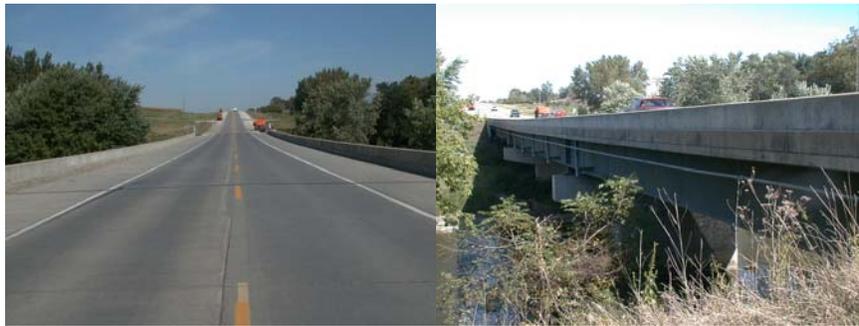
FIGURE 1. Photographs of Bridge Deck and Profile

Bridge 4048.2S017, shown in Fig. 1, is a three span bridge crossing the Boone River on Highway 17 in central Iowa. As shown in Fig. 2, the end spans are 29.7 m and the interior span is 38.1 m. The girders are labeled as G1 to G5 and the diaphragms in each span are labeled as D0 to D5. The bridge has five main plate girders with an integral concrete deck as shown in Fig. 3. The 1.5 m deep girders are connected by X-type diaphragms every 6.1 m. A visual inspection revealed no fatigue cracking in the girder webs near the connections to the diaphragms. However, many multiple steel girder bridges with this diaphragm connection detail in Iowa have experienced cracking in that region.

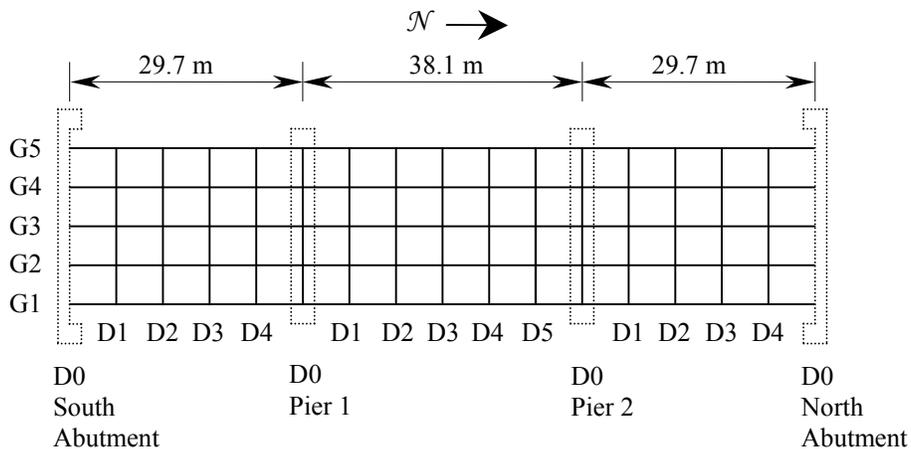
FIGURE 2. Plan View Illustration of Superstructure

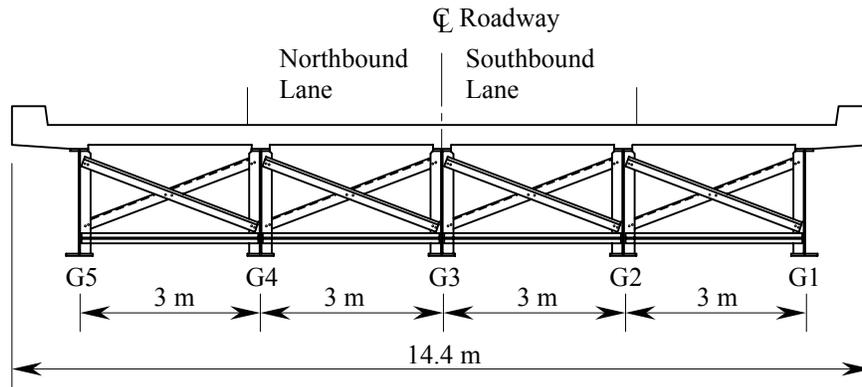
FIGURE 3. Illustration of Bridge Cross Section at Negative Moment Diaphragm

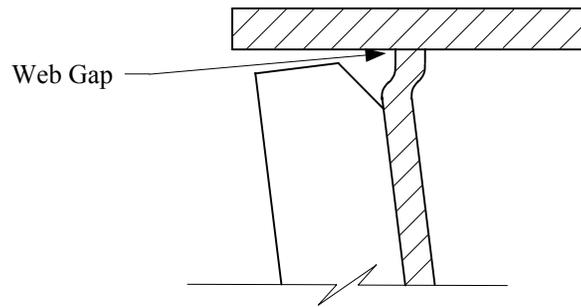
FIGURE 4. Out-of-plane Distortion in Web Gap

Fatigue cracking in the web gap is a result of differential deflection of the adjacent girders due to asymmetric traffic loading on the bridge deck. As vehicles cross a bridge, the adjacent girders deflect differently at the same cross section and the diaphragms between the girders are distorted. This is especially true on bridges with skewed piers. Forces created in the diaphragms cause a rotation at the connection between the girder and the diaphragms. The force is transferred to the girder by the web stiffener, which causes the web gap to displace out-of-plane. The stiffener pulls at the web, but the top flange, being integral with the deck, resists movement and the result is out-of-plane displacement as illustrated in Fig. 4. Continued cycles of this out-of-plane displacement result in fatigue cracking in the web gap. Exterior girders are especially prone to fatigue cracking because, unlike interior girders, they do not have a diaphragm on both sides of the girder to oppose the out-of-plane forces.

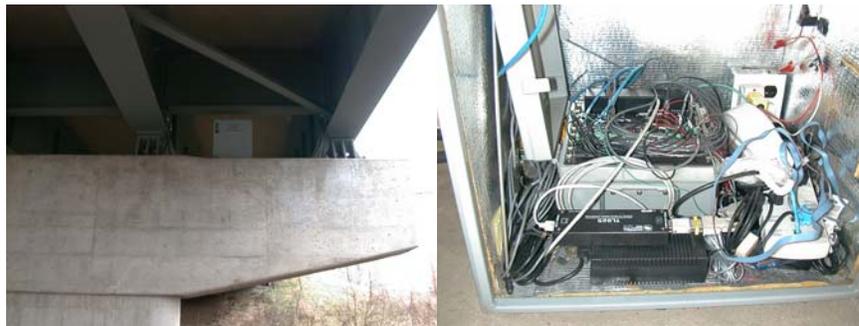
FIGURE 5. Photographs of Environmental Enclosure and CR 9000

A Campbell Scientific CR 9000 was selected as the base for the remote continuous monitoring data collection system. The system was set up in an environmental enclosure on Pier 2, which provided the system protection from the weather and vandalism as shown in Fig. 5. The system has an input capacity of 24 channels with further expansion possible. Thermocouples, strain gages, and displacement transducers were used in this study, but the system is capable of supporting many different sensor types. Instrumentation was focused at a diaphragm in the negative moment region near Pier 2 as illustrated in Fig. 6.

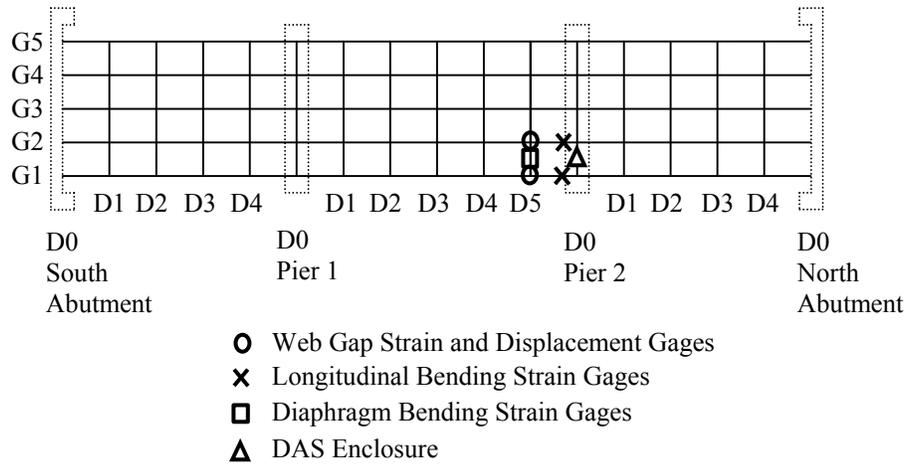
FIGURE 6. Illustration of Instrumentation Locations on the Superstructure

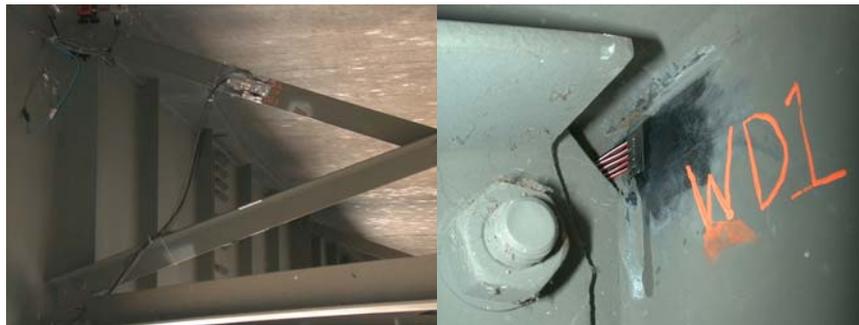
FIGURE 7. Photographs of Diaphragm and Web Gap Strain Gages

Two gradient strain gages were installed in the G1 and G2 web gaps as shown in Fig. 7. These gradient gages consist of five small, foil backed strain gages placed within the web gap to collect a detailed strain profile. For this study the strain in the web gap was the most important indicator of the effectiveness of the retrofit.

Three weldable strain gages were mounted on the diaphragm members between G1 and G2 as pictured in Fig. 7. The gages were encased in plastic to provide protection from the environment.

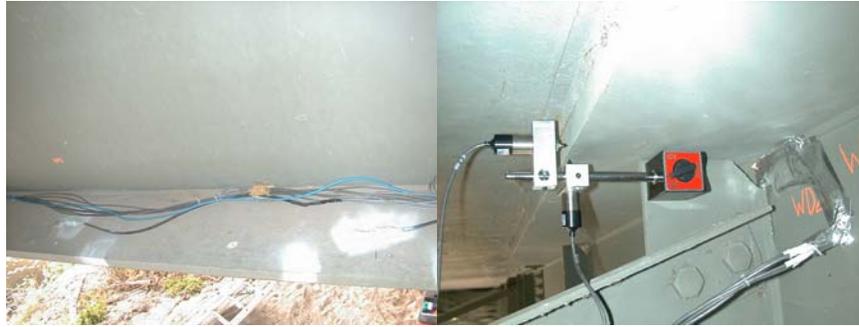
FIGURE 8. Photographs of Longitudinal Strain Gages and Out-Of-Plane Transducers

Four Direct Current Displacement Transducers (DCDT) were installed at the stiffener connection of D5. Two were placed on G1 and two were placed on G2 as shown in Fig. 8. One transducer measured out-of-plane displacement of the web gap and the other measured vertical movement of the flange relative to the stiffener. Out-of-plane displacement of the web was indicated by the change in horizontal position of the stiffener with respect to the top flange, which was integral with the deck. The out-of-plane displacement of the web is an indicator similar to the strain in the web gap of the effectiveness of the retrofit.

Two weldable strain gages were also used to measure the strain in the bottom flange of G1 and G2 at 0.9 m from the bearing at Pier 2 as pictured in Fig. 8. The strain in the girders reflects the global effect the retrofit has on the bridge and was also used as a trigger for the DAS as described below.

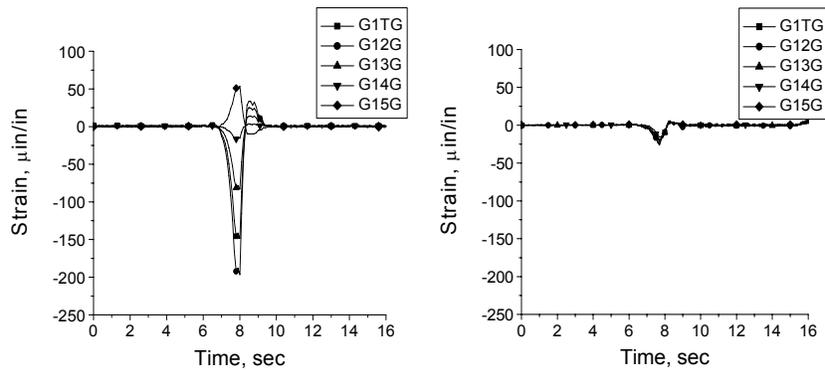
FIGURE 9. Web gap Strain Vs. Time Plots before and after the Retrofit

Typical plots of the 16 seconds of data for the DOT trucks are shown in Fig. 9 before and after implementation of the retrofit. The DOT load trucks showed a substantial (nearly 90 percent) reduction in strain in the G1 web gap following implementation of the retrofit. Other sensors in the web gap region also showed similar reductions with the exception of the bottom flange strain

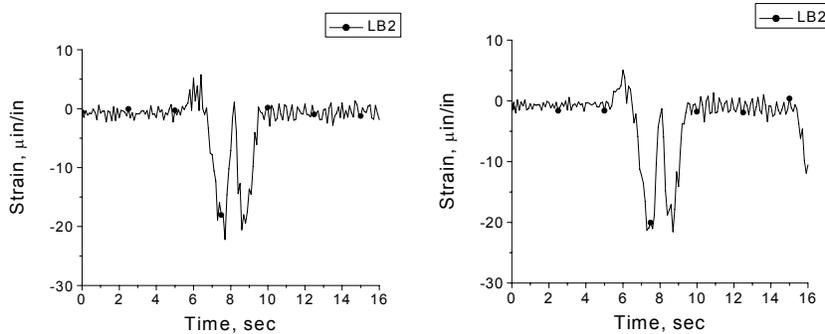
FIGURE 10. Longitudinal strain vs. time plots before and after the retrofit

The girder strain showed very little change after implementation of the retrofit so that the bottom flange strain was useful as a trigger. The strain in the girders during the DOT truck loading was similar with and without the retrofit, about 20 microstrain as shown in Fig. 10, even though the trucks were of slightly different weights. To correct for the difference in weight the plots from before the retrofit were normalized to represent equal loads of approximately 22680 kg in both tests. The longitudinal strain was used to identify load size of ambient trucks before and after the retrofit was installed.

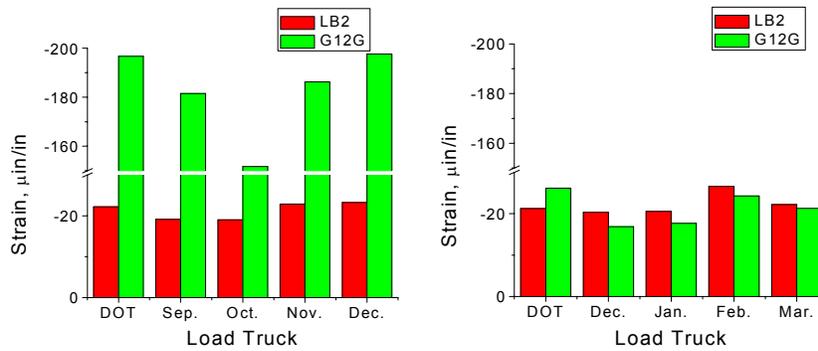
FIGURE 11. Long Term Web Gap and Longitudinal Strain before and after the Retrofit

A sample ambient truck similar to the DOT load trucks as far as causing similar longitudinal strain patterns and peak strains was selected for each of the four months before and after the retrofit was implemented. The longitudinal strain and web gap strain for each of these trucks is plotted in Fig. 11. Web gap strains for each of these trucks and the DOT trucks are similar both before and after the retrofit was implemented suggesting that the reduction in web gap strain does not change over time.
