# Infrastructure Enhancement Utilizing Ultra-High Performance Concrete Bridge Deck Overlay

**Hartanto Wibowo and Sri Sritharan**

Presented at:  
2017 Mid-Continent Transportation Research Symposium  
Ames, IA  
August 16-17, 2017

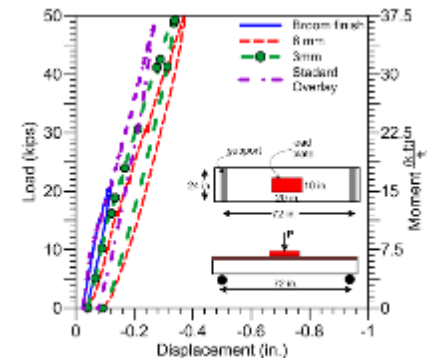
b) Load Arrangement -2

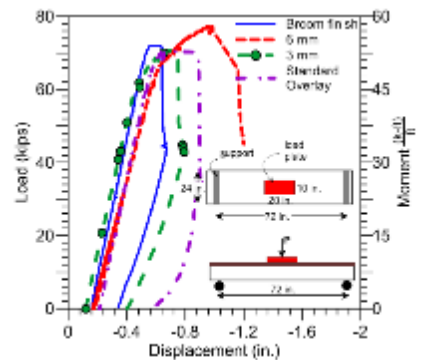
d) Load Arrangement -2

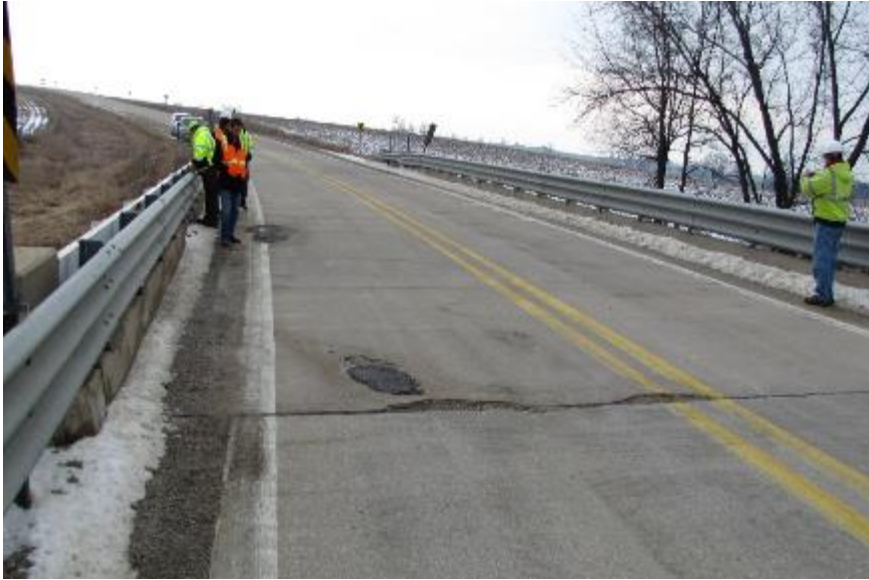
- Before Overlay

Built in the mid-1960s in Buchanan County, IA. The bridge is 100 ft long and 28 ft wide with 5% superelevation

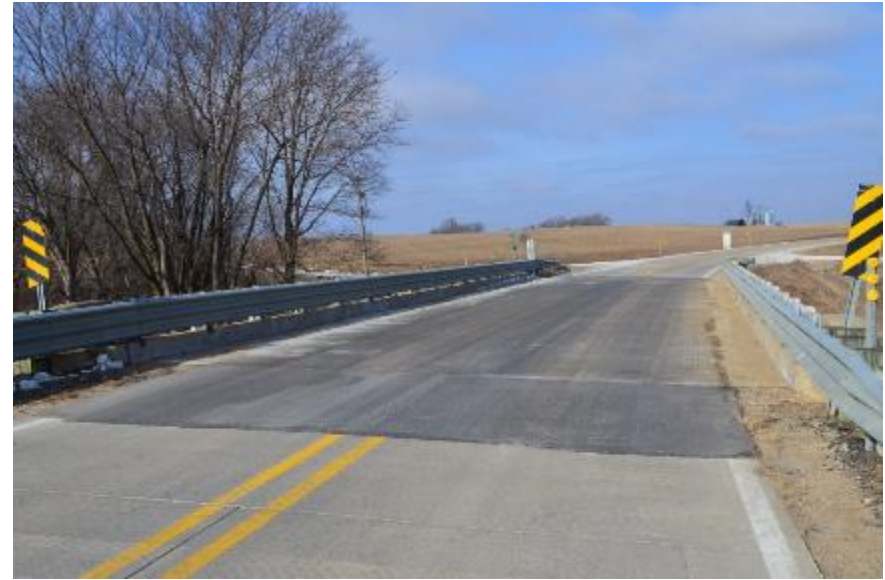
- After Overlay

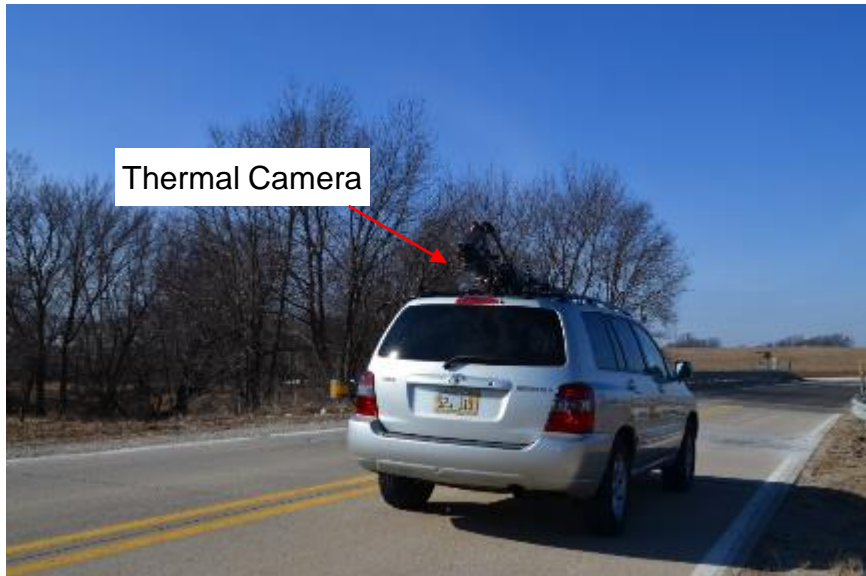
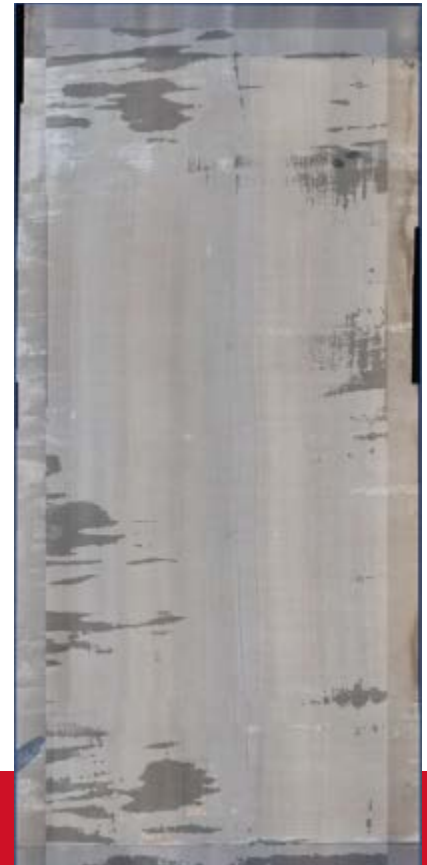
- Thermal camera was mounted on top of a car
- Some potential delamination areas identified
- Limitations exist, but manageable

- UHPC overlay is a simple and cost-effective alternative solution to improve bridge deck performance, which in turn will enhance infrastructure performance
- Potential delamination areas can be identified using infrared imaging, which is a non-destructive method
- For Mud Creek Bridge, no delamination was found at the UHPC-NC interface, only within NC deck (pre-existing condition)

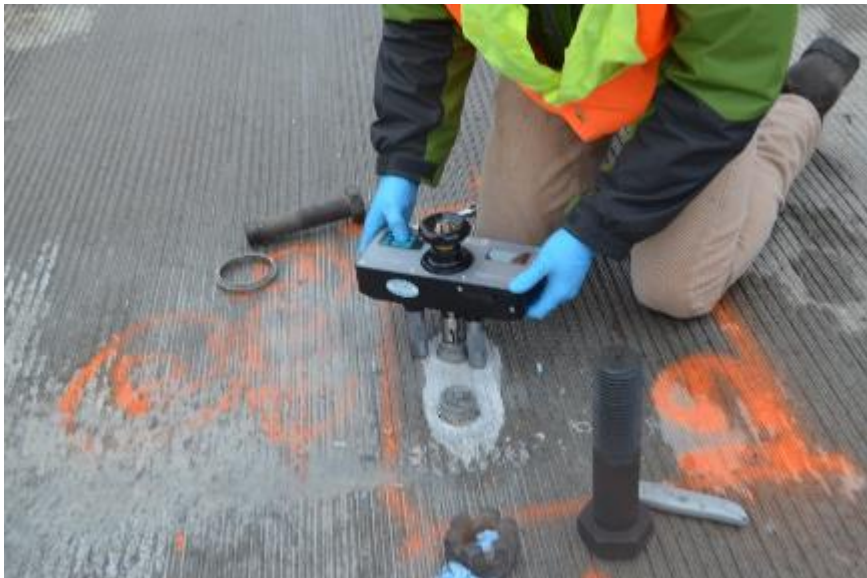
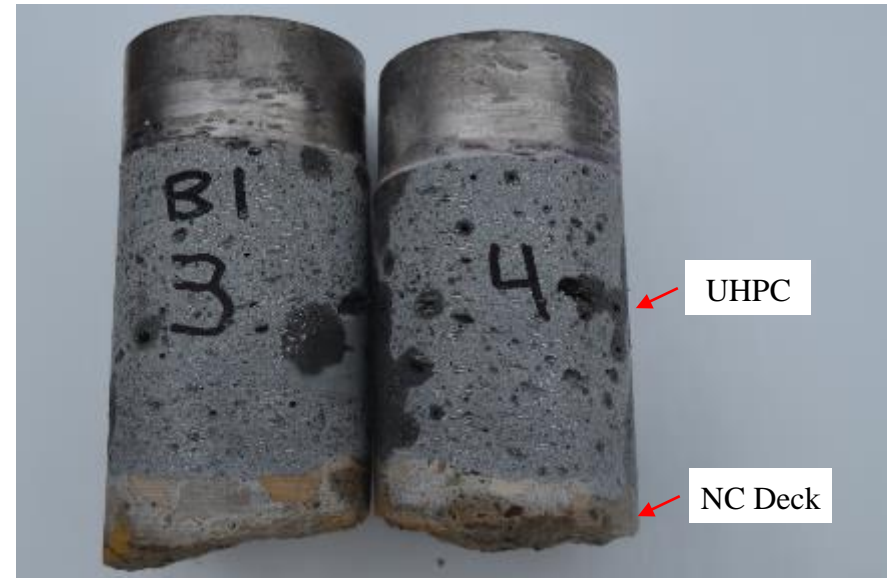
- Pull-off test
- Delamination was not found at UHPC-NC interface but within NC deck

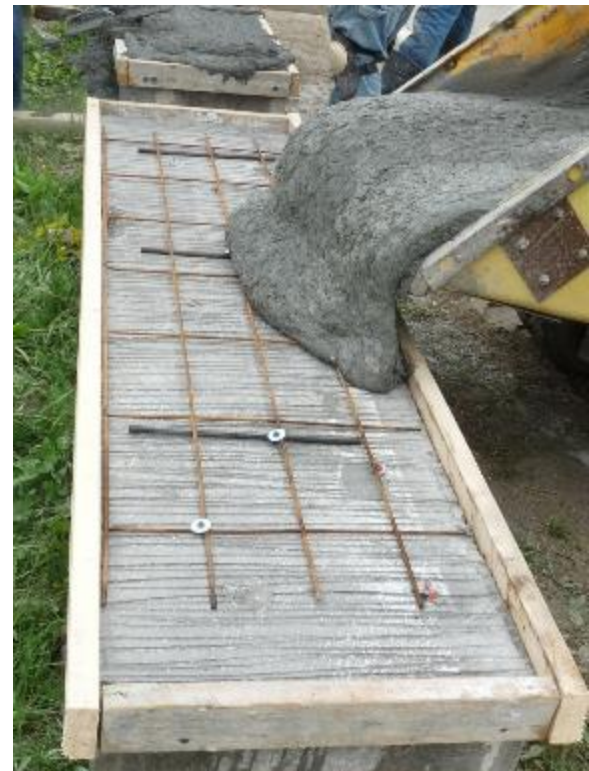
- Slab specimens were brought to the construction site and overlaid with UHPC

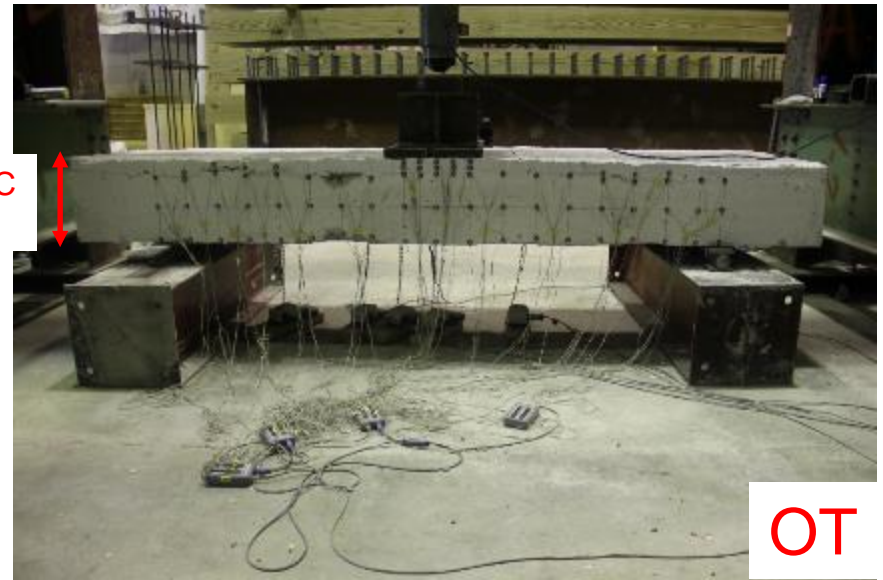
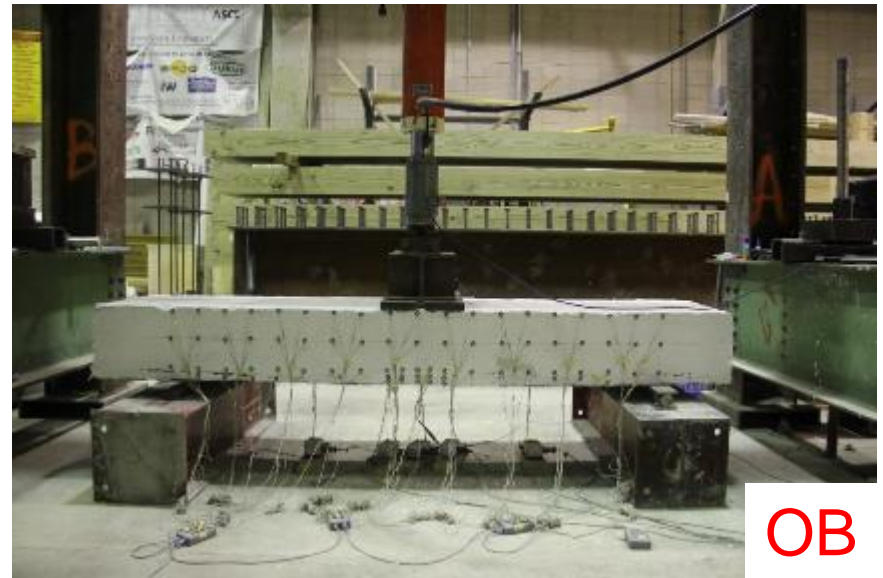
- Three specimens were tested:
  - NC slab only, no UHPC overlay (NO)
  - NC slab with UHPC overlay on top to represent positive moment (OT)
  - NC slab with UHPC overlay on bottom to represent negative moment (OB)

1.5 in UHPC  
9 in NC

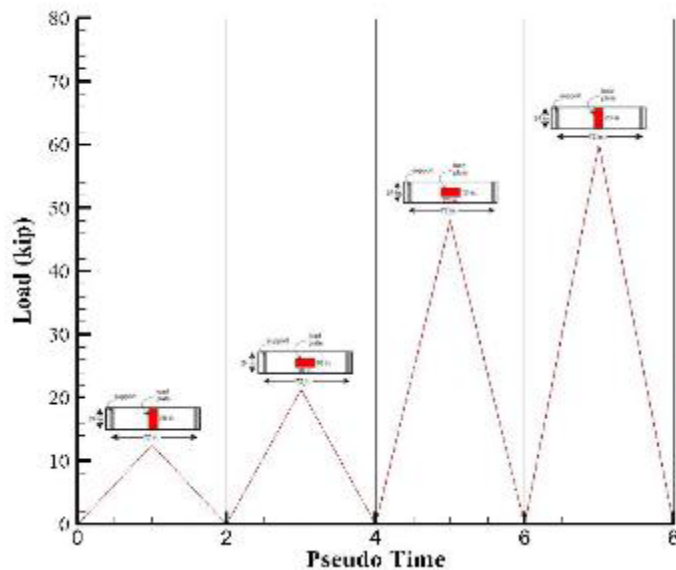
- Loading was applied in 4 loading steps with 2 load orientations
- Specimens were subjected to loads that ultimately cause failure in shear or interface debonding

Load Orientation 1

Load Orientation 2

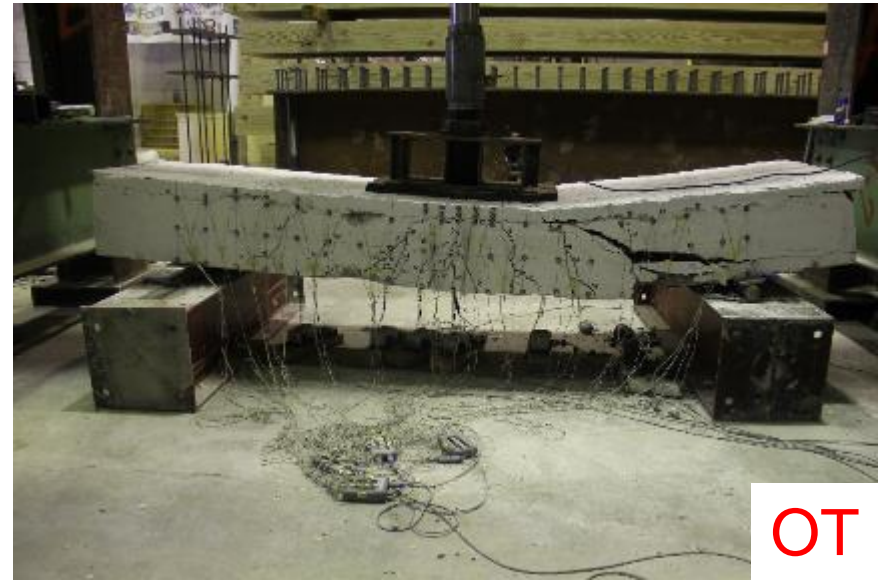
- Specimens at failure

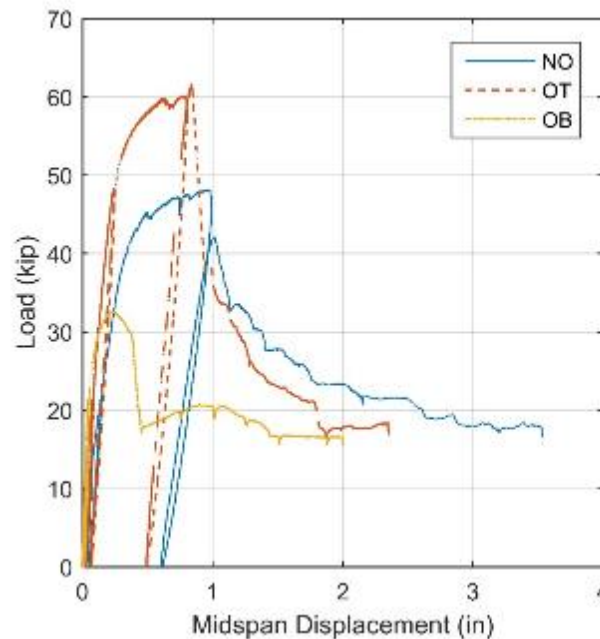
- UHPC overlay increases the stiffness and load capacity (strength) by 28% in positive moment region
- In negative moment region, the failure load is lower as expected

- Based on the laboratory tests, the UHPC overlay was found to increase the stiffness and strength of the NC deck; the strength increase was found to be approximately 28%
- A proper surface roughness is necessary to create good bond at the UHPC-NC interface that will ensure sufficient shear strength is achieved

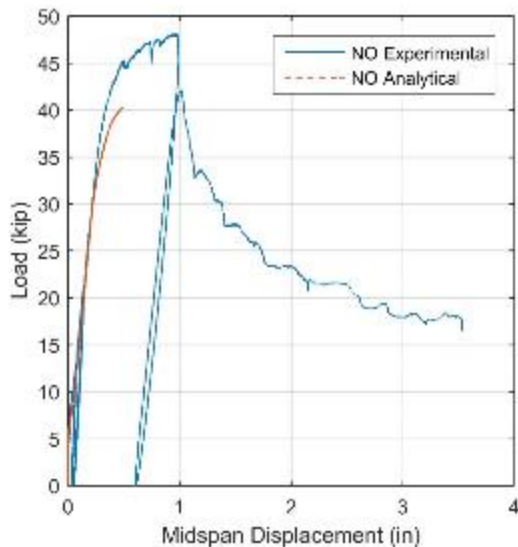
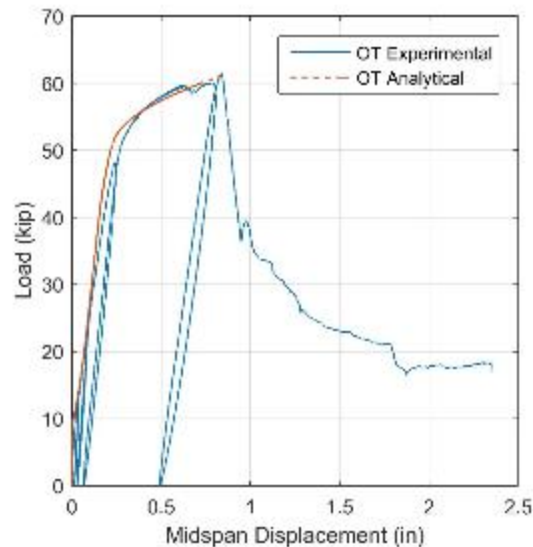
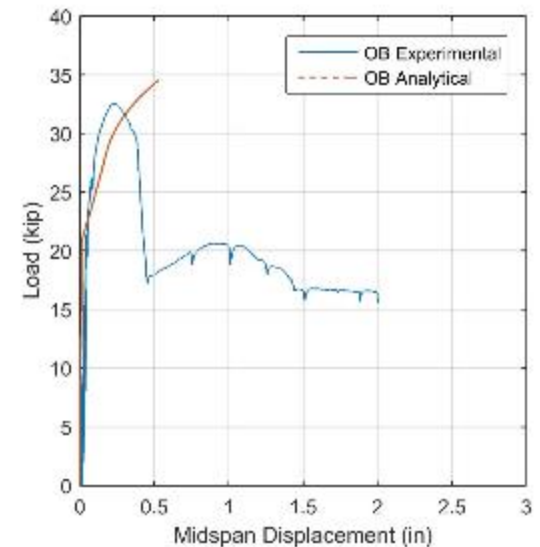
- Analytical results show good agreement with the experimental results
- Discrepancies may be caused by actual vs. assumed properties

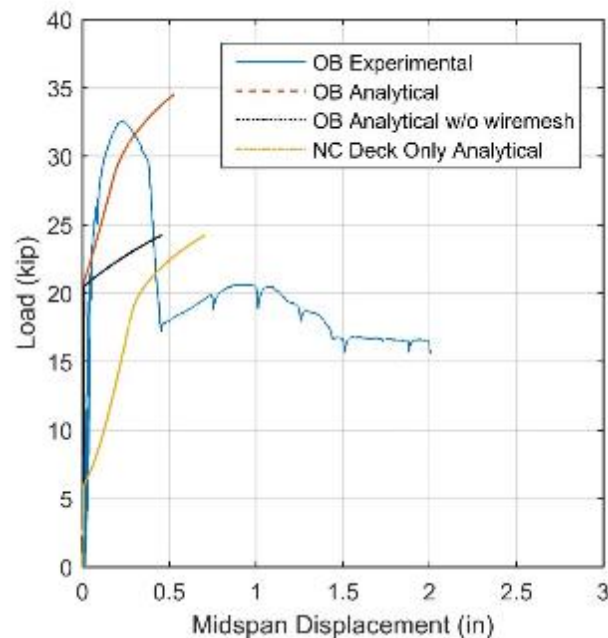
- For negative moment region, when compared with NC deck only, UHPC overlay also provided additional stiffness and strength
- Contribution of wiremesh is proportional to the area

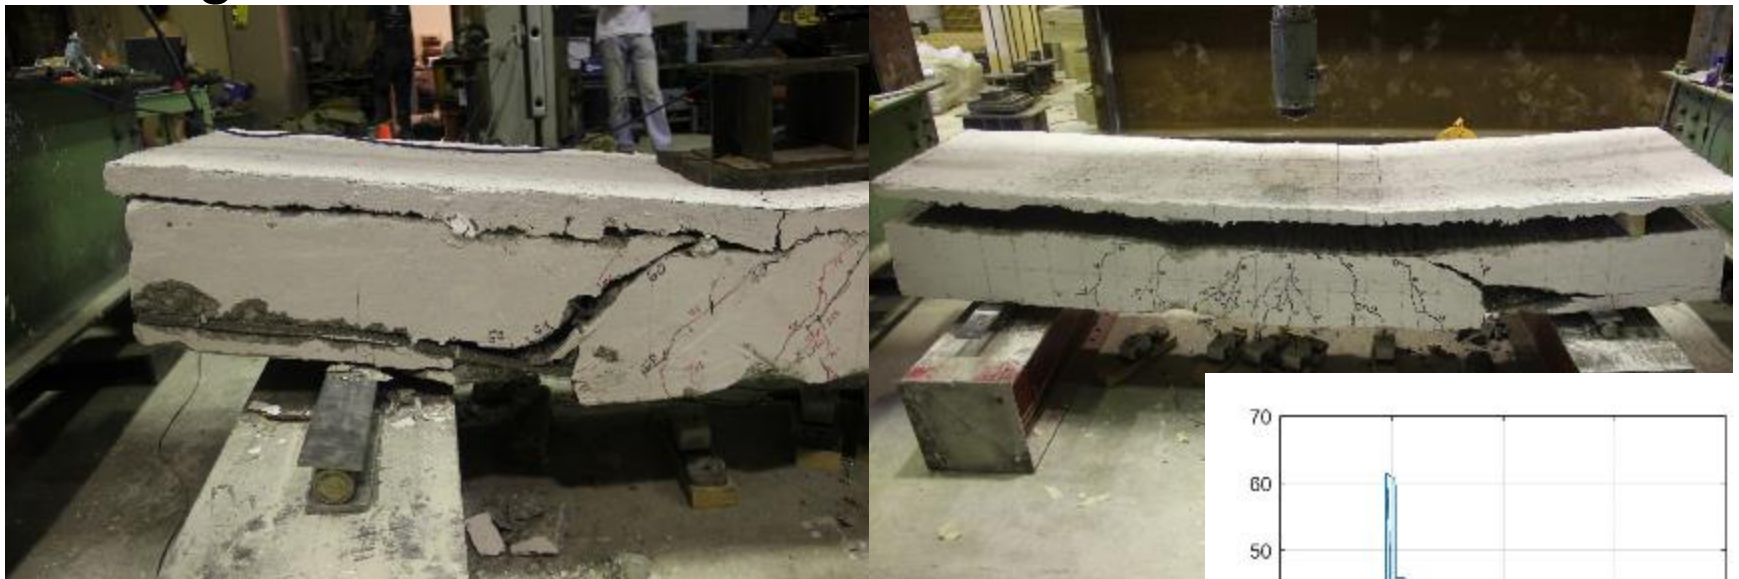
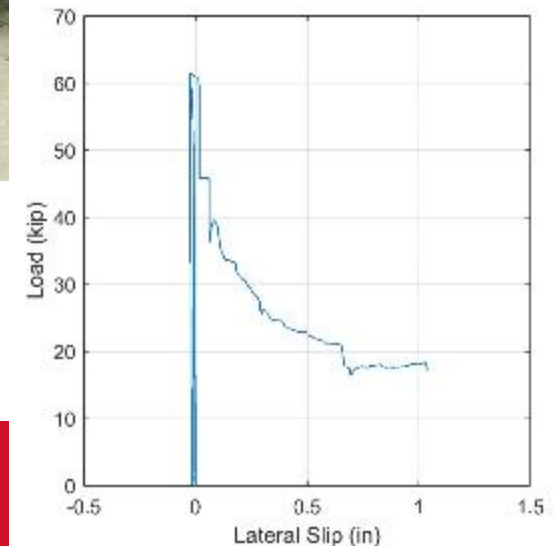
- Overlay debonding due to insufficient surface roughness
