Evaluation of the Metal Fatigue Solutions Electrochemical Fatigue Sensor System

Final Report
May 2018

IOWA STATE UNIVERSITY
Institute for Transportation

Sponsored by
Iowa Department of Transportation
(InTrans Project 15-560)
Federal Highway Administration

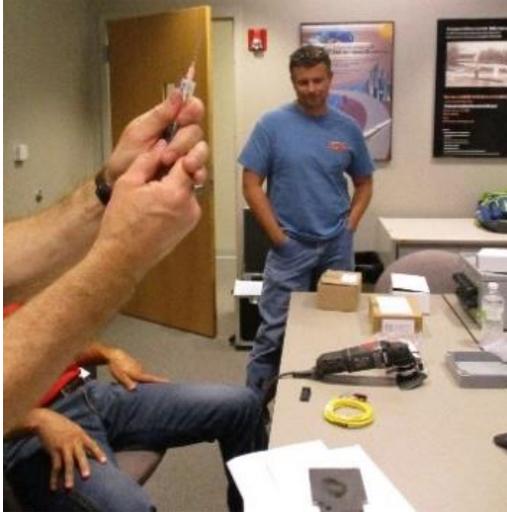
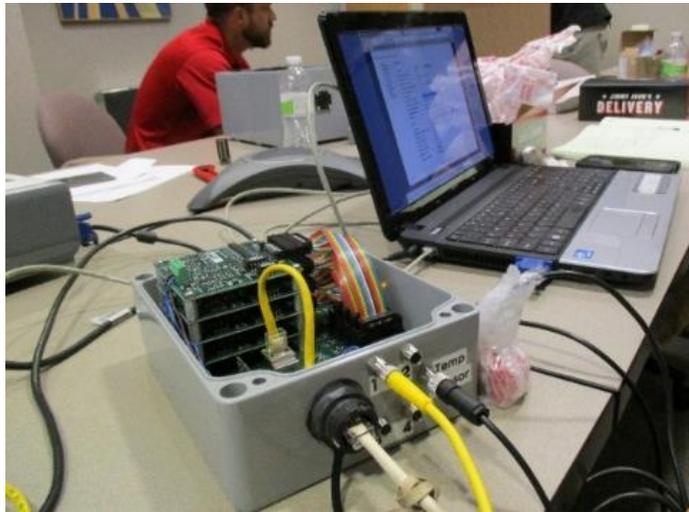
Figure 1. Training and demonstration of EFS system

MFS, Inc. provided approximately 6 hours of training to the staff of the Iowa State University Bridge Engineering Center. This training covered the basics of fatigue, crack initiation and growth, the EFS system operational characteristics, and tutorials on how to collect and analyze data. The training included both classroom and laboratory components. The classroom component illustrated the fundamentals of EFS technologies and how to use the software to collect and process the collected data as shown in Figure 1(b). The laboratory component demonstrated how to connect different components of the systems and install sensors as shown in Figure 1(a).

(a) Sensor Installation

(b) Data process and System Components

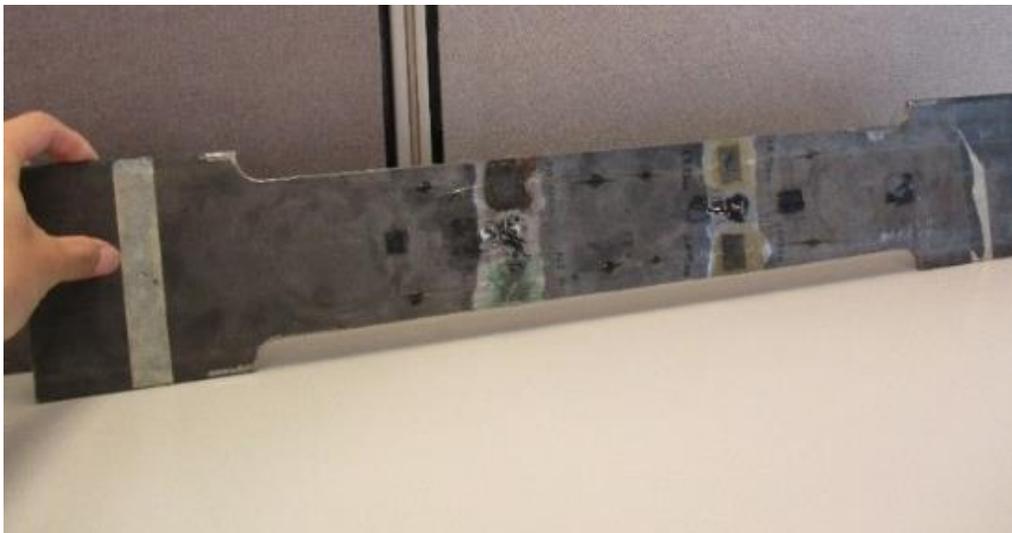
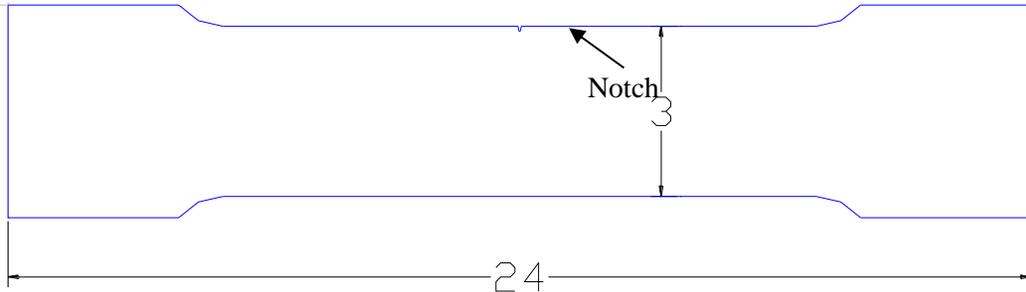
Figure 2. Steel plate specimen for crack detection

(a) Specimen View

(b) Drawing of Specimen and Notch (in.)

The steel plate specimen has a thickness of 1/4 in., a width of 3 in., and a length of 24 in. A full-depth EDM notch was created on the edge and mid-length of the specimen as shown in Figure 2(b). The notch has a width of 0.01–0.06 in. and a length of 0.09 in.

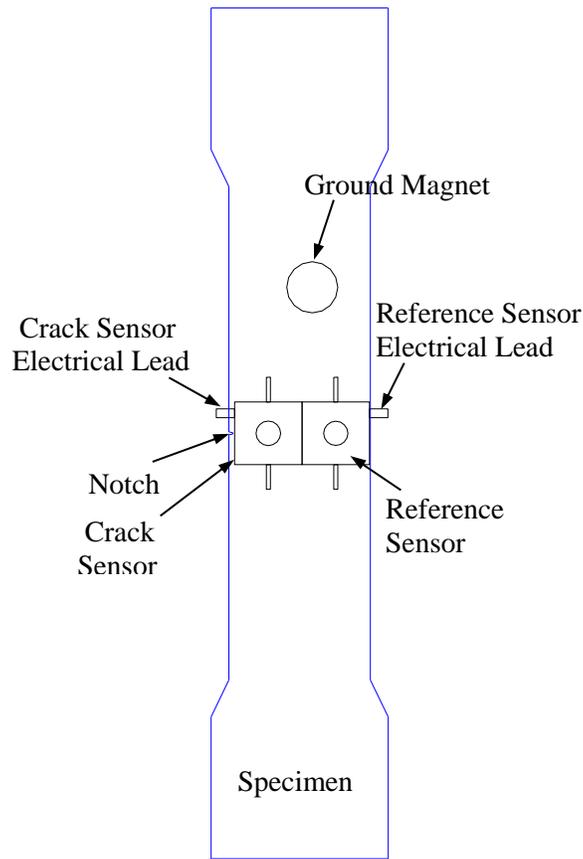
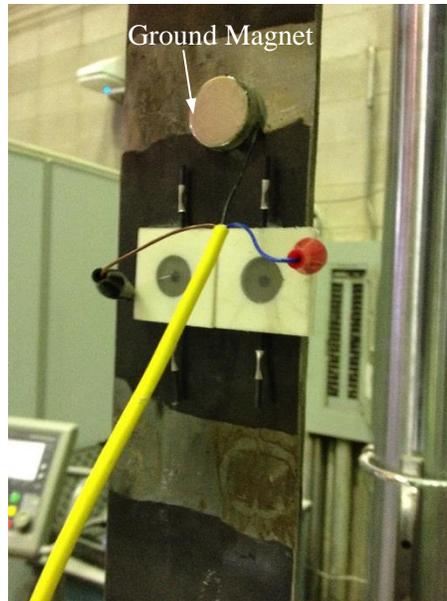
Figure 3. CrackChek sensor installation

Each CrackChek sensor consists of a pair of sensors (i.e., crack and reference sensors). Since a crack was expected to occur at the notch tip, the crack sensor was placed adjacent to the notch tip as shown in Figure 3.

(a) Sketch Illustration

(b) View of Ground Magnet and Sensors on Specimen

If a crack occurred, the crack tip should enter the sensor window and be detected. The reference sensor was placed adjacent to the crack sensor for the purpose of crack detection as shown in Figure 3(a). A ground magnet was attached to the steel plate for connecting to the ground as shown in Figure 3(b). Before the sensor was installed, the steel plate was cleaned to smooth the surface, and all debris under the ground magnet and sensors were removed.

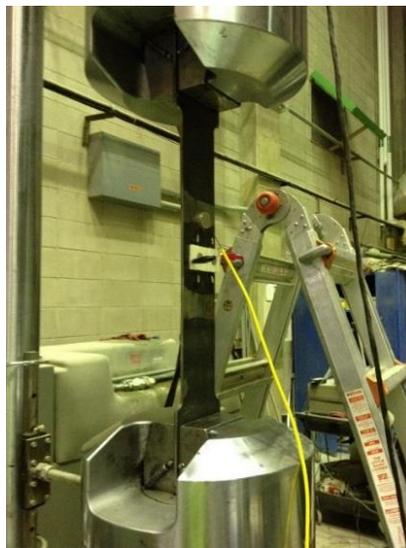
Figure 5. Fatigue load test setup

For testing, the steel plate specimen was clamped in the test equipment. To induce a fatigue crack near the notch region of the specimen, a sinusoidal cyclic fatigue loading test was applied to the two ends of the specimen as shown in Figure 5.

Initially, a fatigue load with a range of 0.5-10 kips, an amplitude of 4.25 kips, and a frequency of 10 Hz was applied to the specimen. Data from the CrackChek sensors were collected every 10 minutes, and the results of processing the preliminary data indicated no cracking in the specimen. After 100,000 load cycles, and based on the data processing results, no crack was found in the specimen. In order to quickly induce a crack in the specimen, the load range and amplitude were increased to 0.5-18 kips and 8.75 kips, respectively. The load frequency was kept the same at 10 Hz.

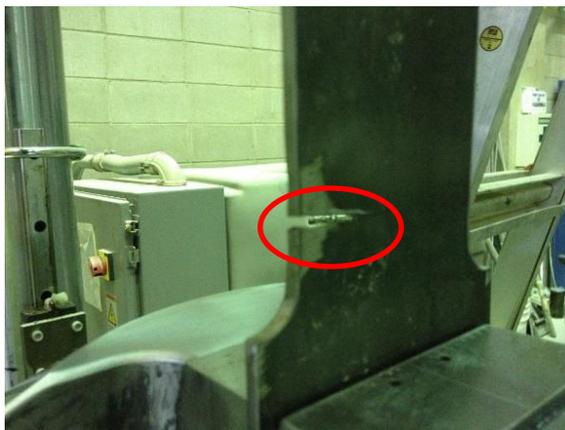
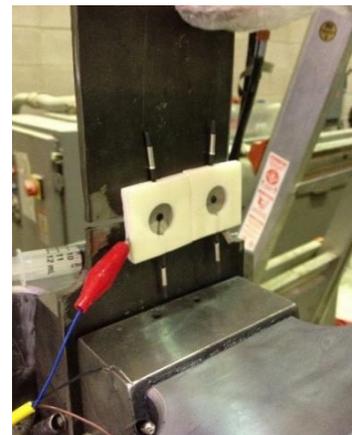
Figure 6. Crack detection at the induced crack location

After approximately 20,000 additional load cycles, a crack formed at the bottom of the specimen instead of the notch location, as shown in Figure 6(a). CrackChek sensors were then installed at the crack tip for the crack detection purposes as shown in Figure 6(b).

(a) Crack

(b) Sensors installed at the crack location

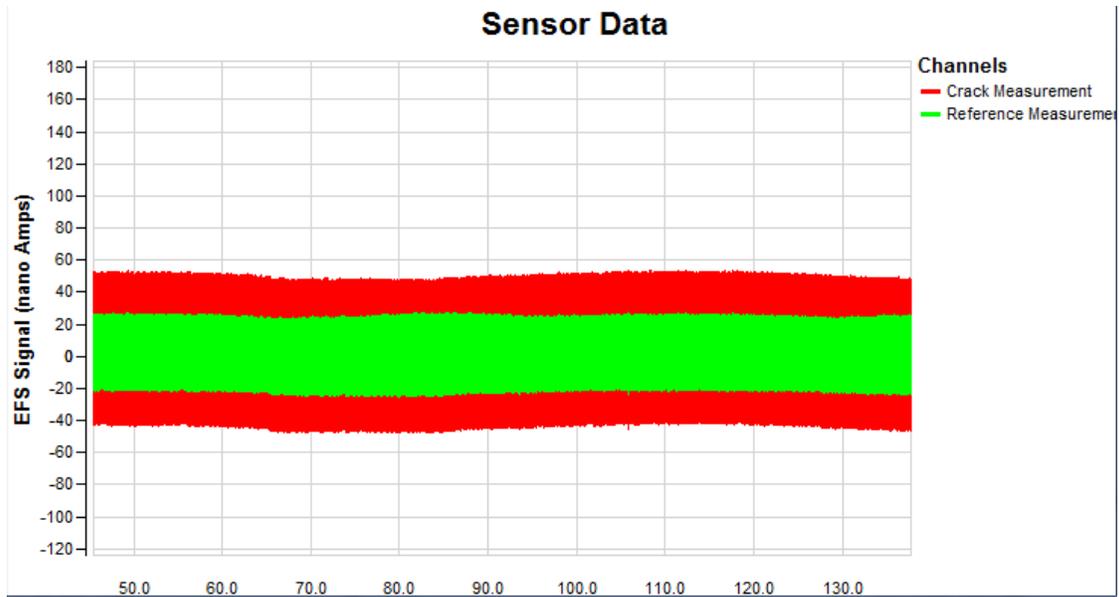
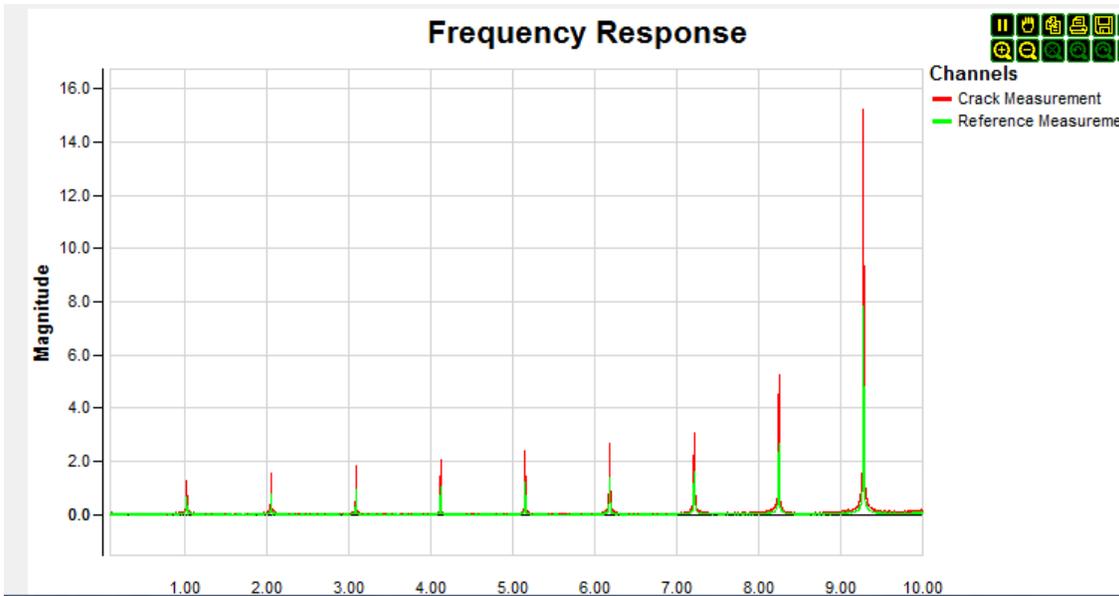
Figure 7. Data collected without a crack

For the no-cracking scenario, the data from the crack sensor in time and frequency domains are plotted in Figure 7(a) and Figure 7(b), respectively.

(a) Time Domain

(b) Frequency Domain

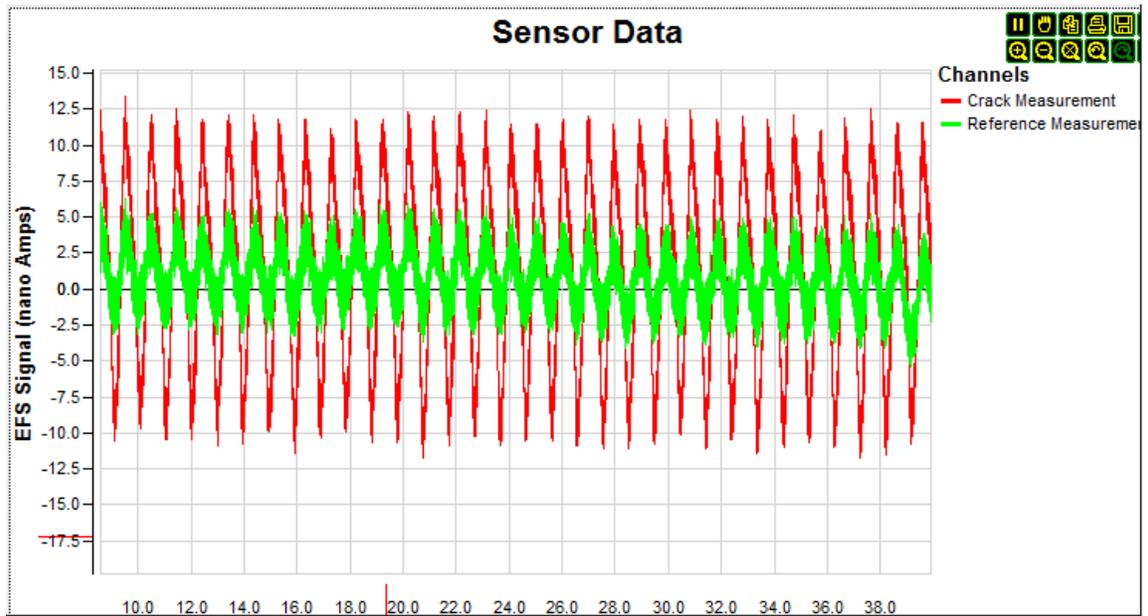
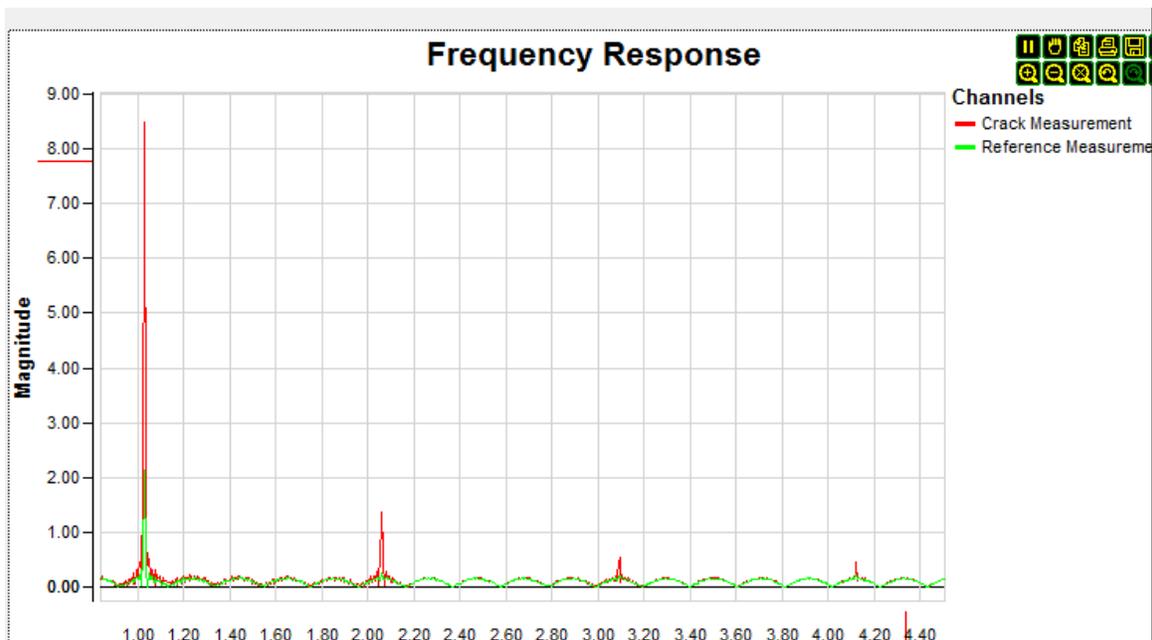
Figure 8. Data collected near the crack location

For the scenario with a crack, the data from the crack sensor in time and frequency domains are also plotted in Frequency Domain

Figure 8 indicate the presence of a growing crack.

(a) Time Domain

(b) Frequency Domain

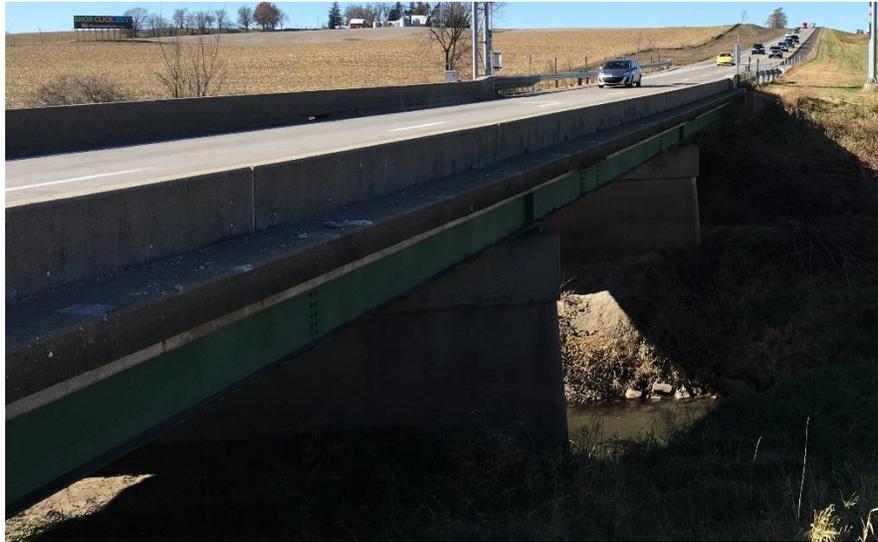
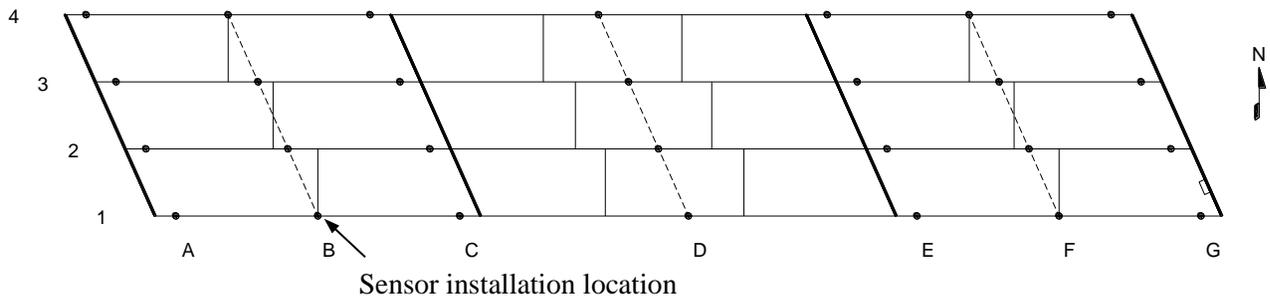
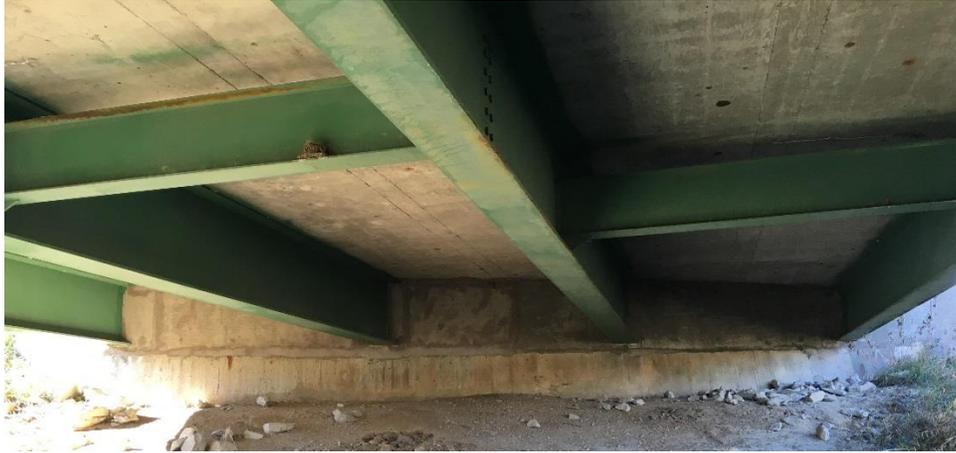
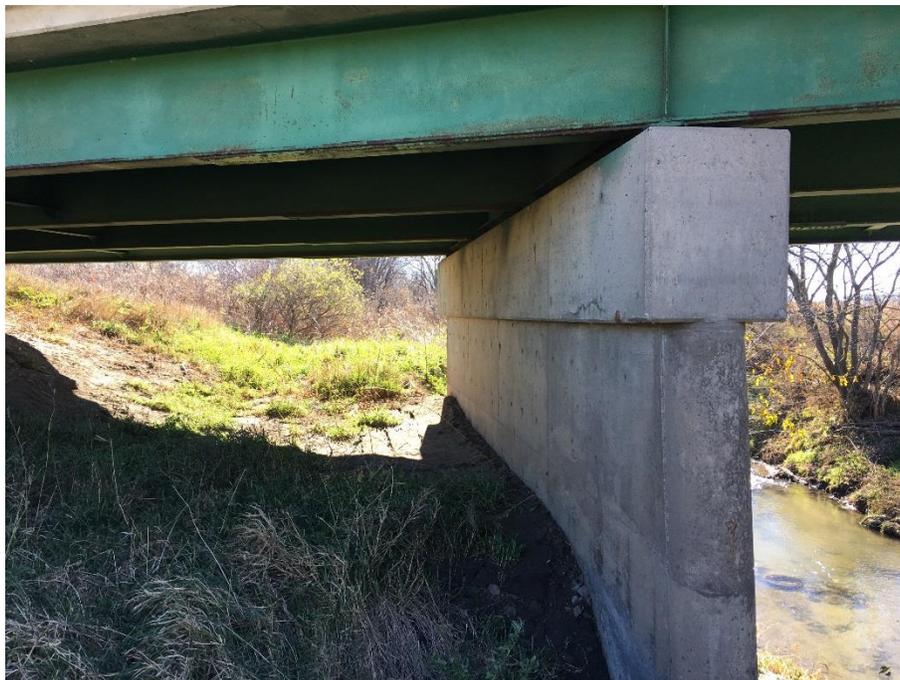
Figure 9. Cherry Creek Bridge

The eastbound Cherry Creek Bridge was selected for instrumentation with the FatigueWatch system. The bridge is located on I-80 and crosses Cherry Creek near Newton, Iowa. The bridge has three spans with a 24-deg skew, a total length of 158 ft and a roadway width of 30 ft as shown in Figure 9(a) and Figure 9(b).

(a) View

(b) Plan view

(c) Abutment

(d) Pier

The bridge supports two eastbound traffic lanes with a posted speed limit of 70 mph. The nominal 7.125-in. thick cast-in-place reinforced concrete deck is supported by four steel girders, two pier diaphragms, and four intermediate diaphragms. The girders are embedded into the abutment and are continuous over the three spans with 49-ft end spans and a 60-ft center span. Both abutments are stub concrete and the two piers are open two-column, concrete cantilevers as shown in Figure 9(c) and Figure 9(d).

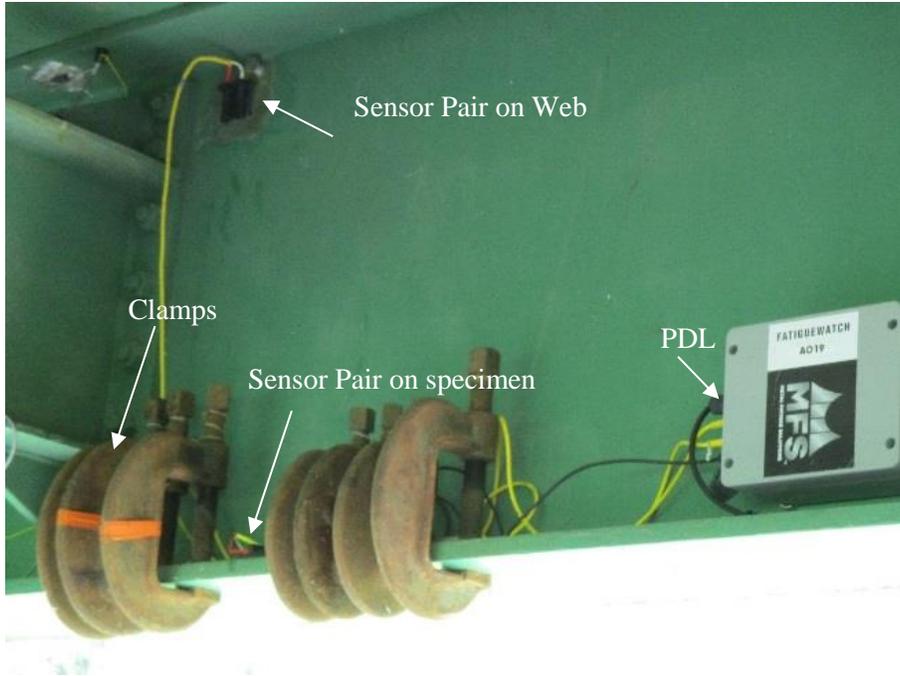
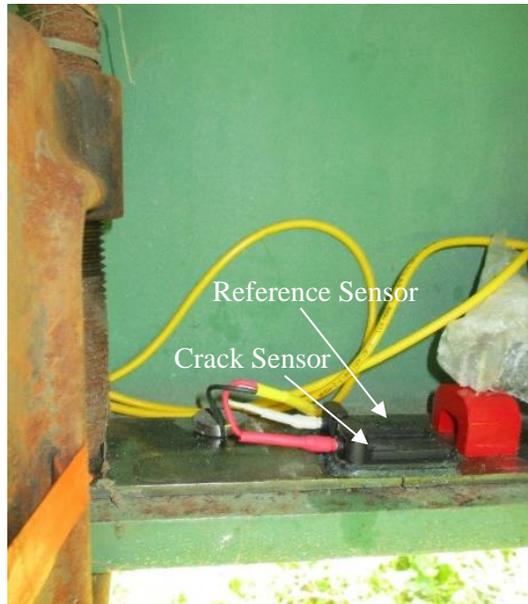
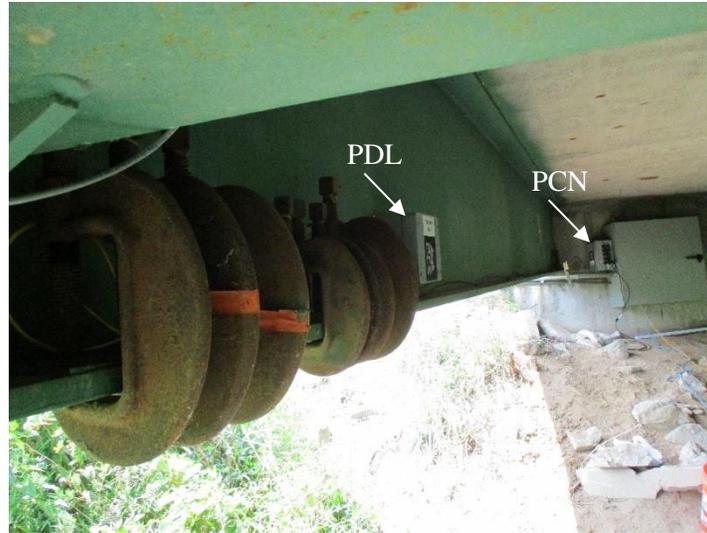
Figure 10. Sensor installation on Cherry Creek Bridge

As shown in Figure 10(a), the two pairs of sensors were installed on the girder web and specimen, and the two ends of the sacrificial specimen were clamped to the girder bottom flange. The crack and reference sensors were mounted on the sacrificial specimen as shown in Figure 10(b). The sensors were connected to the PDL placed on the girder web, and the PDL was connected to the PCN placed at the abutment location as shown in Figure 10(c).

(a) Sensor Installation Locations

(b) Sensors on the sacrificial specimen

(c) PDL and PCN

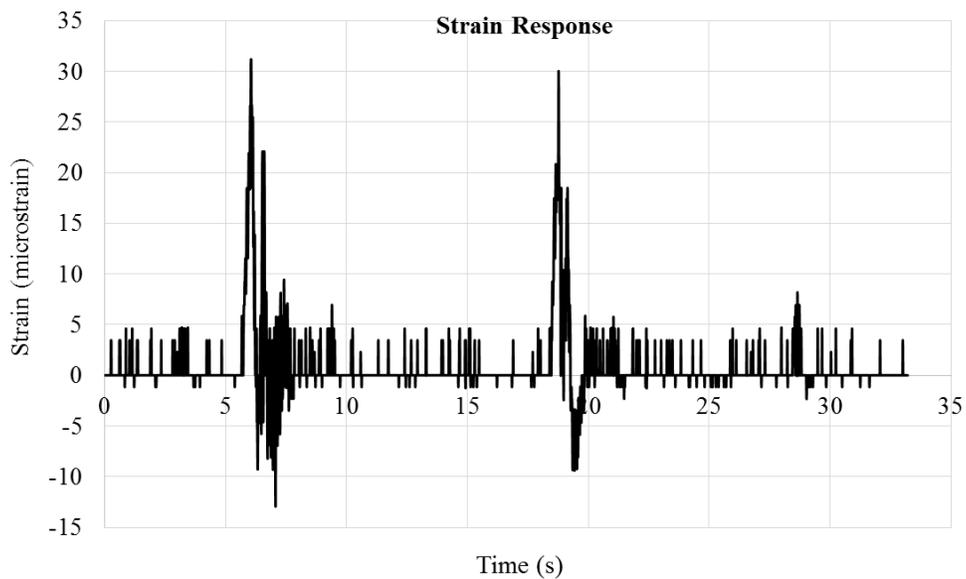
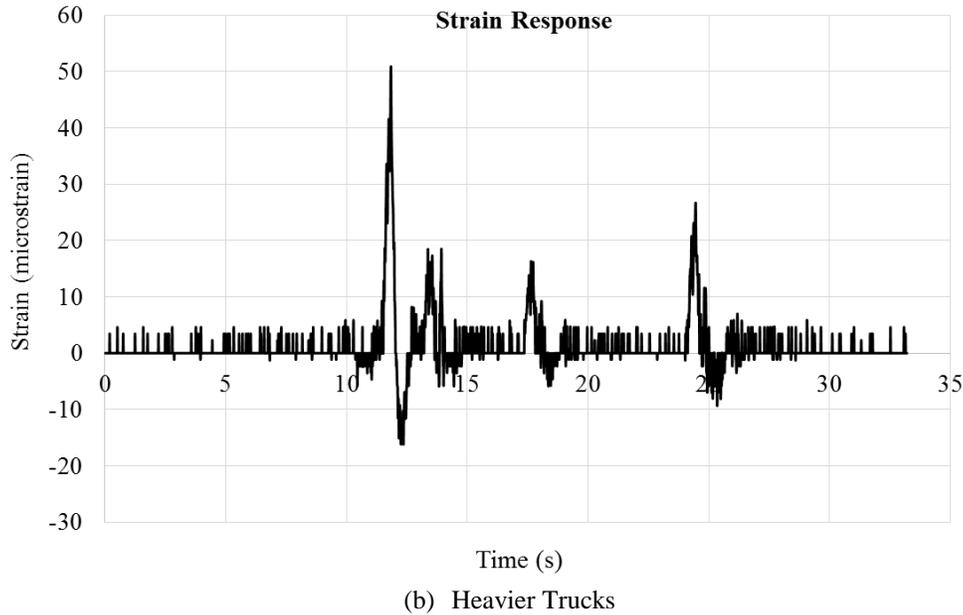
Figure 11. Strain response in sacrificial specimen

In addition to the EFS sensors installed in the sacrificial specimen, a strain gage was also installed to verify that the specimen was being adequately stressed. The strain response is plotted for lighter and heavier trucks in Figure 11(a) and Figure 11(b), respectively.

(a) Lighter Trucks

The peak strains in the sacrificial specimen are around 30 and 50 micro-strains due to the lighter and heavier trucks. Those collected strains are fairly comparable to the strain magnitudes in the girder bottom flange. This also verifies that the clamps are well tightened to ensure sufficient structural response in the steel plate specimen. Accordingly, it is expected a crack will form at the notch location and the collected EFS signal will be sufficient for data analysis in terms of crack detection.

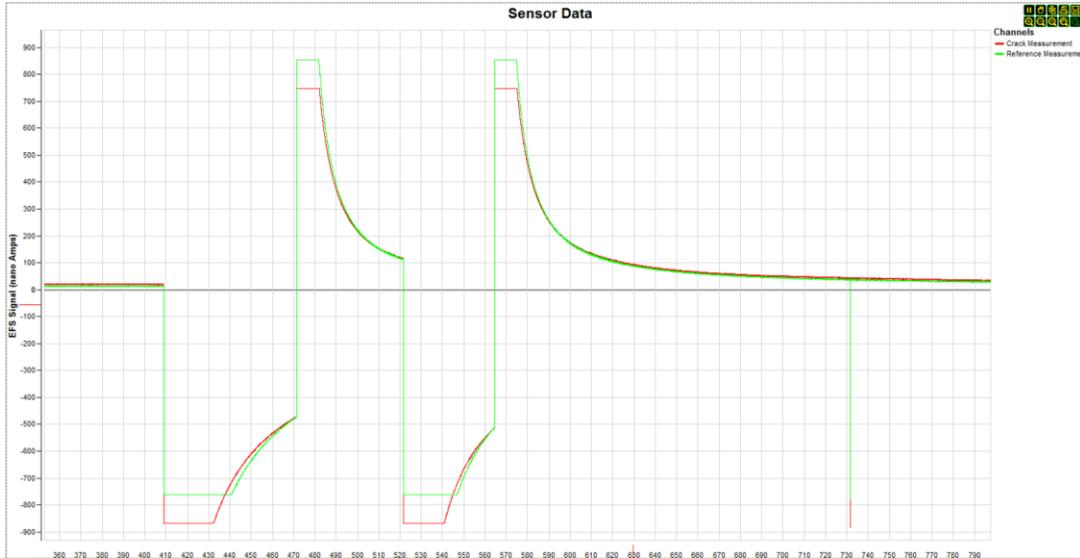
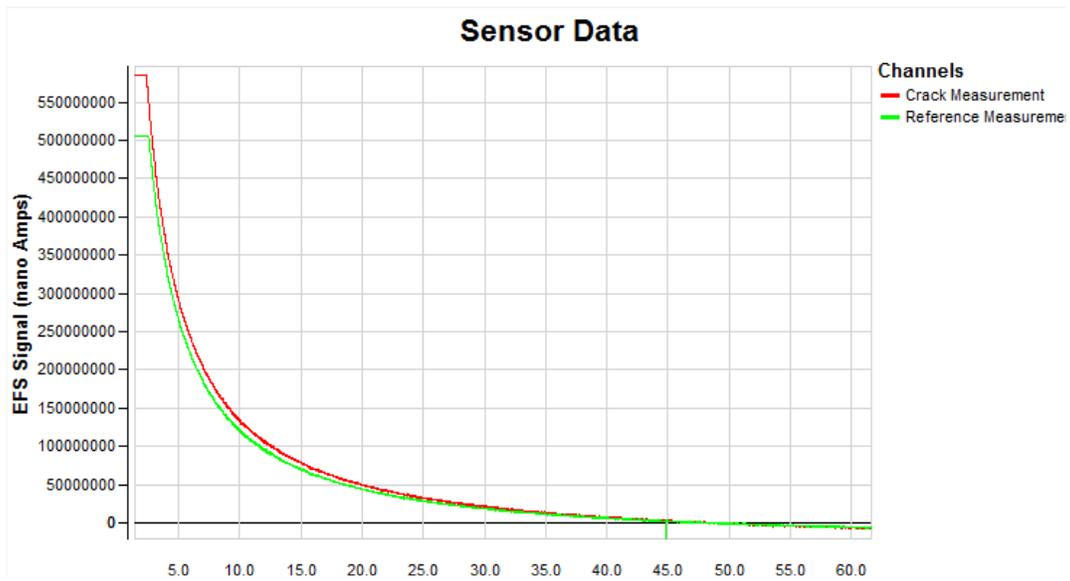
Figure 12. EFS signal from verification test

The data from the sensor install verification test was plotted as shown in Figure 12(a). The sample plot of EFS signal from well-installed sensors is shown in Figure 12(b). Figure 12 indicates that the installed sensors on the Cherry Creek Bridge function well after installation.

(a) Collected EFS Signal from the installed sensors

(b) Sample EFS Signal

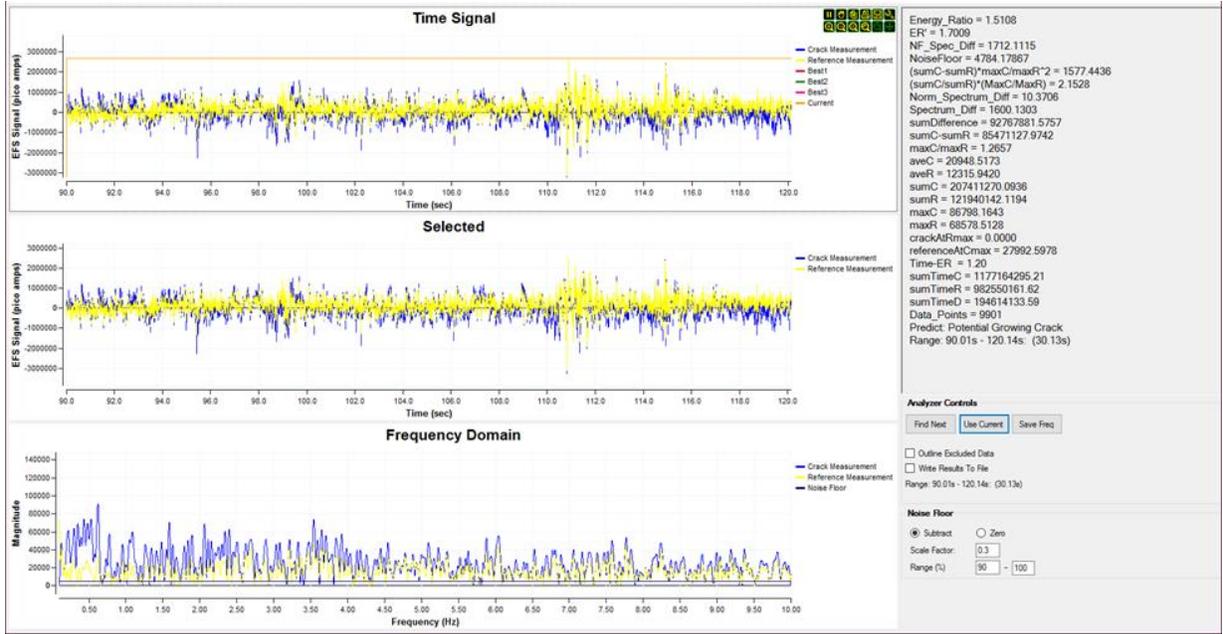
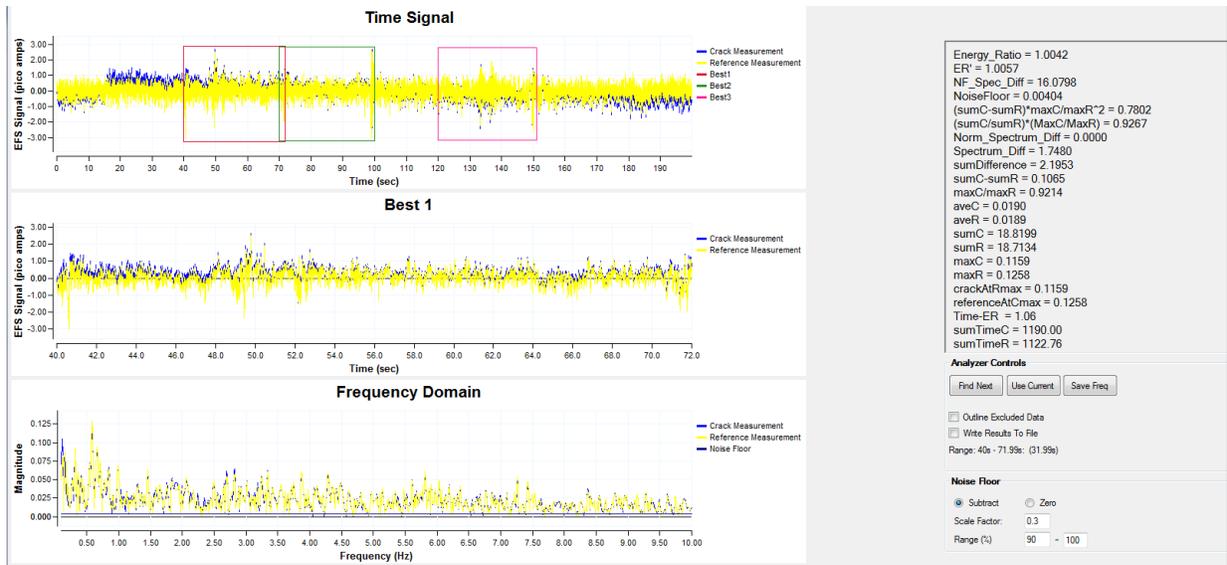
Figure 13. Plots in time and frequency domains without cracking

Commonly, when analyzing the data collected for bridge response in the frequency domain, the frequency content is spread fairly evenly across the 10 Hz range as shown in Figure 13.

(a) Sensors on Sacrificial Steel Plate Specimen

(b) Sensors on Girder Web

Nine months after the sensors were installed, the data plot in the frequency domain from the installed sensors is shown in Figure 13. Figure 13 indicates that no crack had formed in the sacrificial specimen and bridge girder web where the sensors were installed. Several trips were made to the bridge site and no visually observable cracks were found to have formed in the girder web or in the sacrificial specimen.

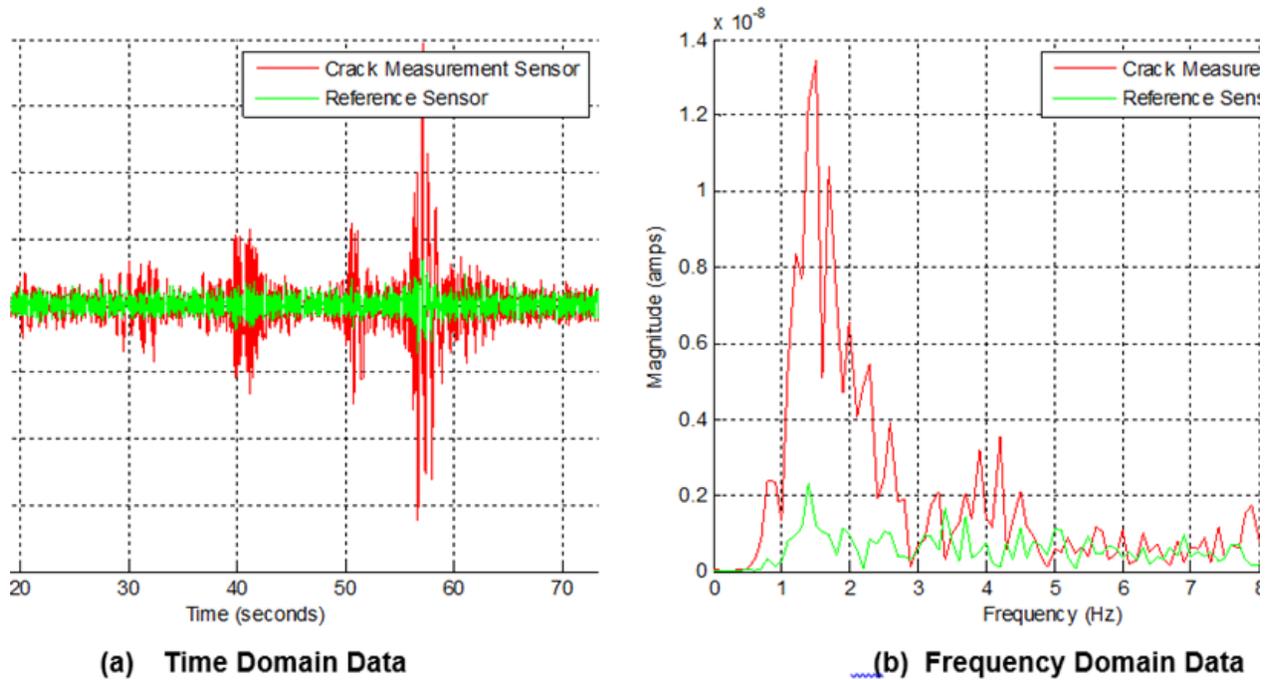
Figure 14. Sample plots in time and frequency domains with cracking

If there was a crack, a frequency amplitude in the lower 1–3.5 Hz to be 3 to 4 times greater than the higher 3.5–10 Hz range as shown in Figure 14.
