Report No. UT-1X.XX

## **INTERNAL CURING OF CONCRETE BRIDGE DECKS IN UTAH: MOUNTAIN VIEW CORRIDOR PROJECT**

Brigham Young University  
Department of Civil and Environmental  
Engineering

**Final Report  
August 2014**

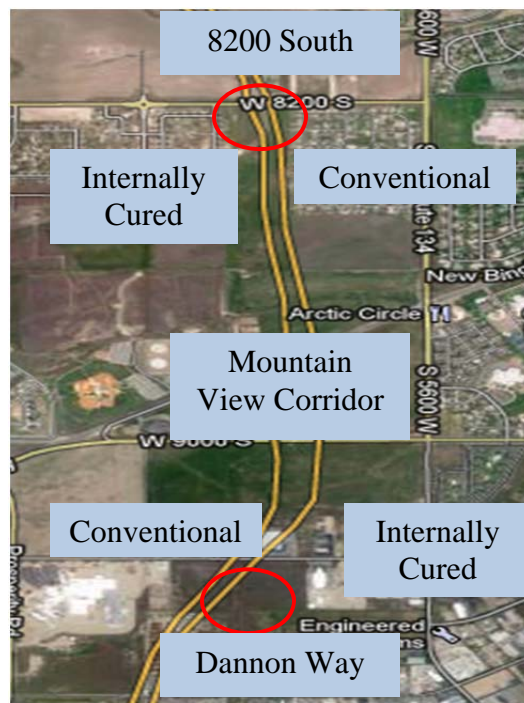
**Figure 3-1 Bridge locations and concrete types.**

In the spring of 2012, the Mountain View Corridor project team of the Utah DOT constructed four new bridges in West Jordan, Utah, including two at Dannon Way and two at 8200 South. At each location, one deck served northbound (NB) traffic and one deck served southbound (SB) traffic. One bridge deck at each location was constructed using a conventional concrete mixture, and one was constructed using a concrete mixture containing a portion of pre-wetted LWFA to facilitate internal curing. Figure 3-1 shows an aerial image of the location of each bridge and indicates the type of concrete utilized at each site.

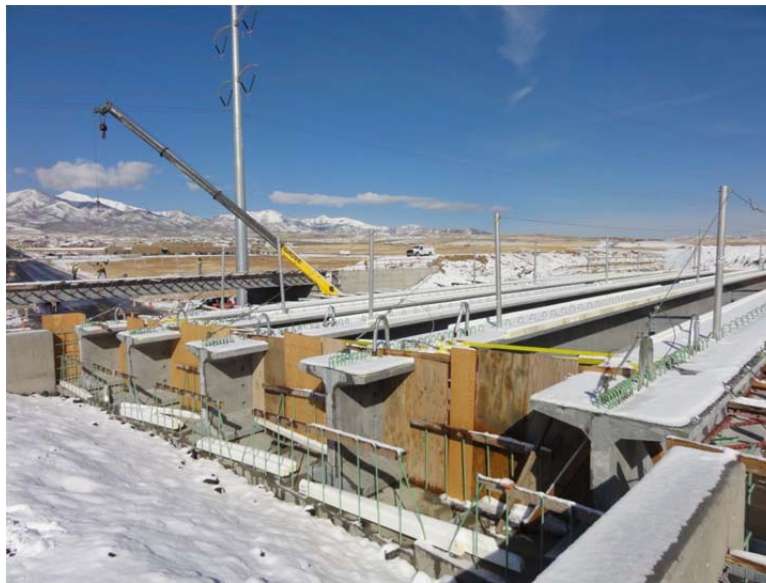
**Figure 3-2 Pre-stressed, pre-cast, single-span concrete girders.**

Each of the four bridges shared a similar design. Each structure incorporated five pre-stressed, pre-cast, single-span concrete girders, as shown in Figure 3-2. Pre-cast half-deck concrete panels, with a width of 7 ft 11 in. and a length of 8 ft, were placed between the girders along the majority of the length of the bridge; at the ends of the decks, smaller panels were used as necessary to terminate the panels at the appropriate locations. Each panel extended 6 in. onto each girder, as shown in Figure 3-3, and was supported by rigid foam that was placed between the girder and the pre-cast panel as illustrated in Figure 3-4; by design, the panels were not connected across the transverse butt joints between them on any of the decks but were simply placed close together as shown in Figure 3-5 for the Dannon Way NB bridge. A mat of No. 5 reinforcing steel was then placed over the tops of the half-deck panels and girders in preparation for concrete placement across the deck. The plans show that the total width of each bridge deck was 50 ft 10 in. and that the deck lengths ranged from about 119 to 128 ft. A minimum concrete cover depth of 2.5 in. over the top mat of reinforcing steel was specified for the project.

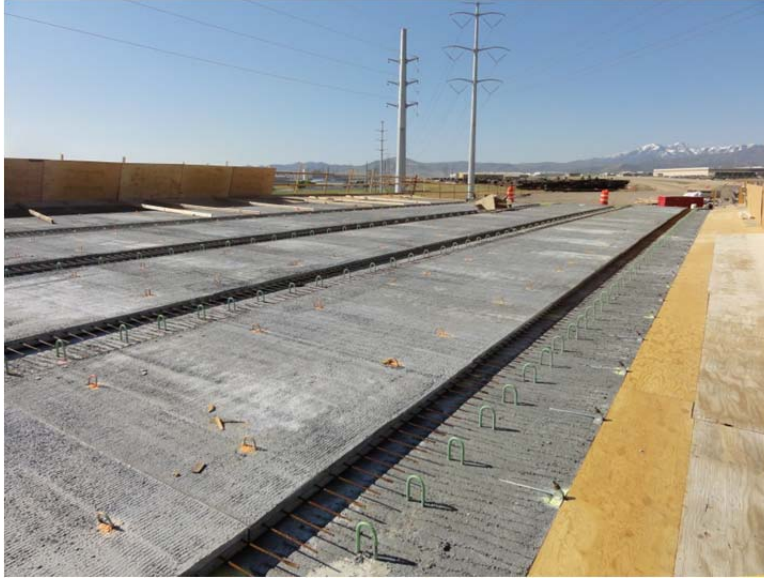
**Figure 3-5 Half-deck concrete panels.**

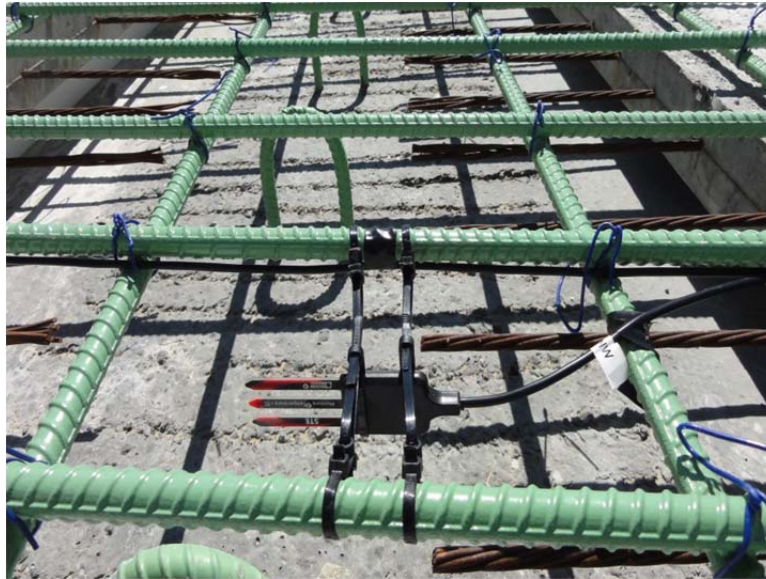
**Figure 3-6 Sensor installed at level of top mat of reinforcement.**

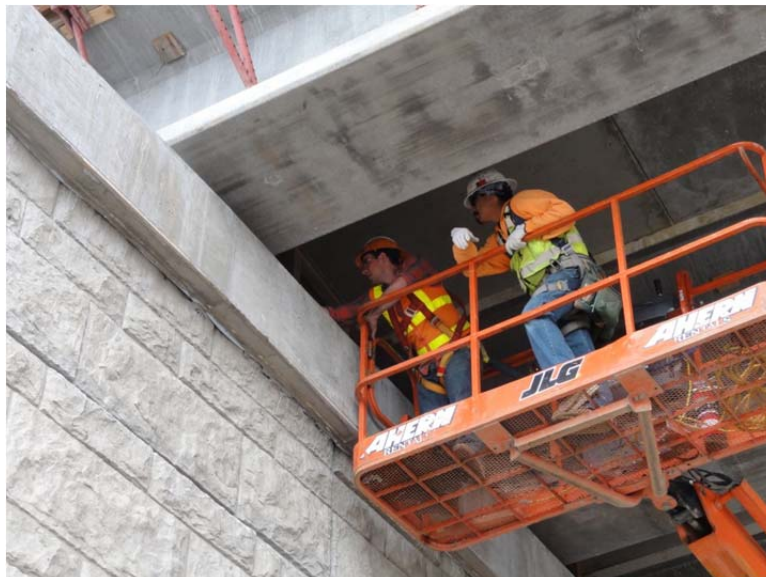
**Figure 3-7 Mounting of data logger box on diaphragm wall.**

nearest diaphragm wall to a location generally between the concrete girders, as illustrated in Figure 3-7, where they could be conveniently terminated in a secure box. A battery-powered data logger was mounted inside the box, as shown in Figure 3-8, to facilitate data collection.

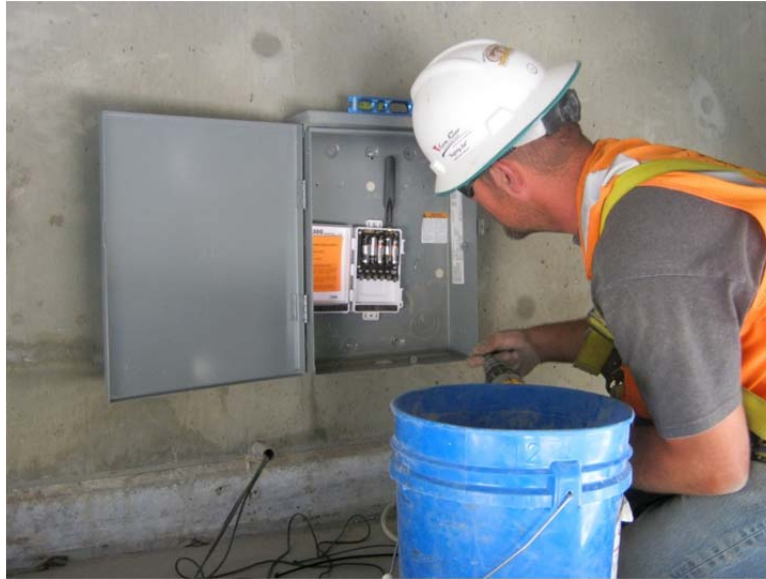
**Figure 3-8 Data logger mounted in box.**

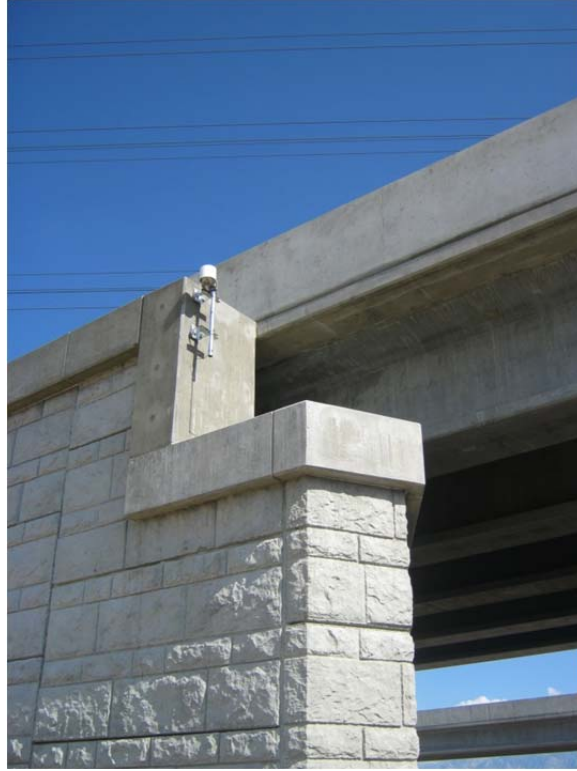
**Figure 3-9 Precipitation gauge mounted on bridge.**

In addition, air temperature, relative humidity, and precipitation gauges were mounted on the bridges to document the ambient conditions to which the bridge decks were exposed. Air temperature and relative humidity gauges were mounted at the 8200 South SB and Dannon Way NB bridges, while precipitation gauges were mounted at the 8200 South NB and Dannon Way SB bridges. A typical installation is shown in Figure 3-9.

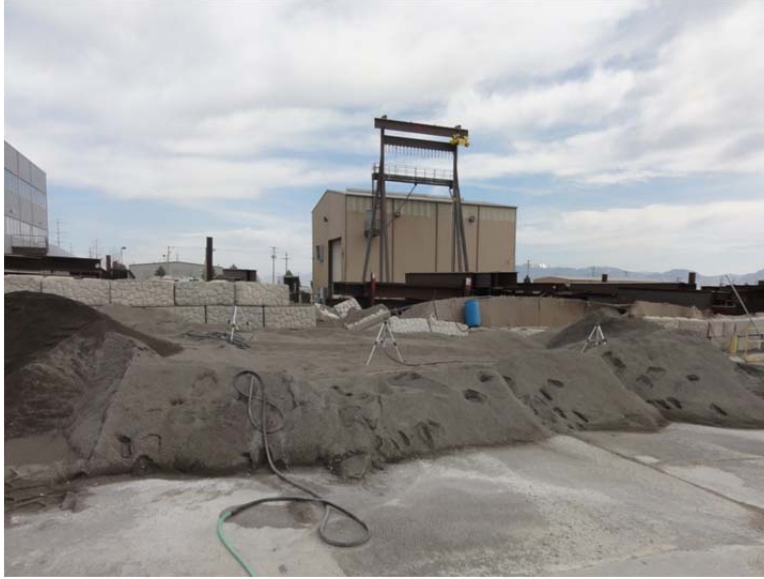
**Figure 3-10 Pre-wetting of lightweight fine aggregate at concrete batch plant.**

For the internally cured concrete, the LWFA was pre-wetted for a minimum of 2 days at the batch plant using a sprinkling system to achieve a minimum moisture content of 15 percent,

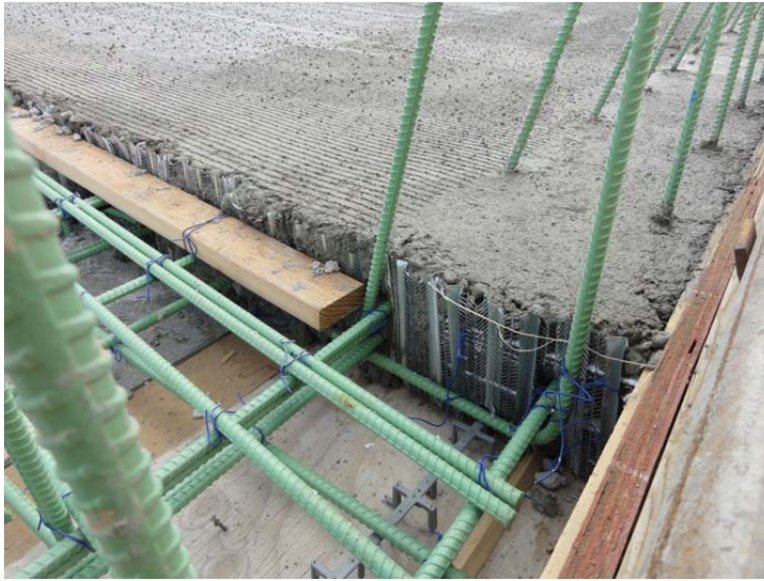
**Figure 3-11 Metal shoring used in deck construction process.**

the metal shoring was often only partially removed or allowed to remain entirely in place for convenience. A curing agent was sprayed onto the deck following concrete placement, and the deck was then covered, as shown in Figure 3-12, for a specified 14-day curing period, after

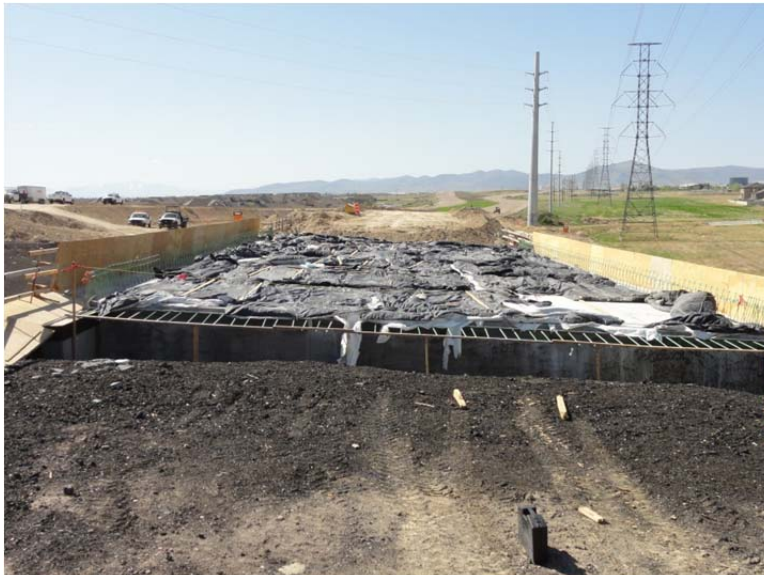
**Figure 3-12 Covered bridge deck during curing.**

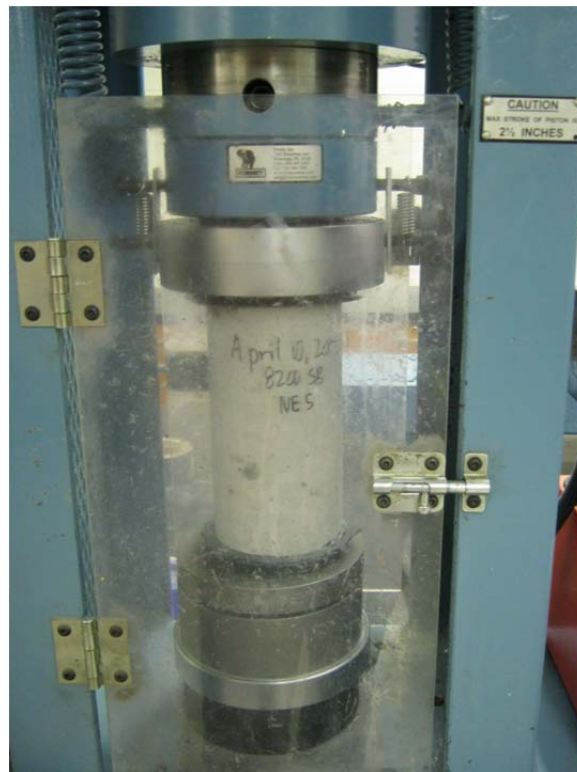
**Figure 3-13 Compressive strength testing.**

As illustrated in Figure 3-13, the cylinders were capped with sulfur and tested at a strain rate of 0.05 in./minute at the Brigham Young University (BYU) Highway Materials Laboratory. For the freeze-thaw cycling, each cycle consisted of 12 hours of freezing at 4°F and 12 hours of thawing in the fog room at 80 to 85°F, based generally on guidelines from ASTM C666 (Standard Test Method for Resistance of Concrete to Rapid Freezing and Thawing). After the final freeze-thaw cycle, the cylinders were capped and tested in compression, again following ASTM C39.

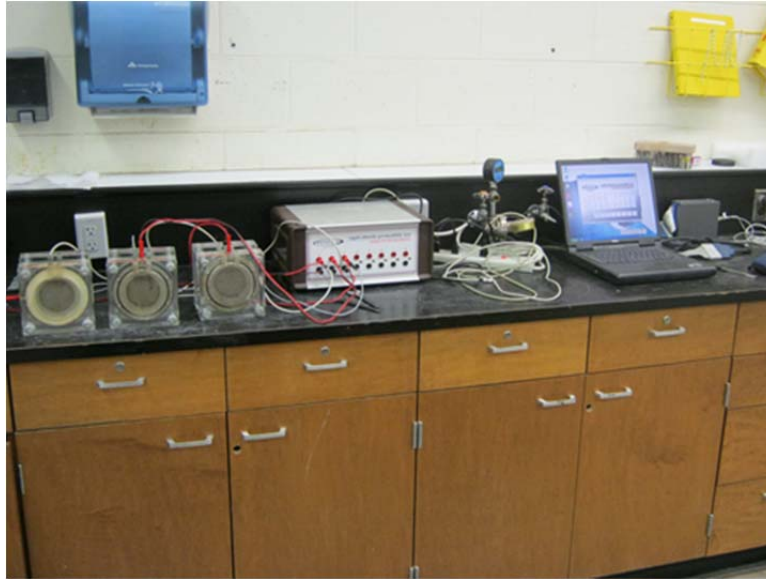
**Figure 3-14 Rapid chloride permeability testing.**

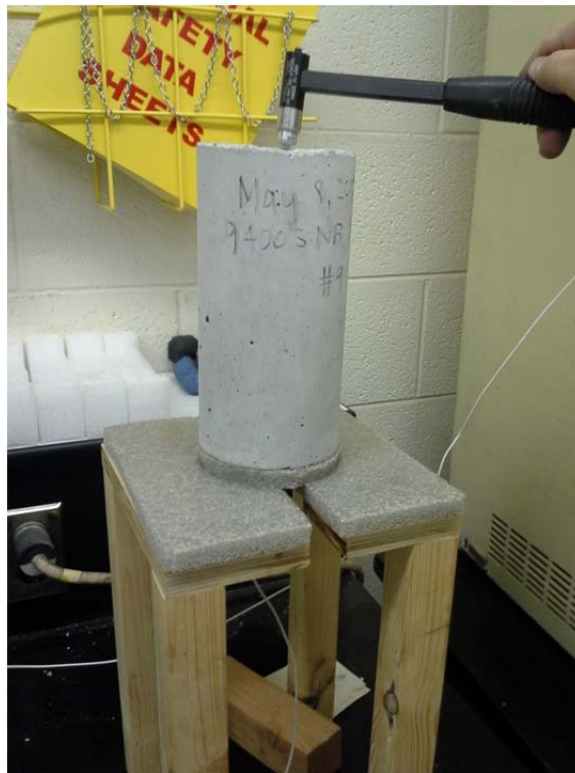
**Figure 3-15 Free-free resonant testing.**

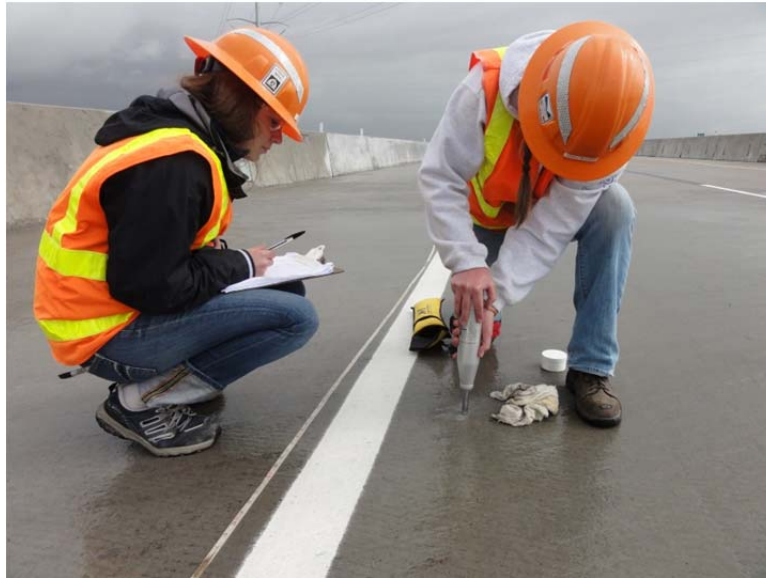
**Figure 3-16 Schmidt rebound hammer testing.**

ASTM C805 (Standard Test Method for Rebound Number of Hardened Concrete). As required, the surface of the concrete at each location was smoothed with a grinding stone before the testing was performed.

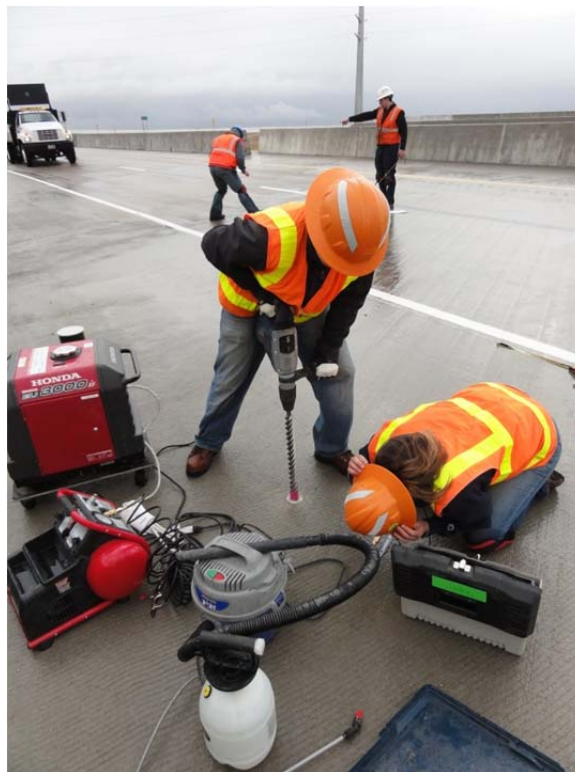
**Figure 3-19 Concrete sampling for chloride concentration testing.**

Chloride concentration testing was conducted on each bridge deck at 1 year and 2 years following deck construction. In order to comply with Utah DOT requirements, testing was limited to only four locations, including two on the east shoulder and two on the west shoulder of each deck that coincided with the Schmidt rebound hammer test locations shown in Figures 3-17 and 3-18 for the Dannon Way and 8200 South bridges, respectively. At each location, a hole was drilled to a depth of 1 in. in two 0.5-in. lifts with a hammer drill as depicted in Figure 3-19; the holes were deliberately situated away from the underlying reinforcing steel, which was located using a cover meter. The shallower lift was drilled with a 1.5-in.-diameter bit, while the deeper lift was drilled with a 1.0-in.-diameter bit. Use of a smaller bit for the deeper lift prevented inadvertent scraping of near-surface concrete that would have otherwise contaminated the deeper sample. After each lift was drilled, the pulverized concrete powder was collected and bagged for titration at the BYU Highway Materials Laboratory. Chloride concentrations were

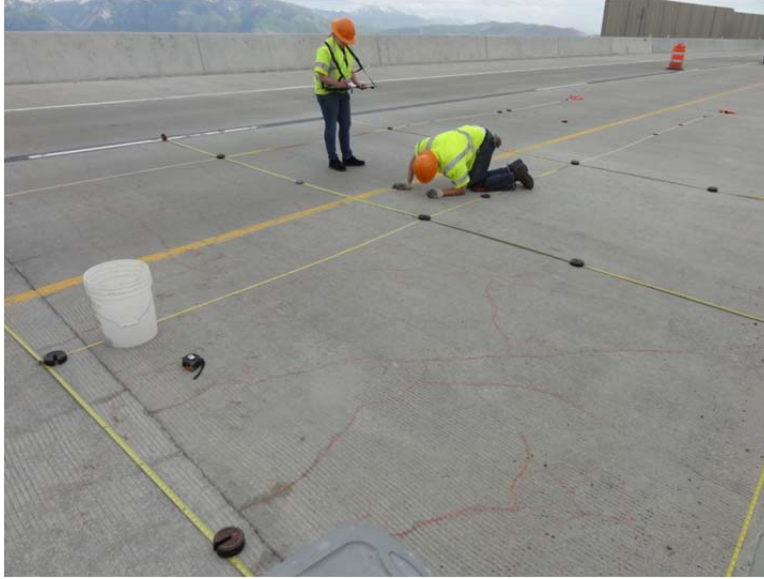
**Figure 3-20 Distress survey.**

After all of the distress surveys were performed, electronic maps of the cracking were prepared in AutoCAD for each deck for each inspection time. Maps previously prepared for the 5-month, 8-month, and 1-year surveys (23, 24, 25) were revised, as needed, to better align with those prepared for the 2-year survey, which was performed using more rigorous methods of defining crack locations than had been previously employed. In addition, the total lengths of the cracking were calculated for all the maps using an automated computer algorithm within the AutoCAD software environment rather than the manual estimation method previously utilized (23, 24, 25).

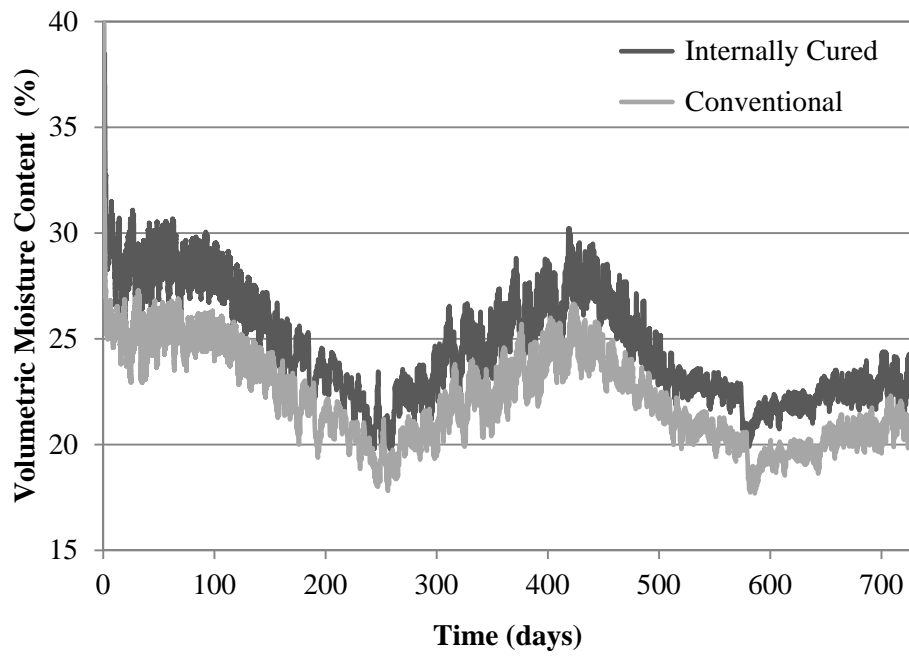
**Figure 4-1 Average volumetric moisture content for decks located at Dannon Way.**

Volumetric moisture contents, generally computed as the average of the readings obtained from each of the three sensors on each bridge deck at a given time, are shown in Figures 4-1 and 4-2 and summarized in Table 4-1. The average volumetric moisture content of the internally cured concrete was 3 to 4 percentage points higher after 7 days and 2 to 3 percentage points higher after 28 days, 3 months, 6 months, and 1 year than the volumetric moisture content of the conventional concrete. The elevated moisture content of the internally cured concrete during this time can be attributed to the use of pre-wetted LWFA in the mixture, which provides an internal source of readily available water. At 2 years, however, the difference in average moisture content between the internally cured concrete and the conventional concrete was much smaller, decreasing to less than 2 percentage points. The converging moisture contents for the internally cured and conventional concrete decks can be attributed to the gradual release and chemical reaction and/or evaporation of the water from the pores within the LWFA during the curing process. (Attributable to cracking that occurred in the internally cured decks at some sensor locations, unrepresentative and possibly erroneous moisture content measurements were observed in the data after approximately 305 days from the date of construction. These

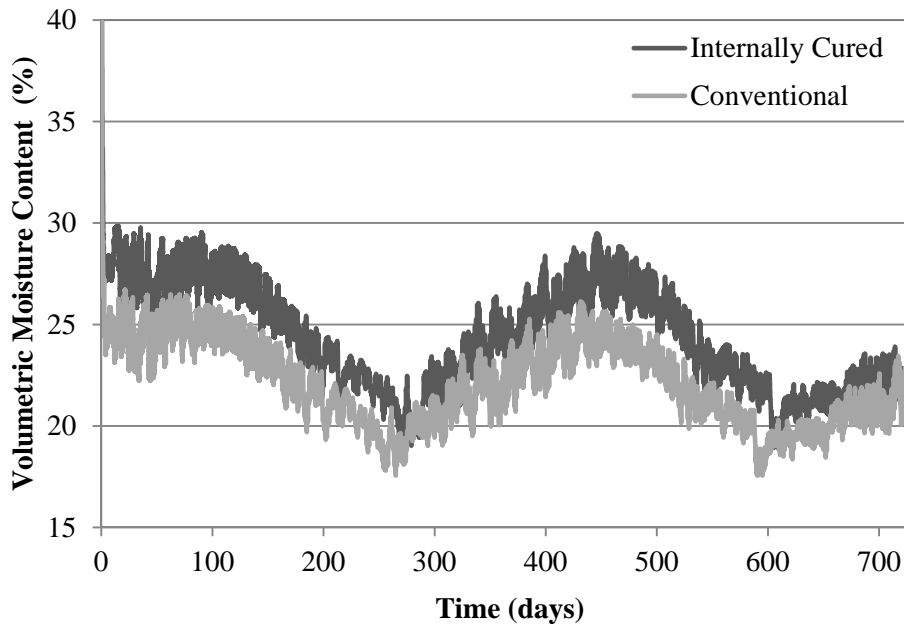
**Figure 4-2 Average volumetric moisture content for decks located at 8200 South.**

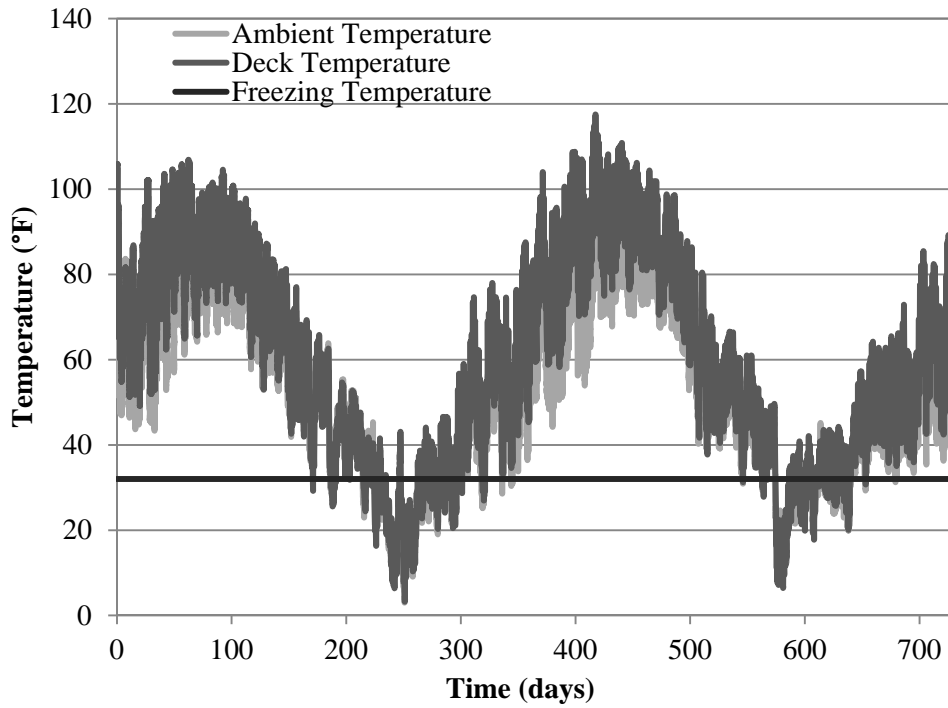
**Figure 4-3 Average temperatures for decks located at Dannon Way.**

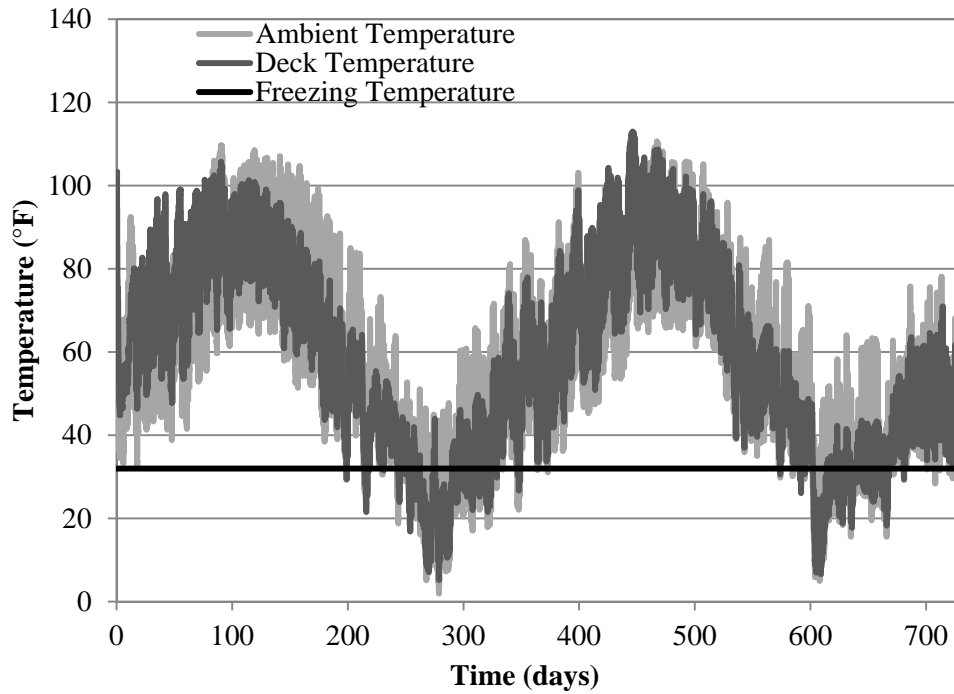
**Figure 4-4 Average temperatures for decks located at 8200 South.**

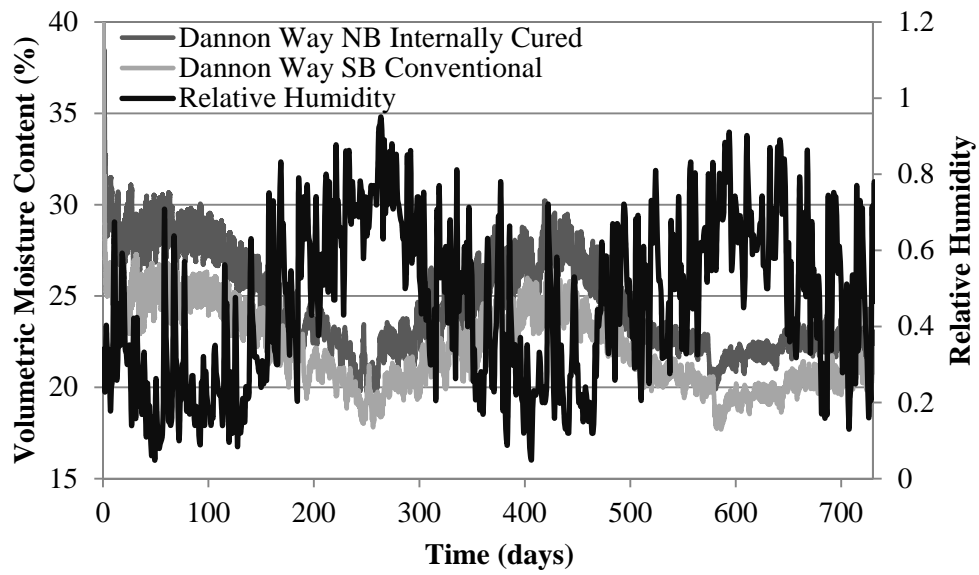
**Figure 4-5 Volumetric moisture content and relative humidity for decks located at Dannon Way.**

The influence of relative humidity and precipitation on the measured in-situ volumetric moisture contents of the concrete bridge decks can be evaluated in Figures 4-5 through 4-8. (The precipitation gauges were not installed until approximately 5 months after deck construction, so

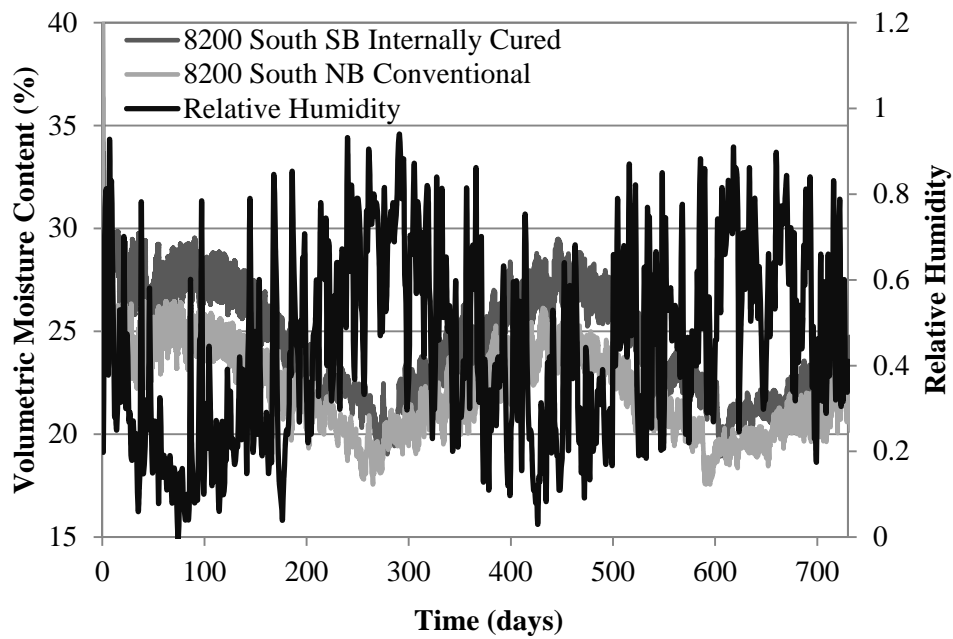
**Figure 4-6 Volumetric moisture content and relative humidity for decks located at 8200 South.**

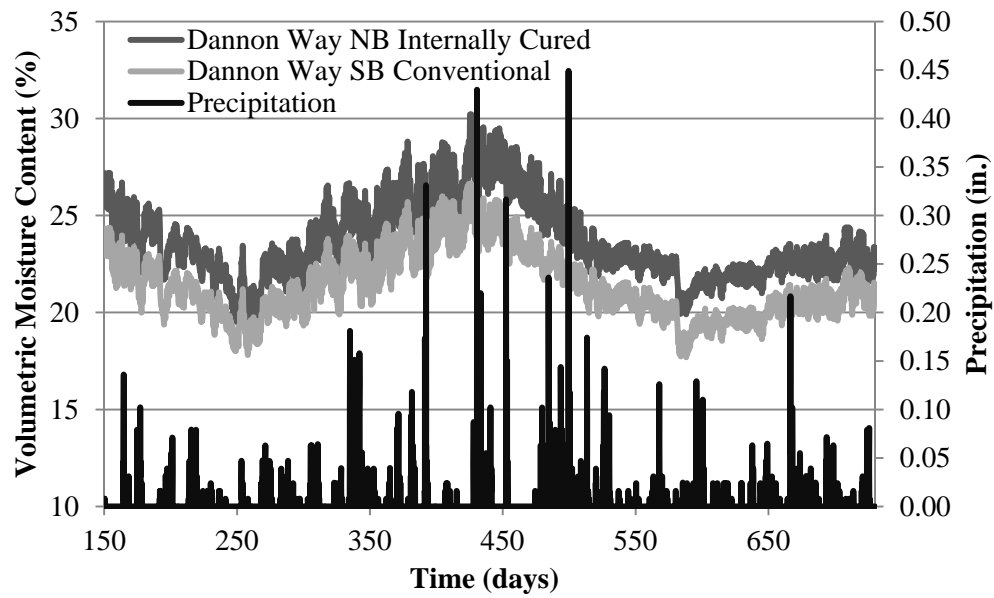
**Figure 4-7 Volumetric moisture content and precipitation for decks located at Dannon Way.**

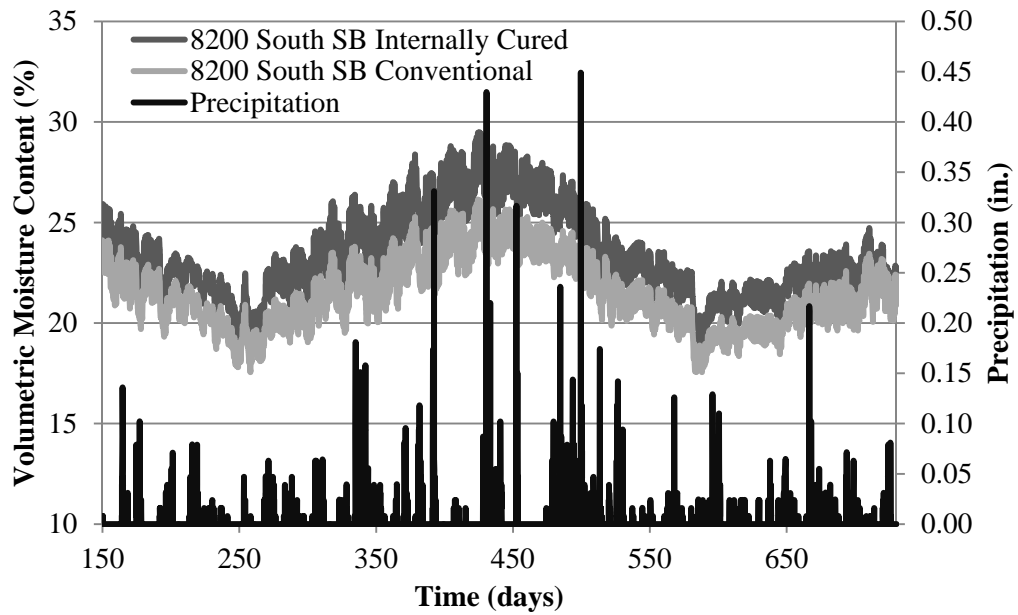
**Figure 4-8 Volumetric moisture content and precipitation for decks located at 8200 South.**

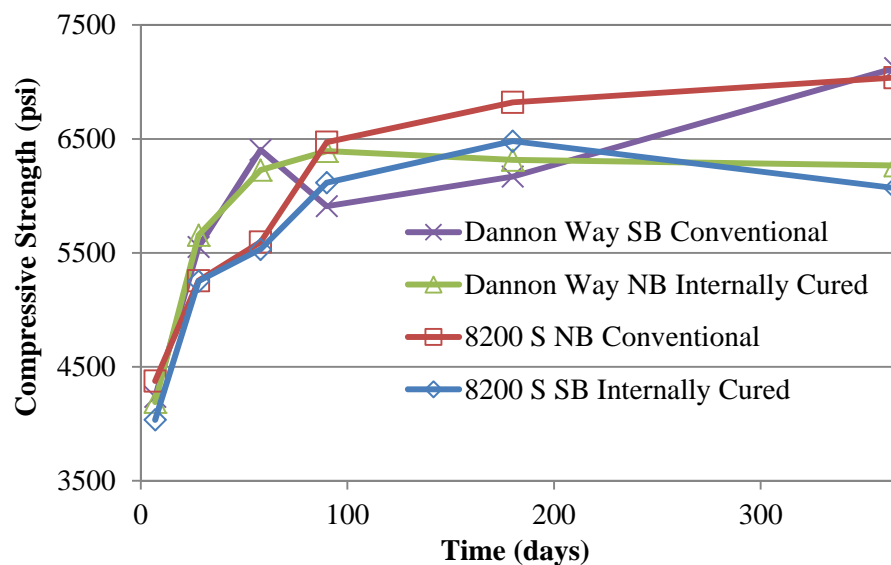
**Figure 4-11 Average concrete compressive strength.**

Figure 4-11 and Table 4-3 show the 7-day, 28-day, 3-month, 58-day, 6-month, and 1-year compressive strengths measured for each bridge deck, and measurements for individual specimens are given in Appendix B. (In Table 4-3, a hyphen means that the standard deviation could not be computed because only one specimen was tested in each case. Valid data for additional specimens was not obtained due to equipment errors.) At 7 days, the conventional concrete was stronger by an average of nearly 4.5 percent, or about 200 psi, than the internally cured concrete; however, at 28 days, the internally cured concrete was stronger by an average of nearly 1.0 percent, or about 50 psi, than the conventional concrete. As shown in Appendix B, these compressive strengths measured at BYU are consistent with those obtained by the Utah DOT for quality assurance purposes. At 3 months, the internally cured concrete was still stronger by an average of 1.0 percent, or about 60 psi, than the conventional concrete, but at 6 months the conventional concrete was stronger by 1.5 percent, or nearly 100 psi. Thus, for the first 6 months, the two concrete mixtures exhibited very similar strength characteristics. However, at 1 year, greater variability was observed in that the conventional concrete was stronger by an average of 12.9 percent, or nearly 900 psi, than the internally cured concrete. For the cylinders that were cured in the fog room for the entire 1 year, the conventional concrete was 7.4 percent, or about 450 psi, stronger than the internally cured concrete.

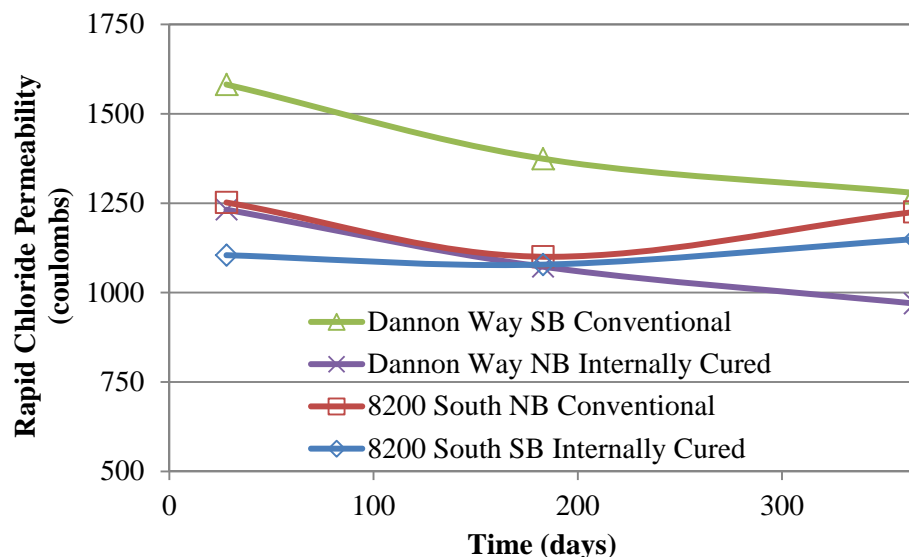
**Figure 4-12 Average rapid chloride permeability.**

For the cylinders that were cured in the fog room for the entire 1 year, the internally cured concrete passed 1.3 percent less current than that passed by the conventional concrete, on average. However, the measured chloride permeability was much lower for both types of concrete; on average, the cylinders cured in the fog room passed 70.0 percent and 65.0 percent less current at 1 year than that passed by the cylinders cured on the laboratory bench in open air

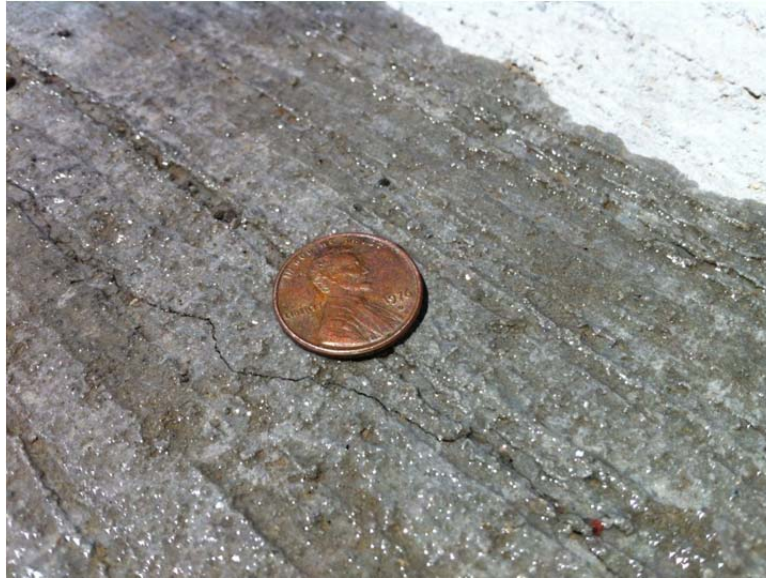
**Figure 4-13 Cracking in Dannon Way southbound conventional concrete deck at 2 months.**

Table 4-9 shows the results of the distress surveys performed at 5 months, 8 months, 1 year, and 2 years, while Appendix C provides pictorial evidence of typical crack lengths and widths and also provides full distress maps prepared for each deck upon completion of these inspections. At 5 months, the average total crack lengths for the conventional and internally cured concrete bridge decks were 216 and 45 in., respectively. At 8 months, following significant drops in temperature as winter commenced, the average total crack lengths increased to 2,244 and 342 in., respectively. Thus, on average, at 5 and 8 months, the conventional concrete bridge decks had 4.8 and 6.6 times more cracking, respectively, than the internally

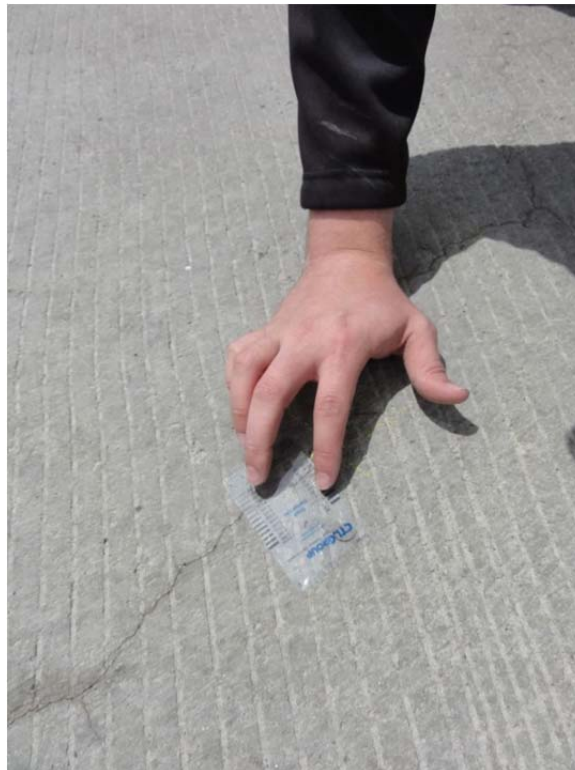
**Figure 4-15 Cracking in 8200 South northbound conventional concrete deck at 1 year.**

While the use of internally cured concrete did not prevent the occurrence of reflection cracking, it did apparently delay the propagation of such cracking. For example, at 8 months, the conventional concrete decks were starting to show evidence of transverse reflection cracking, particularly on the 8200 South NB deck, but none was observed on the internally cured concrete decks. In addition, at 1 year, the internally cured concrete decks exhibited significantly less offshoot cracking stemming from the transverse reflection cracking; indeed, in most cases, the reflection cracking on the internally cured concrete decks had little to no offshoot cracking, while the conventional concrete decks had significant offshoots creating a web-like pattern.

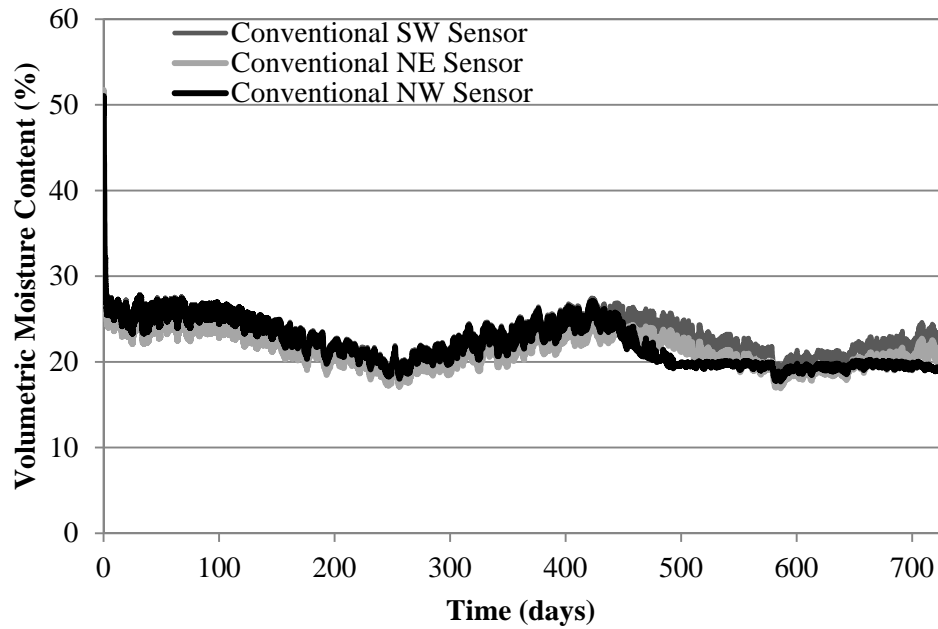
**Figure B-1 Volumetric moisture content sensor readings at Dannon Way southbound conventional deck.**

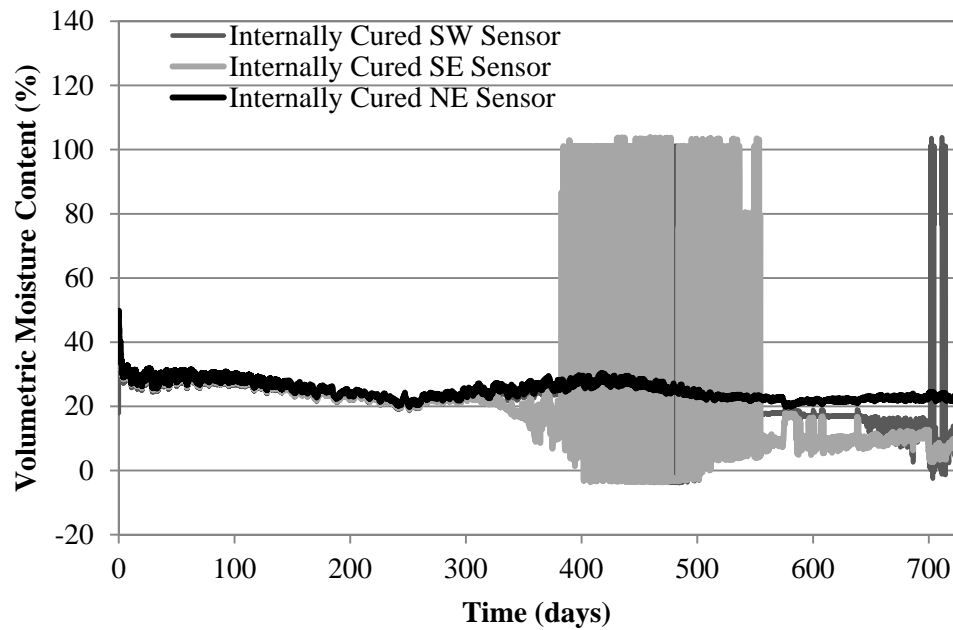
**Figure B-2 Volumetric moisture content sensor readings at Dannon Way northbound internally cured deck.**

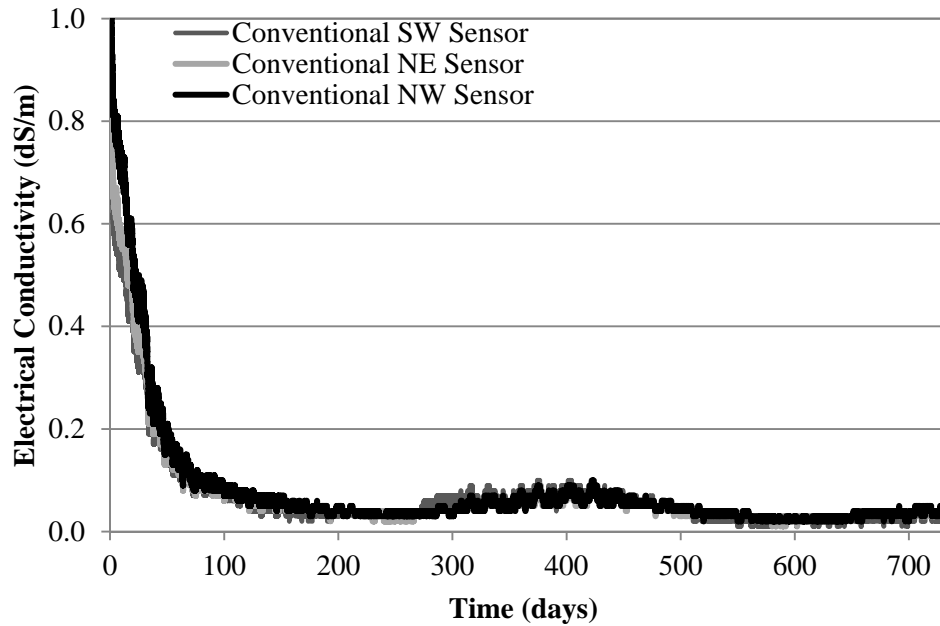
**Figure B-5 Electrical conductivity sensor readings at Dannon Way southbound conventional deck.**

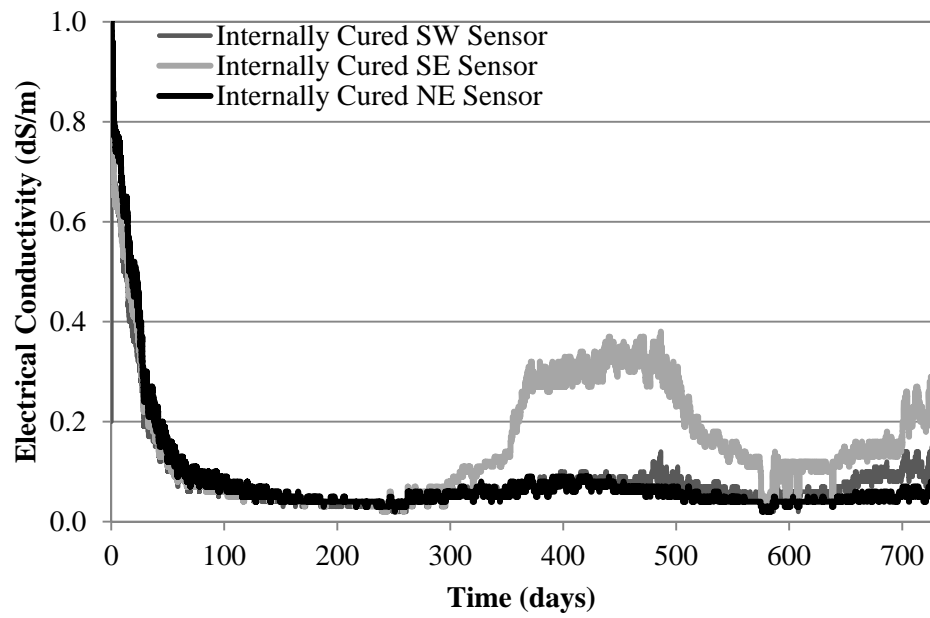
**Figure B-6 Electrical conductivity sensor readings at Dannon Way northbound internally cured deck.**

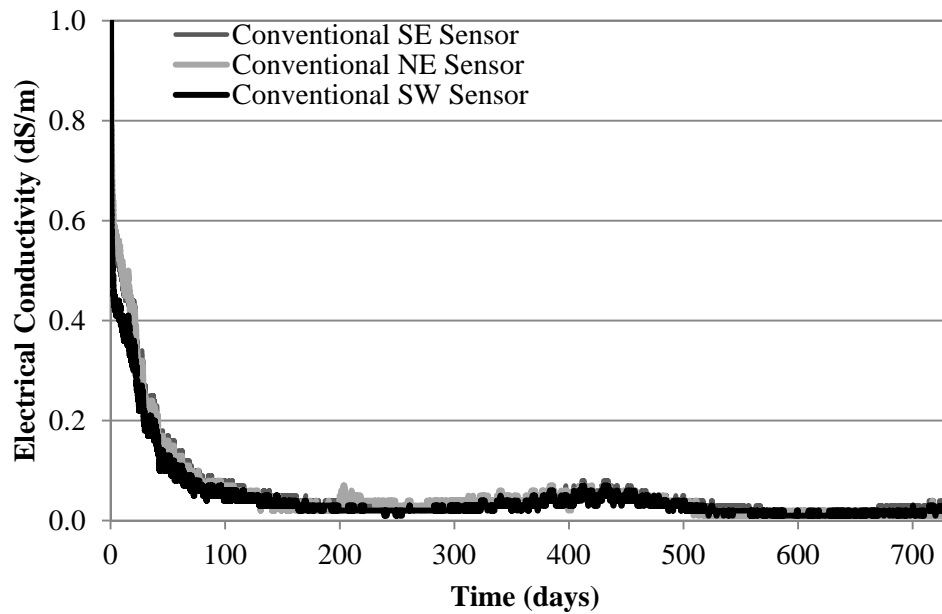
**Figure B-7 Electrical conductivity sensor readings at 8200 S northbound conventional deck.**

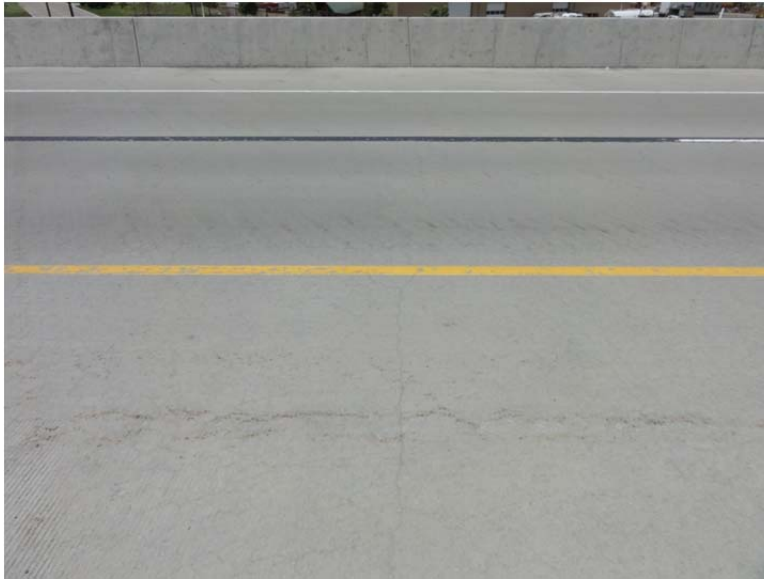
**Figure C-2 Reflection cracking from half-deck concrete panels in Dannon Way northbound internally cured concrete deck at 2 years.**

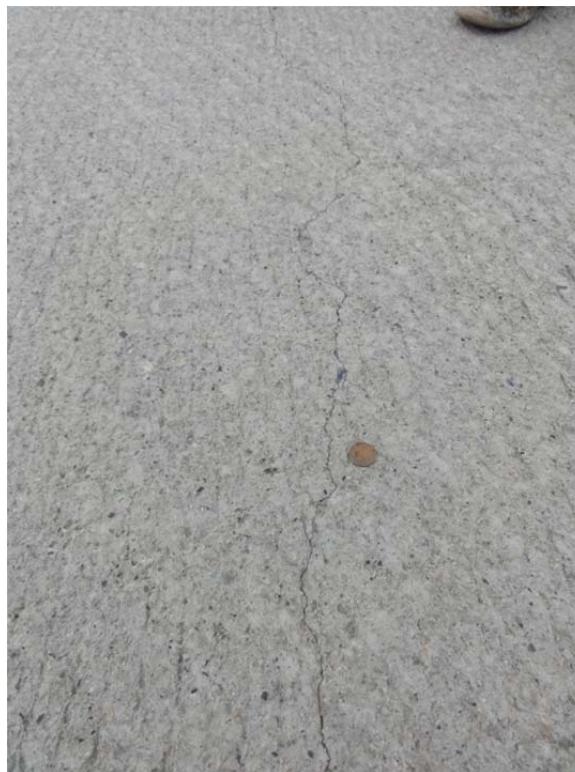
**Figure C-3 Cracking in Dannon Way northbound internally cured concrete deck at 1 year.**

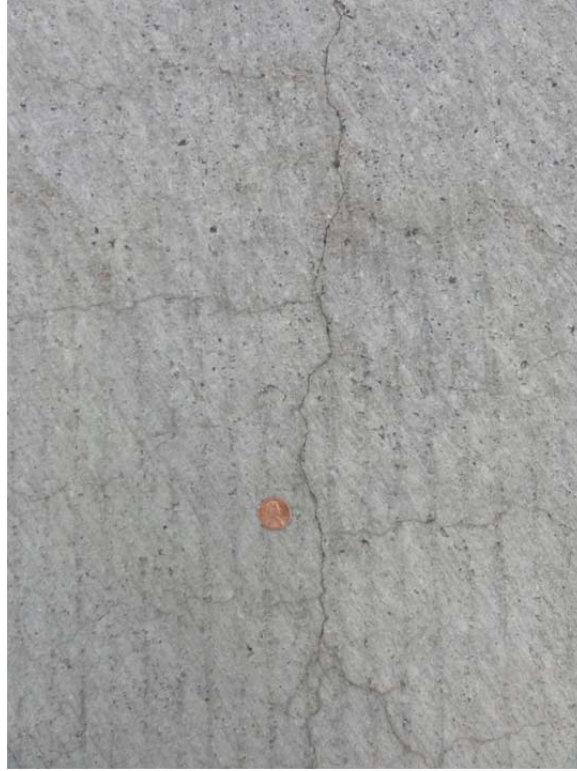
**Figure C-4 Cracking in Dannon Way northbound internally cured concrete deck at 2 years.**

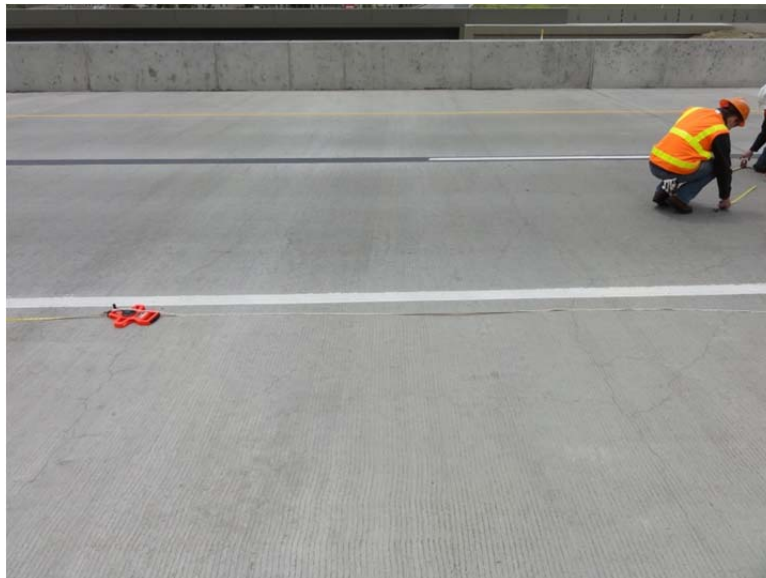
**Figure C-5 Reflection cracking from half-deck concrete panels in 8200 South northbound conventional concrete deck at 1 year.**

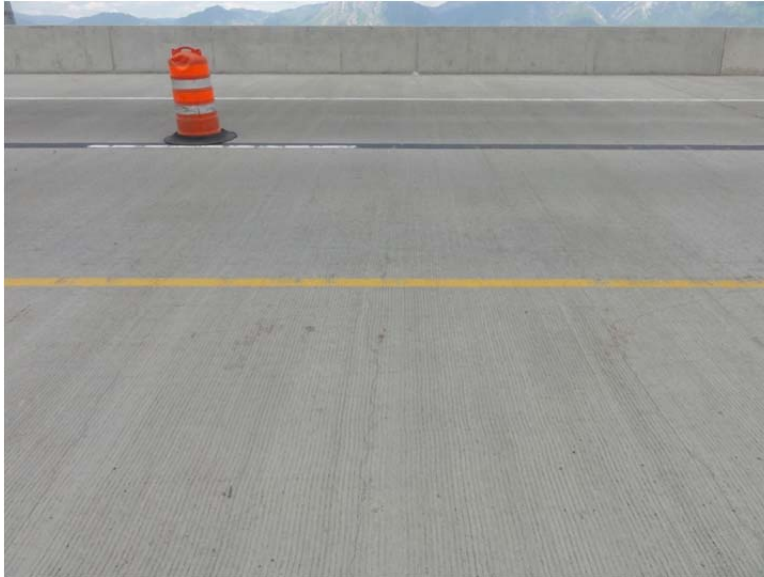
**Figure C-6 Reflection cracking from half-deck concrete panels in 8200 South northbound conventional concrete deck at 2 years.**
