Report No. UT-1X.XX

## **INTERNAL CURING OF CONCRETE BRIDGE DECKS IN UTAH: MOUNTAIN VIEW CORRIDOR PROJECT**

Brigham Young University  
Department of Civil and Environmental  
Engineering

**Final Report  
August 2014**

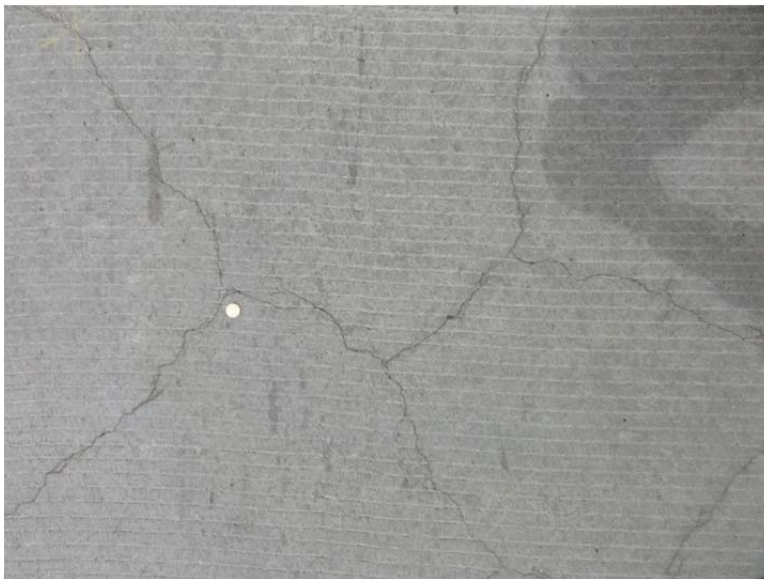
**Figure C-7 Cracking in 8200 South northbound conventional concrete deck at 1 year.**

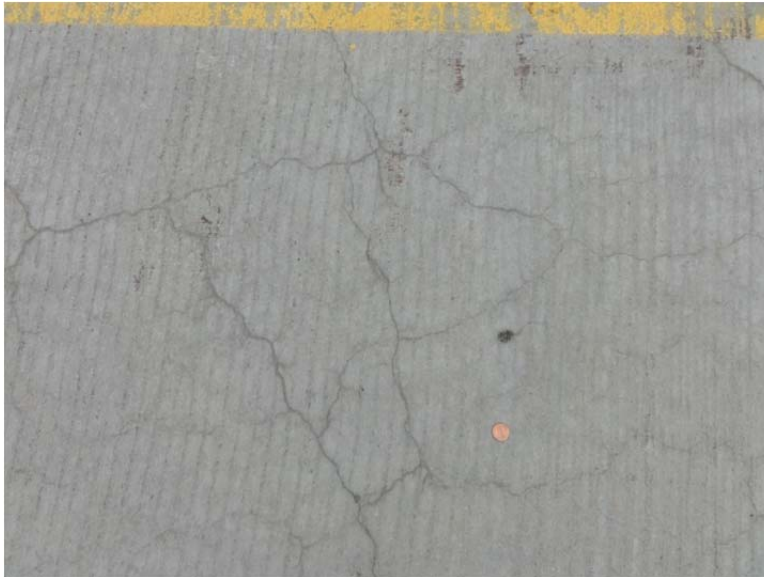
**Figure C-8 Cracking in 8200 South northbound conventional concrete deck at 2 years.**

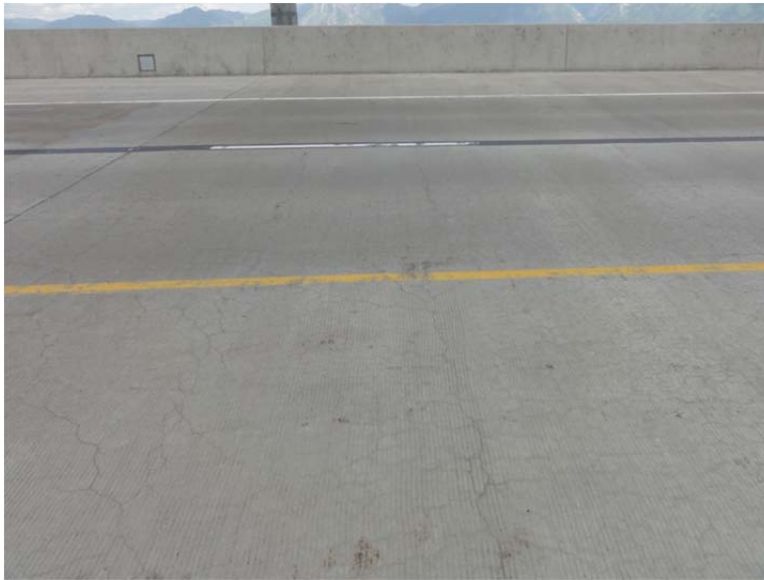
**Figure C-10 Reflection and map cracking in 8200 South northbound internally cured concrete deck at 2 years.**
