# Prevention of Longitudinal Cracking in Iowa Widened Concrete Pavement

**Final Report**  
**June 2018**

**Sponsored by**  
Iowa Highway Research Board  
(IHRB Project TR-700)  
Iowa Department of Transportation  
(InTrans Project 16-563)

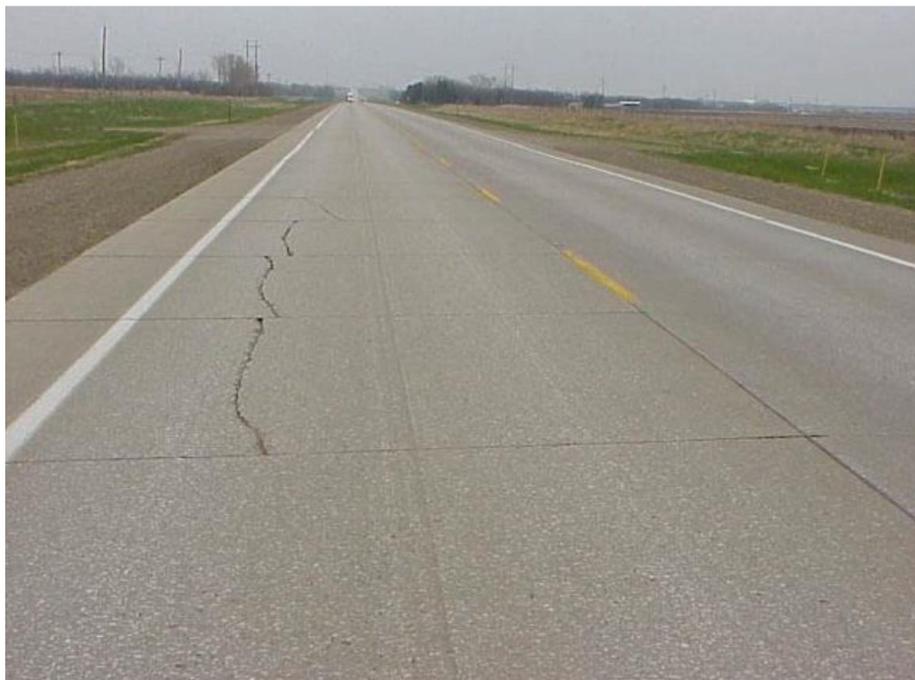
**Figure 19. Longitudinal cracking noticed in South Dakota**

Johnston (2014) presented issues and solutions related to longitudinal cracking of pavements in South Dakota (Figure 19). Several key features related to longitudinal cracking on new pavement projects since 1986 were summarized as follows:

- Length of cracking extends for miles.
- Cracking is typically confined to lane center and outer wheel path.
- Cracks continue to appear over time.
- Cracking predominates in wider 28 to 30 ft pavements compared to conventional 24 ft pavements.
- Cracking shows statewide distribution (Johnston 2014).

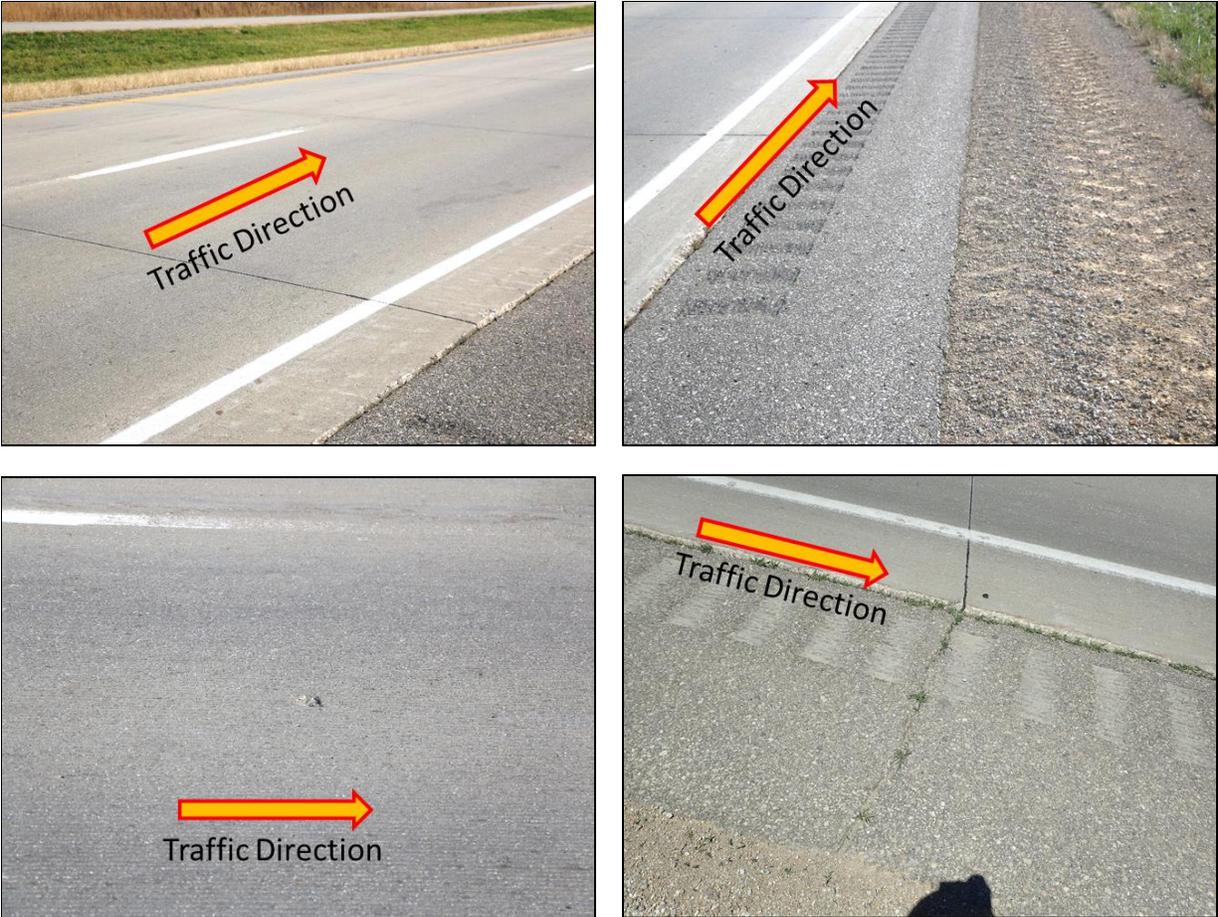
Field investigations at control site 3 on US 30 in Tama County were conducted on the afternoon of June 15, 2017. Photos and measurements taken to document site conditions include slab geometry, shoulder type and geometry, joint type, and amount and location of cracks. As expected, no cracking was observed on the pavement surface at this site. Few cracks were seen on the HMA shoulder. Figure 31 illustrates site conditions based on the field investigation.

**Figure 31. Field investigation on control site 3 on US 30 near Tama County, Iowa**

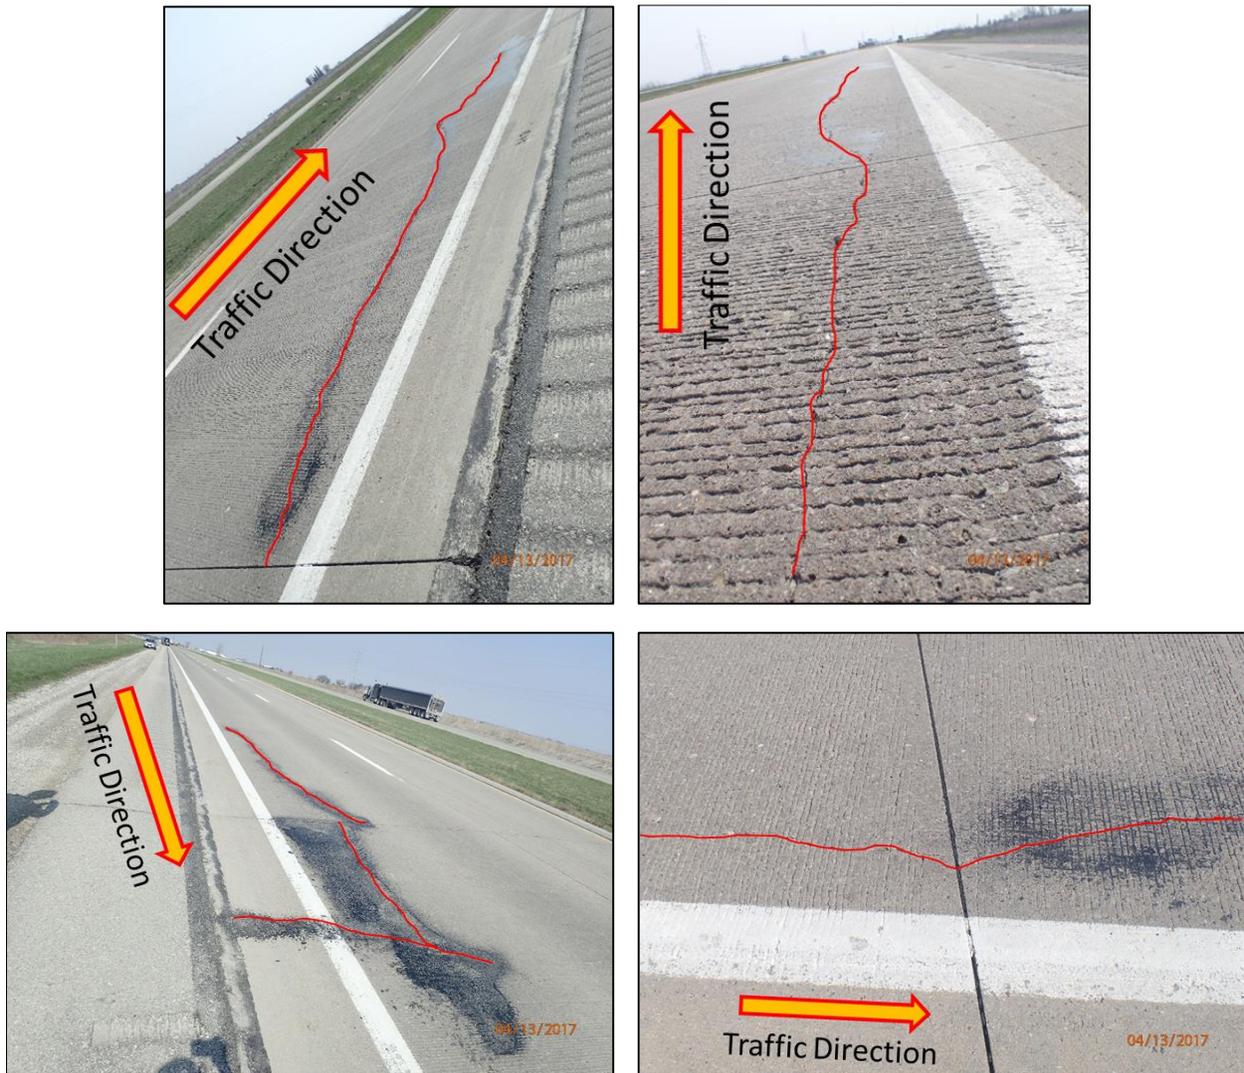
transverse cracking was observed at some slabs. Figure 43 illustrates the longitudinal cracking observed during the field survey.

**Figure 43. Field investigation on LC site 5 on IA 163 near Jasper County, Iowa**
