Deicer Scaling Resistance of Concrete Pavements, Bridge Decks, and Other Structures Containing Slag Cement

Pooled Fund Project TPF-5(100)

S. Schlorholtz, Iowa State University
R.D. Hooton, University of Toronto

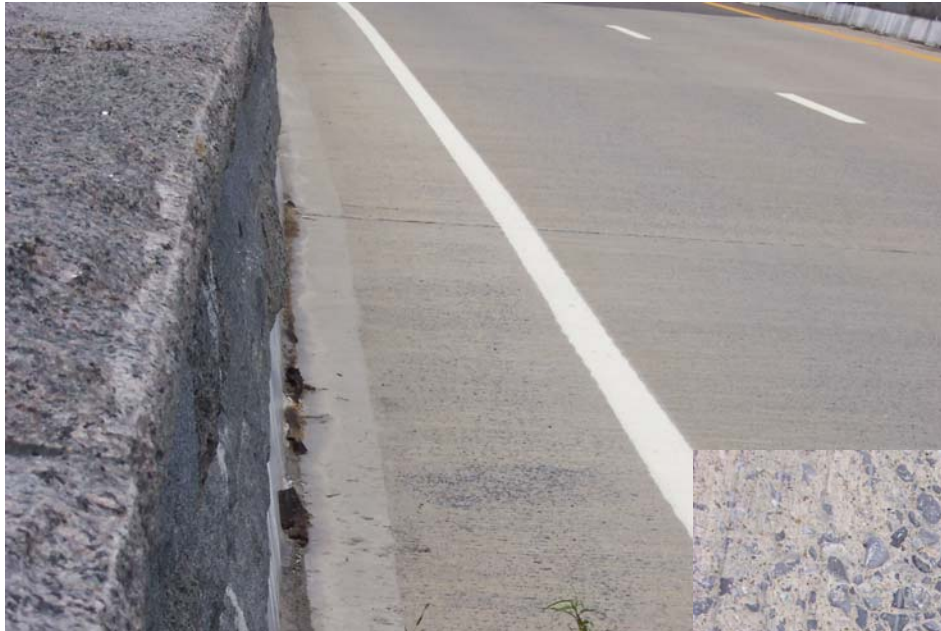
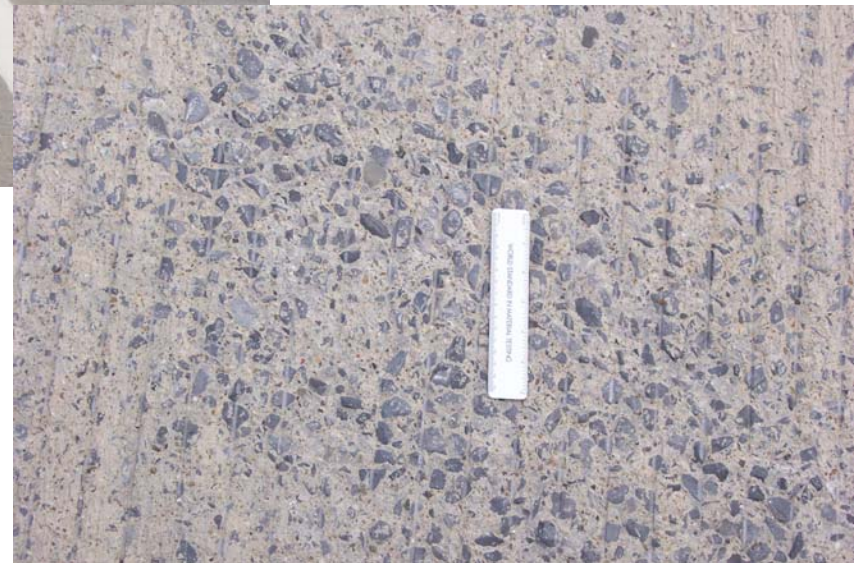
Site 2: NY, Taconic St. Parkway, SB

Scaling on shoulder
but less on driving
lanes.
