ROAD MAP TRACK 1
Performance-Based Concrete
Pavement Mix Design Systems

PRIMARY SOURCE
Deleterious Chemical Effects of Concentrated Deicing Solutions on Portland Cement Concrete
Lawrence Sutter (Michigan Technological University [MTU]), Karl Peterson (MTU), Thomas Van Dam (MTU), R. Doug Hooton (University of Toronto), and Gustavo Julio-Betancourt (University of Toronto)

MAP Brief 1-2:

Deleterious Chemical Effects of Deicing Solutions on Concrete Pavements

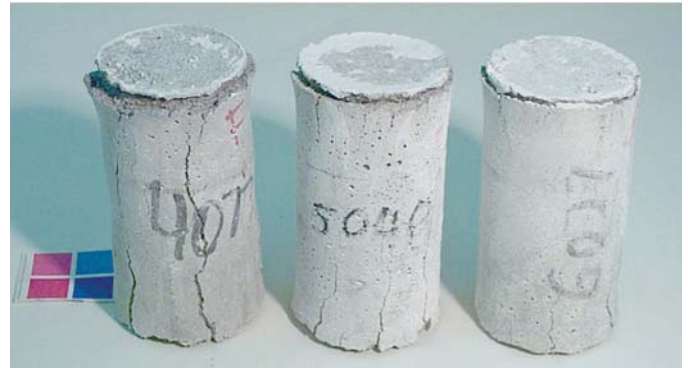
Figure 1. Cylinders exposed to CaCl_2 solution after 84 days of constant low temperature test. From left to right: 0.40, 0.50, and 0.60 w/c mortar cylinders.

The specimens exposed to CaCl_2 and MgCl_2 (figures 1 and 2) exhibited severe deterioration, while those exposed to NaCl and lime water did not show any signs of deterioration (figures 3 and 4).

In all cases, petrographic analysis found that the observed deterioration was caused by the formation of expansive calcium oxychloride and magnesium oxychloride. The oxychloride phases form through a chemical reaction between calcium hydroxide in the hardened cement paste and chloride ions from the deicer.

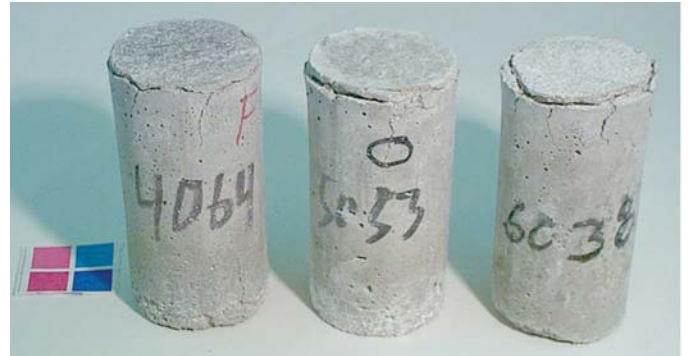
Figure 2. Cylinders exposed to MgCl_2 solution after 84 days of constant low temperature test. From left to right: 0.40, 0.50, and 0.60 w/c mortar cylinders.

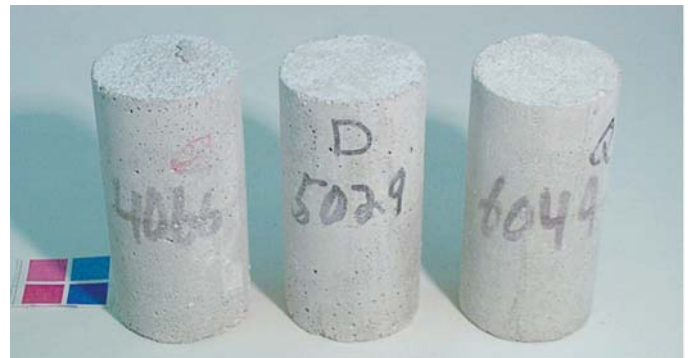
Figure 3. Cylinders exposed to NaCl solution after 84 days of constant low temperature test. From left to right: 0.40, 0.50, and 0.60 w/c mortar cylinders.

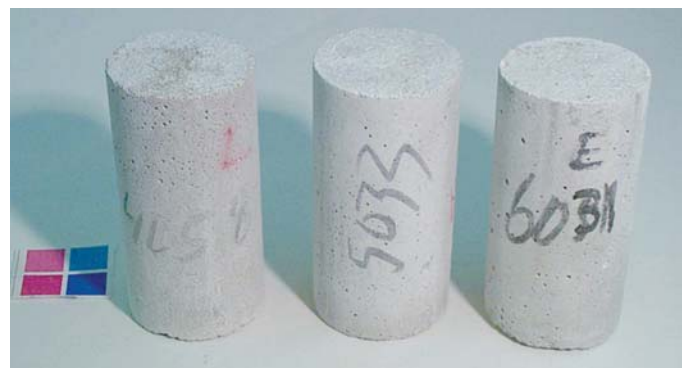
Figure 4. Control cylinders exposed to lime water solution after 84 days of constant low temperature test. From left to right: 0.40, 0.50, and 0.60 w/c mortar cylinders.

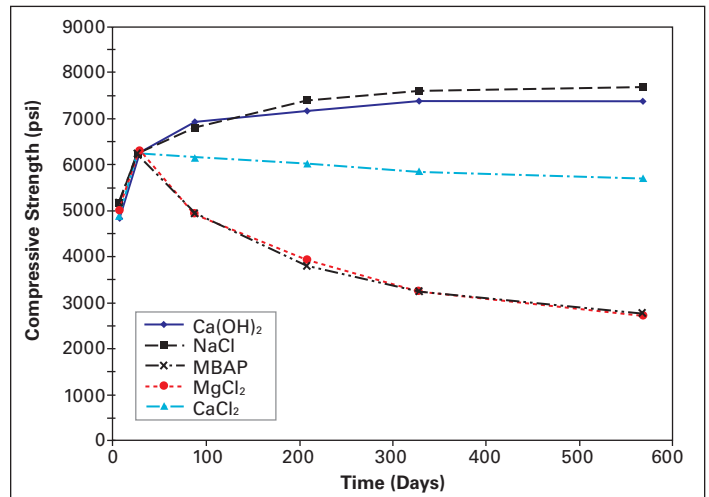
Figure 5. Compressive strength evolution with time of mortar cubes exposed to different deicers.

Other mortar specimens (cubes and length change bars) were prepared using a w/c of 0.485 and cement-sand ratio of 2.75, per the ASTM recommended mixture for mortar specimens (ASTM C1012- 04, “Test Method for Length Change of Hydraulic-Cement Mortars Exposed to a Sulfate Solution”). However, these specimens were immersed in three molar concentration solutions of the respective deicers and subjected to tests at various time intervals. The specimens exhibited significant loss in strength and expansion, as shown in figures 5 and 6, as well as mass gain.

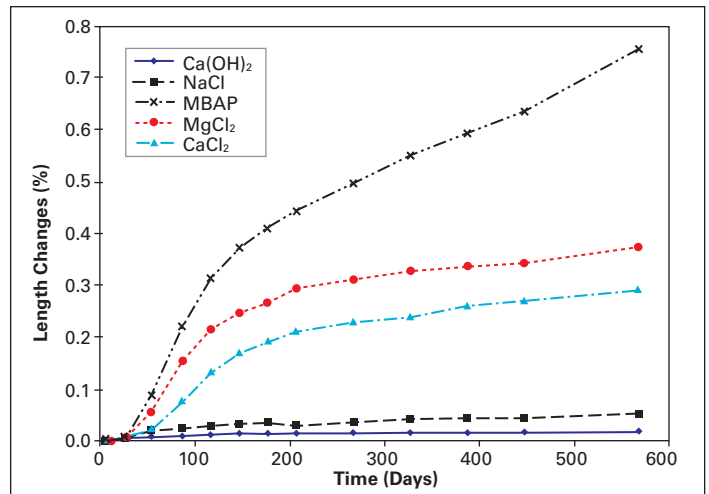
Figure 6. Length change of mortar bars with time for mortar bars exposed to different deicers.

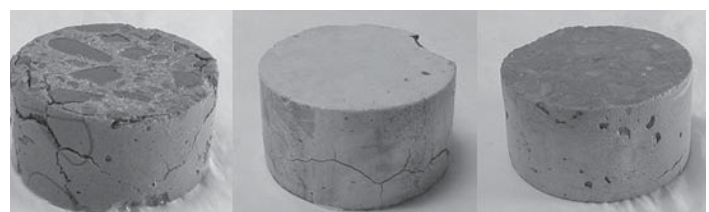
Figure 7. Four-inch [100 mm] diameter 0.45 w/c portland cement concrete specimens after 500 days in high concentration brines. L to r: Samples exposed to CaCl₂, MgCl₂, and MBAP brines.

The specimens were immersed in the same deicers used in the mortar experiments, as well as calcium magnesium acetate and a magnesium chloride-based agricultural product. The concrete specimens were exposed under the same conditions used in the mortar experiments (i.e. for both solution strength and temperature) but for longer times, up to 500 days. Deterioration of the concrete specimens resembled that seen for the mortar specimens (figures 7-8). In all cases, the observed distress was associated with the formation of the oxychloride phases seen in the mortar specimens.

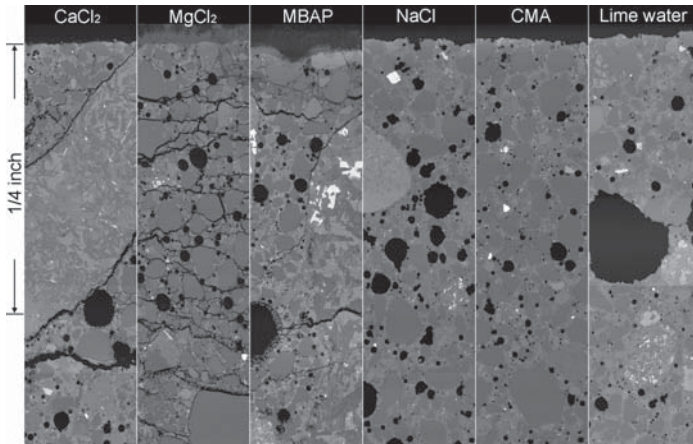
Figure 8. Cross-section at concrete surface after long-term exposure to various solutions at 40° F, back-scattered electron images

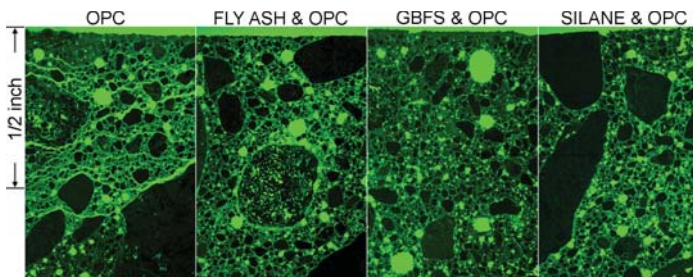
Figure 9. Cross-section at concrete surface after long-term exposure to magnesium chloride brine at 40° F, epifluorescent optical microscope images

In all cases, concrete mixtures prepared using Class F fly ash or GBFS performed significantly better than those made with portland cement alone, with no distress observed in specimens after 500 days of exposure (figure 9). Quantitatively, the reduction in chloride ingress observed was shown by a dramatic reduction in diffusivity for all deicers, a reduction in sorptivity, and microstructurally by reduced calcium hydroxide depletion and oxychloride formation.

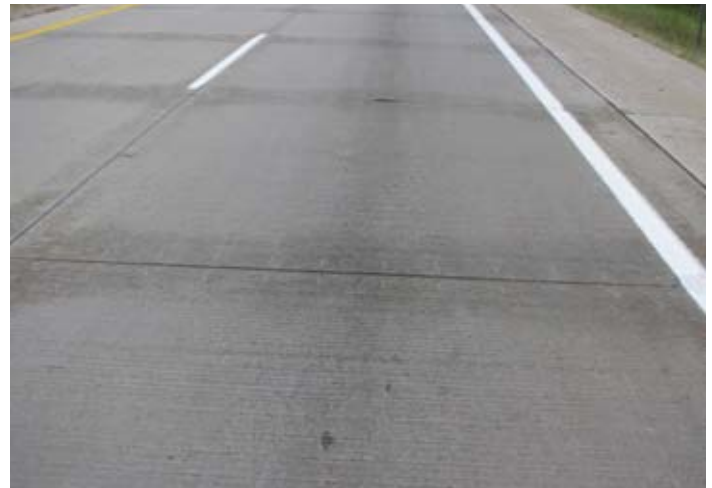
Figure 10. Several concrete freeway pavement projects constructed since 1999 have developed unexpected spalling with associated dark staining along joints.

In a number of upper-Midwestern states, for example, several concrete pavements constructed since 1999 have developed unexpected scaling/spalling with associated dark-

staining along joints (figure 10), particularly the longitudinal, centerline joint. Initial studies have identified a number of possible causes, including chemical attack from deicers. Understanding the cause of this reported premature deterioration is integral to understanding the life-cycle impact of deicers on concrete.
