Report Title		Report Date: 2000
Speed Monitor Display		
Principle Investigator Name Maze, Tom Affiliation Iowa State Univ Address 2901 S. Loop Drive, Suite 3100 Ames, IA 50010 Phone 515-294-9523 Fax 515-294-0467 Email tmaze@iastate.edu		Vendor Name and Address Speed Measurement Labs Carl Fors 2300 Harvest Glen Fort Worth, TN 76108 (817) 560-9318
Author(s) and Affiliation(s)		
Supplemental Funding Agency Name and Address (if applicable)		
Supplemental Notes		
Abstract

SPEED MONITOR DISPLAY

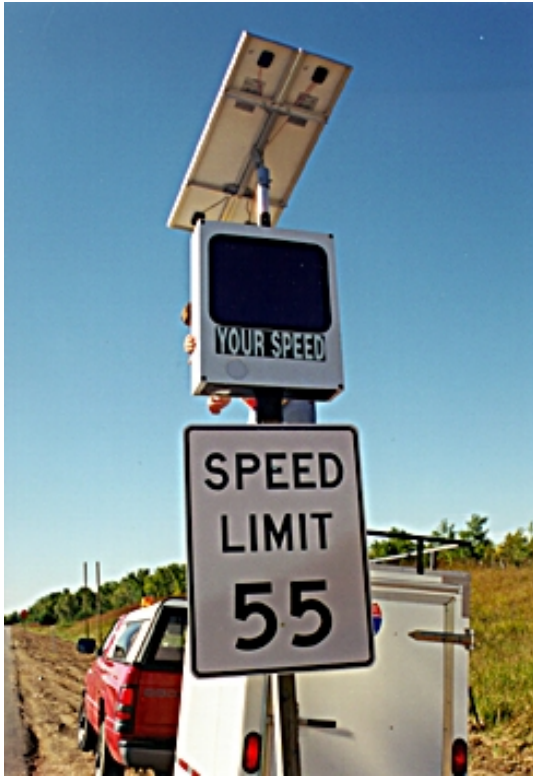
FIGURE 2-6 Speed monitor display mounted on Interstate 35.

The speed monitor display consists of a large white box which houses a K-band radar and two 18-inch LED characters, which are visible in direct sunlight from up to 1,000 feet away. The radar detects the approaching vehicles and shows their speeds on the LED display. The display box also has an overspeed option, which flashes motorists' speeds when they exceed the speed limit. The speed threshold in this study was set to 55 mph, which was the posted regulatory speed limit of the work zone.

The speed monitor display used in this study included a solar power panel, which was mounted atop the box. This panel supplied power to the unit, and excess power was stored in a solar car-type battery housed in the box. The K-band radar used in the system broadcasts a directional radar beam over approximately one mile.

The case study work zone consisted of a left lane closure with a crossover leading into head-to-head traffic. The speed display was mounted atop a stationary pole (see Figure 2-6) located 2,250 feet upstream of the lane closure taper.
