MIDWEST SMART WORK ZONE DEPLOYMENT INITIATIVE
MwSWZDI
FHWA POOLED FUND STUDY

Report Title		Report Date: 2000
LightGuard System		
Principle Investigator Name Meyer, Eric Affiliation Meyer ITS Address 2617 W 27th Terrace Lawrence, KS 66047 Phone 785 843 2718 Fax 785 843 2647 Email emeyer@insighthawks.com		Vendor Name and Address LightGuard Systems, Inc.
Author(s) and Affiliation(s) Eric Meyer (Univ of Kansas)		
Supplemental Funding Agency Name and Address (if applicable)		
Supplemental Notes		
Abstract This project designed and evaluated a system of lighted RPMs used to delineate a crossover in advance of an Interstate work zone. Vehicle speeds were collected at the crossover and approximately half a mile upstream of the crossover. Lane keeping data was also collected by utilizing several automatic traffic recorders, a complex array of pneumatic hoses, and some custom software. The system was found to result in statistically significant reductions in speed and in the number of vehicles nearing the edgeline (i.e., within 1-ft for cars, 2-ft for trucks). The system demonstrated the capability to improve delineation in a rural crossover, but the need for power to operate the lights cou

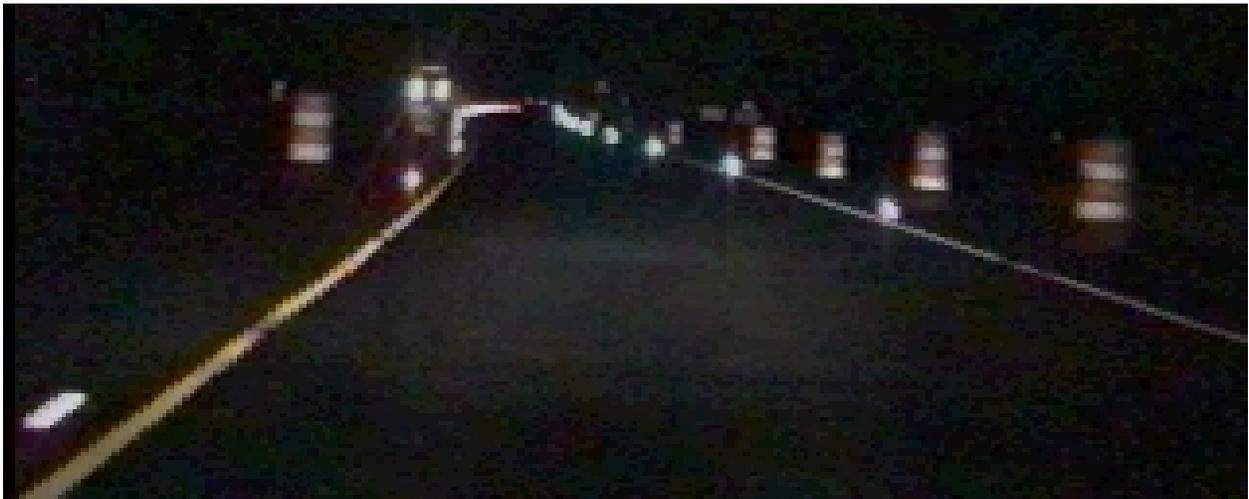
FIGURE 3-7 Crossover delineated by Lightguard Lighted RPMs.

Figure 3-7 is a portion of a frame from the drive-through video taken in the crossover after the LightGuard system had been turned on. The lighted RPMs clearly delineate the geometry of the roadway ahead. Figure 3-8 was excerpted from video footage of another crossover in the same construction project. Standard traffic control was used in this crossover, including only reflectorized drums and edge lines for delineation.

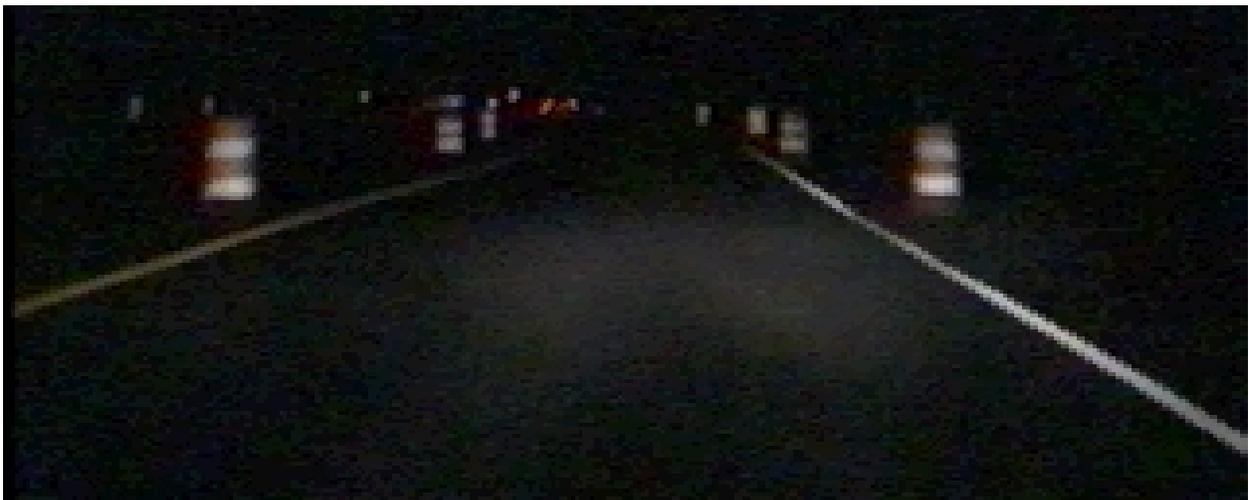
FIGURE 3-8 Crossover without lighted delineation.
