REMOVABLE ORANGE RUMBLE STRIPS

Advance Traffic Markings

Evaluation Team

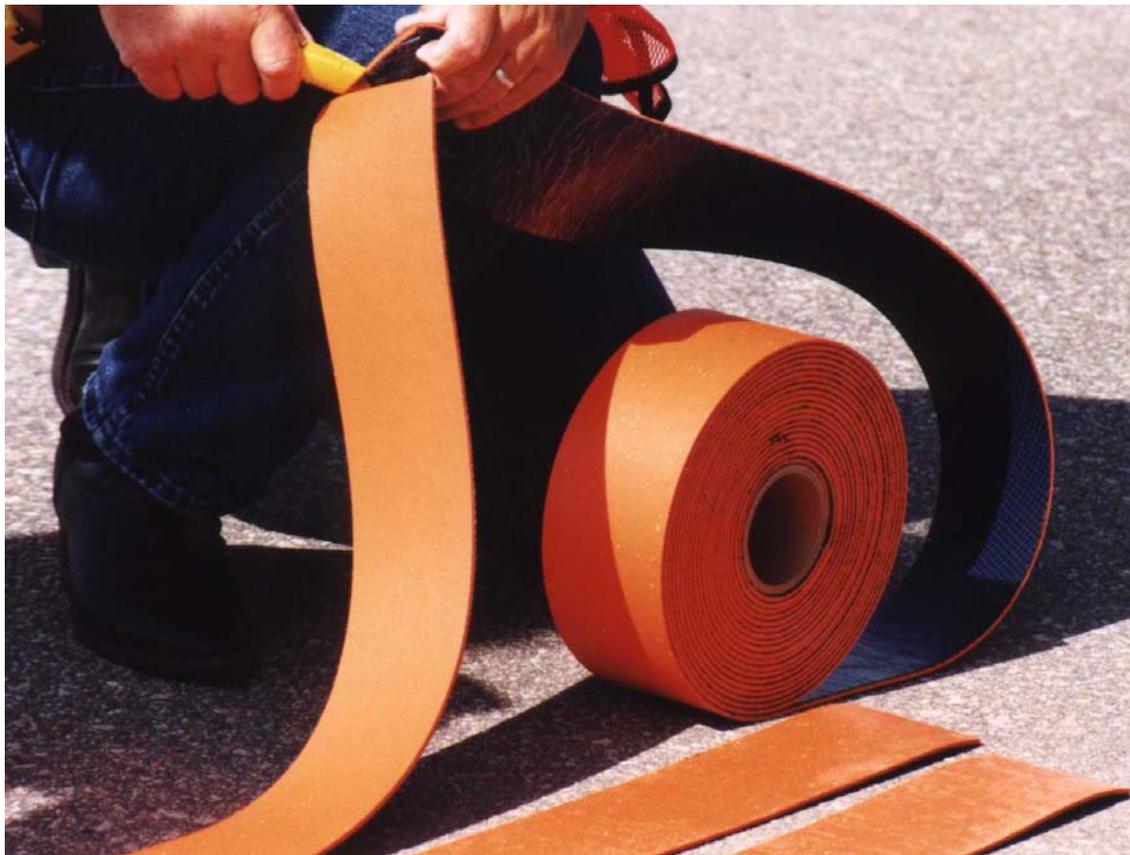
Figure 4. Cutting Rumble Strips to Appropriate Length

The installation of the removable rumble strips was very simple. The locations were set out with a measuring wheel and a tape measure. A 12" spacing was chosen to coincide with the spacing of the standard pattern of asphalt rumble strips. Strips were cut in 12 ft segments, as depicted in Figure 4, to run from centerline to edgeline. One by one, each strip was held on each end while a third crew member peeled the protective backing to expose the tar based adhesive. Then the strip was positioned on the pavement and pressed into place. Finally, a tampering cart with a 200 lb loading, shown in Figure 5, was rolled across each strip six times to assure good adhesion between the strip and the pavement. No additional adhesive was used, and the strips were placed on the pavement in its existing condition.

Because the amount of product available was insufficient for a complete pattern of rumble strips, the pattern was adjusted to include only one set of three groups of strips, each comprised of 6 strips. A crew of 5 men worked for approximately 30 minutes to install the pattern of 18 strips. It should be noted that only one member of the crew had ever worked with this product before. It is likely that an experienced crew of 3 could have performed the installation just as quickly.
