WIZARD CB ALERT SYSTEM

The primary goal of this evaluation was to determine the effectiveness of the Wizard CB alert system (CB message) as located in the approach to a highway work zone. The CB message is intended for use both with stationary long-term work zones and with short-term moving projects. The specific research objectives were:

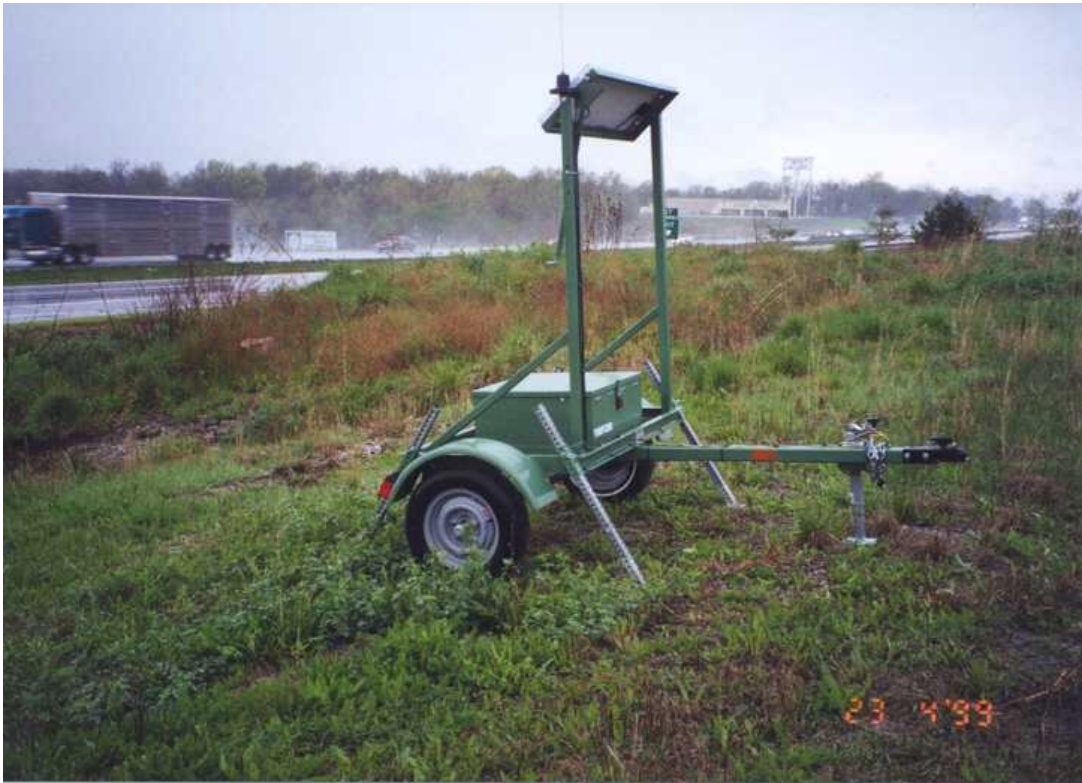
FIGURE 4-36 Wizard CB alert system.

The highway normally has a 70-mph speed limit, but the posted speed limit approaching the work zone was reduced first to 60-mph and then to 50-mph. The solar-powered, trailer-mounted CB wizard alert system broadcasts a work zone alert and information for advance warning about potentially hazardous conditions on a CB radio channel (Figure 4-36). The CB message was broadcast on Channel 19 from a location approximately 6 miles (9.67 km) upstream of the lane closure. The system transmitted the following message when the right lane was closed: "This is the Missouri Department of Transportation. The right lane of Eastbound I-70 is closed ahead. Watch for slow or stopped traffic." A similar message was transmitted when the left lane was closed.

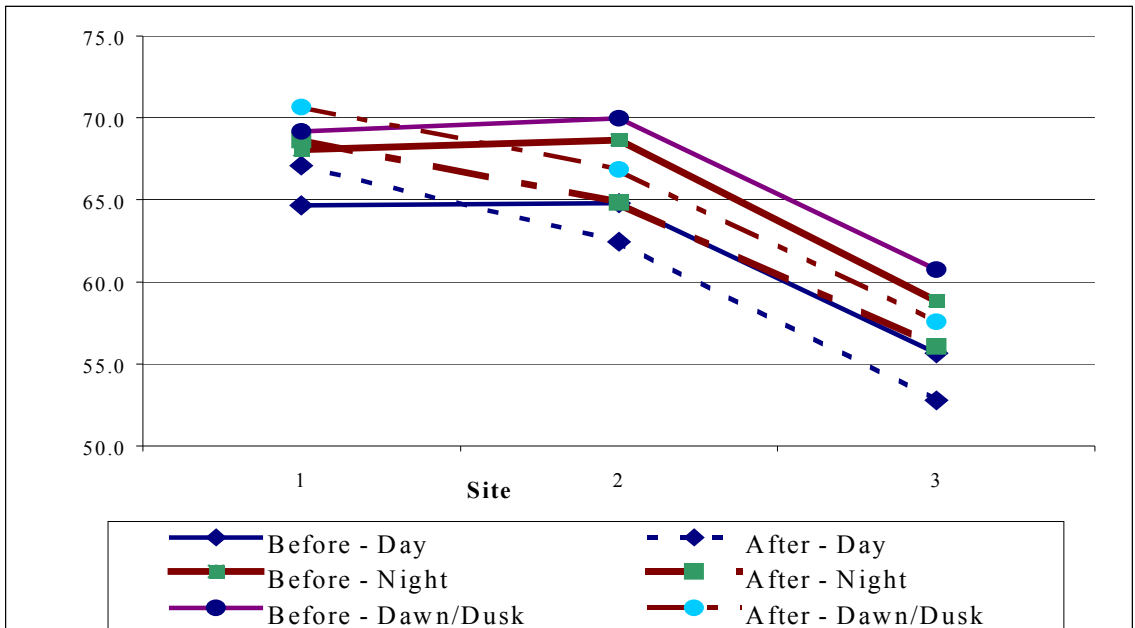
FIGURE 4-42 Mean speed profiles for open lane – *passenger vehicles*.

Figures 4-41 to 4-43 show the mean speed profiles for the open lane for the before and after cases. At Sites 2 and 3, mean speeds tended to be lower in the after case.
