Report Title	Report Date: 2002
Evaluation of Rumbler, Preformed Rumble Strip	
Principle Investigator Name Horowitz, Alan Affiliation Univ of Wisconsin, Milwaukee Address PO Box 784 Milwaukee, WI 53201 Phone 414-229-6685 Fax Email horowitz@uwm.edu	Vendor Name and Address Swarco Industries Tom Sheets PO Box 89 Columbia TN 38402 (319) 732-5195
Author(s) and Affiliation(s) Alan J. Horowitz (Univ of Wisconsin, Milwaukee), Thomas Notbohm (WisDOT)	
Supplemental Funding Agency Name and Address (if applicable)	
Supplemental Notes	
Abstract The Rumbler is a temporary rumble strip consisting of several plastic bumps that are six inches wide, four (to six) feet long, and between 0.15 and 0.25 inches high. They are affixed to the pavement with an adhesive. The Rumbler was installed on the northbound approach of a recently signalized intersection in rural Dodge County, WI. Vehicular speeds were measured both before and after the installation of the Rumbler to test the hypothesis that the warning would evoke an immediate driver response. In addition, noise and vibration levels interior to an automobile were recorded for both the Rumbler and a nearby conventional rumble strip. The Rumbler is much

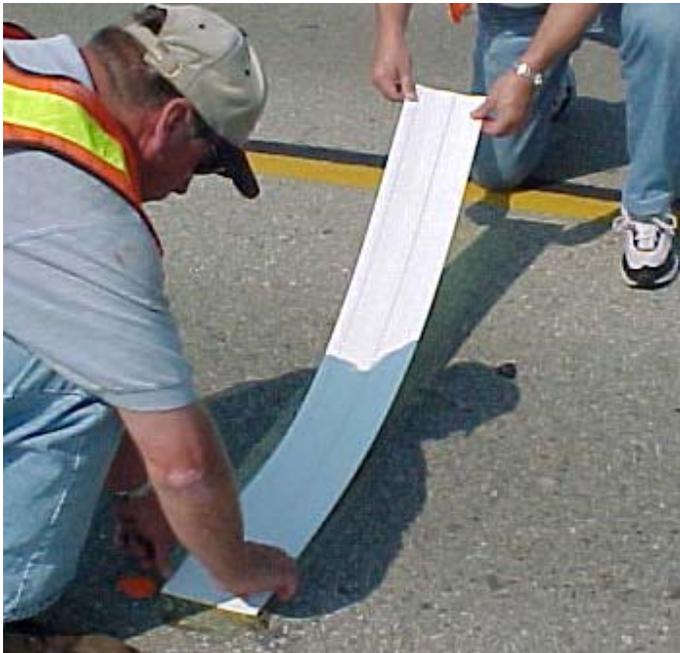
The Rumbler is a product of Swarco Industries (PO Box 89, Columbia TN 38402). The product consists of several plastic strips that are six inches wide, four (to six) feet long, and between 0.15 and 0.25 inches high. The plastic is a mixture primarily of polymer resins and glass beads. It comes in three solid colors; white strips were used in this evaluation. Swarco describes the Rumbler as “designed to provide a durable, cost-effective means of producing an audible, visual and vibratory warning to the motorist in areas where the motorists should be alerted to changes in their normal traffic or driving environment”. Swarco further states that the Rumbler is “ideal to effectively influence driver behavior where speed reduction, advance notice of upcoming construction zones or potentially critical traffic situations need to be managed”. The Rumbler is glued to the pavement in a set of lines such that a vehicle’s tires would hit several strips within a short time interval. The Rumbler is advertised to produce an 80 decibel (dB) warning interior to a vehicle at speeds between 30 and 55 mph. Figure 1 shows a Rumbler being glued to a road.

Figure 1. A Strip of the Rumbler Being Glued to a Road

The installation of the Rumbler was judged to be very straightforward. A flagging operation was needed to divert traffic from the lane. The surface of the road was inspected for condition. The road was swept clean, and two layers of contact cement were applied to the road location of each strip, and one layer was applied to the bottom of the strip. The first layer of adhesive was allowed to dry for 10 minutes before applying the second layer, which was also allowed to dry for 10 minutes before pressing the strip into place. Each strip was tamped using a tamping cart containing approximately 200 lbs. of weight. Installation of all 12 strips took about 1 ¼ hours. A representative of the manufacturer supervised the whole process of installation.

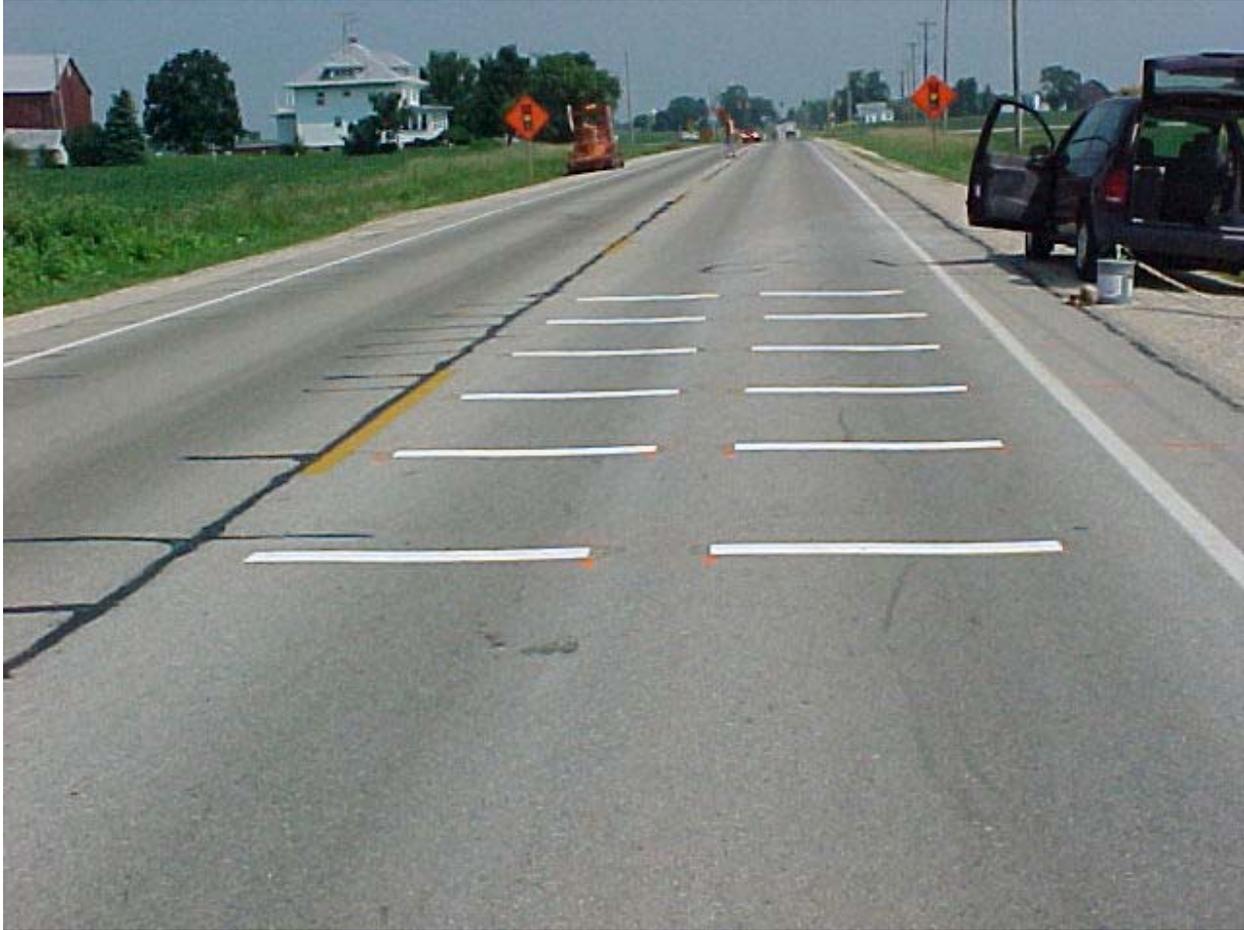
The Rumbler was installed 1106 feet from the stop line. The installation involved a total of 12 separate strips in 6 lines, two strips per line. Each strip was 4 feet long and was located to cover the area that a wheel would track when the vehicle is roughly centered in the lane. About 14 inches in the center of the lane was left clear. Strips were placed 7 feet apart so that motorcycles would not hit more than one strip at a time if they were not precisely centered in the lane. This spacing is somewhat greater than the recommended spacing in the product literature. The total longitudinal length of the Rumbler was therefore 35 feet. The layout of the Rumbler can be seen in Figure 2. Figure 2 is looking north; the signal is barely visible near the top, center of the picture.

Figure 2. Rumbler as Installed on STH 26

The distance of the Rumbler from the stop line was determined by the placement of a pair of “signal ahead” signs that had been located 906 feet from the stop line. The intention of the Rumbler installation was to alert drivers to the signs as well as to the signal itself. The “signal ahead” signs are visible in the background of Figure 2. A special warning sign reading “rumble strip ahead” was placed about 200 feet south (upstream) of the Rumbler.

As seen in Figure 2, the surface of the road near the Rumbler was nearly free of cracks.

As seen in Figure 2, the strips were not perfectly aligned when installed. However, the strips amply covered the normal track of wheels from both automobiles and trucks.
