| <b>Reflectorized Sleeves for Barrel Delineators</b> | | |
| Abstract<br>The reflectorized sleeves are designed to wrap around a standard reflectorized drum, providing an alternate color scheme (orange, white, and green stripes). The use in this evaluation was to apply the sleeves to drums on an exit within an Interstate work zone where the exit is delineated by drums. The intent of the application was to provide more positive guidance for the driver by more clearly defining which two drums on the mainline mark the mouth of the exit ramp. Three configurations of sleeves were compared to baseline data collected without the sleeves. The measure of effectiveness was the speed reductions occurring within the exiting stream before the vehicles leave the mainline. Speeds were monitored just upstream of the exit and immediately downstream of the exit on both the ramp and on the mainline. Custom software was developed to identify exiting vehicles in the downstream data and extract their speeds from the upstream data. The idea is that drivers often slow while still on the mainline, partly because the ramp is more difficult to identify when delineated by drums than under normal conditions.

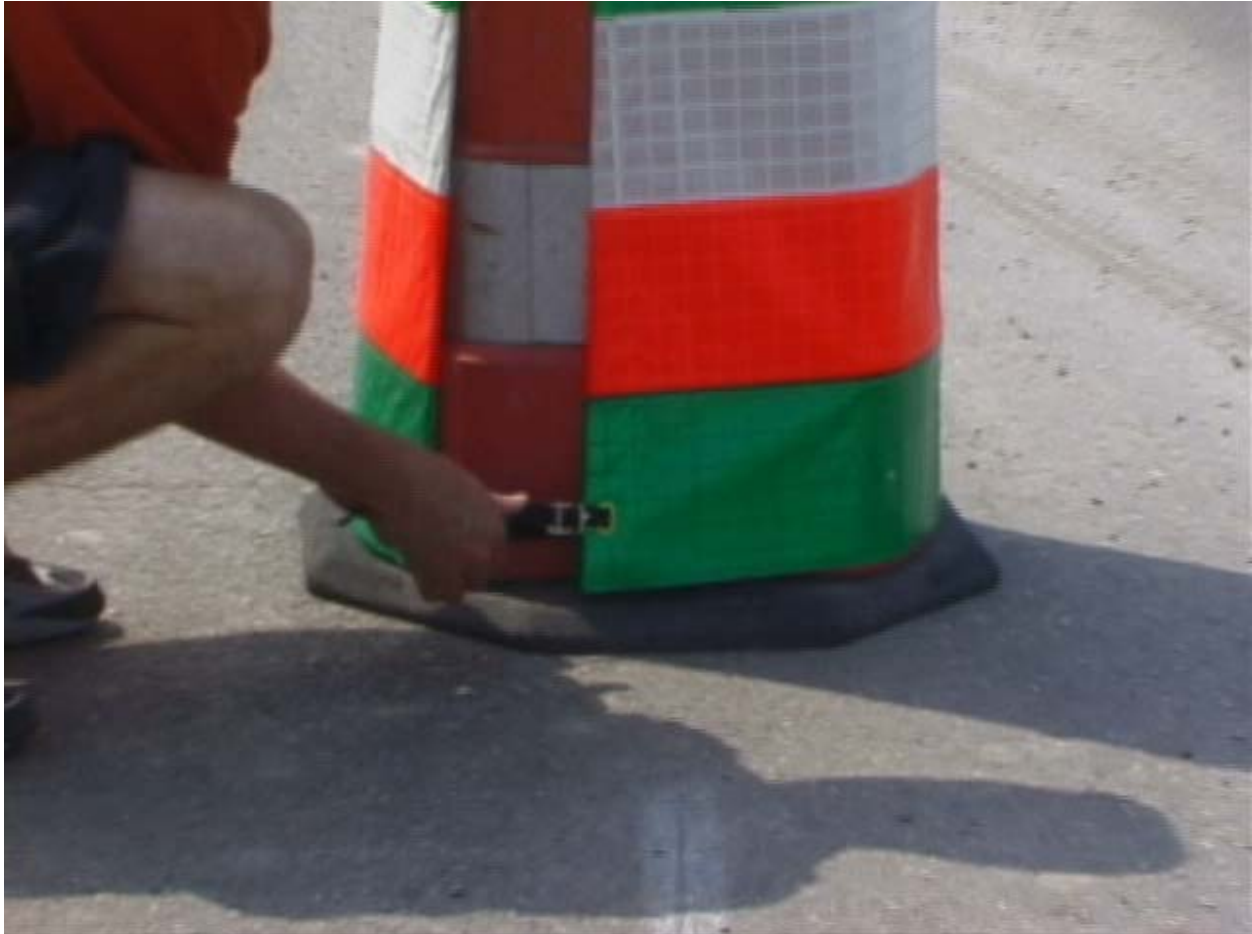
**Figure 4. Drum sleeve installation.**

The sleeves required less than 2 minutes each to install. Removal time was similar. The drums are affixed with nylon straps and a threaded buckle, as shown in Figure 4. The sleeves hold firmly to the drums. Although several drums were knocked over by severe storms and at least two were hit by vehicles, none of the sleeves came off their drums. When the sleeves were removed, all sleeves seem as tightly affixed to the drum as when they were installed.

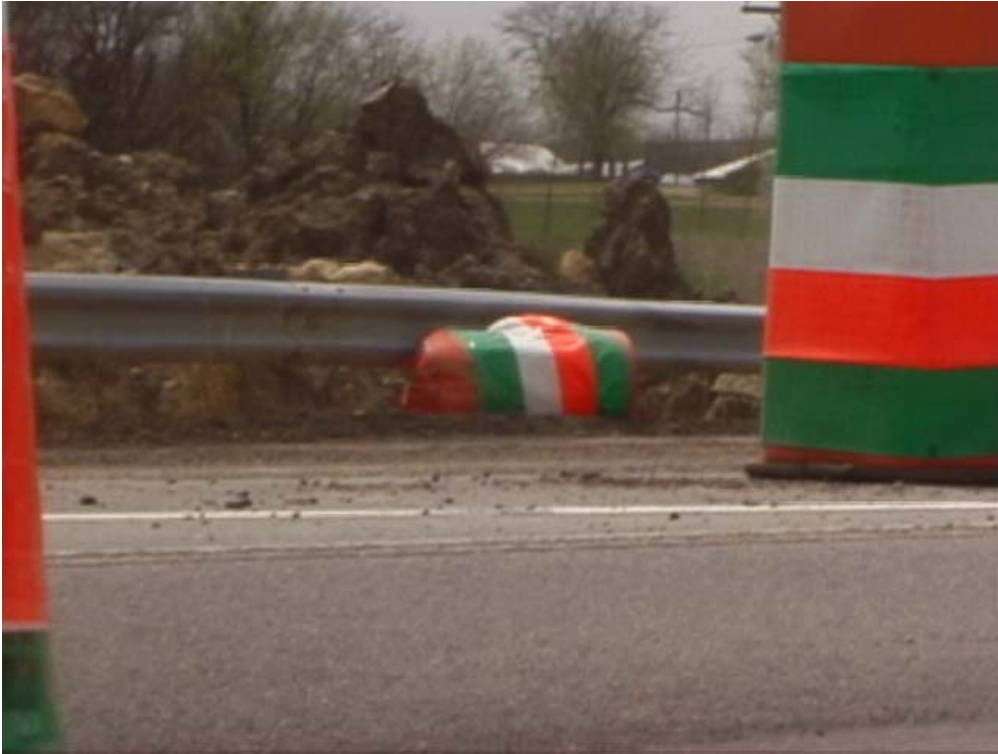
**Figure 5. Drum that was destroyed during the test.**

The two sleeves that were on drums that were struck by vehicles suffered only minor damage, although the damage to one was near the upper buckle, probably requiring under most circumstances that it be removed from service. Figure 5 shows the drum most severely damaged, and Figure 6 shows the resulting damage to the drum sleeve that had been attached. The other sleeve that was damaged during the test is shown in Figure 7.

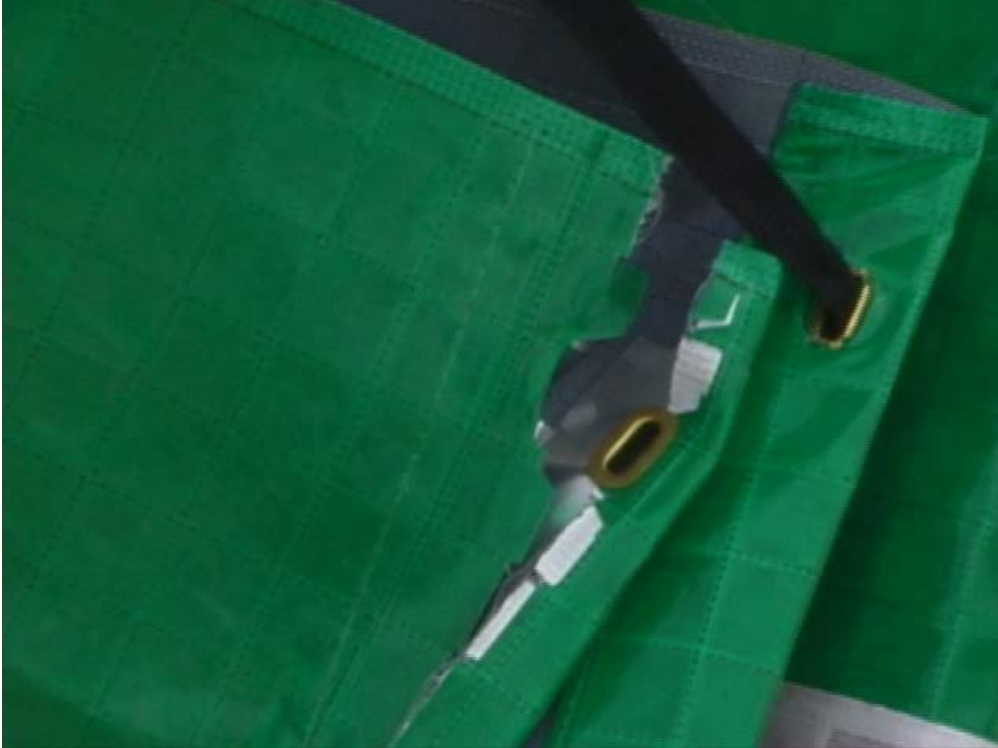
**Figure 6. Resulting damage to sleeve on drum that was destroyed.**

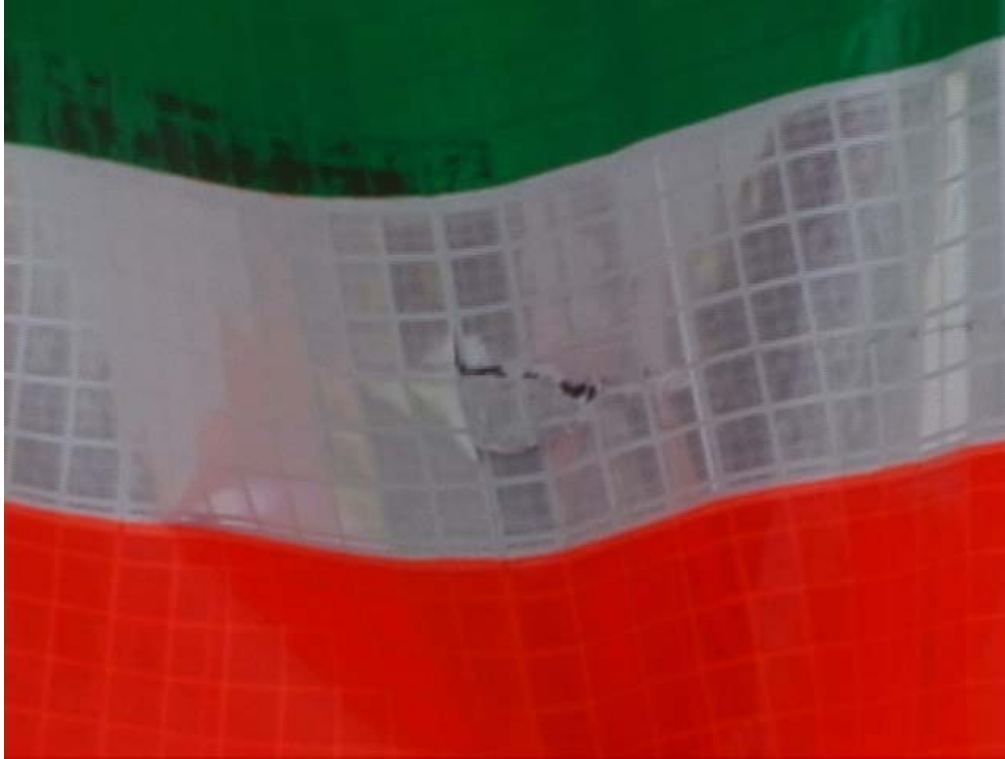
**Figure 7. Minor damage to drum sleeve.**

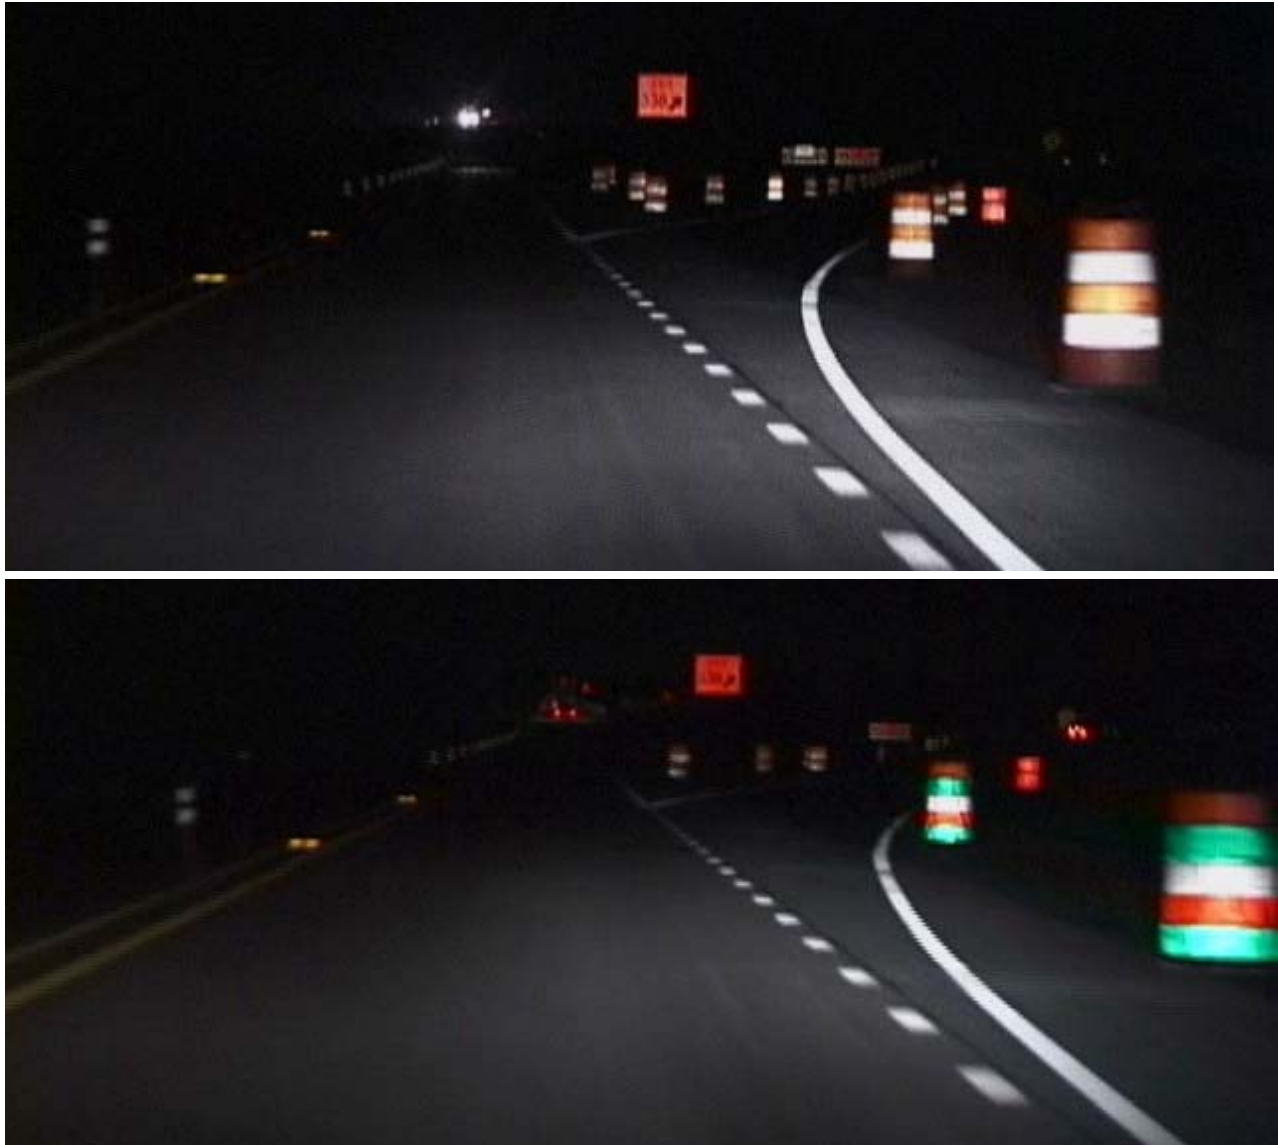
**Figure 8. Study site with and without drum sleeves (Configuration 2).**

Figure 8 shows the exit from the mainline at night both with and without drum sleeves in use. As can be seen from the figure, the sleeves are easily distinguishable from the non-sleeved drums. Additionally, the image reveals the primary reason the data were inconclusive. The exit is so clearly marked without the drum sleeves that no improvement was needed.
