D-25 Speed Advisory System Evaluation

Geza Pesti

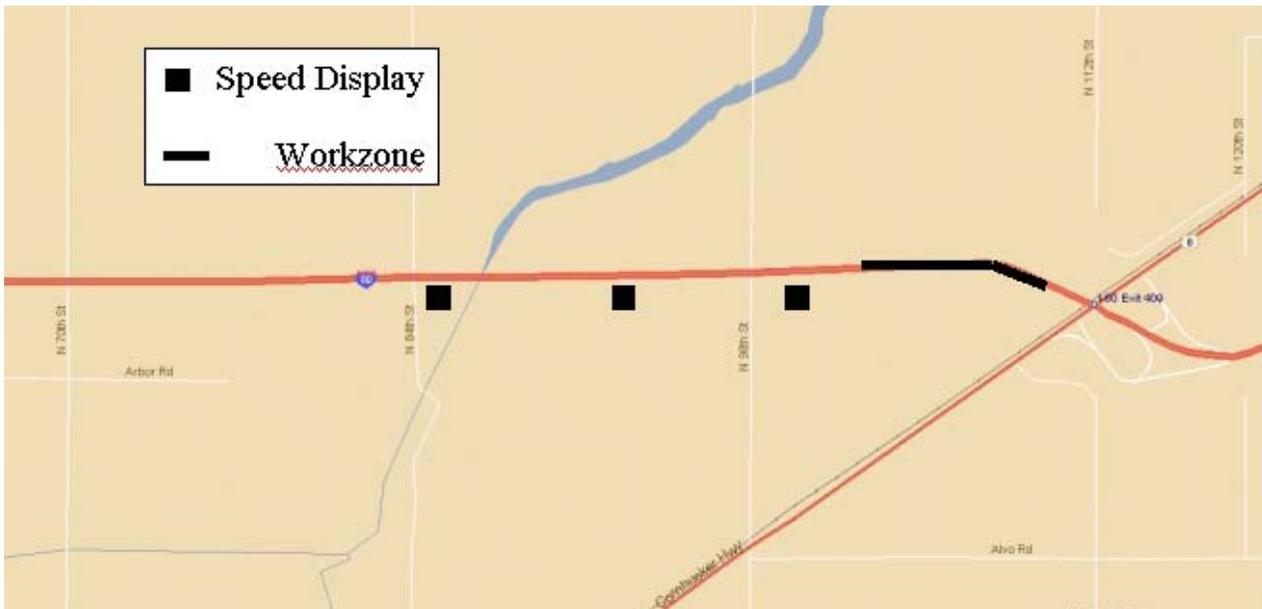
FIGURE 2 Study site

The Speed Advisory System was evaluated at a work zone on I-80 near Lincoln, Nebraska. The study site is shown in Figure 2. The average daily traffic volume on the four-lane section of I-80 was approximately 40,000 vehicles per day with 21 percent trucks. The normal speed limit on I-80 was 75 mph, and the speed limit in the work zone was 55 mph. The evaluation was conducted on the eastbound approach to the work zone. The work zone was for an interstate bridge reconstruction project, which involved the closing of the right lane, reducing the two eastbound lanes of I-80 to one lane. The traffic control plan on the approach is shown in Figure 3. It included the following sequence of signs on each side of the roadway:

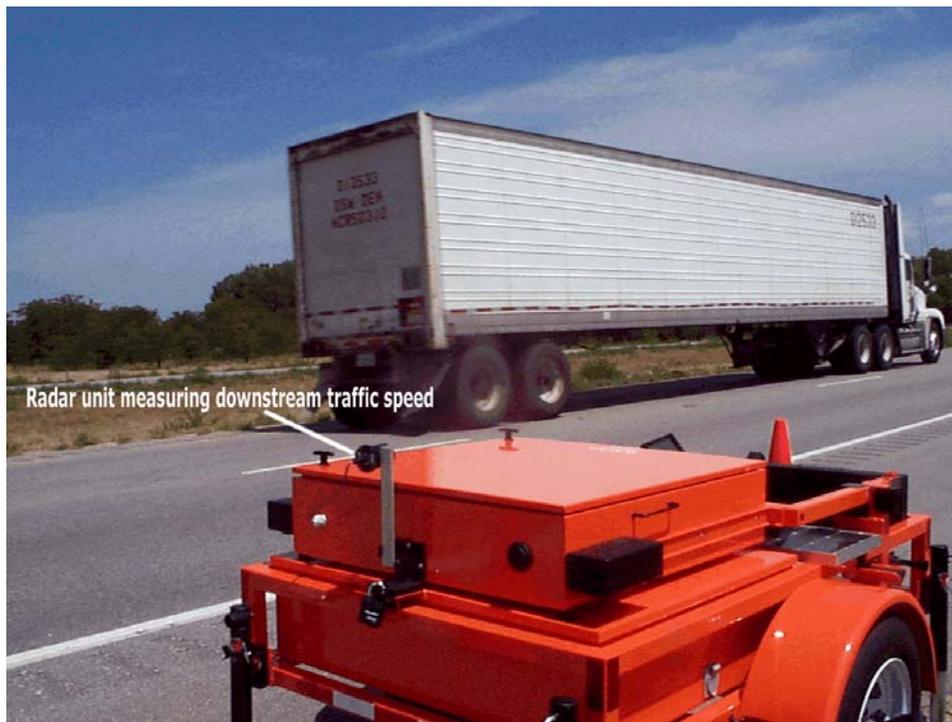
FIGURE 5 Speed Data Collection by Speed Trailers' Radar Unit during "Before" Study

The radar units of the D-25 speed trailers were also used to measure speeds. These speeds together with volume data were used to check if there were any significant changes in traffic conditions between the “before” and “during” periods of the study period. Speeds were measured by the D-25 trailers’ radar units in every quarter of a second, and the data were stored in a system log. The speed measurement zones for the trailers’ radar units are indicated in Figure 4. The speed trailers were deployed for the entire study period (even during the “before” studies) in order to use their radar unit for speed data collection. For the “before” studies, the speed display unit of the trailers were folded down, as shown in Figure 5. Only the radar units were used during this period. During system operation the speed displays were folded up and activated; they informed approaching motorists about the traffic speed ahead. Speed data were downloaded from the speed trailers’ system logs every 3 days or whenever there was a change in the setup. Approximately 165 hours of speed data were collected.
