Determining CoTE for Concrete

Elizabeth Lukefahr, P.E., Ryan Barborak, P.E., Gary Peterson, and Andy Naranjo, P.E.,
 Texas DOT

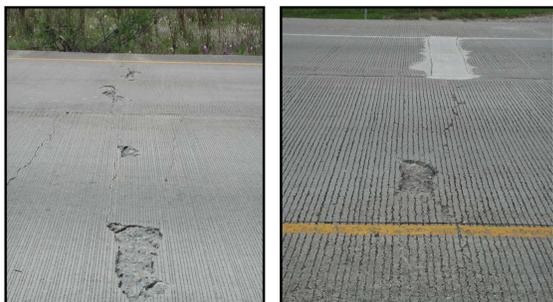
Figure 1: Typical Shallow Spalling in CRCP

Early-age distress, primarily shallow spalling, in continuously reinforced concrete pavements (CRCP) in Texas has been a problem for several decades. This type of distress comprises almost 50% of the distresses observed in CRCP. Over the past 20 years, repairs of these early-age shallow spalls have cost TxDOT nearly \$500 million in the Houston District alone. Through years of research, the majority of these early-age distresses have been linked to use of coarse aggregates with high coefficient of thermal expansion (CoTE). In early 2000's, several Districts began requiring concrete for CRCP to have CoTE values of 6.0 μ -strain/ $^{\circ}$ F or less. This resulted in the elimination of virtually all the early-age spalling.

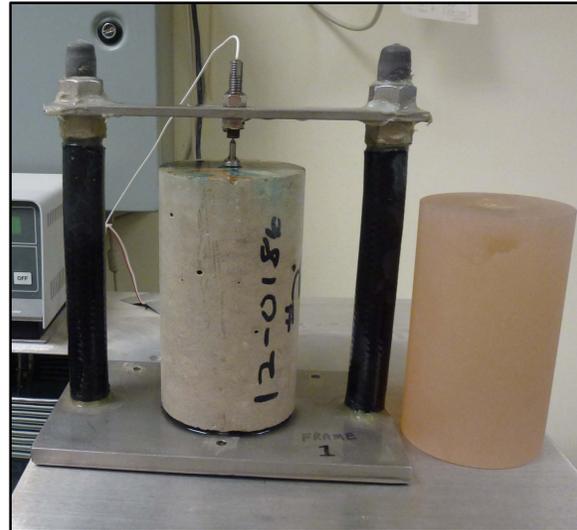
The original test setup used a typical LVDT to collect the displacement data, but due to the configuration of the frame and water bath, this left the majority of the LVDT housing out of the water bath which seemed to have an effect on the CoTE value of the sample. The sample height also resulted in variations in the CoTE value of the same sample. These issues seem to be corrected by switching to a temperature compensating DVRT device. The correction factor for each frame and DVRT setup is established by testing a ceramic cylinder having essentially a 0 μ -strain/ $^{\circ}$ F CoTE value. Any movement recorded is due to the movement of the test frame.

Figure 2: CoTE Test Frame with Sample and Ceramic Cylinder

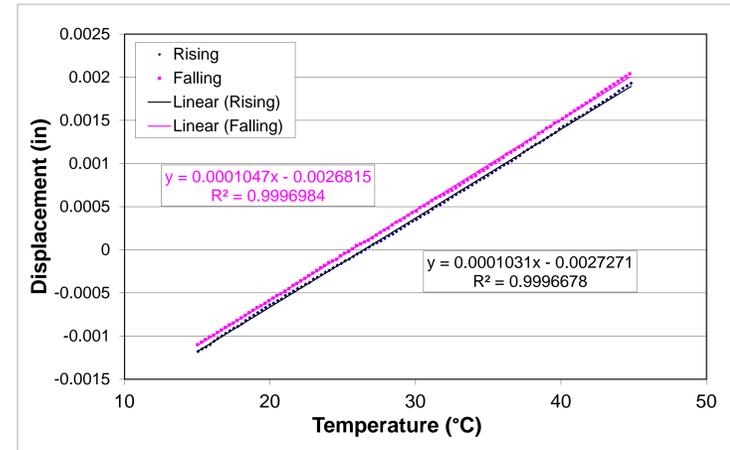
Figure 3 shows the raw data collected during testing. The concrete sample is cycled three times between 10 $^{\circ}$ C and 50 $^{\circ}$ C. At the end each end point, the temperature is held constant for 30 minutes. The displacement of the sample is continuously measured for each cycle. Data from cycle 2 and cycle 3 are used to calculate CoTE value.

Figure 3: Typical Raw CoTE Test Data

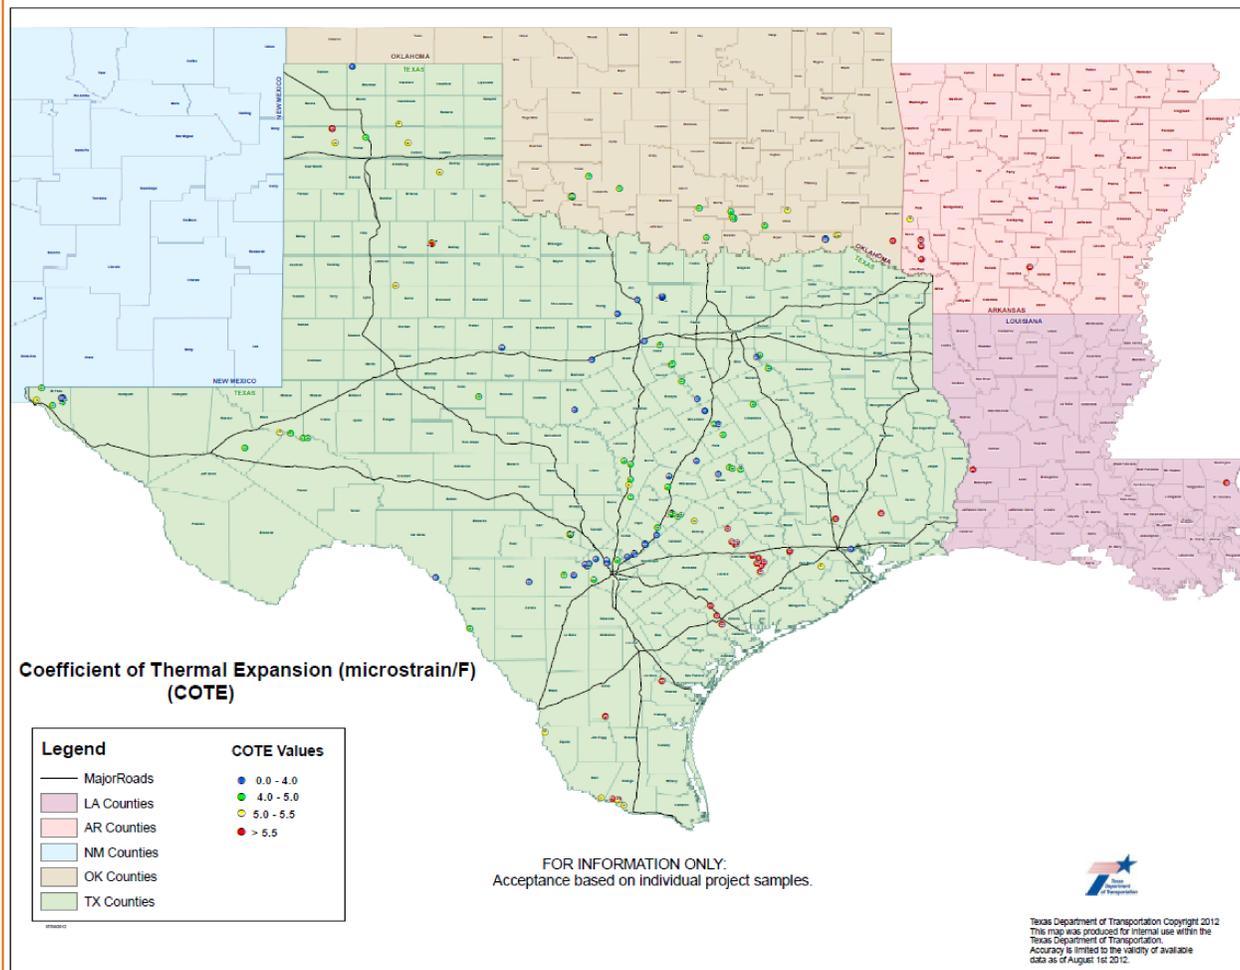
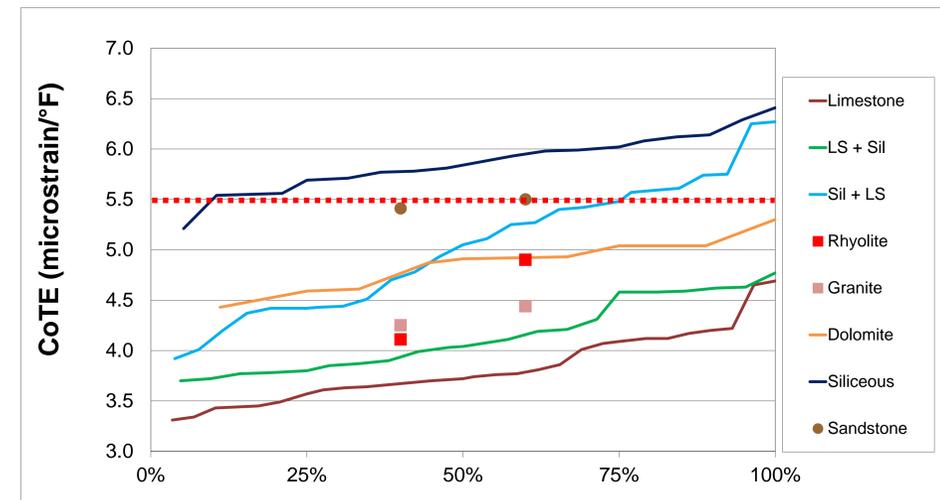
Figure 4: Frequency Distribution of CoTE Data by Aggregate Type

Figure 4 shows the frequency distribution of the all the CoTE values for different aggregate material types. The red line at 5.5 μ -strain/ $^{\circ}$ F is the proposed maximum specification limit for concrete pavement.
