## Development of a Smart Timber Bridge Girder with Fiber Optic Sensors

### Summary

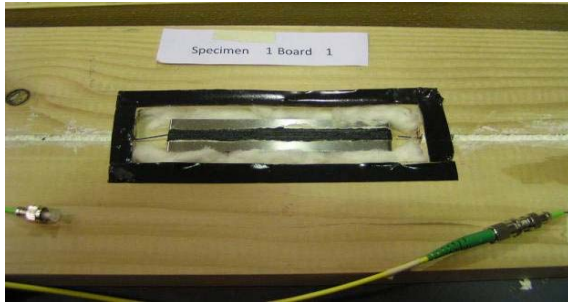
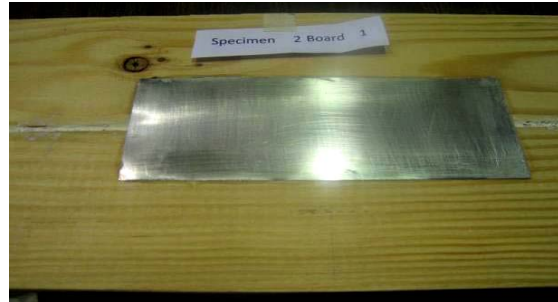
Figure 2. Non Structural Package: Materials and Installation

structural packages were prepared with a combination of stainless steel shims and aluminum foil as backing materials which were bonded with two different types of adhesives and two adhesive tapes. The process of installing the FBG non-structural packages consisted of the wood preparation by routing a recess area, to house the FBG sensor, isolation materials, and leads, and the application of the non-structural FBG package on an external wood surface (see Figure 2). In all cases, the packages were cured for a minimum of 24 hours. Five small scale three-ply glued-laminated specimens were instrumented with ten FBG strain sensors isolated with non-structural packages.

(a) FBG sensor in a recess area and applied adhesive tape.

(b) Installed backing material

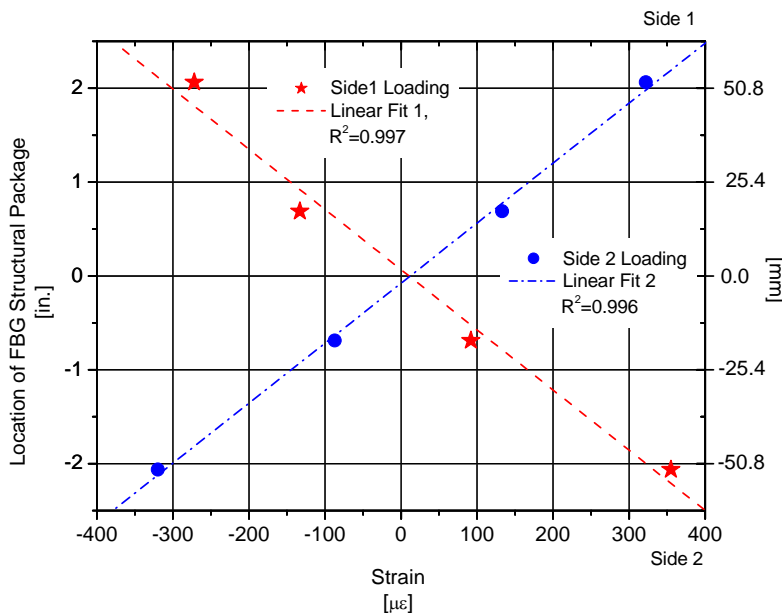
Figure 4. Bending Test – Structural FBG Sensor Packages' Results: Strain levels vs. Linear Regression Model

All FBG sensors immediately responded to loading and unloading with a nearly linear elastic strain response. In Figure 4, a typical plot of the external and internal FBG strains for an applied load of 11 kN (2500 lbs) for both Side 1 and 2 loadings compared to a linear regression model are shown. In all cases, the compressive and tensile flexural strains were dissimilar. The differences were attributed to anatomical wood factors in the vicinity of the FBG sensor packages. In Specimen 1, material properties varied significantly due to the included knots and slope of grain near the sensors; this is

evident by the consistent difference of 50  $\mu\epsilon$  between the Side 1 and 2 loadings. When comparing to the theoretical upper bound strains (with  $E = 10$  GPa (1500 ksi)), all external and internal FBG strains were lower. With respect to the theoretical lower bound strains (with  $E = 14$  GPa (2000 ksi)), the FBG strains differed by up to 40%. In Figure 5, the external FBG sensors, foil strain gages and strain transducers readings were plotted to evaluate their performance. Comparing the external FBG strain values with the average strain determined as the arithmetic mean of all external sensor readings, both strain values differed by up to 11%. Specimen 1 differed by up to 17%.

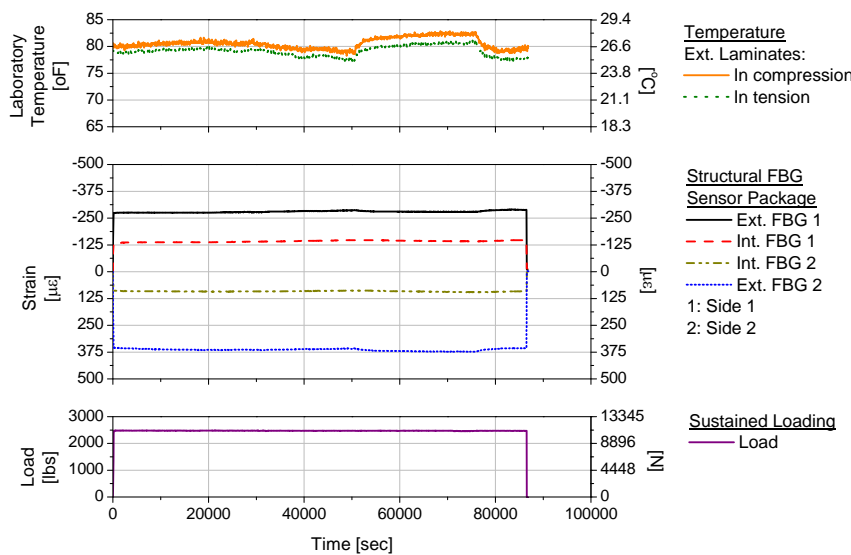
Figure 6. Sustained Loading Test – FBG Strains, Load and Temperature vs. Time

and internal FBG strains visibly varied with the temperature fluctuations (up to  $\pm 2$  °C ( $\pm 4$  °F)) (e.g., Figure 6). When assessing the wood and package materials' thermal properties, only the FBG sensors are significantly affected by temperature variations. A linear regression model was fit to the strain and temperature data to investigate the strain-temperature relationship. The resulting  $R^2$  coefficients varied from minimal to 0.96. The higher values may indicate the higher influence of the

temperature fluctuations in the strain variations. The minimal values may indicate the predominant effect of the time-dependant load over the temperature variations. The presence of residual strains at the end of the loading revealed that creep deformation, due to the combined effect of load and temperature effect, had occurred in all packages. For each sensor, the strain recovery was evaluated by calculating the rate of recovery as the strain difference per unit time. The rate of recovery was determined for the strain data collected for a minimum of 15 min. The positive rate of recovery values indicated that the FBG packages' response would decrease to zero strain. In the case of Specimen 1, Side 2 Loading, the FBG sensors had higher residual strains which may indicate changes in the internal make up of this specimen.
