General
Technical
Report
FPL-GTR-160

Condition Assessment of Timber Bridges

2. Evaluation of Several Stress-Wave Tools

Brian K. Brashaw
Robert J. Vatalaro
James P. Wacker
Robert J. Ross

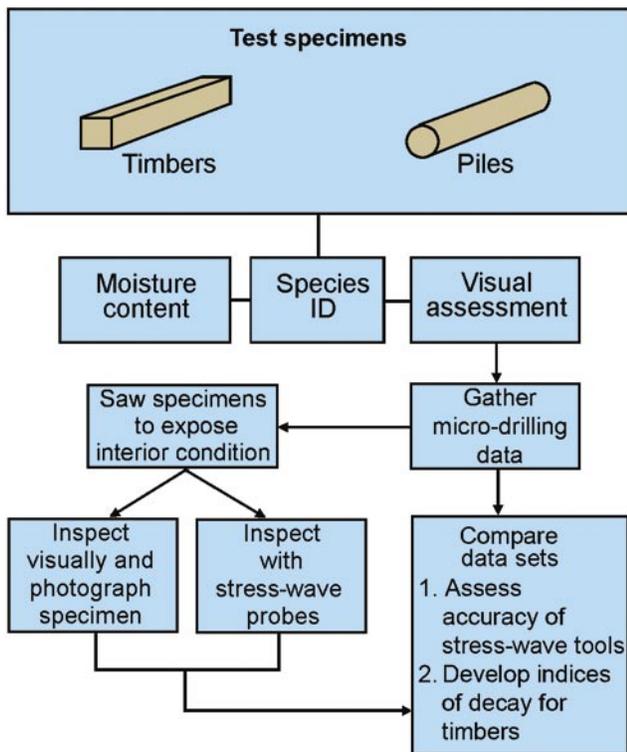
Figure 1—Stages of this study.

This study was accomplished in several different stages (Fig. 1). Several types of data were collected on the timber specimens in their original (unsawn) condition. First, the timber specimens were tested to determine moisture content and wood species. Second, the bridge timbers were visually inspected to locate deteriorated areas. Then stress-wave measurements were collected at several locations on each specimen. Last, micro-drilling resistance measurements were collected from each of the timber bridge specimens. Micro-drilling resistance results from this study are published in a companion report (Brashaw and others 2005).

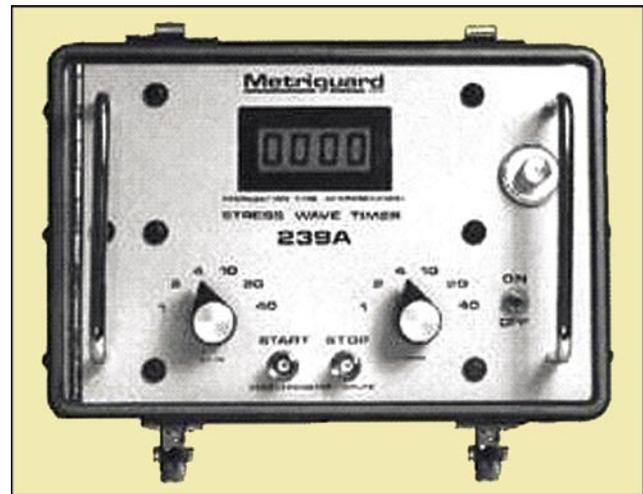
Figure 2—Metriguard 239A Stress-Wave Timer.

specimens (Figs. 2–5). In general, each piece of equipment induced a mechanical stress wave into a timber specimen by a hammer or other means, which was detected with accelerometers at two points along the propagation path. The timer started when the wave front arrived at the first accelerometer. The timer stopped when the wave front arrived at the second accelerometer and displayed the propagation time between accelerometers in microseconds. Additional information on equipment manufacturer, method of operation, key considerations, specifications, and testing procedures is provided in the Appendix.

Because we used a direct-contact measurement technique with the Metriguard 239A, results can be variable if the surface of the wood member is damaged. It is possible to mount the start and stop accelerometers to lag bolts for increased consistency, although that was not done during this study.

A mechanical stress wave is induced in a member by a hammer or other means and is detected with accelerometers at two points along the propagation path. The timer starts when the wave front arrives at the first accelerometer. The timer stops when the wave front arrives at the second accelerometer and displays the propagation time between accelerometers in microseconds.

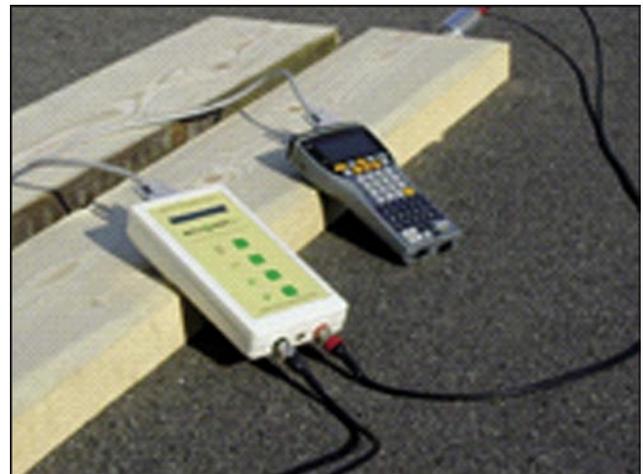
Figure 3—Sylvatest Duo.

We used two techniques with the Sylvatest Duo during the inspection of timber bridge components: for the first set

of measurements, we placed the probes in direct contact with the member, and for the second set, we drilled a small contact hole and placed the probes into the hole. Both techniques were effective in locating severe decay in wood members, but the direct-contact technique resulted in more variability in measurements, especially for those members with no or low levels of decay. We recommend that only experienced operators use the probes through direct contact when the shell condition of the member is good. If the shell is damaged, we recommend placing the probes in predrilled-contact holes. The Sylvatest Duo also determines the peak energy received during testing. This information should only be used if the data are collected using the predrilled-contact holes method.

The Sylvatest unit uses an ultrasonic pulse generator to impart a stress wave into a member. Two transducers are placed a fixed distance apart on a member. A transmitting transducer imparts a wave into the member, and a receiving transmitter is triggered upon sensing of the wave. The time it takes the wave to pass between the two transducers is then coupled with various additional information, such as wood species, path length, and geometry (round or square section), to compute modulus of elasticity. A second set of pulses is evaluated to determine the maximum energy of the received wave.

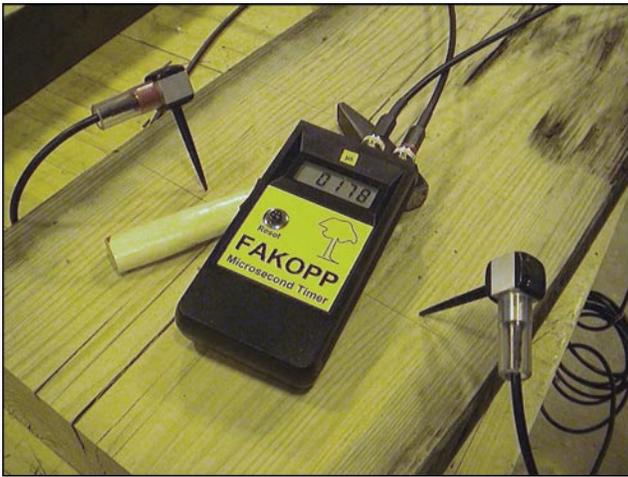
Figure 4—Fakopp Microsecond Timer.

This unit has its transducers mounted directly to metal spikes, which provide intimate contact points when hand pressed into the timber test specimens.

A mechanical stress wave is induced in a member by a hammer or other means into an accelerometer-instrumented sharp probe that is inserted into the member. A similar probe is inserted on the opposite side of the member. The timer starts when the wave front arrives at the first accelerometer. The timer stops when the wave front arrives at the second accelerometer and displays the propagation time between accelerometers in microseconds.

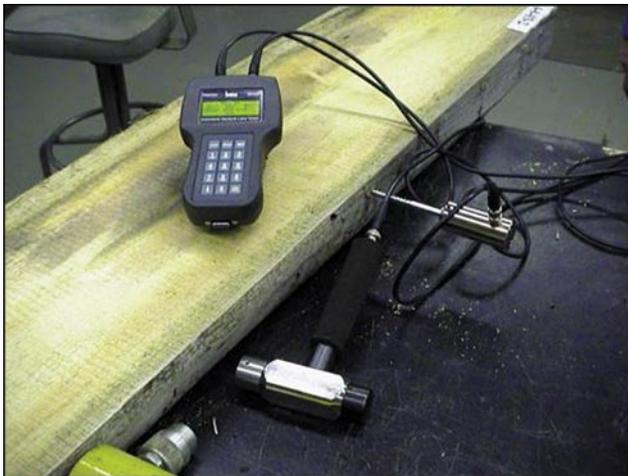
Figure 5—IML Electronic Hammer.

Several timbers were scanned using the IML Electronic Hammer, which was effective in identifying decay in the timber specimens evaluated during the project. We discontinued using this equipment after three timbers, however, because of the time-consuming process required to obtain measurements. Further information on the IML Electronic Hammer is in the Appendix.

A mechanical stress wave is induced in a member by striking an instrumented hammer into a lag bolt that is inserted into the member. A similar lag bolt is inserted on the opposite side of the member. The timer starts when the lag bolt is impacted. The timer stops when the wave front arrives at the second accelerometer and displays the propagation time between accelerometers in microseconds.

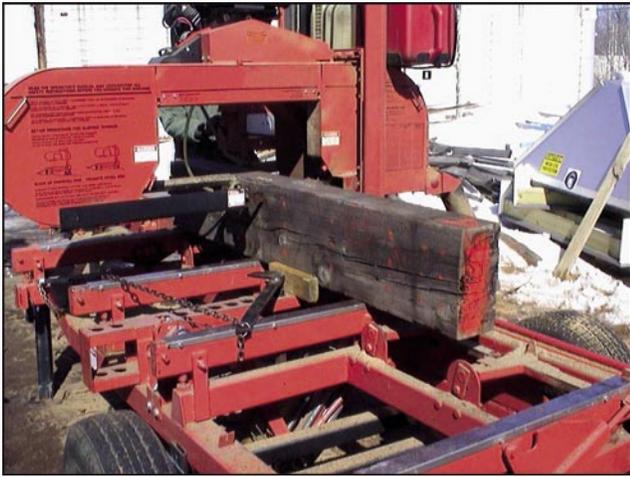
Figure 7—Portable band saw cutting timbers lengthwise along measurement lines.

Following stress-wave testing, each timber was cut into slices using a portable band saw (Fig. 7). Each timber specimen was cut along the measurement lines A, B, and C along the length of the piece. Each section was then laid out so that the interior faces of each measurement line were revealed and could be documented through digital pictures. Figure 8 demonstrates how the sawn samples were typically laid out for visual assessment and documentation. The top board corresponds with data collected along measurement line A. The bottom board corresponds with data collected along measurement line B.

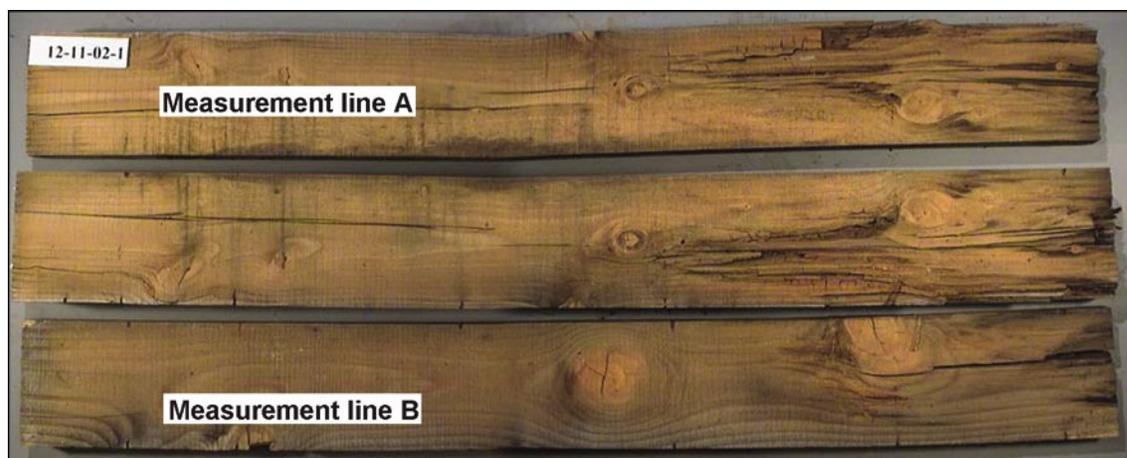
Figure 8—Typical layout of sawn timber specimens for photograph documentation.

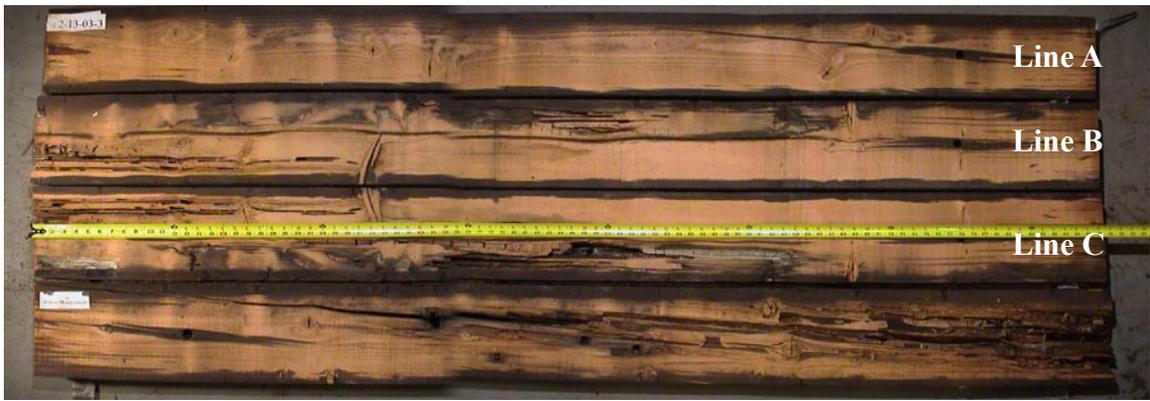
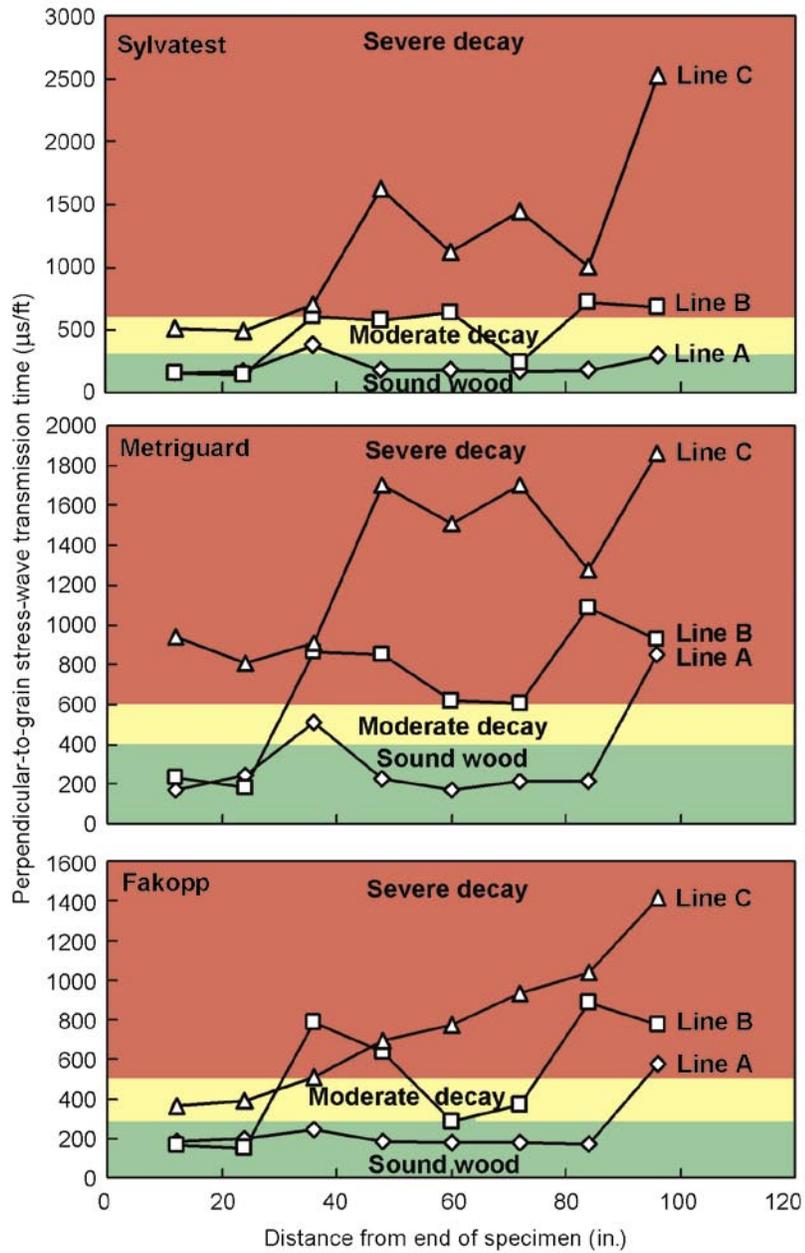
Figure 9—Comparison of stress-wave transmission plots and interior photographs of Douglas-fir specimen 2-13-03-3 reveals areas of moderate and severe deterioration and sound wood.

Figure 9 illustrates results obtained from a specimen with areas of severe, moderate, and no (sound wood) deterioration. All stress-wave transmission times were within the severe deterioration zone for a majority of the points along line C. Stress-wave transmission times along line B were mostly in the moderate decay zone by Sylvatest, whereas Metriguard and Fakopp detected severe deterioration at many test locations. Transmission times along line A

revealed mostly sound wood or slightly moderate decay except for the stress-wave transmission time at 96 in. (244 cm), which was within the severe decay zone by all stress-wave devices. Figure 10 illustrates results obtained from a specimen that showed mostly sound wood with a pocket of moderate–severe deterioration at approximately 60 in. (241 mm) from the specimen end after being cut open. Nearly all measured stress-wave transmission times were within the sound to slightly moderate decay zones. However, the stress-wave transmission time measured at 60 in. (241 mm) was in the severe to slightly moderate decay zone for the Sylvatest device, whereas it was in the severe decay zone for the Metriguard and Fakopp devices. Figure 11 illustrates results obtained from a specimen that showed sound wood, with no deterioration after being cut open. All stress-wave transmission times for Lines A, B, and C were within the sound wood zone using all stress-wave devices. However, stress-wave transmission times measured with the Metriguard device along Line A were slightly higher and were in the proximity of the moderate decay threshold level.

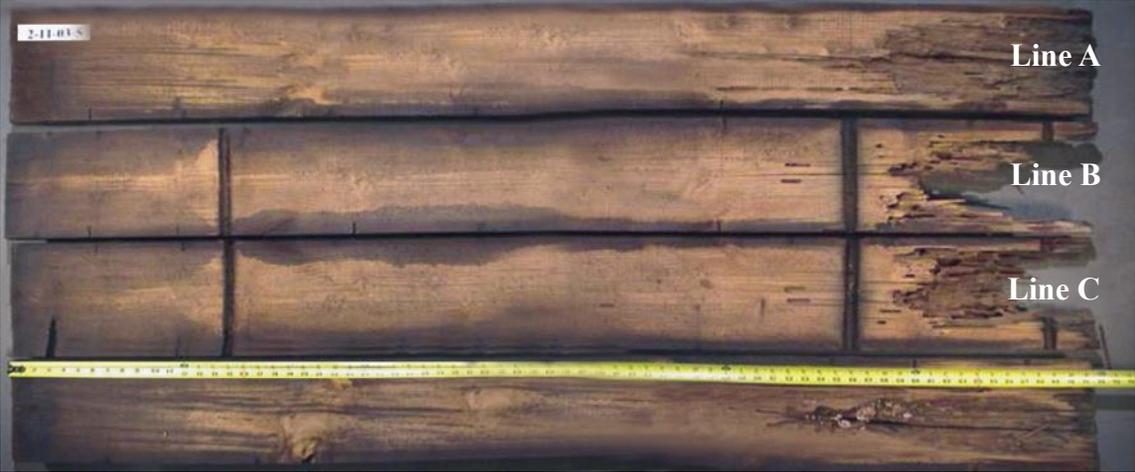
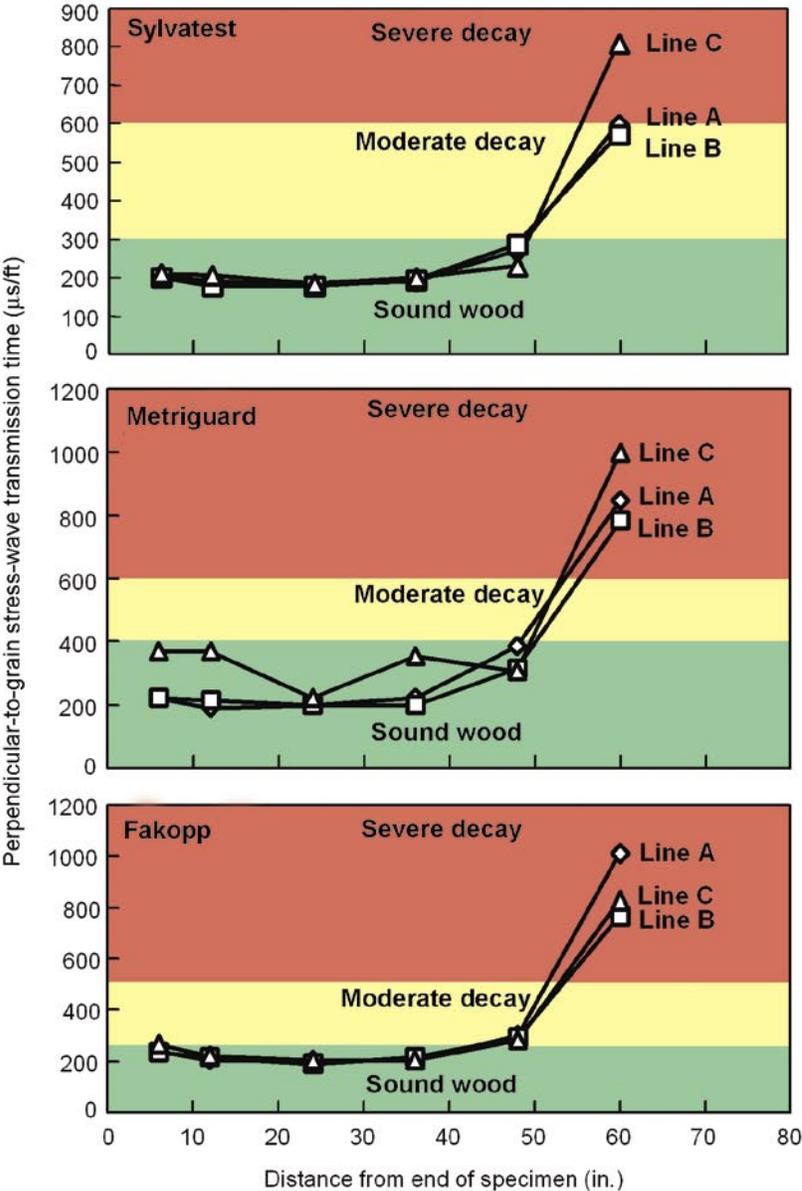
Figure 10—Comparison of stress-wave transmission plots and interior photographs of Douglas-fir specimen 2-11-03-5 reveals mostly sound wood with a pocket of moderate–severe deterioration at approximately 60 in. (241 mm) from specimen end.

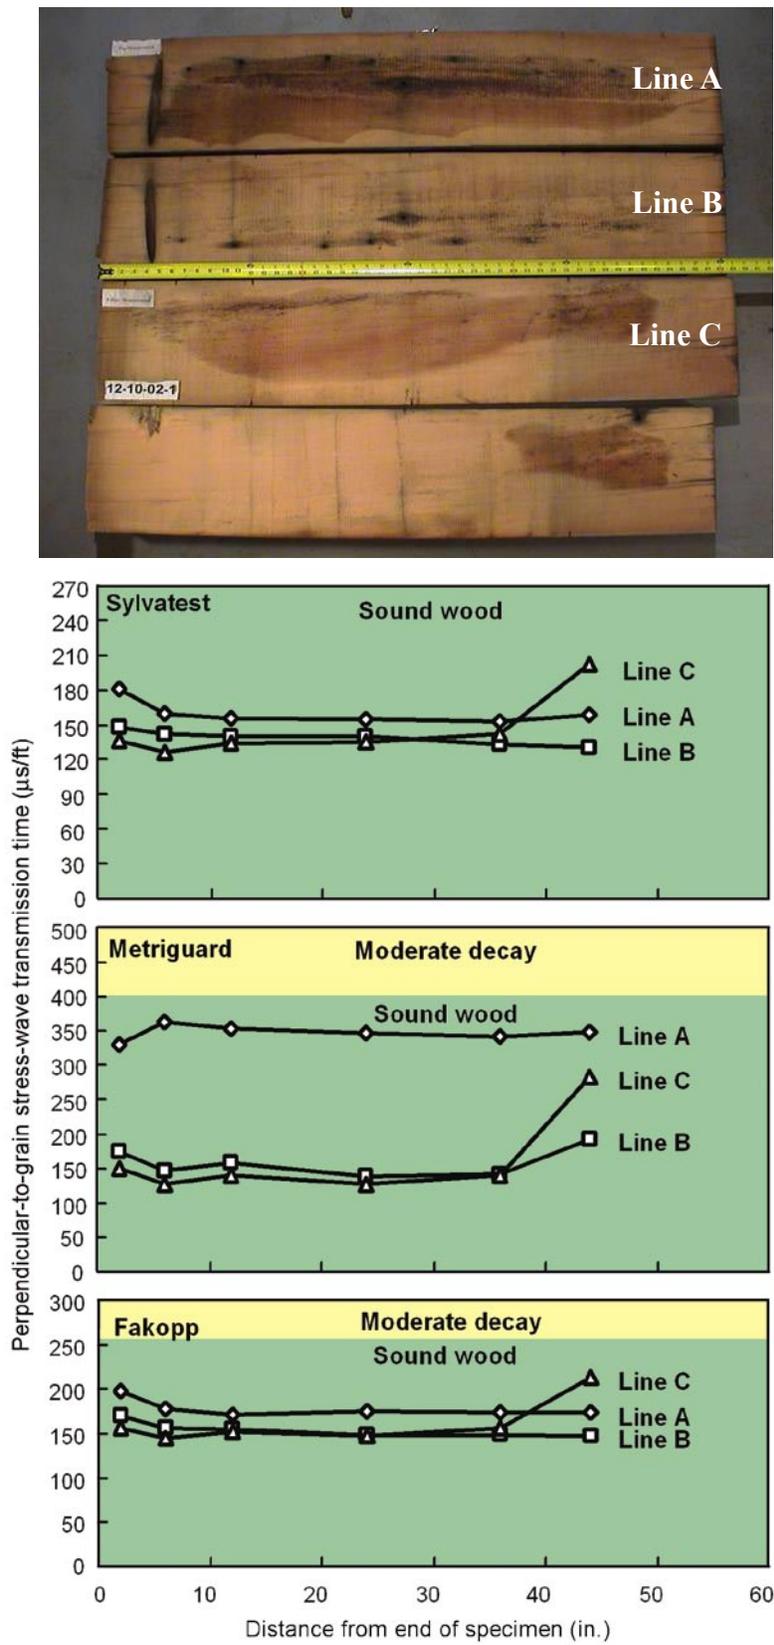
Figure 11—Comparison of stress-wave transmission plots and interior photographs of Douglas-fir specimen 12-10-02-1, reveals sound wood throughout with no deterioration.
