Research  
Paper  
FPL-RP-547

# Field Performance of Timber Bridges

## 5. Little Salmon Creek Stress-Laminated Deck Bridge

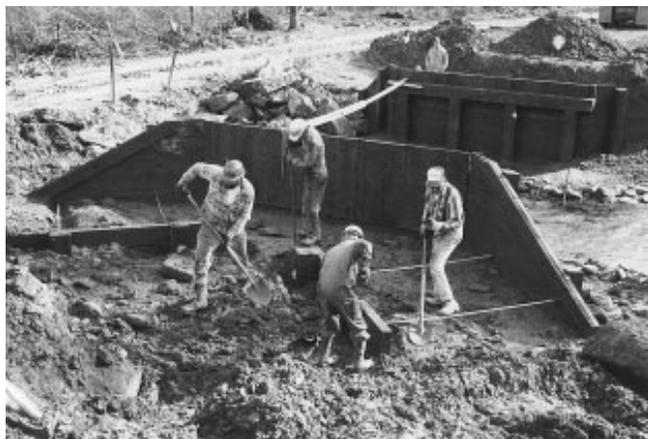
Figure 5—Construction of the post and sill abutments for the Little Salmon Creek bridge.

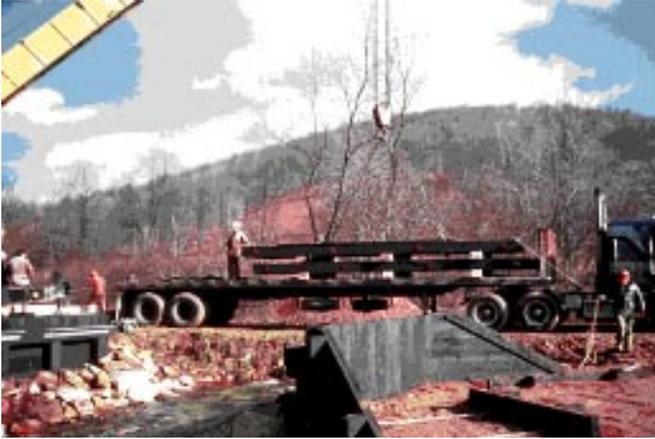
**Figure 6**—The two deck sections for the Little Salmon Creek bridge were transported from the treating plant to the bridge site on a flatbed truck.

After completion of the substructure, the deck sections were loaded on a flatbed truck at the treating plant and were transported to the bridge site (Fig. 6). At the site, the sections were unloaded from the truck and placed side-by-side on temporary supports on the approach roadway. The temporary steel bars were removed, and stressing bars were inserted through both sections (Fig. 7). The stressing bars were tensioned to the required 60,000-lb force using a single hydraulic jack. After bar tensioning, the entire superstructure was lifted as a unit by a small crane onto the abutments (Fig. 8). Attachment of the superstructure was completed by bolting the deck to a steel angle that was then bolted to the side of the substructure cap (Fig. 9).

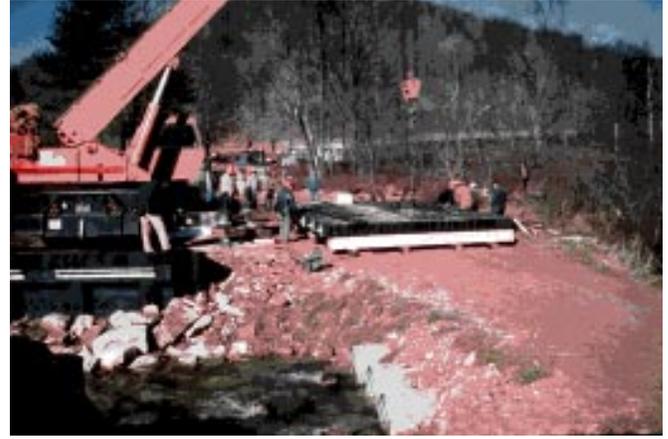
**Figure 8**—After the stressing bars were tensioned, the entire superstructure was lifted on the abutments by a small crane.

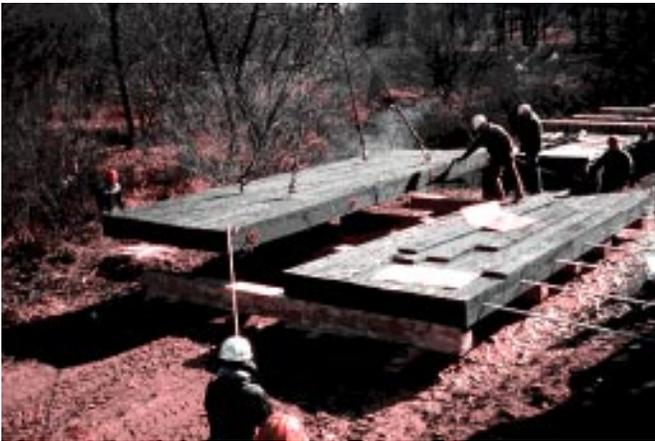
**Figure 7**—At the bridge site, the temporary steel bars in the two deck sections were removed and stressing bars were inserted through both deck sections.

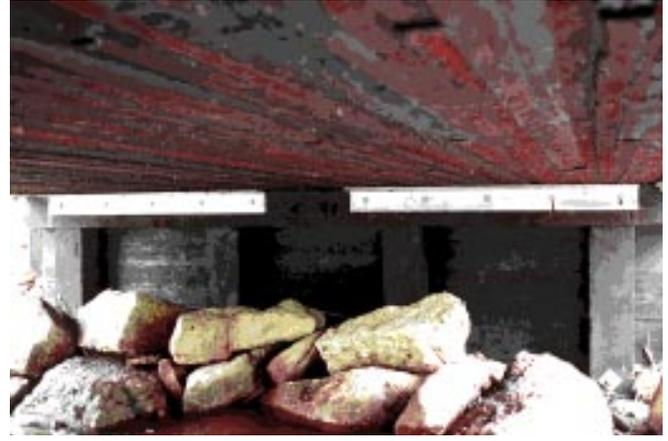
**Figure 9**—Attachment of the superstructure was by bolting the deck to steel angles that were then bolted to the side of the substructure cap.

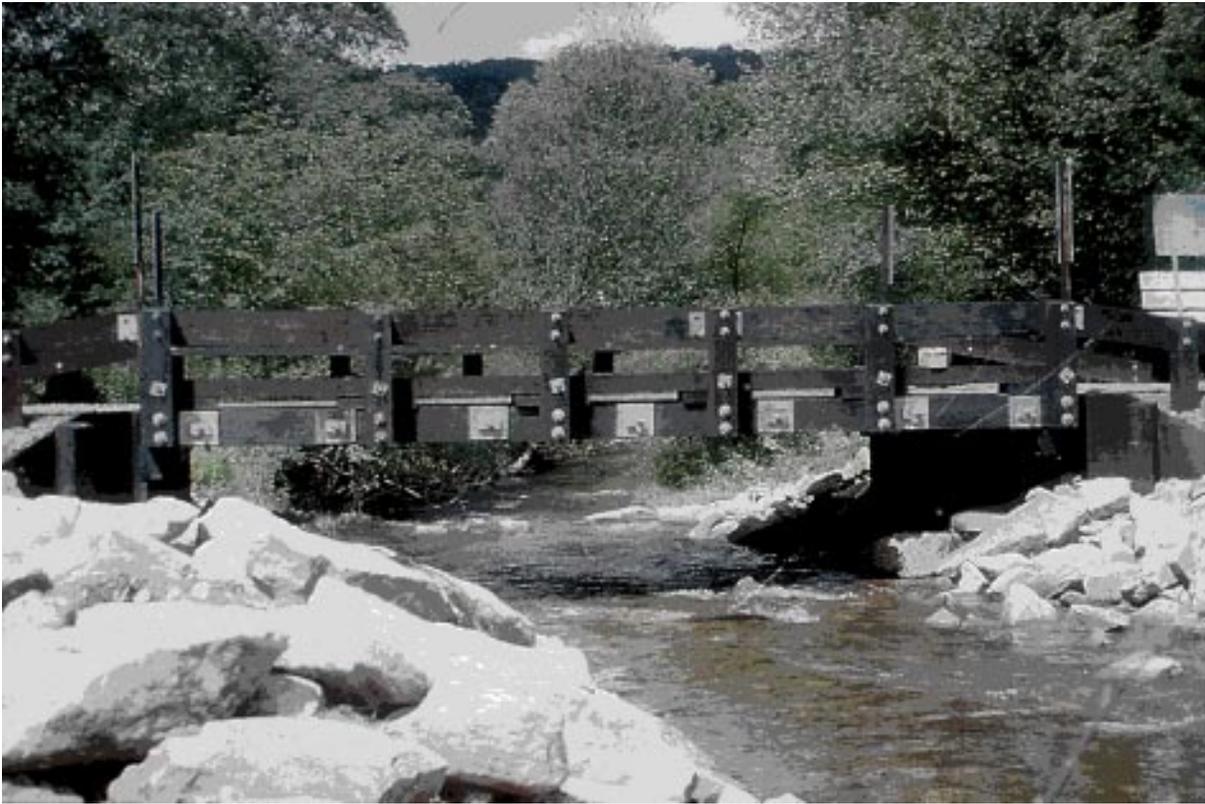
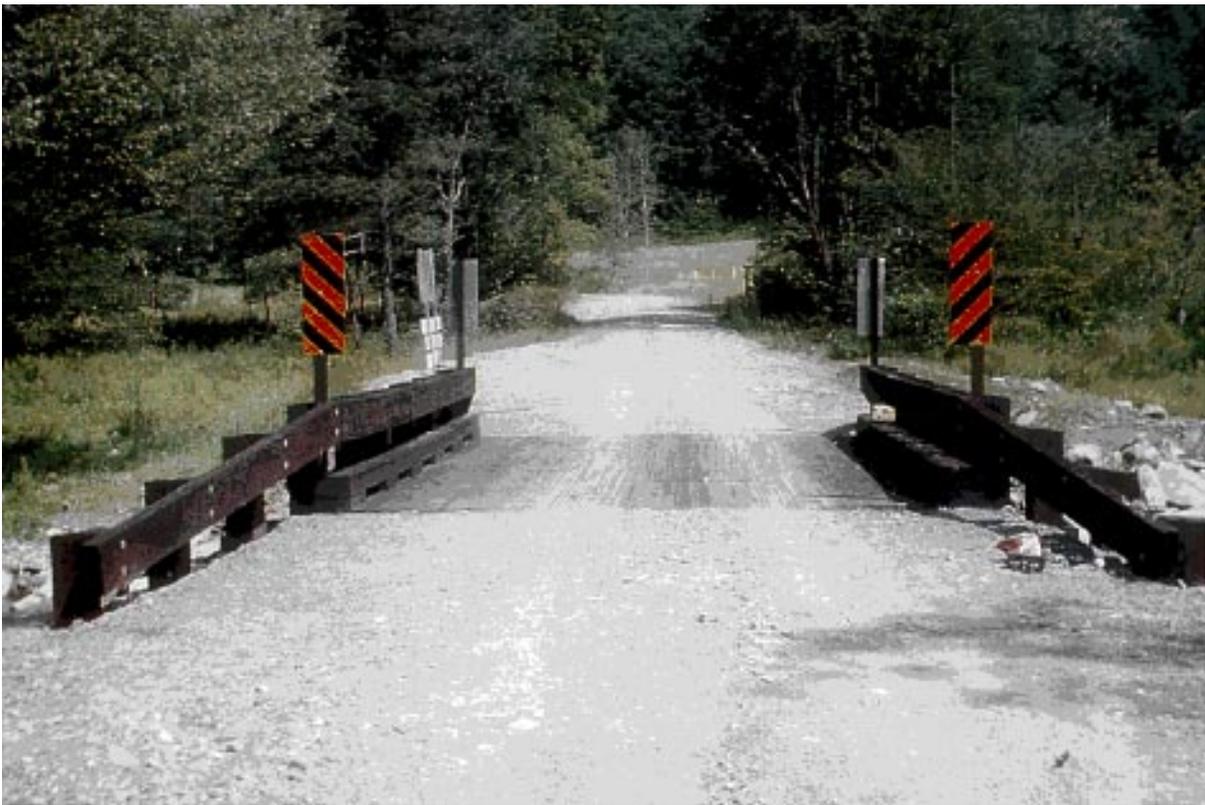
Figure 10—Completed Little Salmon Creek bridge.

The installation of the bridge superstructure was completed in 1 day under winter weather conditions, which included snow and freezing temperatures. After the initial bar tensioning, the bars were again retensioned to 60,000 lb approximately 1 and 6 weeks after installation. The curb, bridge railing, and approach railing were installed shortly after the bars were tensioned for the second time. The completed bridge is shown in Figure 10.

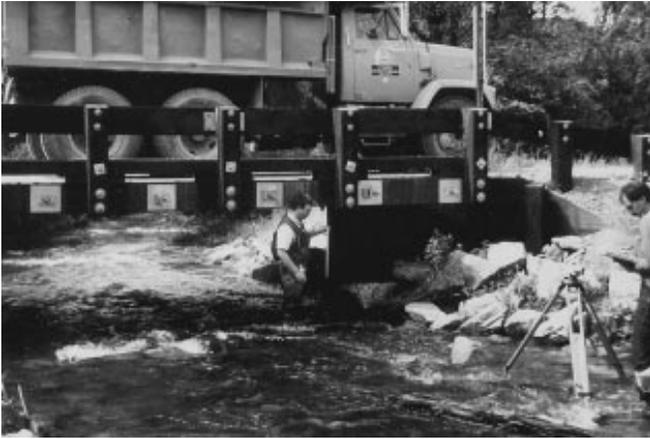
Figure 13—Load test 1 bridge deflections were measured by suspending a calibrated rule from the deck underside and reading displacement values with a surveyor's level.

load position 2, the vehicle was positioned on the downstream side, with the center of the inside wheel line over the bridge centerline. Measurements of the bridge deflection from an unloaded to loaded condition were obtained by placing a calibrated rule on the deck underside and reading values with a surveyor's level to the nearest 0.005 ft (Fig. 13). The accuracy of this method for repetitive readings is estimated to be  $\pm 0.06$  in.

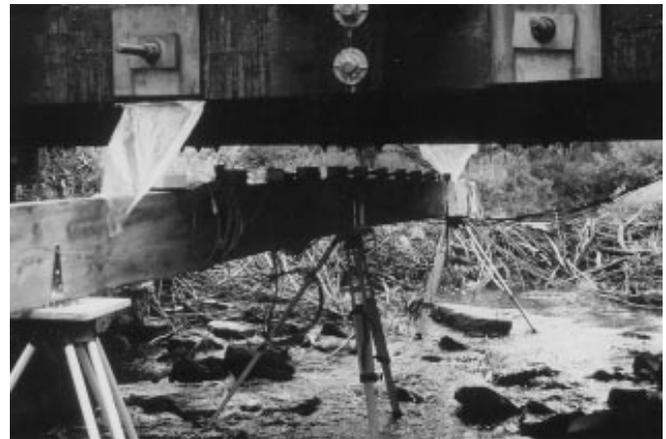
Figure 16—Load test 2 bridge deflections were measured with string potentiometers attached to the underside of the bridge. The transducers were supported by a wood beam and tripods.

measured using string potentiometers and an electronic data acquisition system (Fig. 16). The accuracy of this method for repetitive readings is estimated to be  $\pm 0.0005$  in.

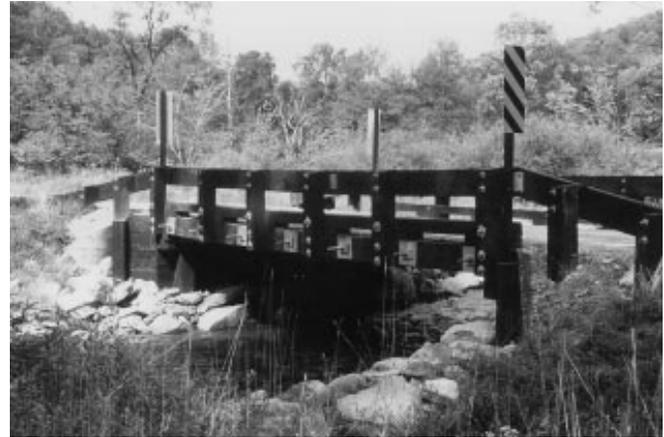
Figure 18—The 2.5 in. of superstructure sag on the downstream bridge side is visually evident in the bridge deck and the railing.

The Little Salmon Creek bridge was constructed without camber and was approximately level with the abutments when installed. In September 1990, approximately 1 year into the monitoring period, the bridge had sagged below the level position, and 1.7 in. of negative camber was measured along the downstream bridge edge. In July 1993, at the conclusion of the monitoring period, negative camber measured 2.5 in. on the downstream bridge edge and 2 in. on the upstream bridge edge (Fig. 18). The visible sag in the bridge is due to creep and is not typical of most stress-laminated timber bridges. It is likely that the high moisture content of the laminations and cyclic moisture changes in the exposed deck surface contributed significantly to this high creep level.

- Vertical creep over the monitoring period resulted in a sag at the superstructure midspan of 2.5 in. along the downstream bridge edge and 2 in. along the upstream bridge edge. This is much greater than expected and is again attributed to the high lamination moisture content.

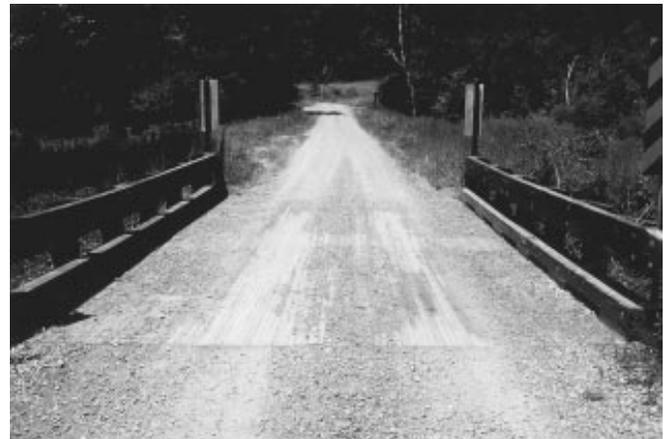
**Figure 25—Debris accumulations on the bridge's deck noted during condition assessment.**

The Little Salmon Creek bridge was designed and constructed without a wearing surface; hence, vehicles ride directly on the treated-wood deck. During each site visit, gravel and other debris from the unpaved approach roadway were present on the deck surface (Fig. 25). Deck wear from vehicle tracking and debris abrasion was noted in several locations, although the level of wear was minor and did not significantly reduce the deck section or extend below the preservative treatment. Over time, it is anticipated that deck wear will continue and could result in reduced deck section

and accelerated deterioration as the preservative treatment envelope wears away.
