Research
Paper
FPL-RP-564

Field Performance of Timber Bridges

14. Dean, Hibbsville, and Decatur Stress-Laminated Deck Bridges

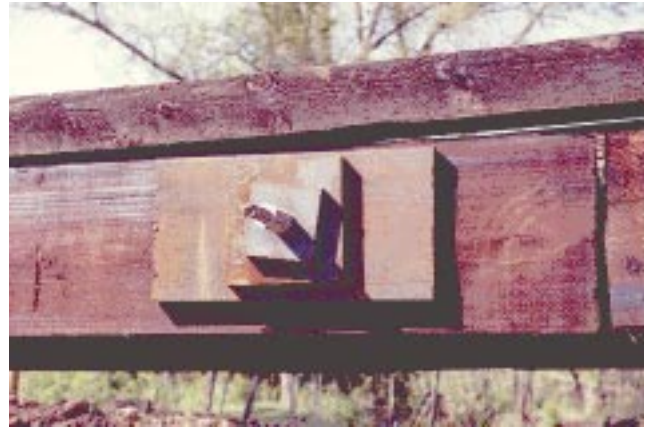
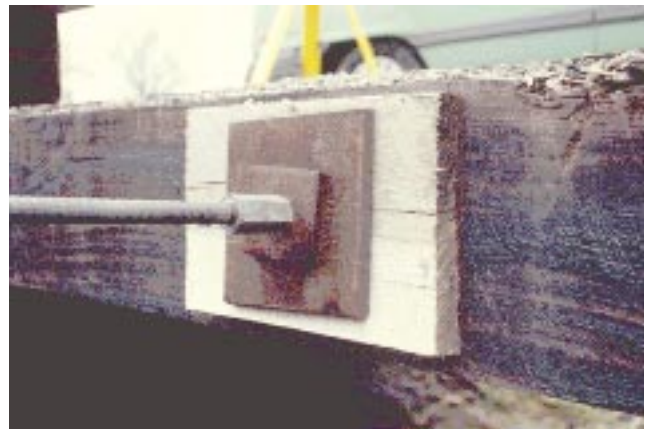
Figure 4—Details of the Dean (top), Hibbsville (middle), and Decatur (bottom) discrete plate anchorage configurations.

Inspection of the anchorage systems at the Dean and Decatur bridges revealed checks in the white oak plates (Fig. 4). Currently, the oak plates are not adversely affected by the checks and are performing as designed. However, because the plates are untreated and the checks provide avenues for moisture penetration, it is expected that the plates will eventually deteriorate and have a negative effect on the bar force. This can be prevented by treating the plates with a wood preservative prior to installation or substituting galvanized steel plates for the oak plates. In addition, conclusive evidence does not exist that the white oak plates perform the same function as do the full-length, dense hardwood exterior laminations. Bar force loss occurred rapidly; therefore, the anchorage systems were not required to perform under the full design force for an extended period. The reduced compression beneath the bearing plates explains the absence of exterior lamination crushing.

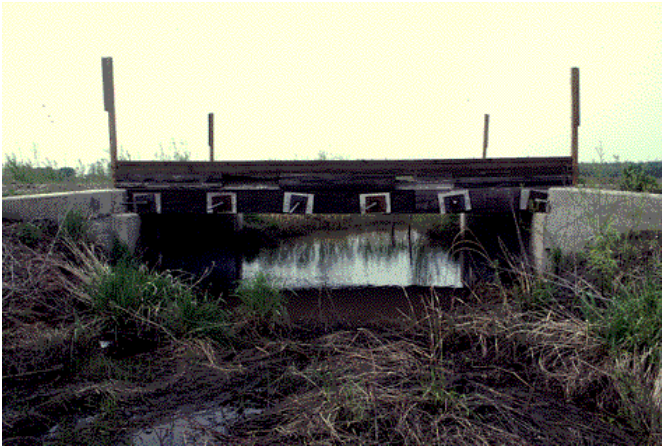
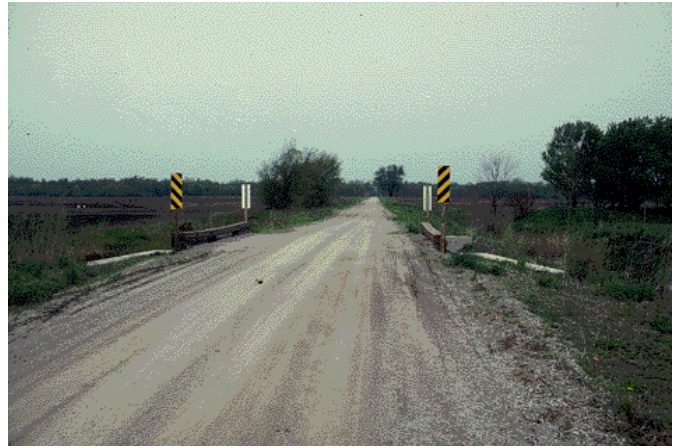
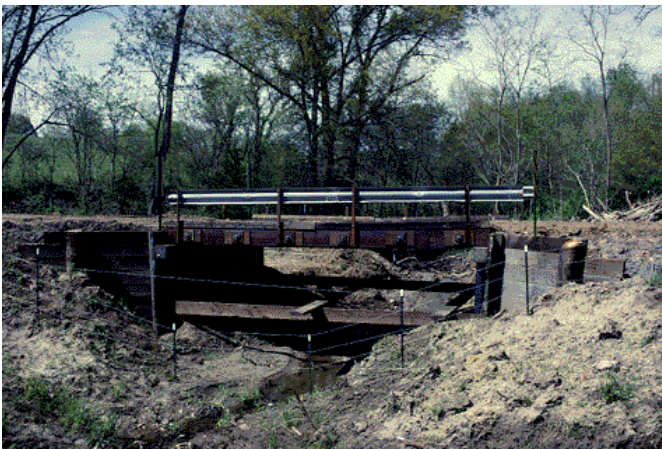
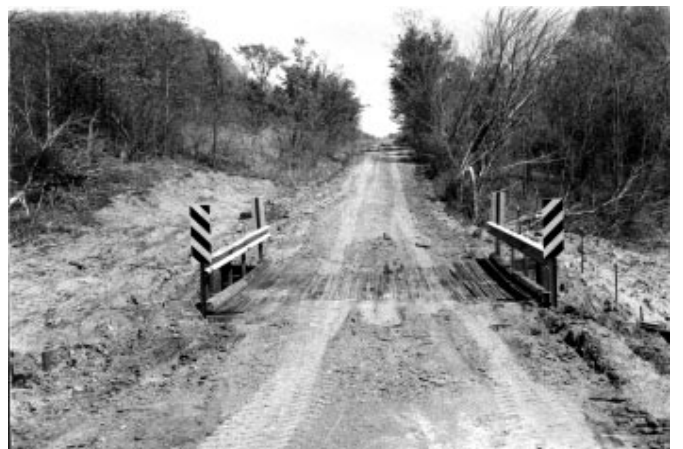
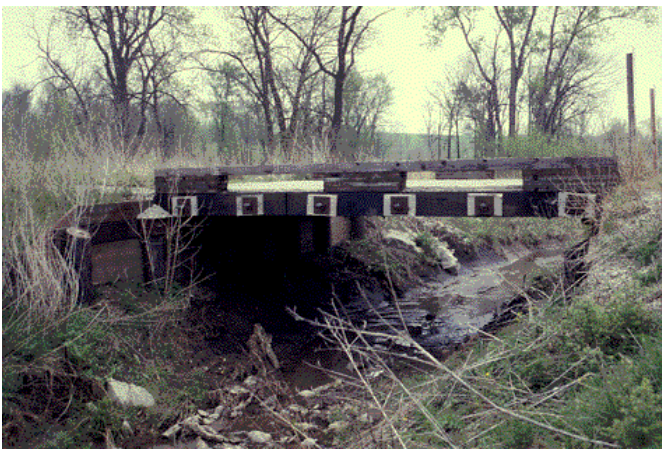
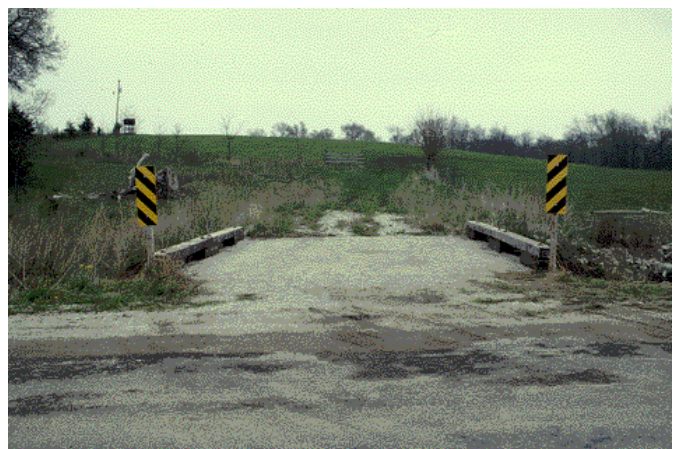
Figure 5—Completed bridges: Dean (top), Hibbsville (middle), and Decatur (bottom).

Approximately 2 weeks after the initial tensioning, the steel bars were tensioned to the design force a second time to compensate for losses in bar force (Ritter 1990). The bars were tensioned a third time at the first load test, approximately 7, 4, and 2 months after construction of the Dean, Hibbsville, and Decatur bridges, respectively. The first bridge inspections were also completed at the first load test. Inspection revealed that the as-built bridge configurations varied slightly from the design configurations (Fig. 2). For the Dean, Hibbsville, and Decatur bridges, the average width of the out-to-out bridge measured 6.98, 5.24, and 6.46 m (22.9, 17.2, and 21.2 ft), respectively. The length of the bridge measured 7.35, 7.19, and 7.22 m (24.1, 23.6, and 23.7 ft), respectively, and the span of the bridge, center-to-center of bearings, measured 6.80, 7.04, and 6.92 m (22.3, 23.1, and 22.7 ft), respectively. It was also noted that the laminations used for the Dean bridge were uneven in width and resulted in gaps between adjacent laminations near the buttjoints. The completed bridges are shown in Figure 5.

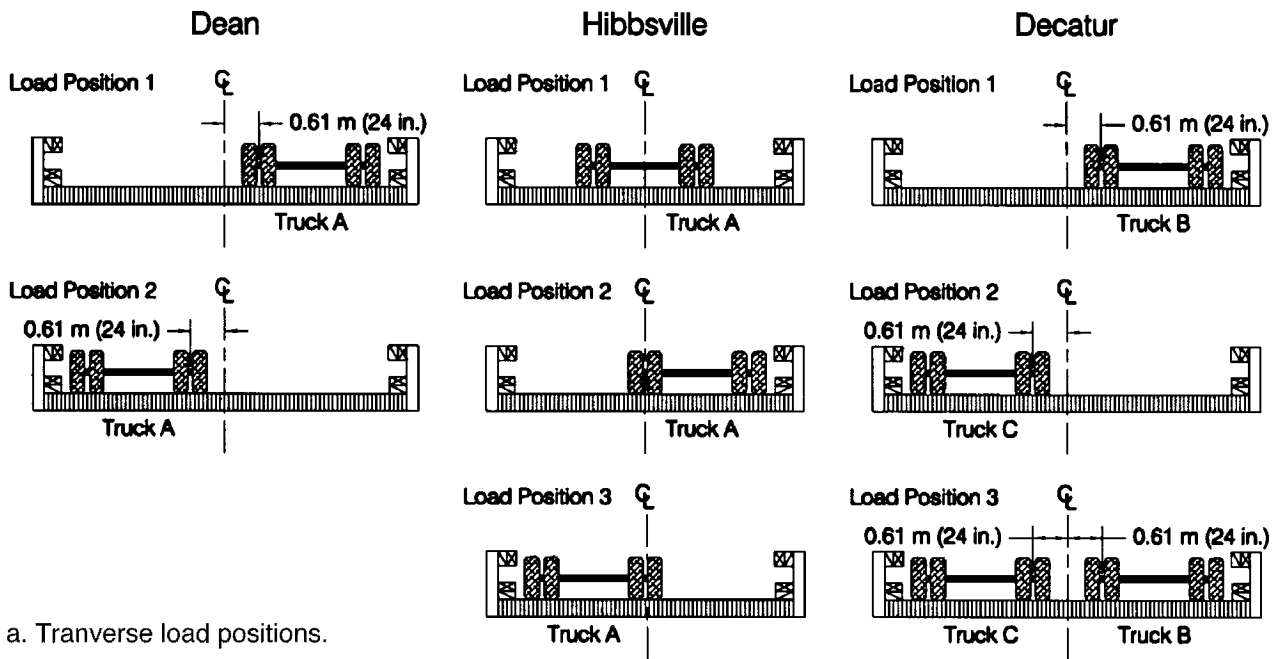
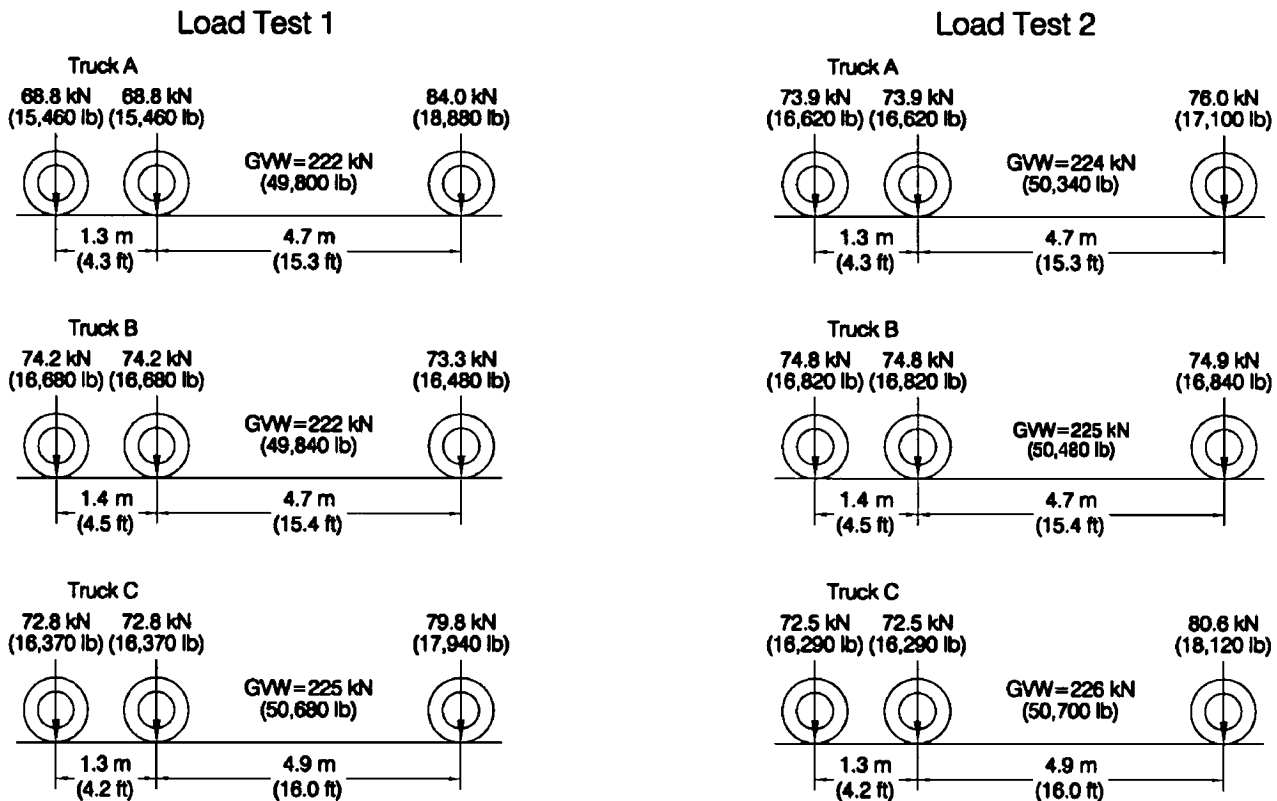
a. Transverse load positions.

b. Vehicle configurations.

Figure 6—(a) Transverse load positions used for load tests (looking west). Only load position 1 was conducted at the second Hibbsville bridge load test. (b) Test vehicle configurations and axle loads for load test 1 and 2 (right single axle is vehicle front). The transverse vehicle track width, measured center-to-center of the rear tires, was 1.8 m (6 ft).

For each load test, fully loaded trucks were transversely positioned on the bridge in centric and eccentric load positions and longitudinally with the rear axles centered about the midspan (Figs. 6 and 7). As a result of the extremely muddy road condition, only load position 1 was tested for the second Hibbsville bridge load test. For each load position, resulting deflections were measured at a series of locations along the midspan of the bridge. Measurements of deck deflections were taken prior to testing (unloaded), for the load positions (loaded), and at the conclusion of testing (unloaded). Measurements of bridge deflections were obtained by suspending calibrated rules from the underside of the deck and reading values to the nearest 0.1 mm (0.004 in.) with a surveyor's level (Fig. 8). The accuracy of measurements was estimated to be ± 0.1 mm (± 0.004 in.).

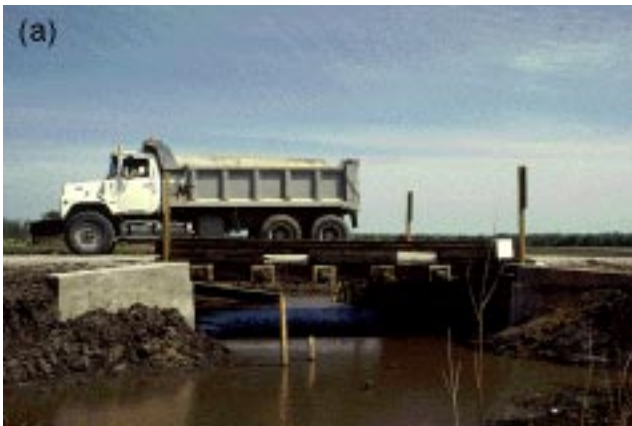
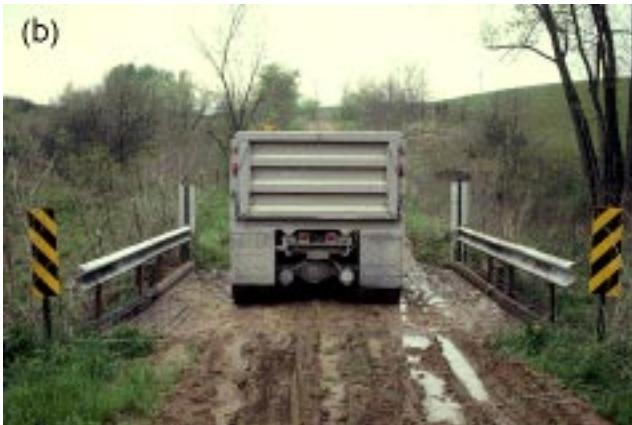
Figure 7—(a) Load position 2 used for the first Dean bridge load test (looking north). (b) Load position 1 used for the second Hibbsville load test (looking west).

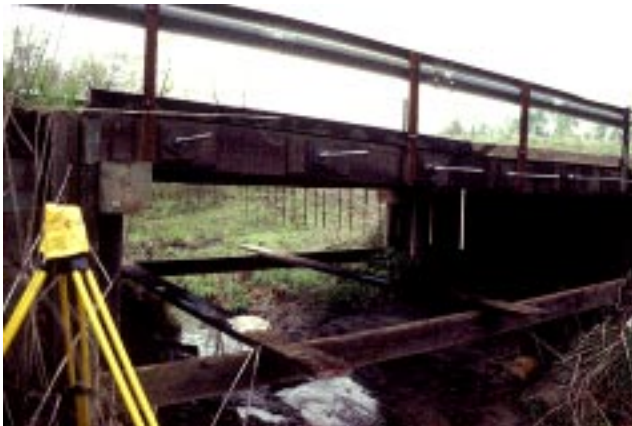
Figure 8—Load test deflection measurements were obtained by reading values from calibrated rules suspended from the underside of the deck with a surveyor's level. Load test 2 of the Hibbsville bridge is shown.

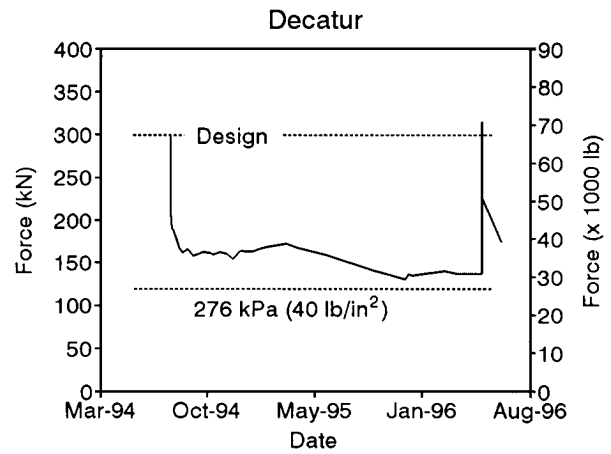
Figure 9—Average trend in bar force for the Dean, Hibbsville, and Decatur bridges.

The average bar force trend for the Dean, Hibbsville, and Decatur bridges is illustrated in Figure 9. These figures also indicate a bar force of 128, 120, and 120 kN (28,800, 26,888, and 26,888 lb), which represents the minimum recommended interlaminar compression level of 276 kPa (40 lb/in²) for the Dean, Hibbsville, and Decatur bridges, respectively (Ritter 1990). In each case, data begin at the

time of the first load test when the bars were tensioned to the approximate design force of 320 kN (72,000 lb) for the Dean bridge and 299 kN (67,200 lb) for the Hibbsville and Decatur bridges. Data end shortly after the second load test, at which time the bars were tensioned to approximately 110% of the design force. Additional bar tensionings occurred during the monitoring period for the Dean and Hibbsville bridges. As indicated, initial force loss after bar tensioning occurred rapidly and ranged from approximately 15% to 40% within several days. The Dean bridge experienced the largest initial loss. Typically, rapid force loss continued at a decreasing rate until the bar force stabilized at approximately 138, 133, and 160 kN (31,000, 30,000, and 36,000 lb), which corresponds to interlaminar compression levels of 296, 310, and 372 kPa (43, 45, and 54 lb/in²) for the Dean, Hibbsville, and Decatur bridges, respectively.

The majority of bar force loss is attributed to stress relaxation of the lumber laminations caused by the applied compressive force. For these bridges, the effects of stress relaxation were greatly augmented by the high moisture content of the cottonwood laminations.

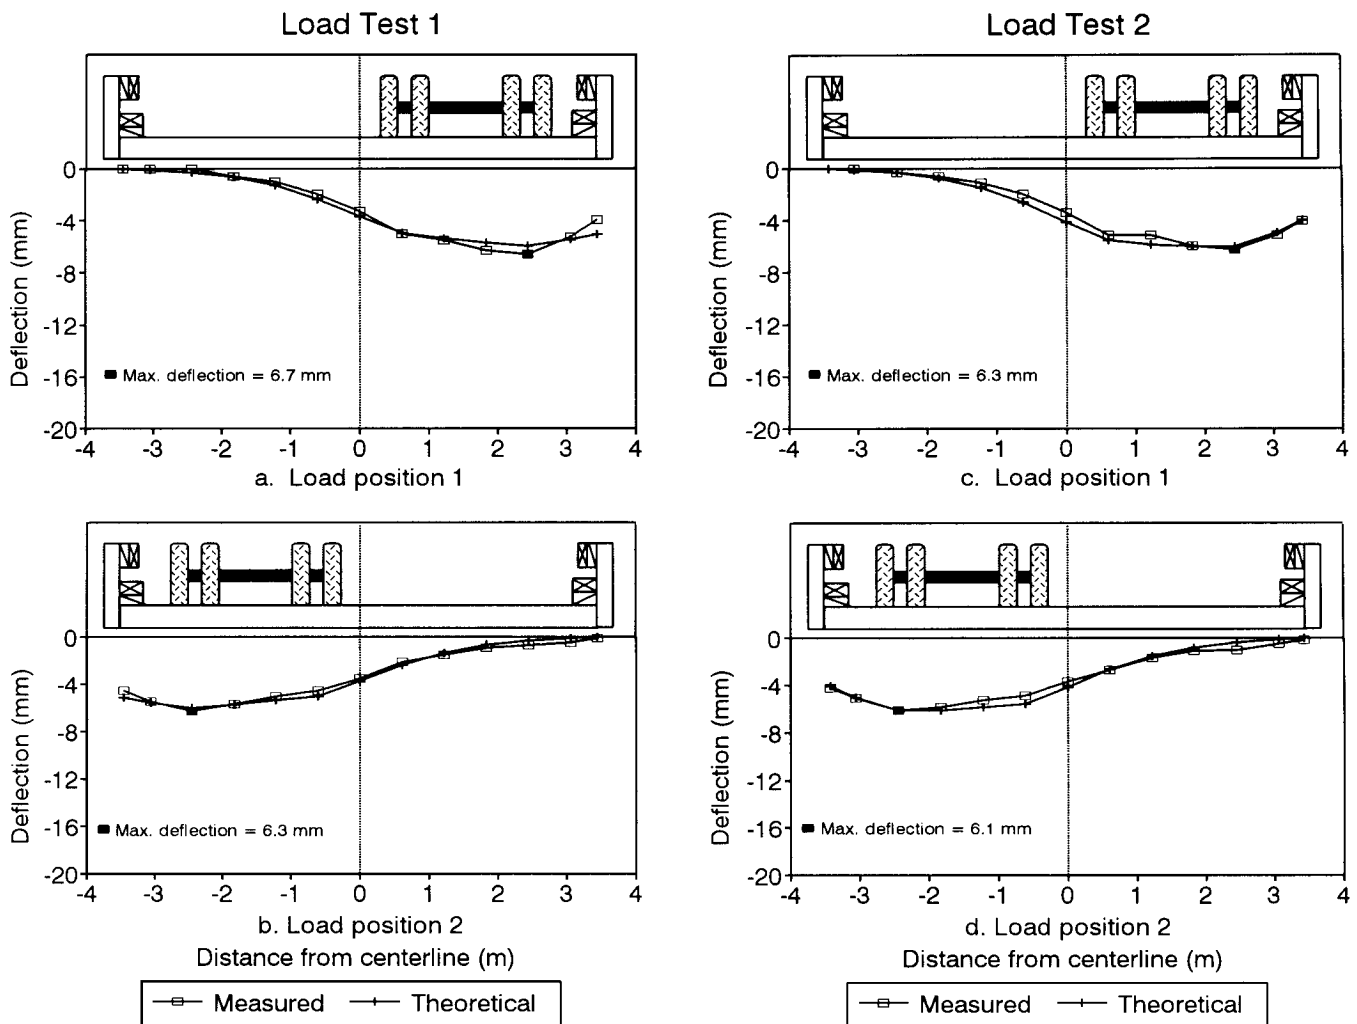
Figure 10—Transverse deflections for the Dean bridge load tests (looking west), measured at the midspan. Bridge cross-section and vehicle positions are shown to aid interpretation and are not to scale.

Comparisons of the measured load test deflections to the theoretical bridge response in Figures 10–12 indicate that the theoretical deflections are generally similar to those measured. The theoretical response for the Dean bridge is nearly identical to the actual response with minor variations at the edges of the bridge. For the Hibbsville bridge, the load test

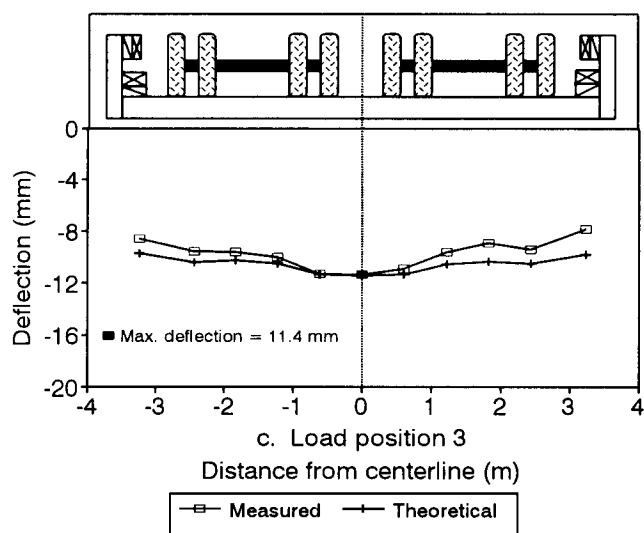
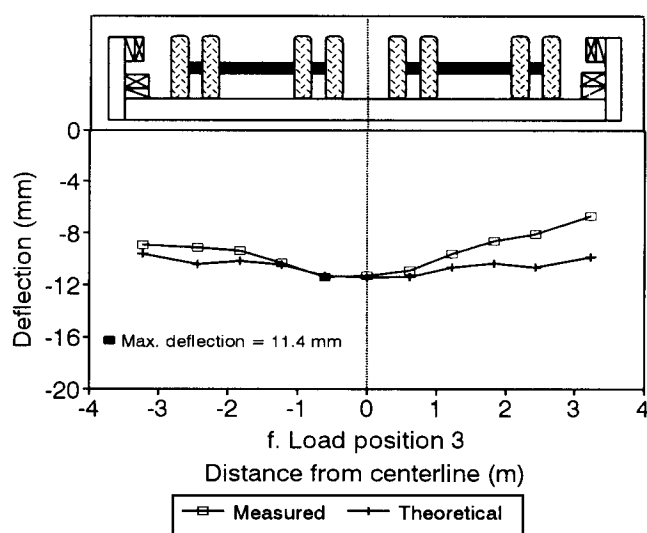
Figure 12—Transverse deflections for the Decatur bridge load tests (looking west), measured at the midspan. Bridge cross-sections and vehicle positions are shown to aid interpretation and are not to scale.

For each load test of the Decatur bridge, the theoretical response accurately predicted the behavior of the bridge for load position 2 and overestimated the deflections of load position 1. The difference between the measured and theoretical deflections for load position 1 was anticipated, because the orthotropic plate model assumes constant bridge properties, and as mentioned previously, the longitudinal stiffness of the north (right) side of the bridge appears to be greater than that of the south side. For load position 3, the theoretical deflection closely matched the absolute maximum measured deflections, but greater variation between the deflections was again evident at points away from the centerline on the north (right) side.

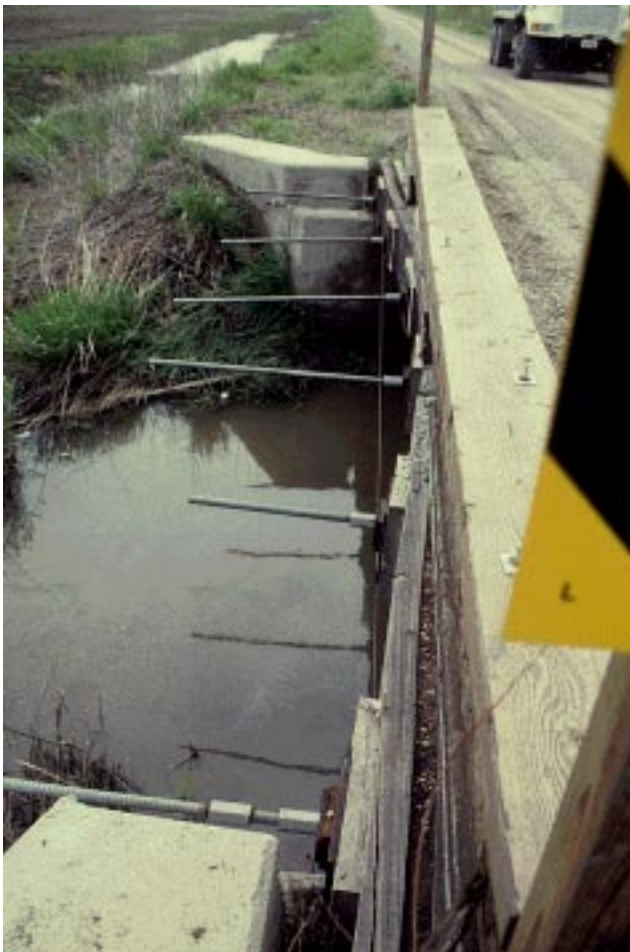
Figure 19—Distortion of north edge of Dean bridge. The width is approximately 216 mm (8.5 in.) narrower at the midspan than at the abutments.

Inspection of the geometry of the Dean, Hibbsville, and Decatur bridges revealed diverse conditions. The largest deck distortion occurred in the Dean bridge. At the time of the first load test, measurements of the width of the bridge indicated that the south deck edge was essentially straight and the north deck edge was approximately 216 mm (8.5 in.) narrower in width at midspan than at the abutments. This distortion was remeasured at the time of the second load test, revealing no additional reduction in width (Fig. 19). It is suspected that this distortion was largely attributable to the layout of the cottonwood laminations, which varied in width as much as 13 mm (0.5 in.) at the butt joints along the north third of the bridge width. This could have been prevented had the laminations been surfaced to a uniform thickness. In addition to the width distortion of the Dean bridge, only three laminations were bearing on the south end of the east abutment along the first 1.8 m (6 ft) of bearing.

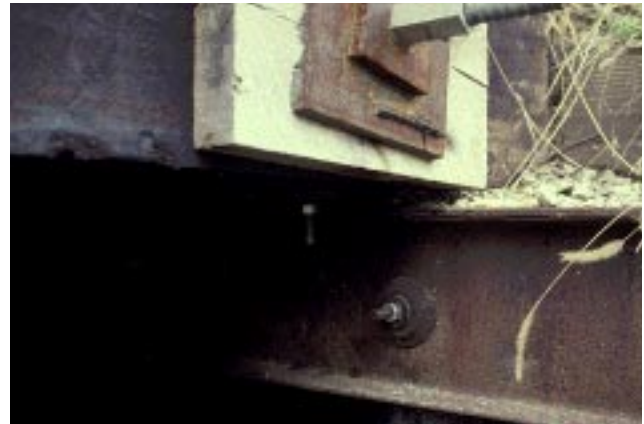
Figure 20—(top) Schematic of west abutment of Decatur bridge. The edges of the deck curve upward away from abutment; (bottom) gap between abutment and deck at the northwest corner of the Decatur bridge.

corners of the deck along the west abutment curled upward approximately 38 mm (1.5 in.) (Fig. 20). At both edges, the displacement of the deck relative to the abutment gradually decreased until at 457 mm (18 in.) from each deck edge, the deck made contact with the abutment. This condition remained unchanged throughout the monitoring period. In addition to this distortion, the first bar at the southeast corner was observed to be angling upward (Fig. 21).

The uneven bearing contact and the bar distortion are probably a result of constructing the deck on uneven temporary supports.

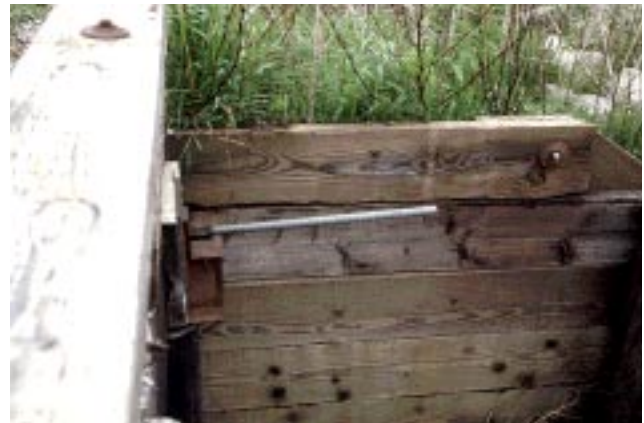
Figure 21—Stressing bar angles upward at southeast corner of Decatur bridge.

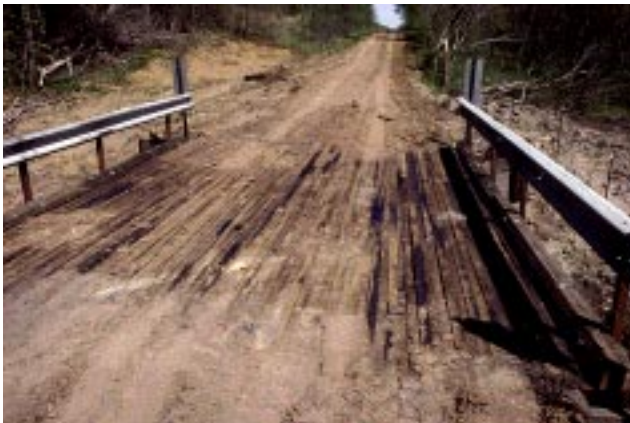
Figure 22—Uneven deck surface of the Hibbsville bridge as a result of unequal depth of the laminations.

Inspection of the geometry of the Hibbsville bridge revealed no deficiencies, although it was noted that the depth of the laminations varied, resulting in an uneven deck surface (Fig. 22).

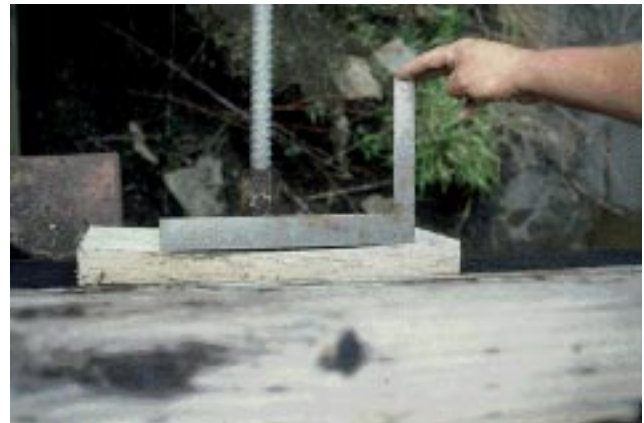
Figure 23—Top view of white oak bearing plate deformation in the Decatur bridge.

The second condition assessment of each bridge revealed that the discrete plate anchorage system was performing as designed. Crushing of the steel and white oak bearing plates into the outer deck laminations at each bridge was negligible. No distortion was exhibited by the steel plates, but the white oak plates did show slight deformation, resulting from the stressing bar force (Fig. 23). The ungalvanized steel plates showed signs of corrosion, but the galvanized stressing bars did not. At this time, corrosion of the plates was minor and not affecting system performance. The rate of corrosion is expected to be slow because these roads are not salted during the winter. However, the plates may eventually deteriorate to the point where they are no longer structurally sound. Such deterioration is preventable by galvanizing all steel components prior to construction.

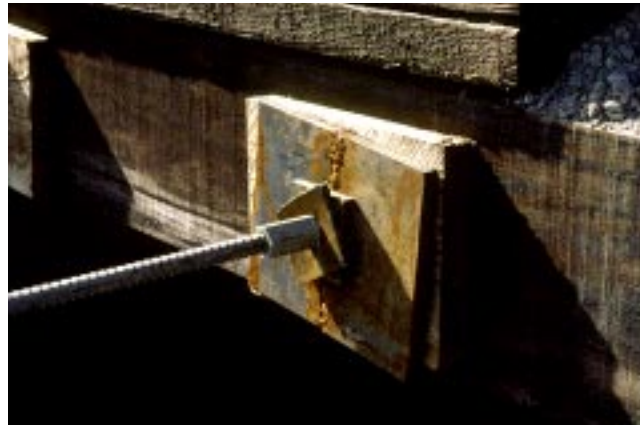
Figure 24—Two steel plates butt jointed and welded together to form bearing plate at the Dean bridge.

During the anchorage inspection at the Dean bridge, it was noted that one steel bearing plate was composed of two solid-steel plates, butt jointed at the centerline and welded together (Fig. 24). At present, the plate is performing properly; however, this modification is not recommended because it produces a bearing plate more susceptible to bending deformation.
