**NCC State Reports**

**Spring 2019, Lakewood, Colorado**

**Tire Chain Wear and Wheel Path Rutting**

April 2, 2019

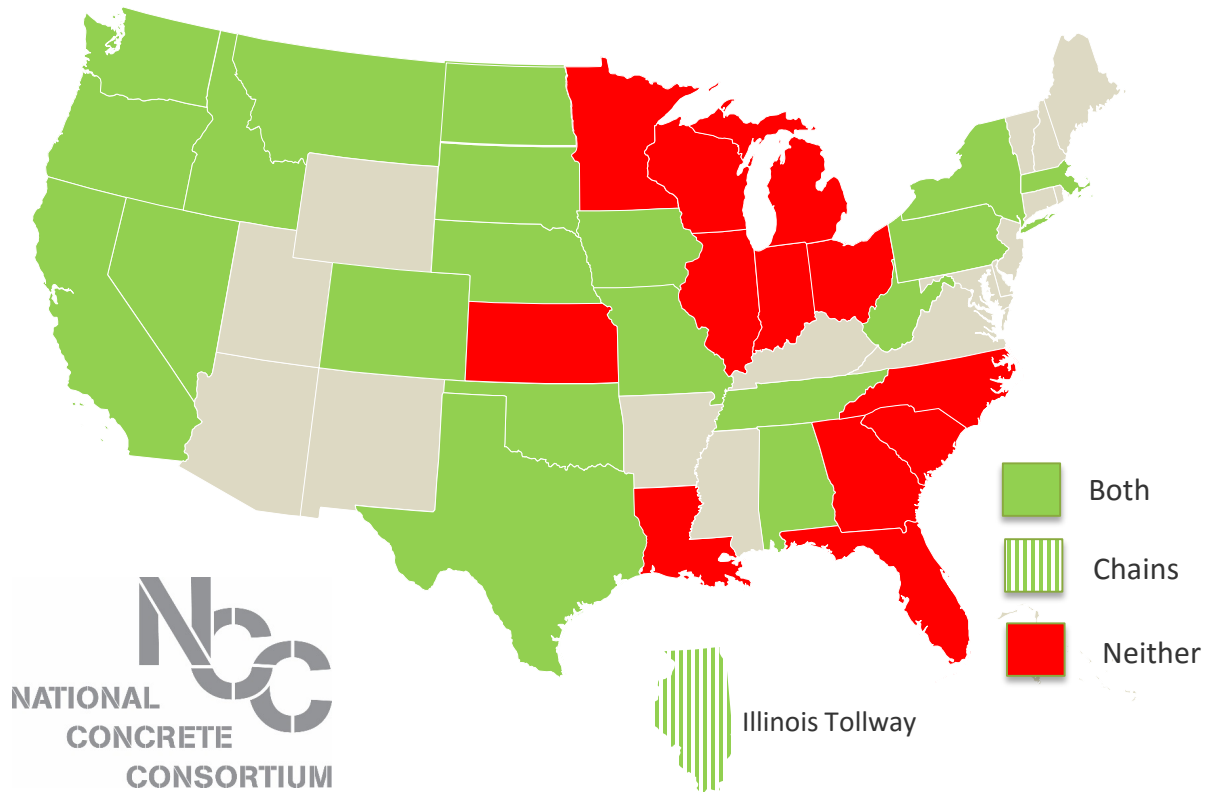
# Does your state allow studded tires, chains or other traction devices?

Answered: 33 Skipped: 0

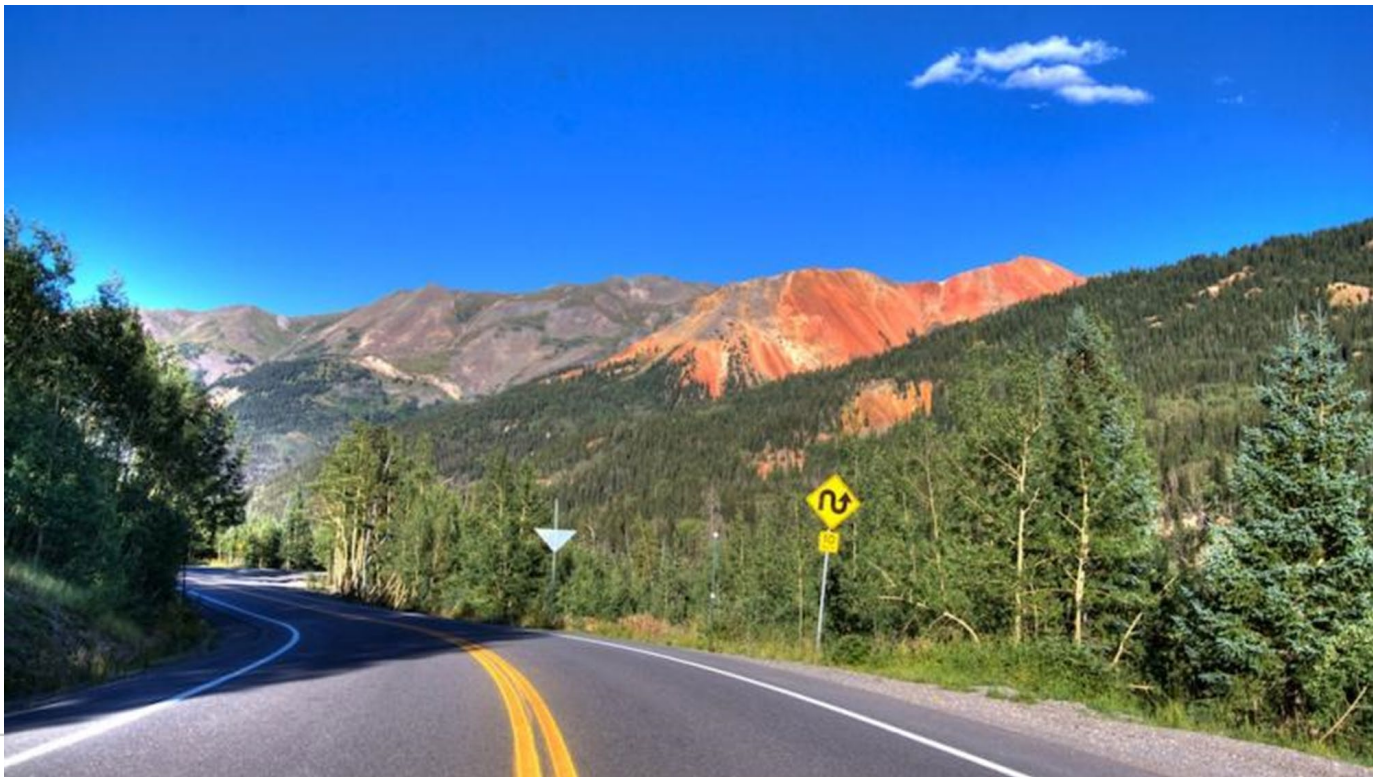
# Red Mountain Pass (US 550) Summer

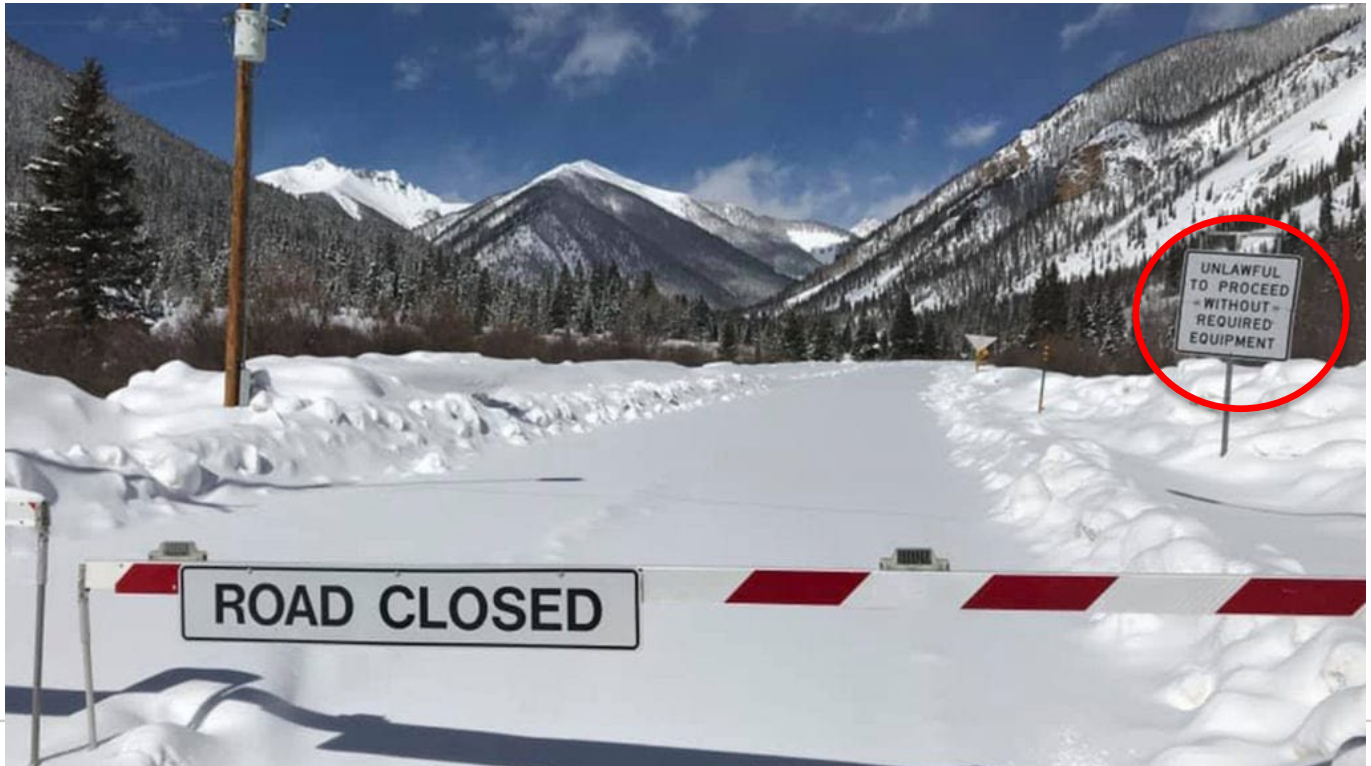
# Red Mountain Pass (US 550) Winter

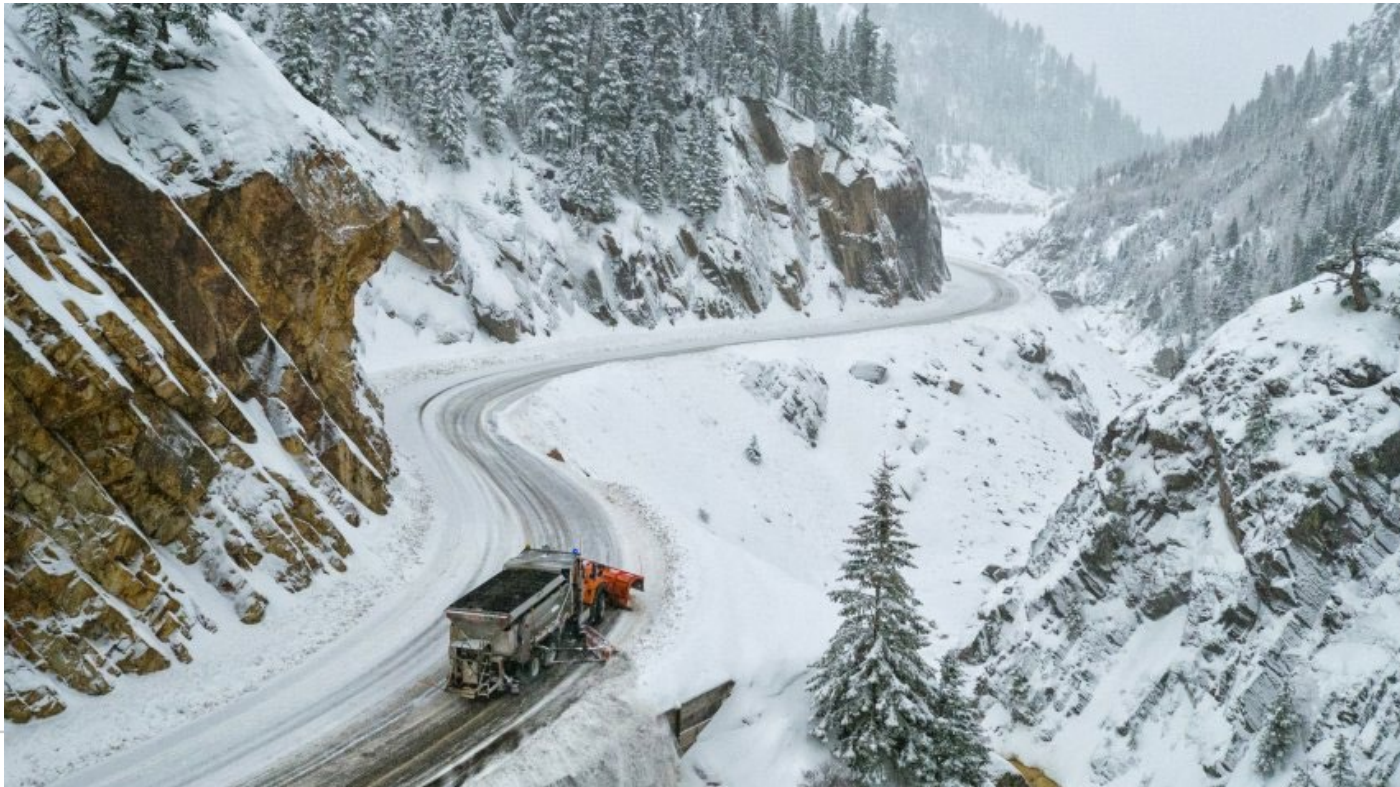
# Red Mountain Pass (US 550) Winter

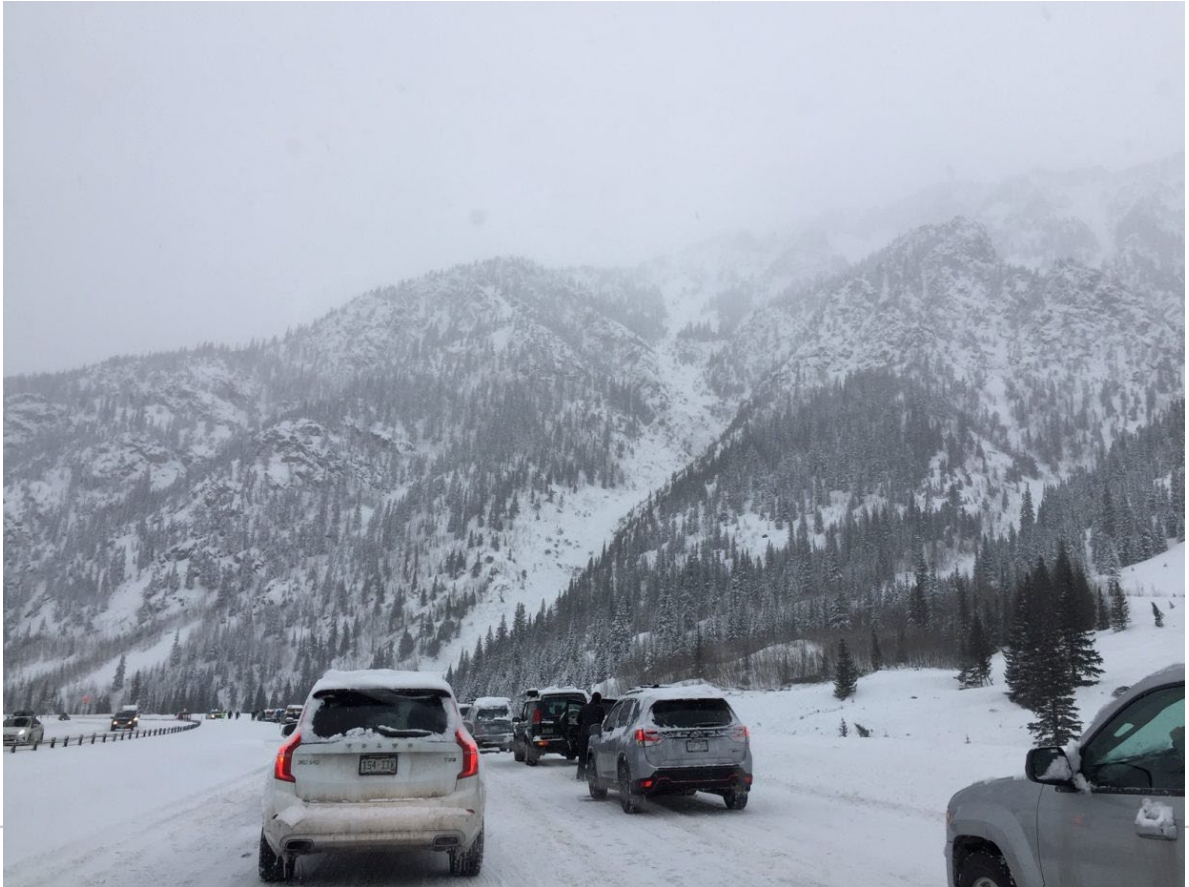
# Vail Pass (I-70)

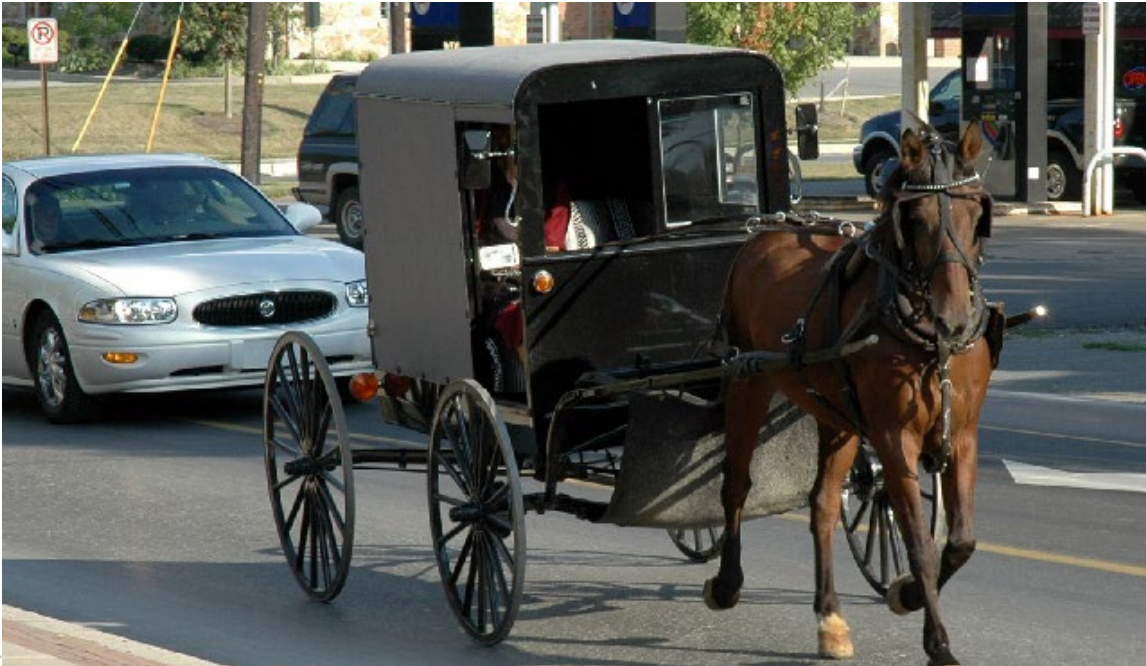
**Do your concrete pavements experience wheel path rutting that is not caused by traction devices?**

Pennsylvania is the only state to have other causes of rutting. They have rutting in Amish country from horse traffic.
