NRRA Concrete Pavement Research Update

Tom Burnham, P.E. | Senior Road Research Engineer, Minnesota Department of Transportation

Spring 2019 NCC Meeting, Denver, CO

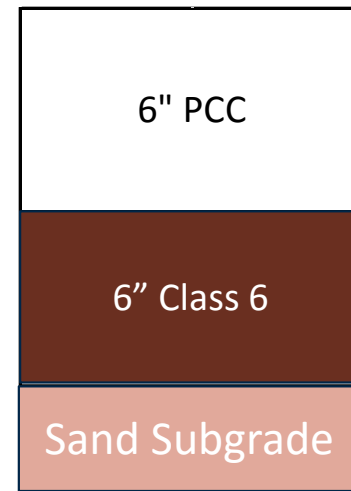
- **MnROAD Cells 124-624**

(Low Volume Road Traffic)

- **Standard panel size 12'W x 15'L**
- **Standard concrete mix**
- **Doweled joints**
- **Early sequential traffic loadings**
 - **Based on maturity**
- **Vehicle driven across concrete before full set to cause visible damage**

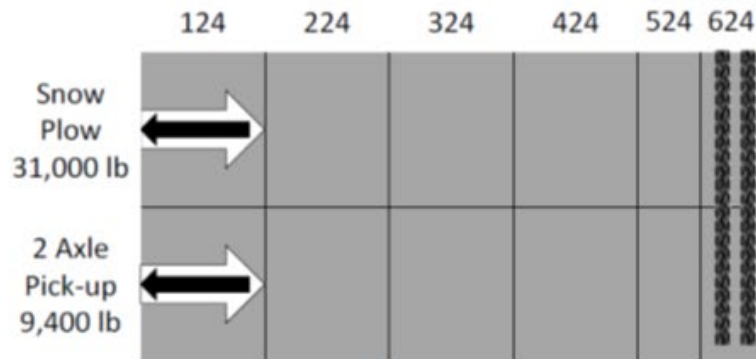
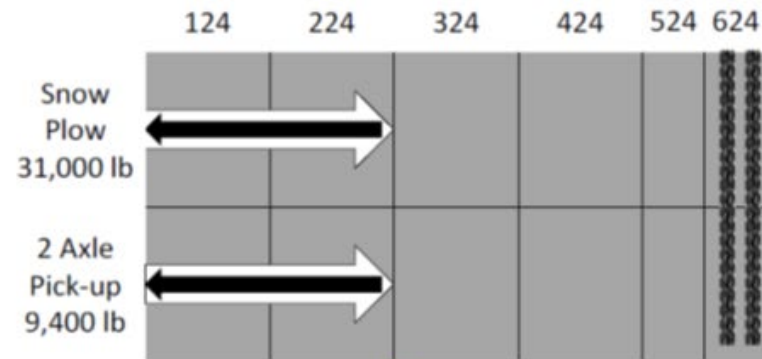
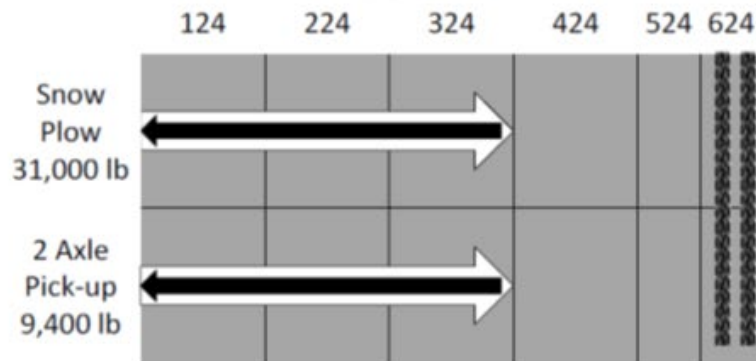
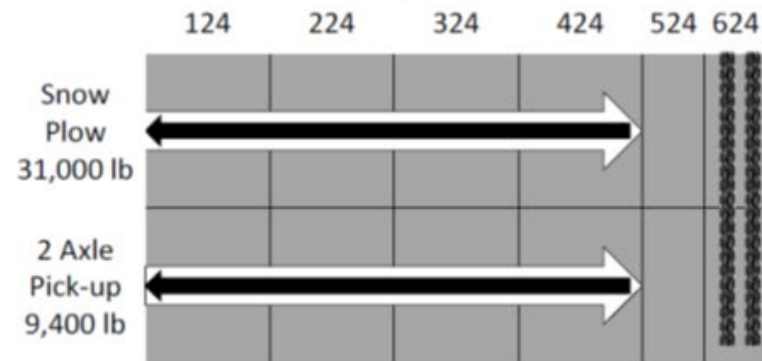
4,000 lb axle vs 14,000 lb axle loads

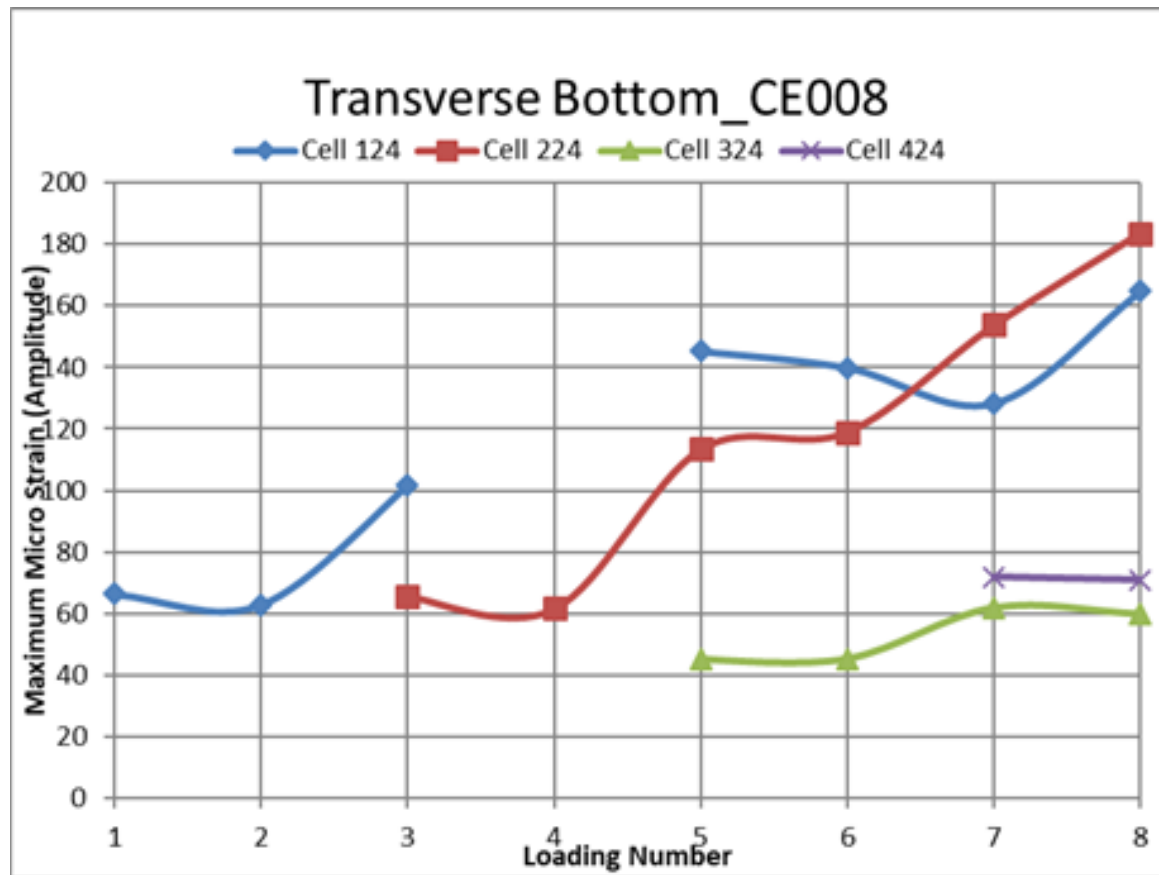
Dynamic Strain Sensor Data

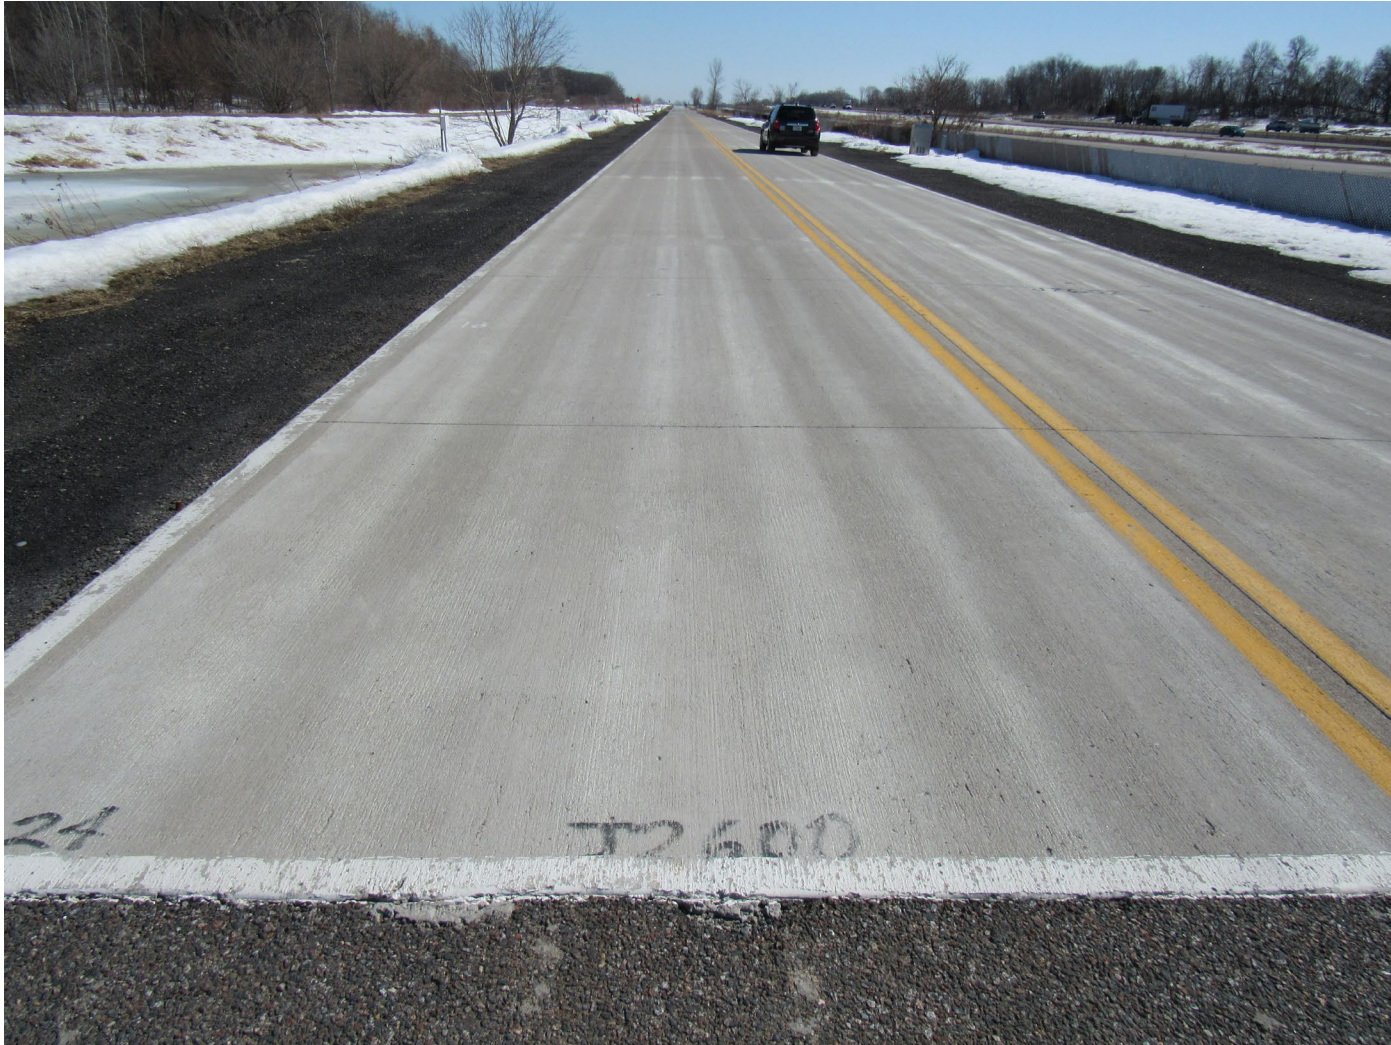
Spring 2019 Cell 124 Condition

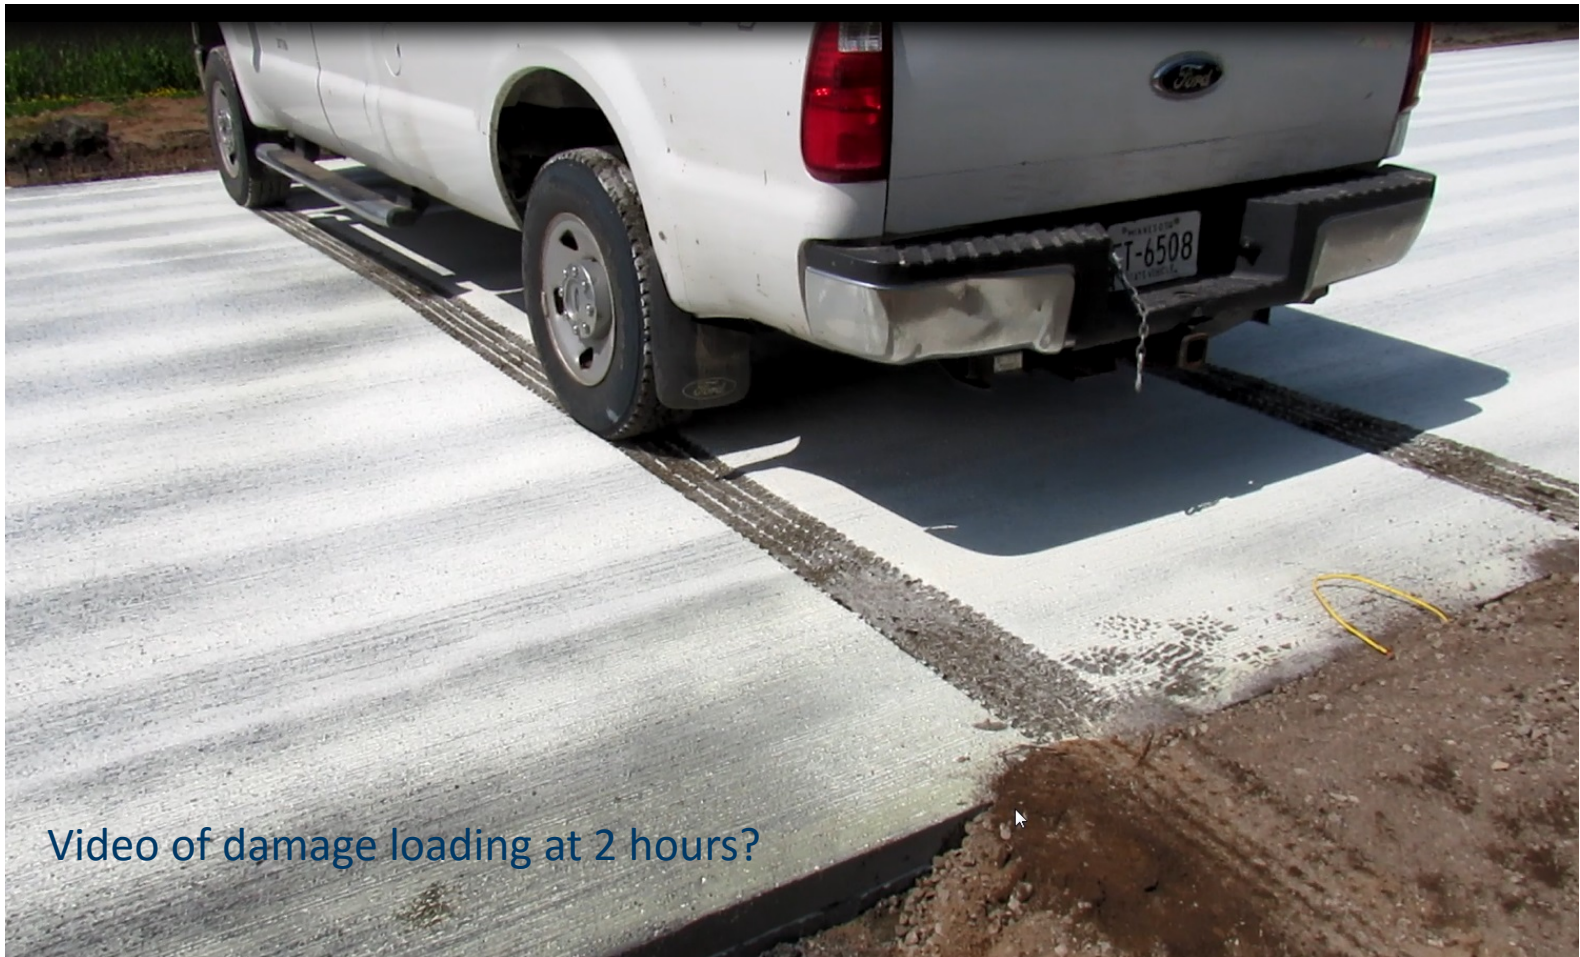
4,000 lb axles @ 2 hrs (very warm day!)

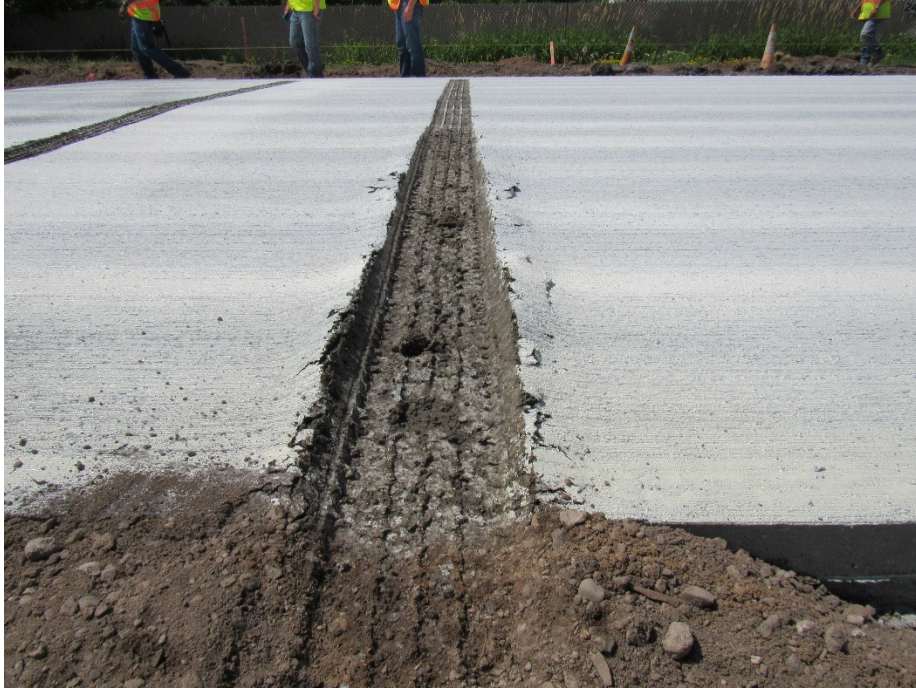
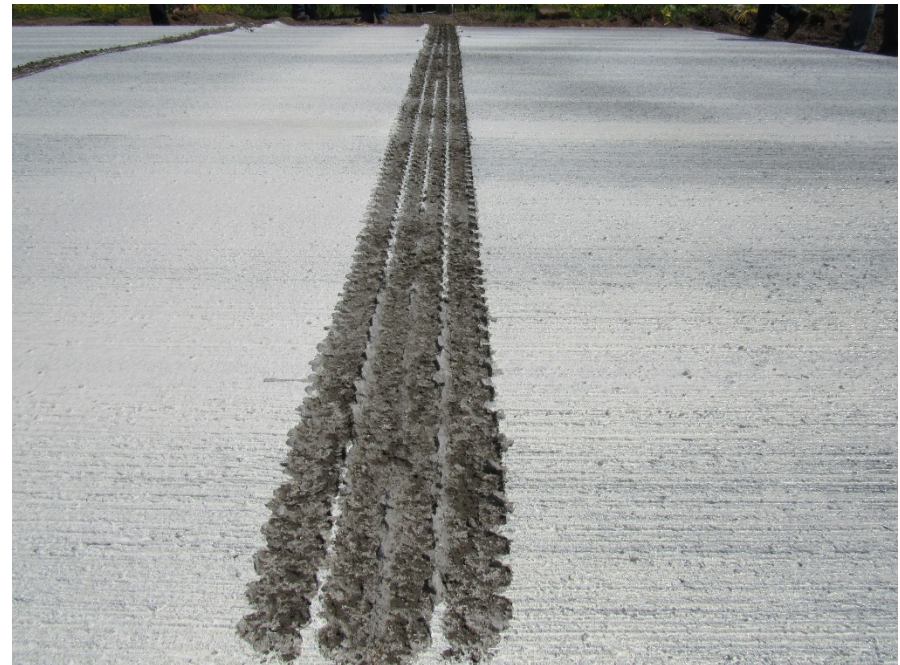
Inside lane

Outside lane

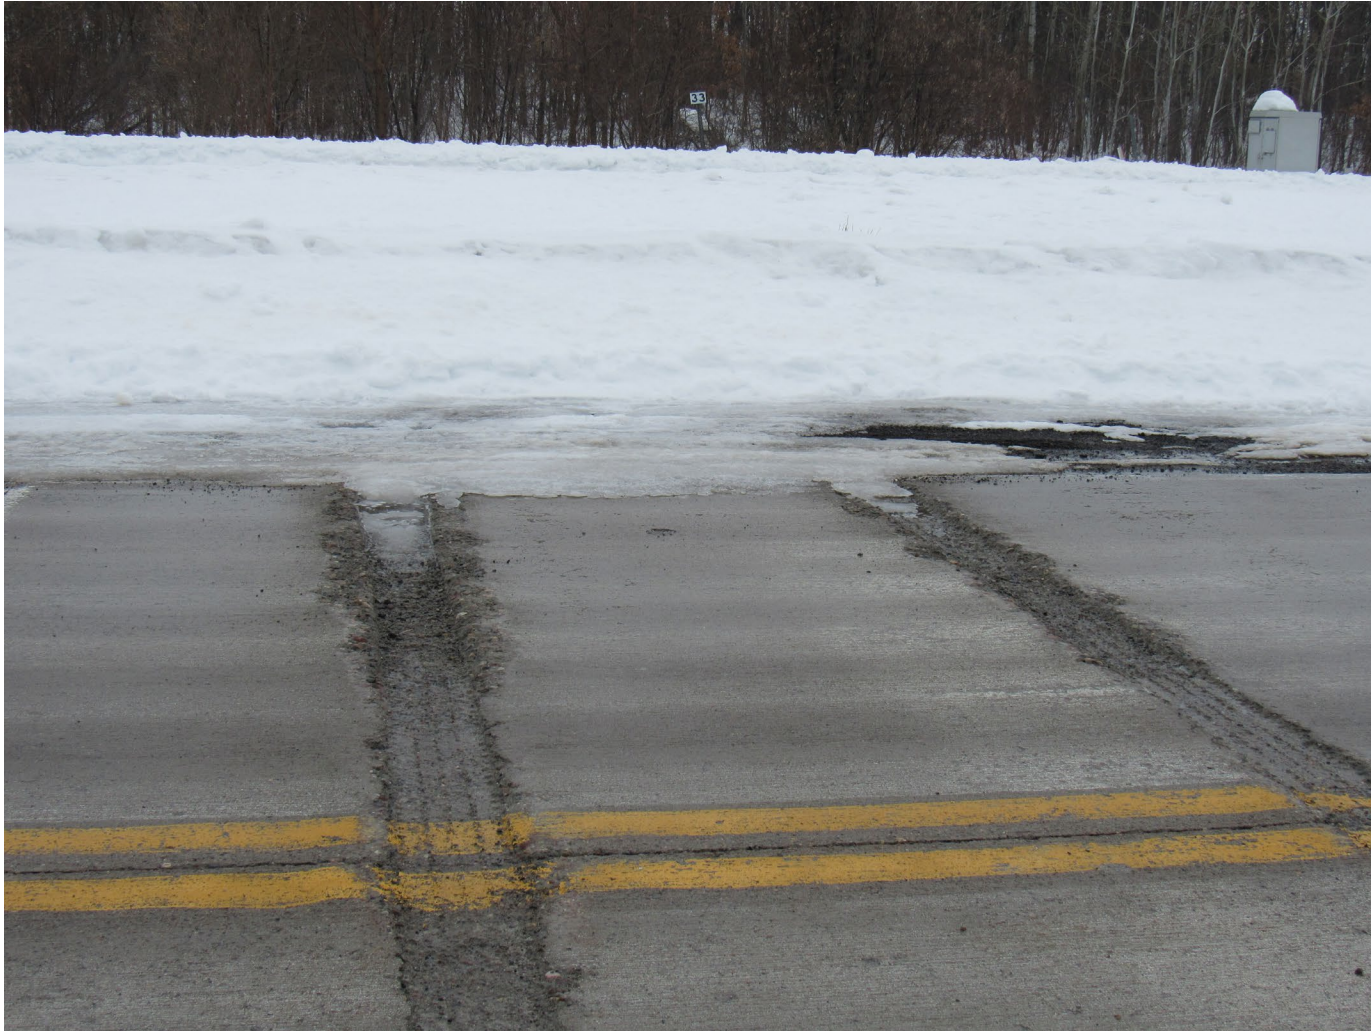
Spring 2019 Cell 624 Condition

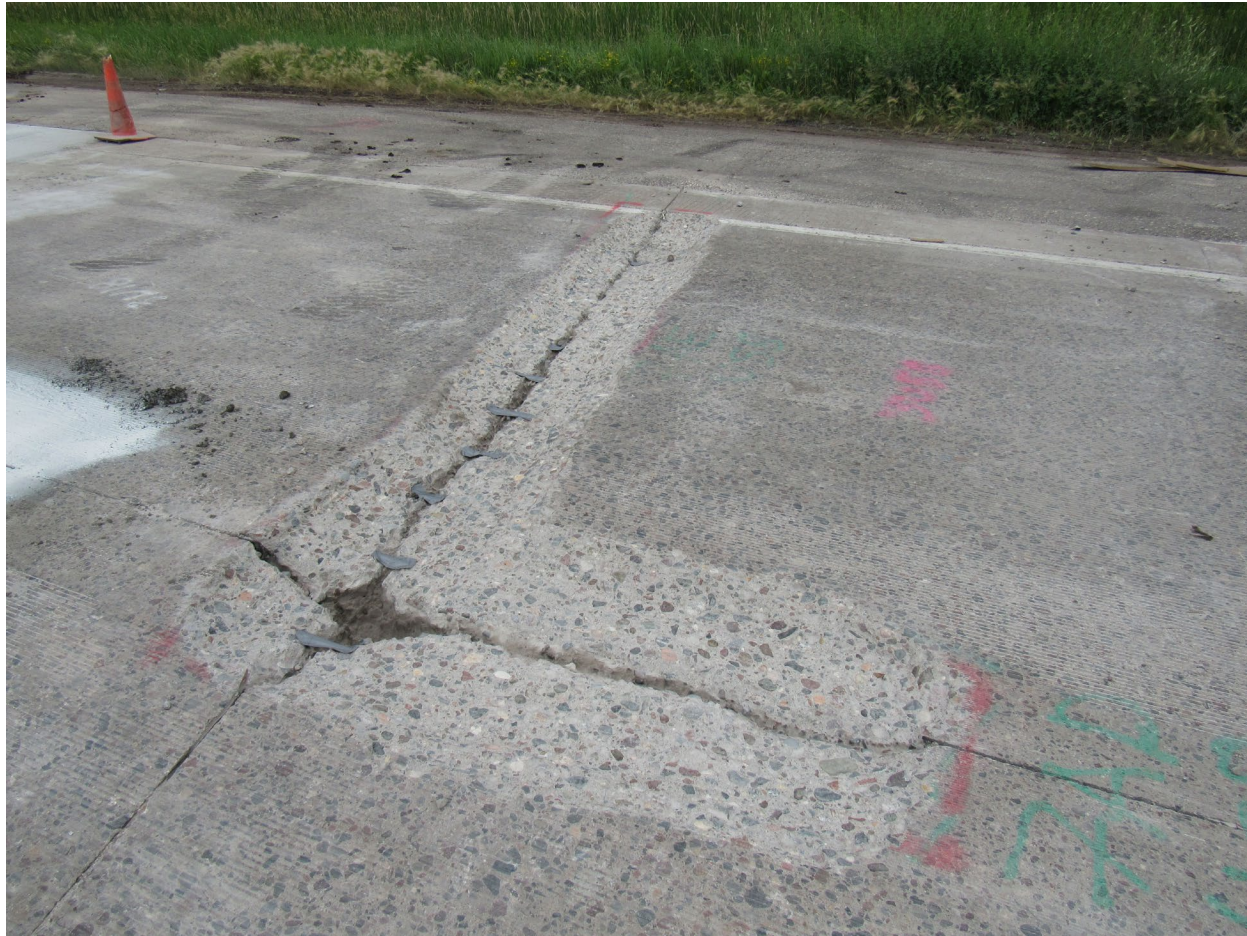
Partial Depth Repairs

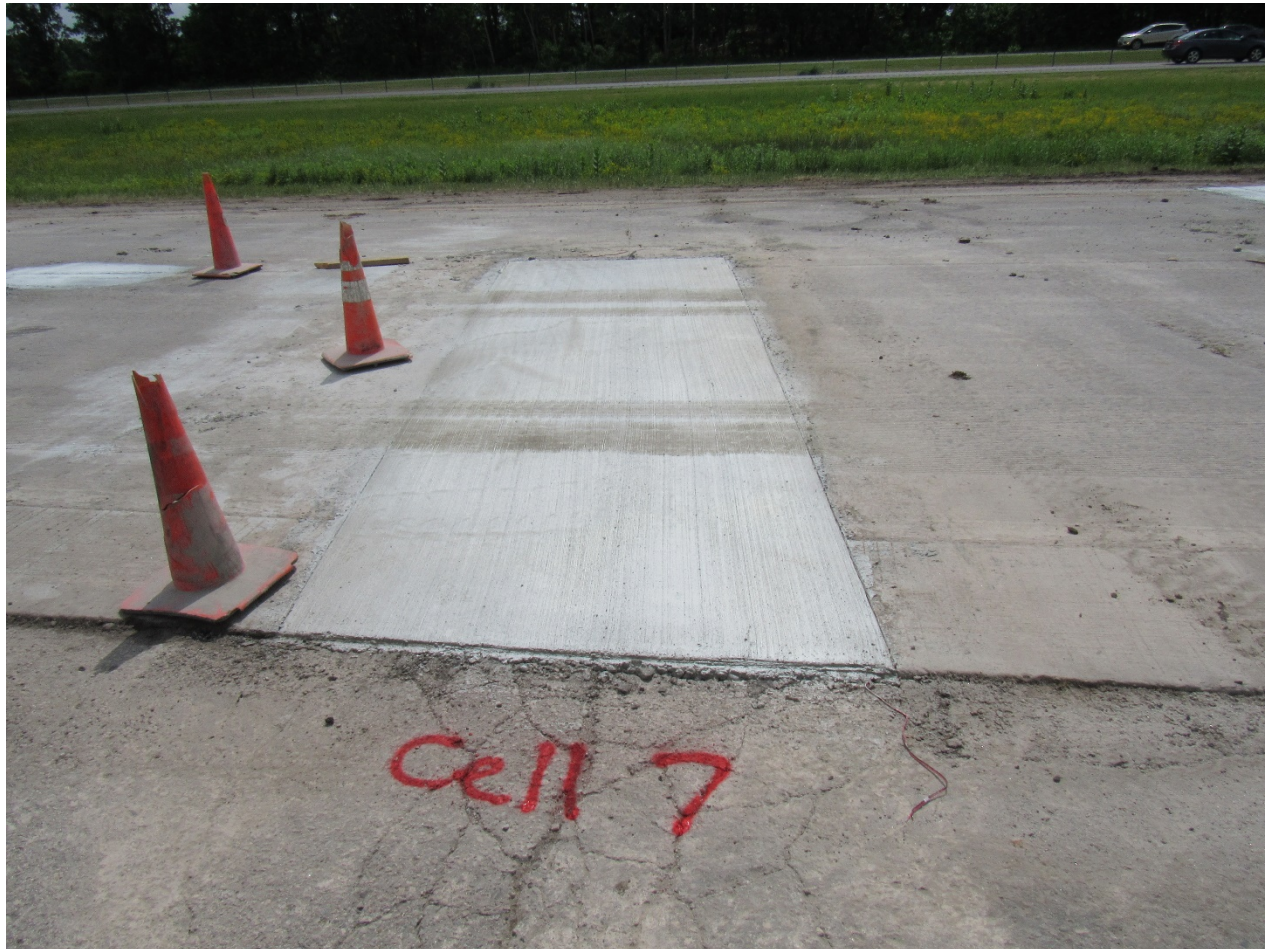
Full Depth Repairs

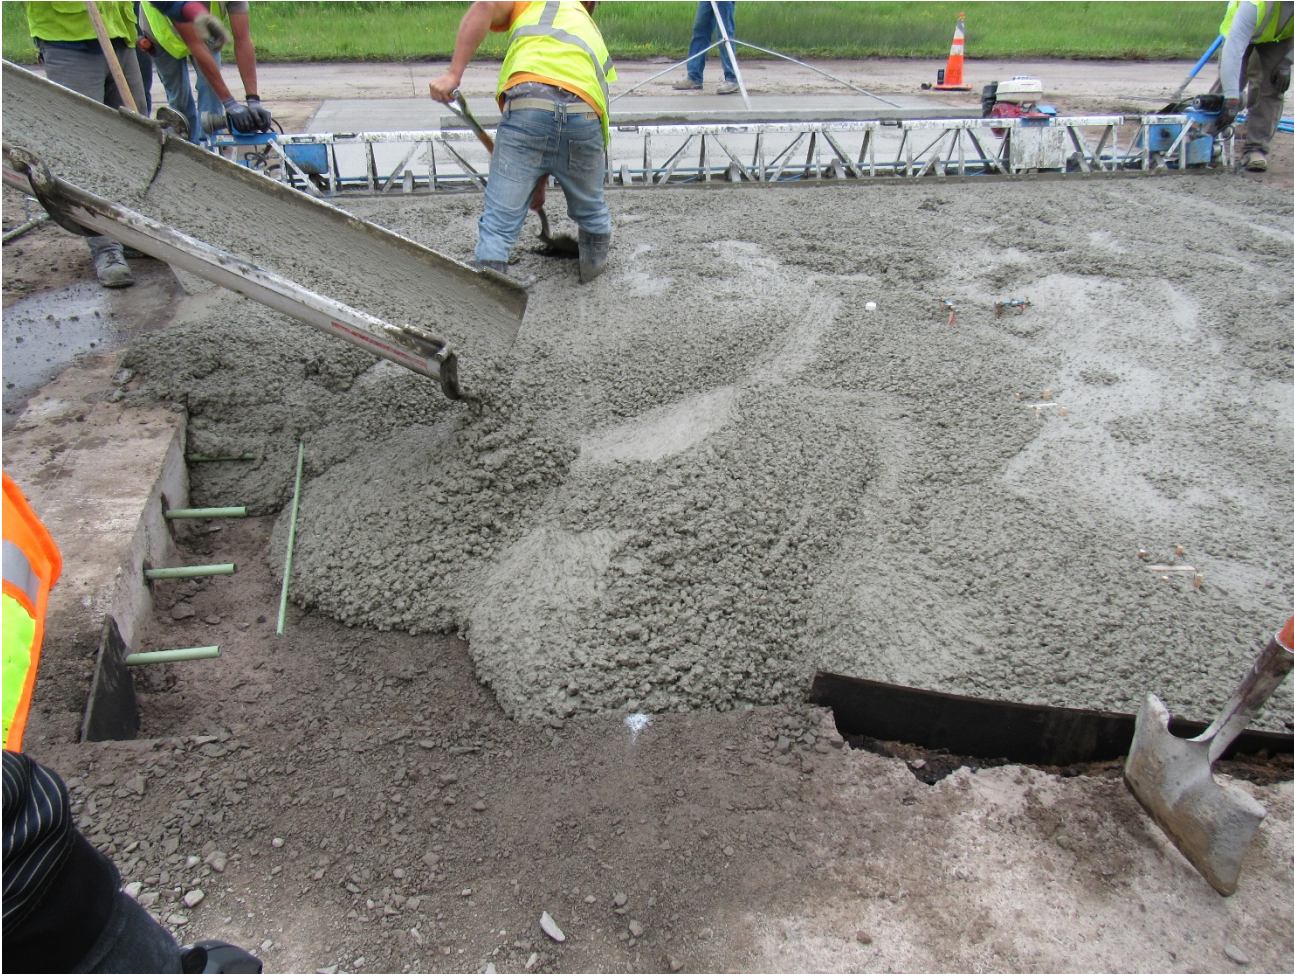
Internal Cure Mix - High Early Strength

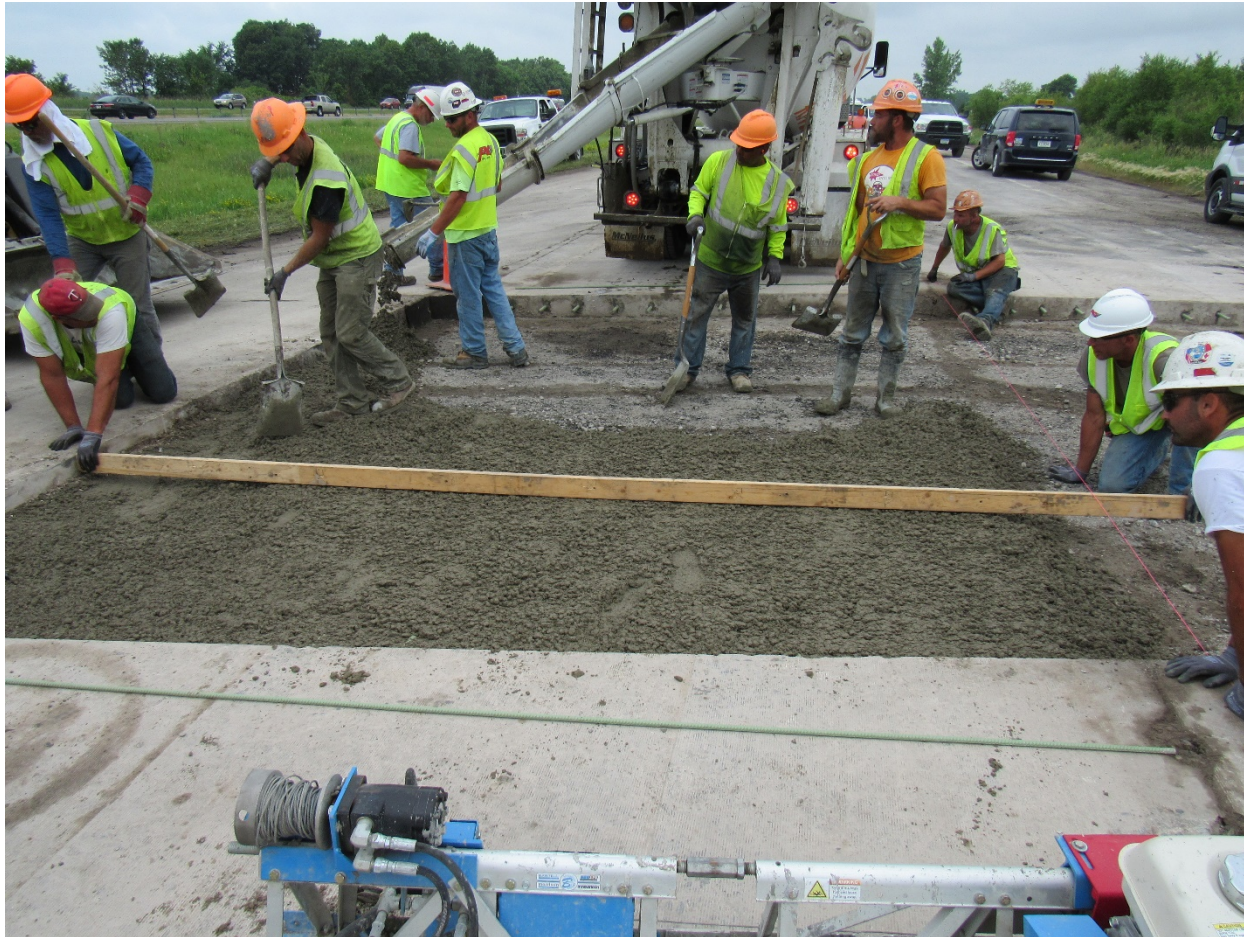
1 and 2 lift RCC (with dowel bars)

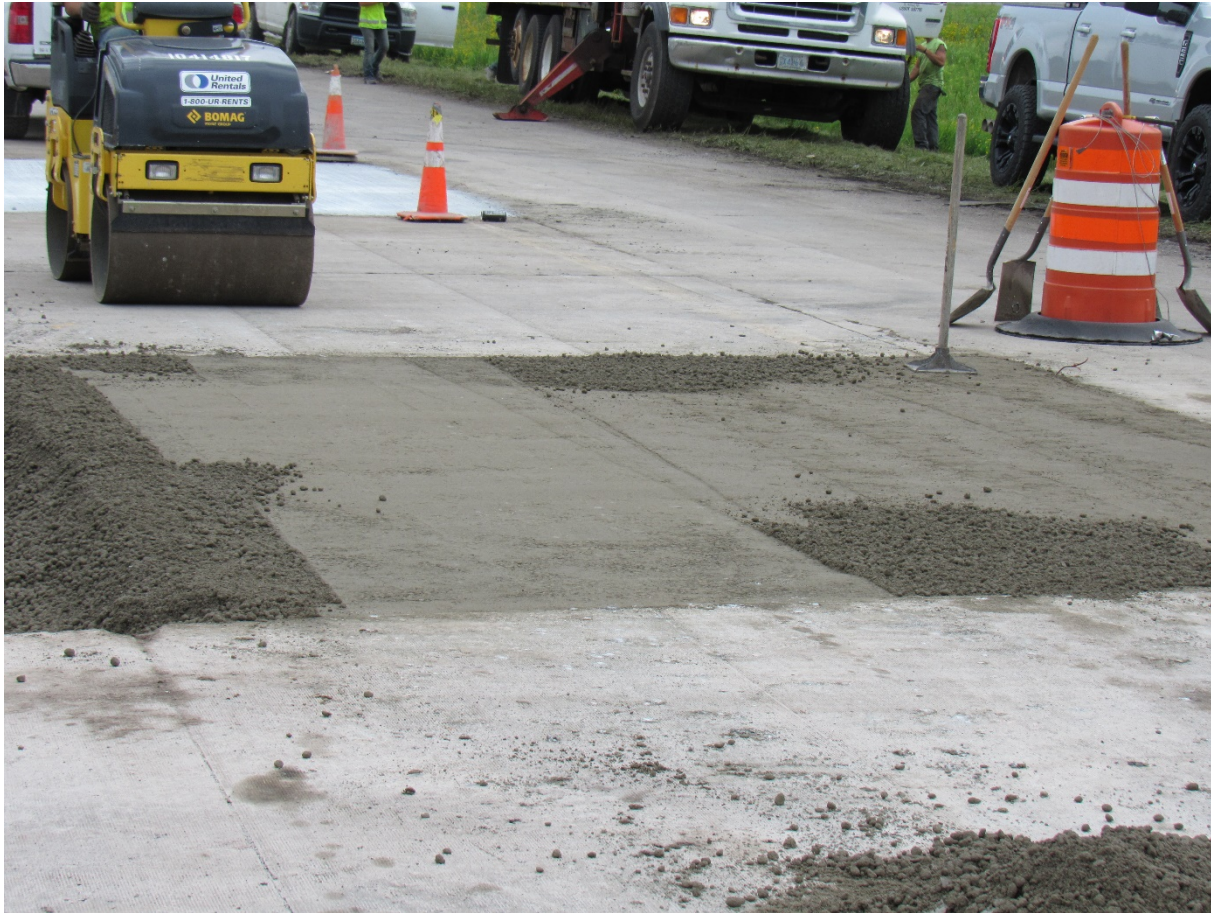
Small roller compaction

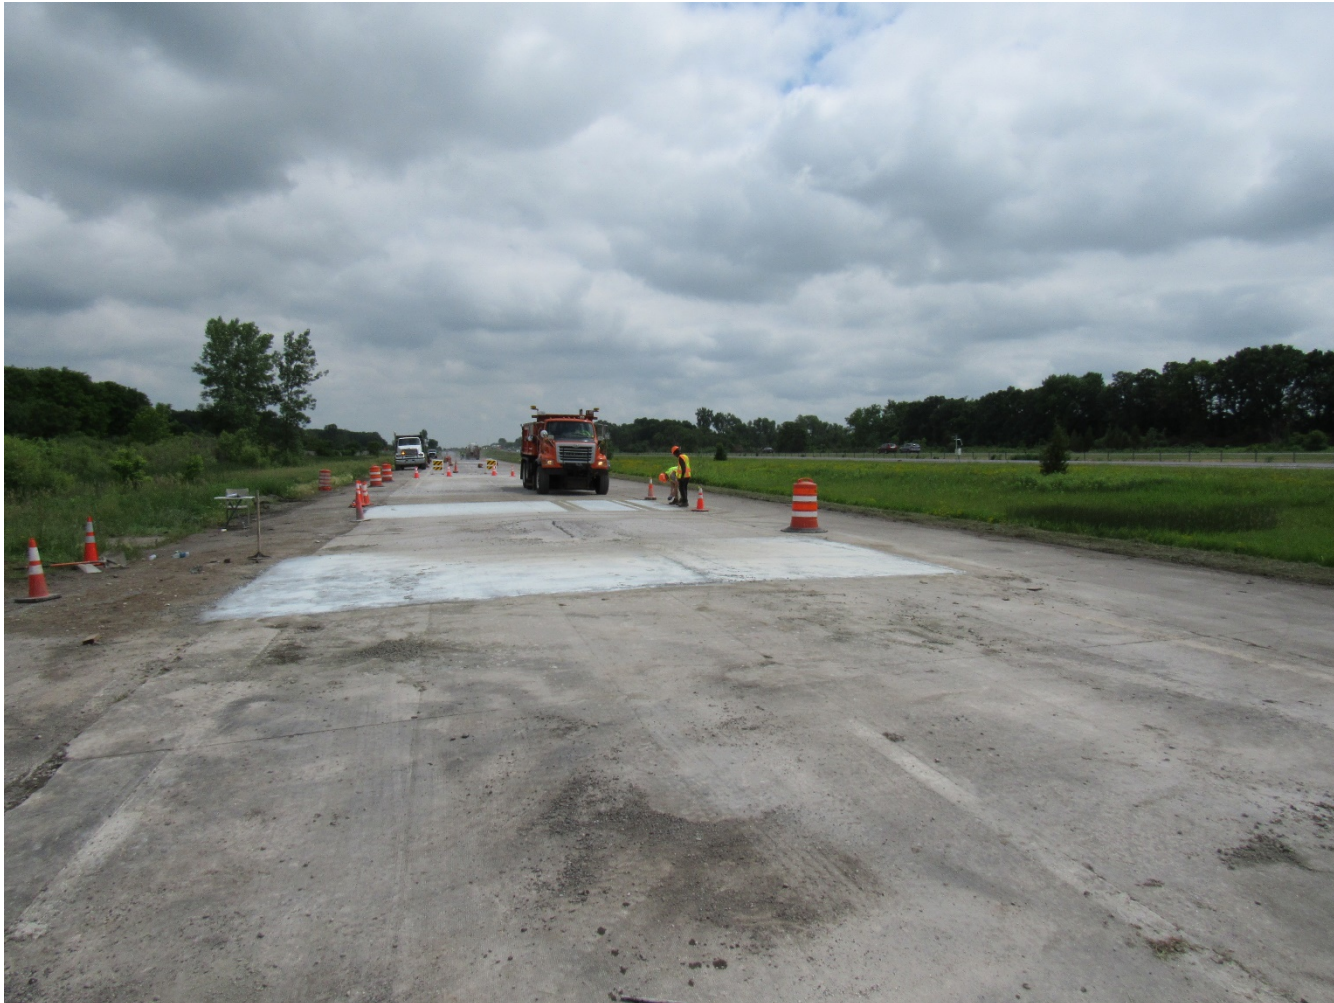
Early Age Loading

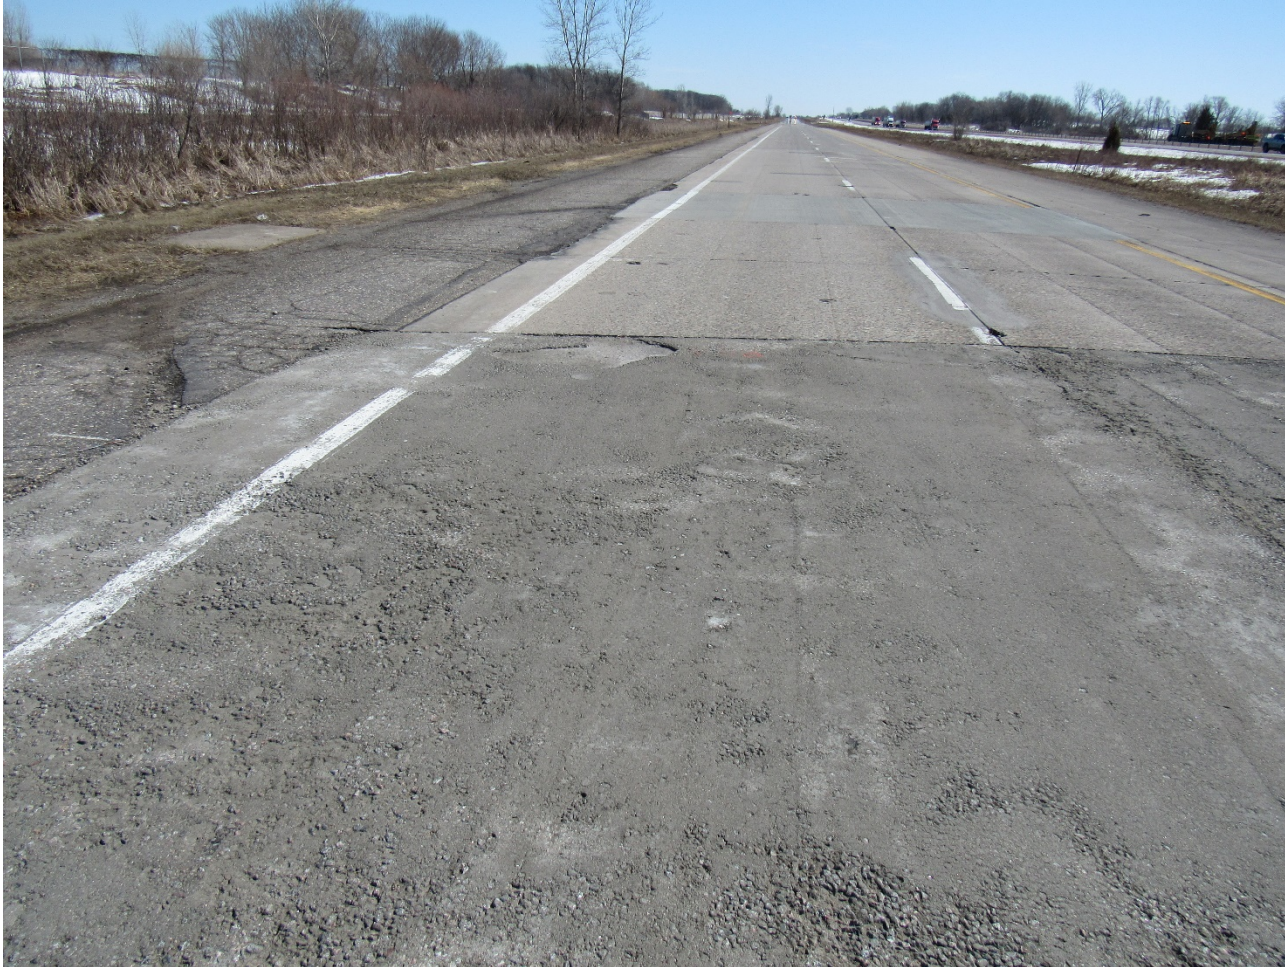
RCC repair condition - March 2019

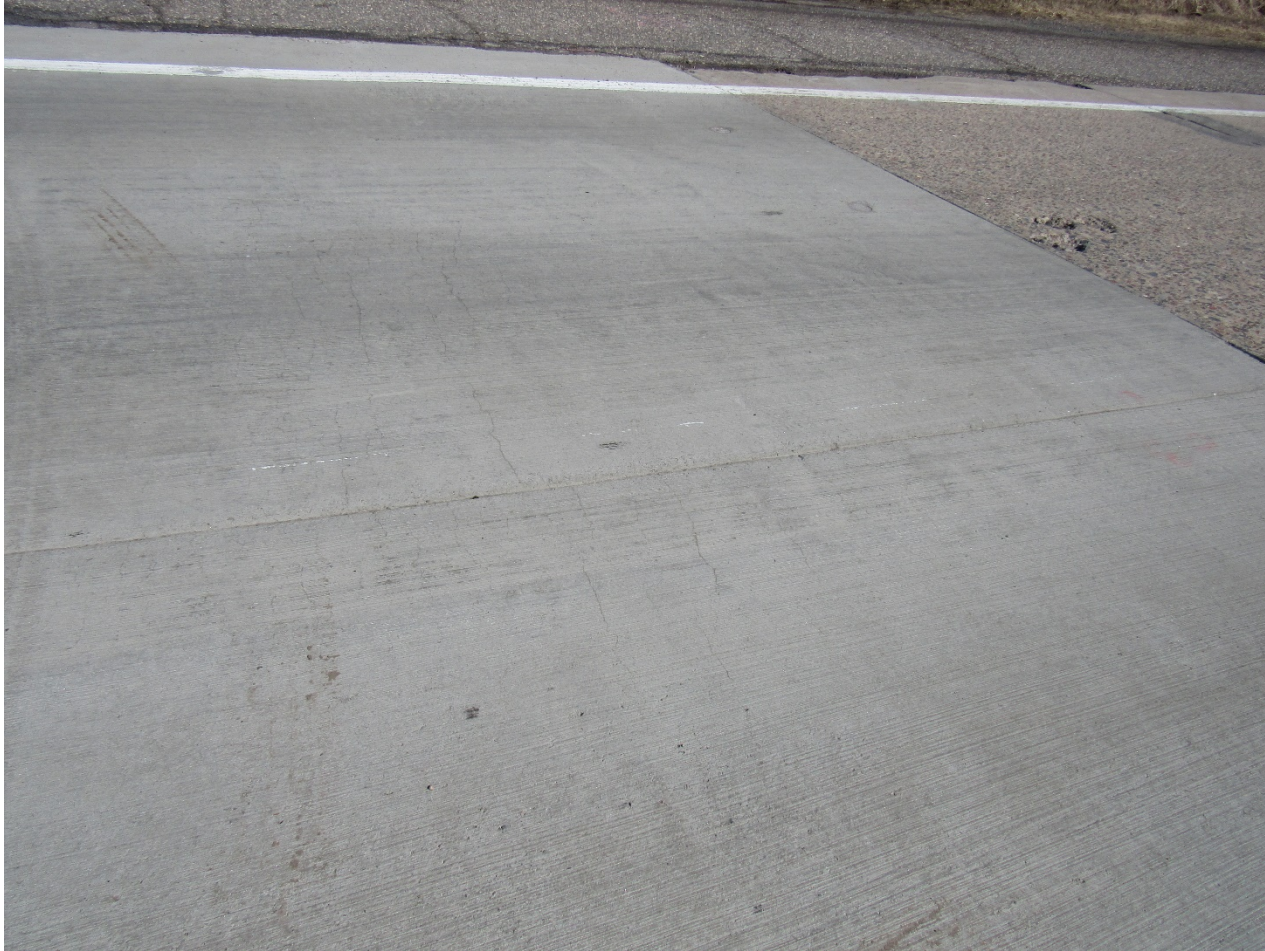
Internal cure mix repair condition - March 2019

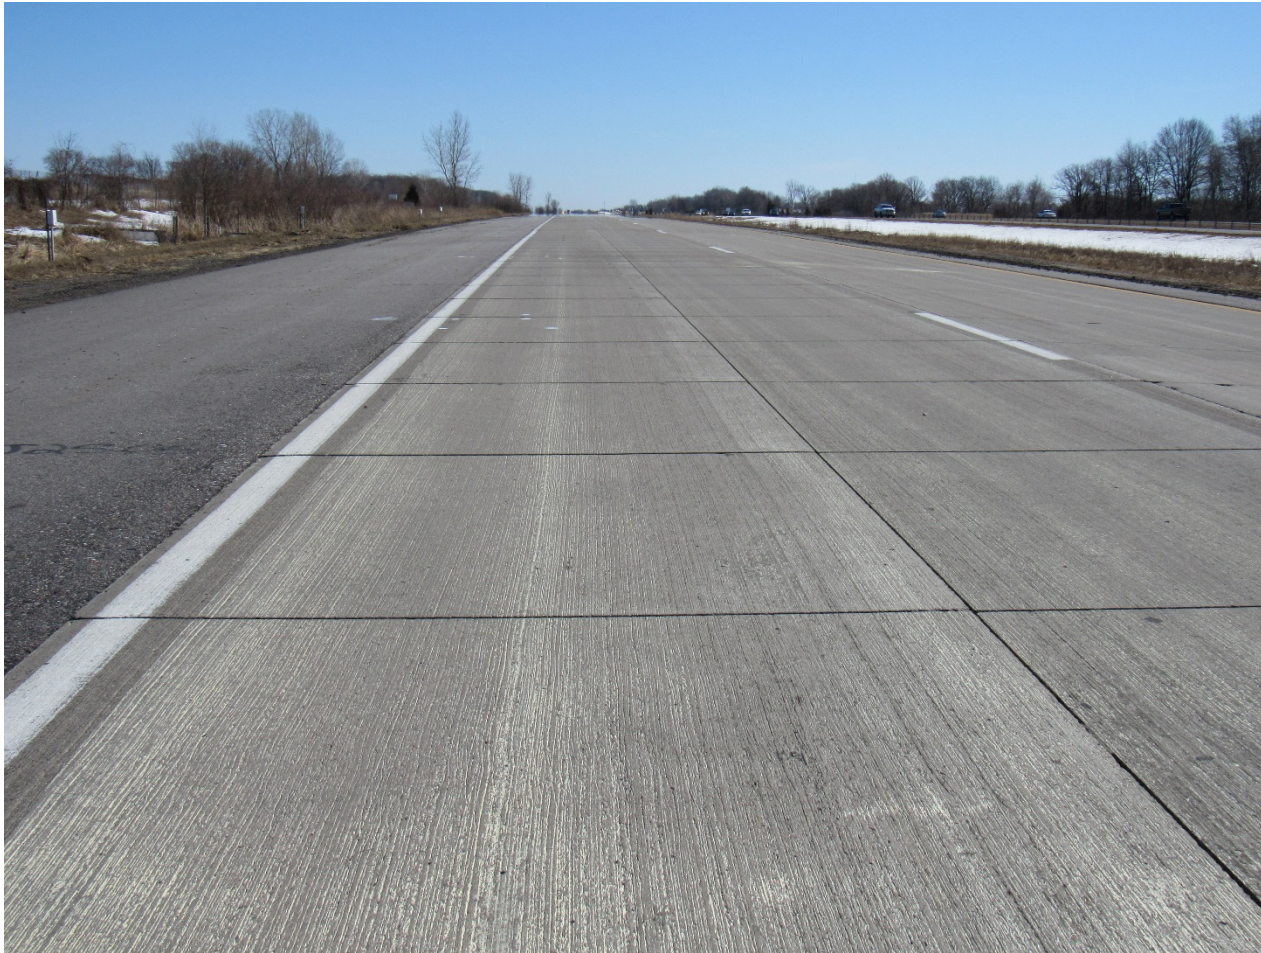
Cell 506 Control (No fibers)

March 2019 condition: Faulted joints

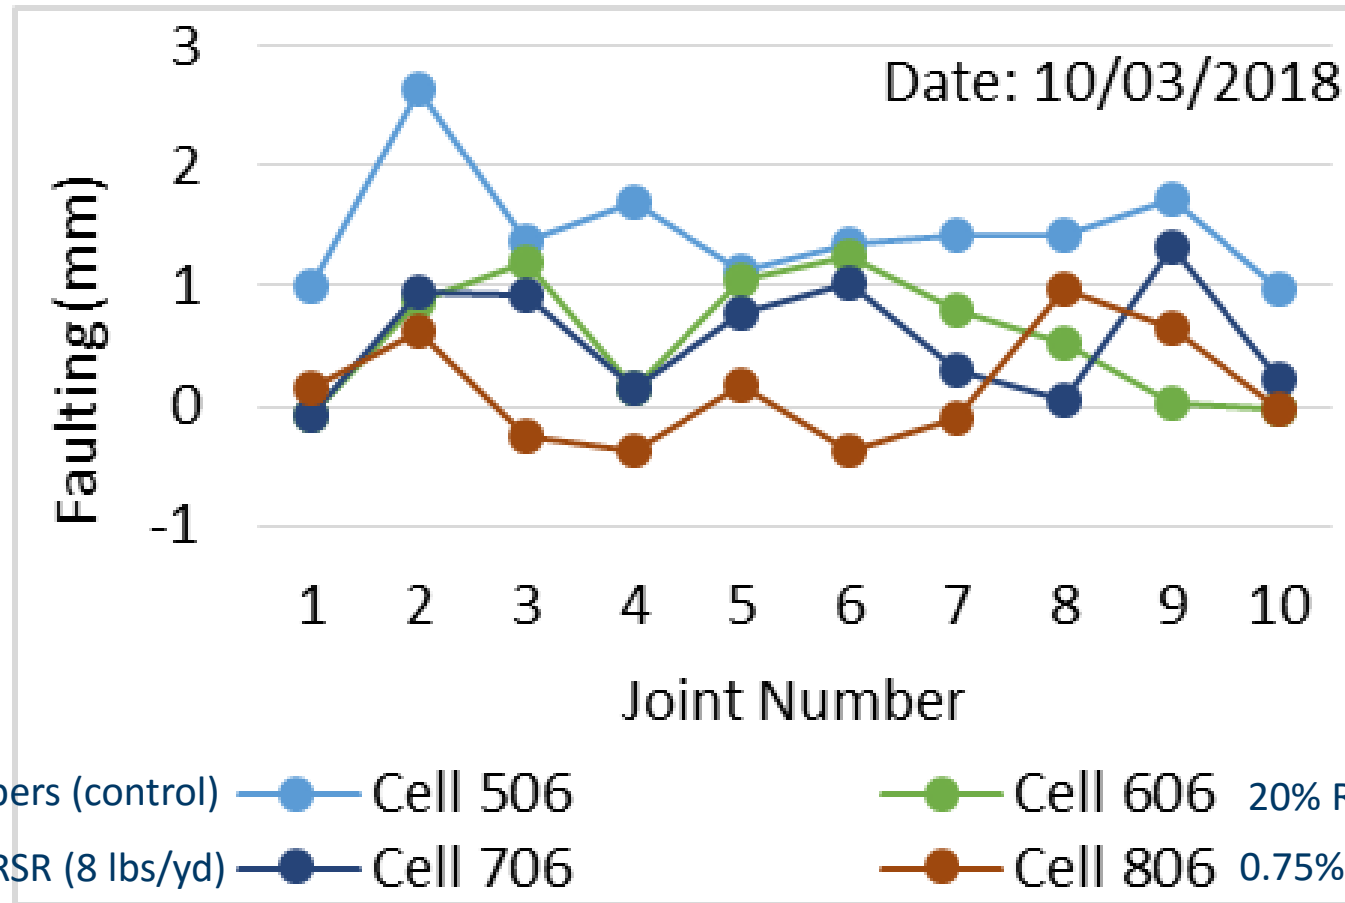
FRC Cells 506 – 806: Transverse Joint Faulting

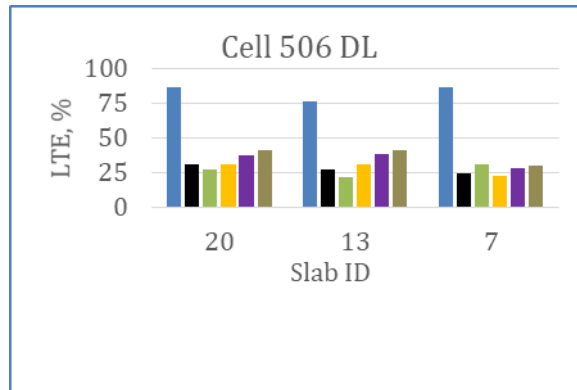
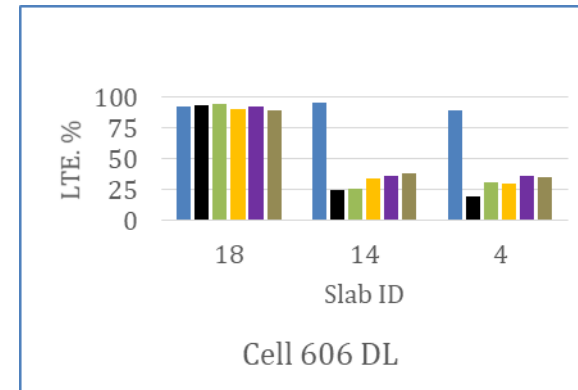
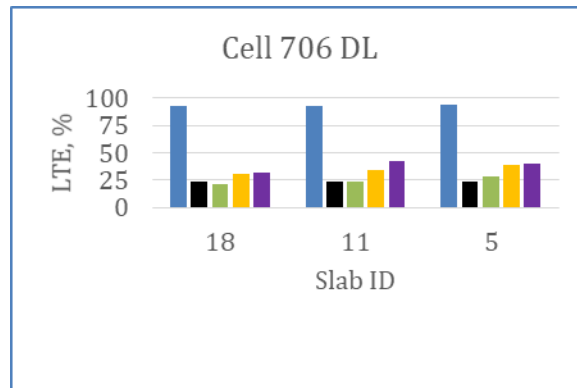
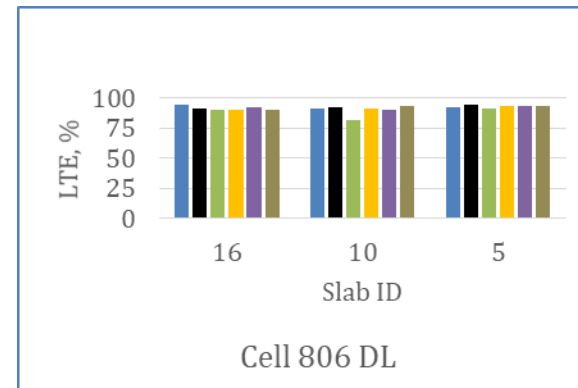
No fibers

20% RSR (5 lbs/yd)

30% RSR (8 lbs/yd)

0.75% volume (11.7 lbs/yd)

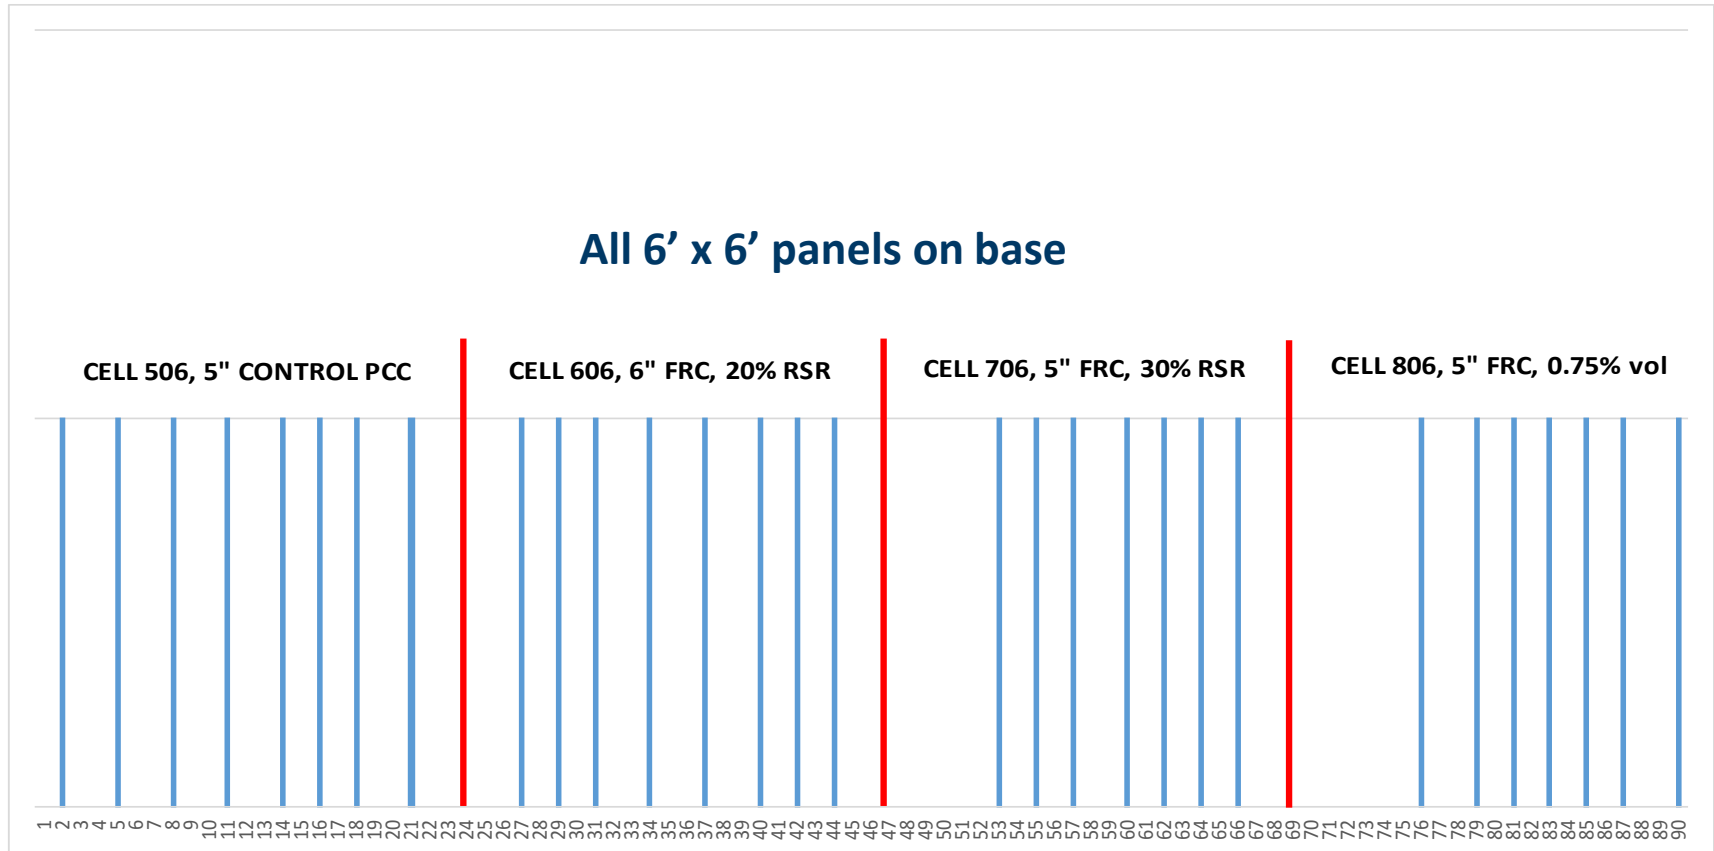
Early Transverse Joint Deployment

Observation (pavement edge) on 7-5-17, age range: 5 to 9 days, no traffic loads
