NRRA Concrete Pavement Research Update

Tom Burnham, P.E. | Senior Road Research Engineer, Minnesota Department of Transportation

Spring 2019 NCC Meeting, Denver, CO

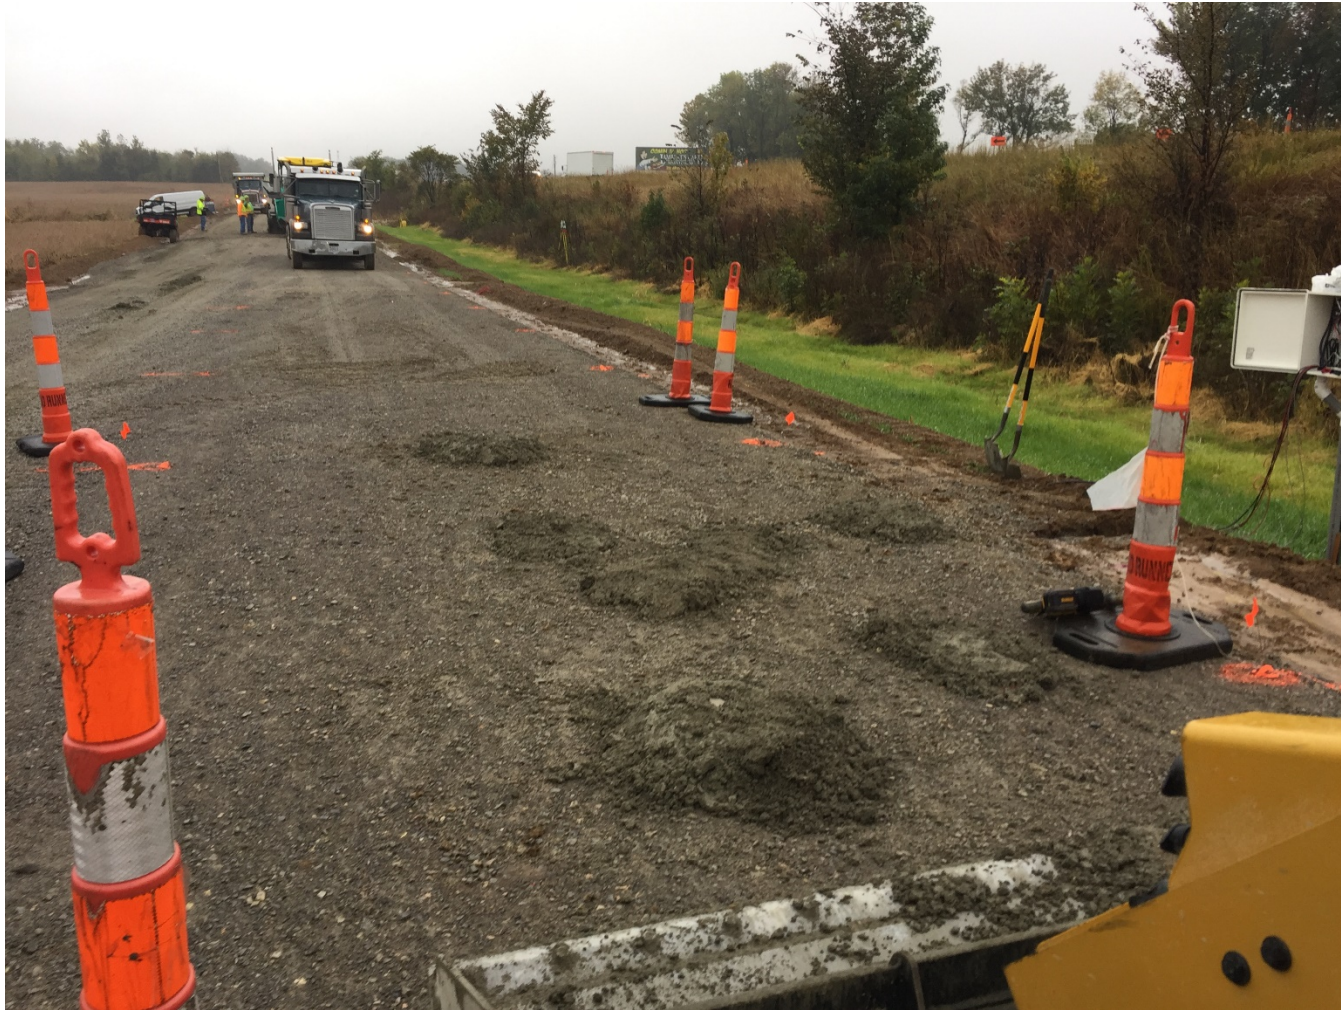
- **Cell 551: Control, 550', 15'Lx12'W panels**
- **Cell 552: Short panel, 555', 12'Lx12'W panels**
- **Cell 553: Fiber-reinforced, 280', 15'Lx12'W panels**

Broom Finish

6" RCC
4" Base
12" Lime Treated Subbase

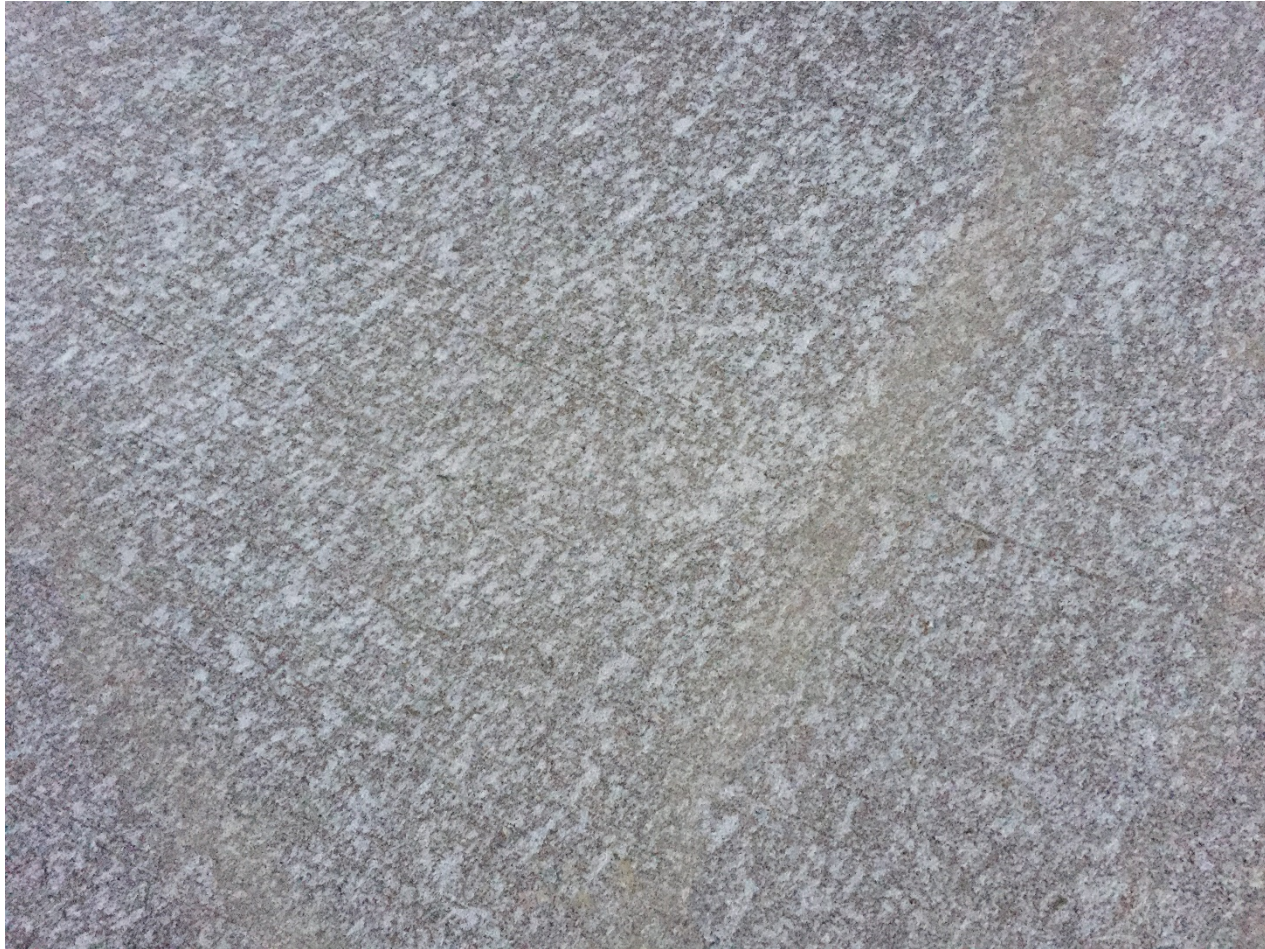
Broomed Surface
