Concrete, Geotechnical and Structural Laboratory and

**Materials and Corrosion Laboratory
Hydraulics Investigation and Laboratory**

**Technical Service Center
Denver, Colorado**

U.S. Department of the Interior
Bureau of Reclamation

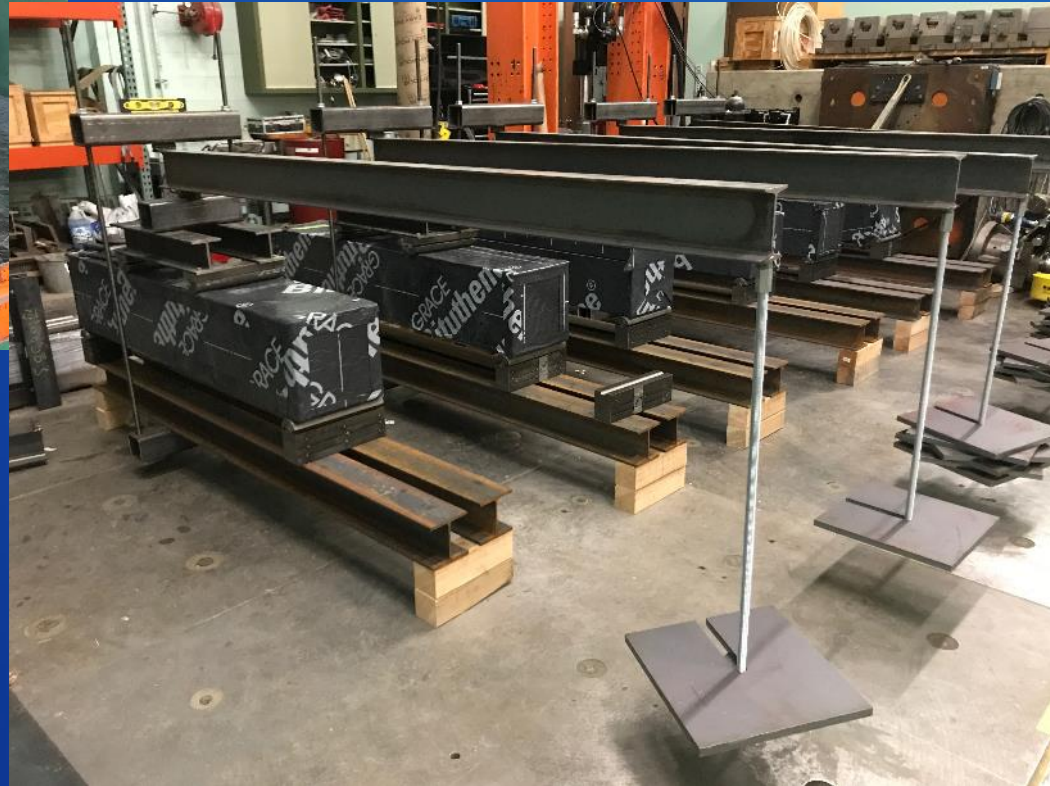
Large Diameter Concrete Core Testing for

18" ϕ Direct Tension
10" ϕ Static and Dynamic
Compression, Direct Tension,
Direct Shear
6" ϕ Static Compression,
Direct Tension, Direct Shear

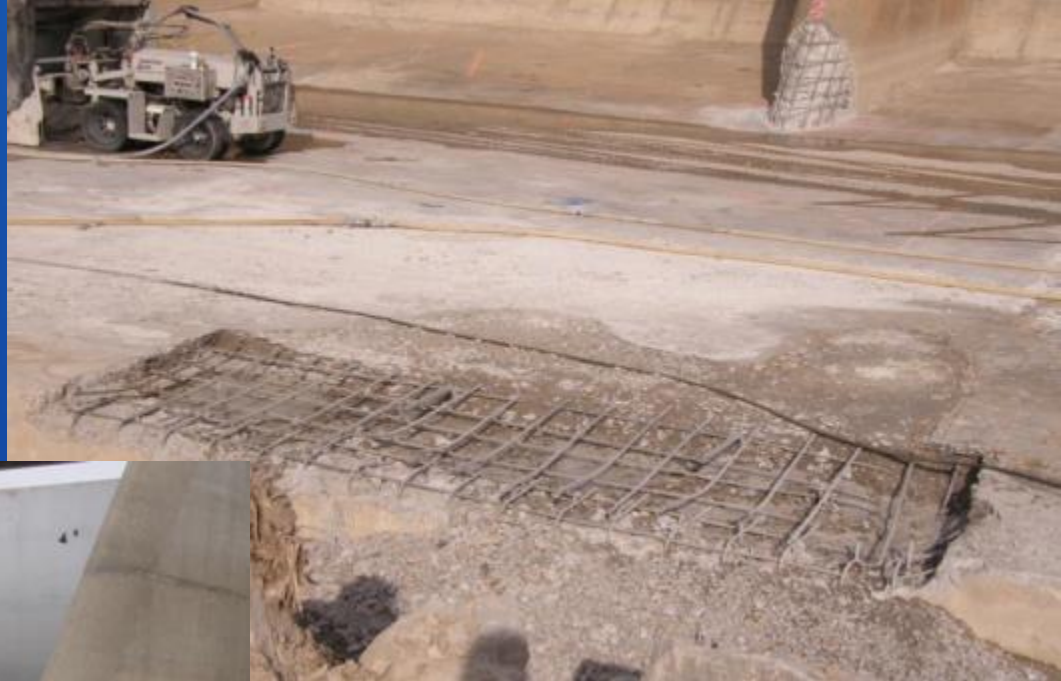
Glen Elder Dam

Hydro-demolition 20,000 psi 6" depth

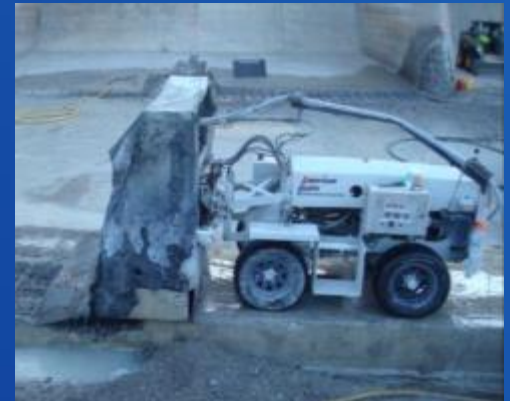
80-90% crack reduction
with new concrete additive

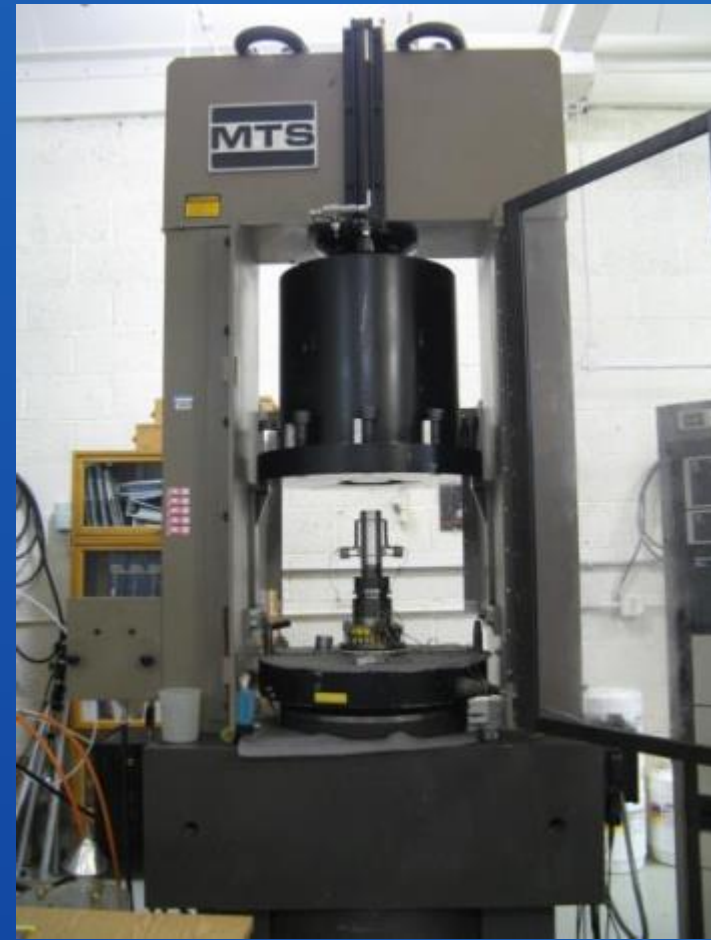
**Rock Compression Testing
(Triaxial and Unconfined with
elevated temperatures and pore
pressure measurements)**

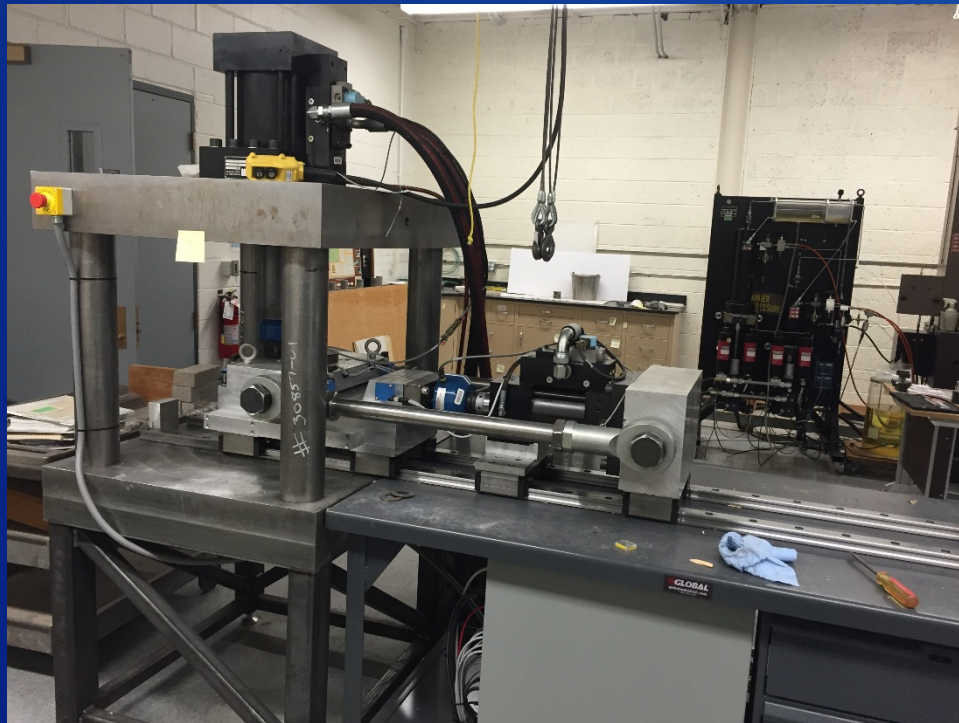
Direct Shear Machine (7" and 12" diameter specimens)

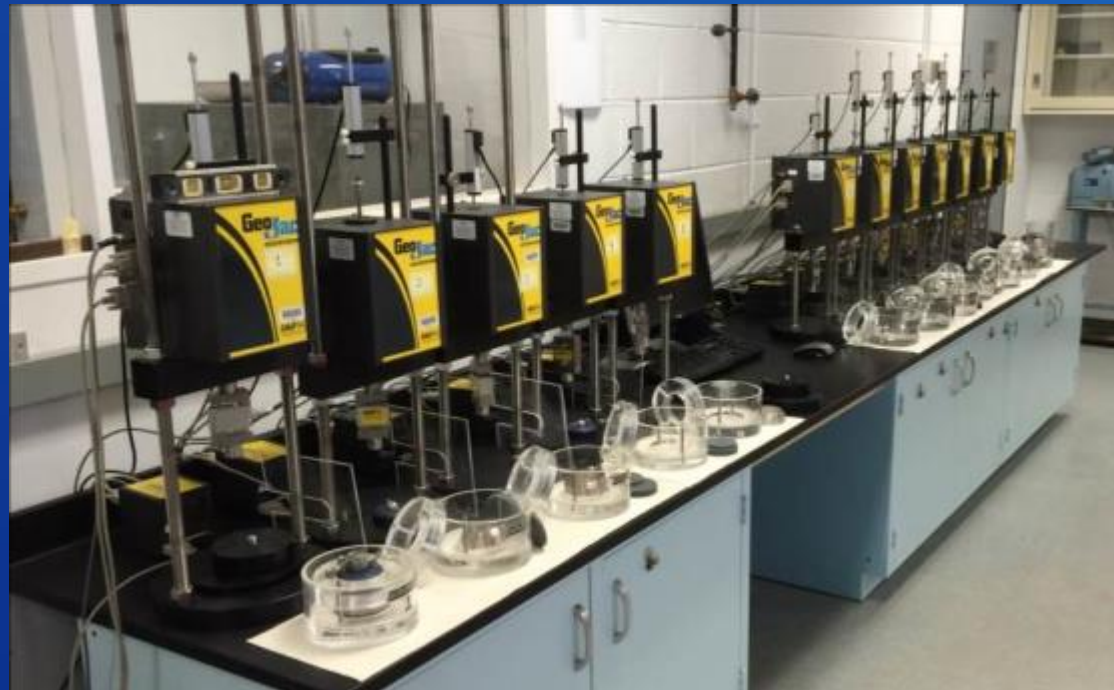
Internal Erosion Permeameter

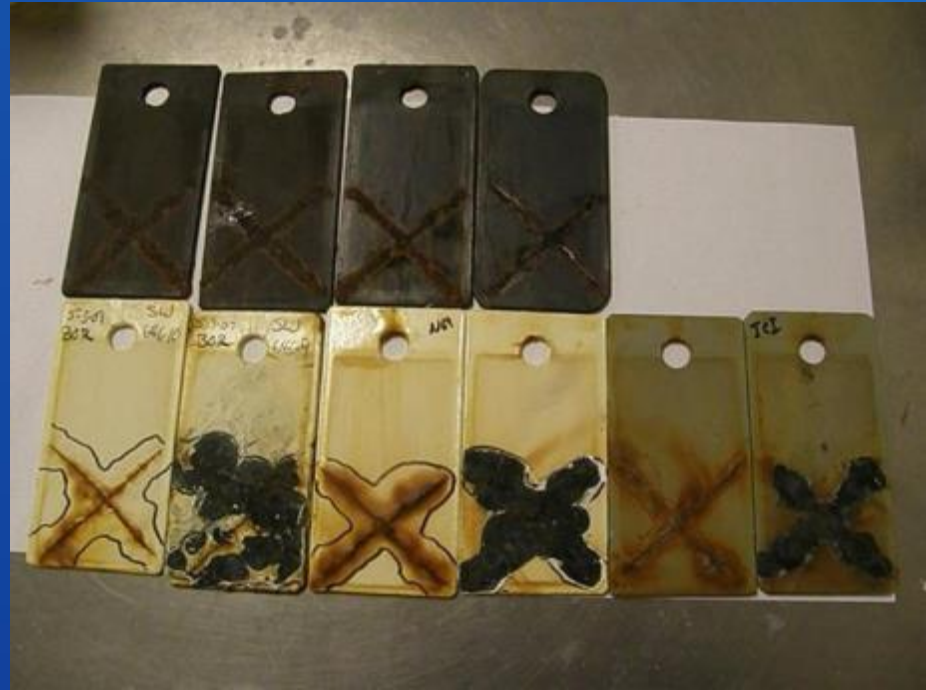
Undercutting Test

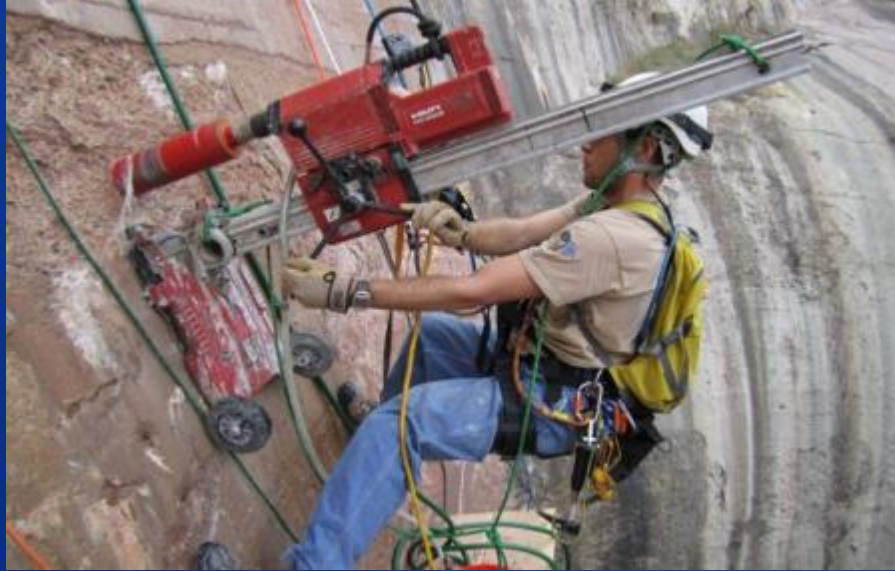
Core drilling – Guernsey Dam Spillway

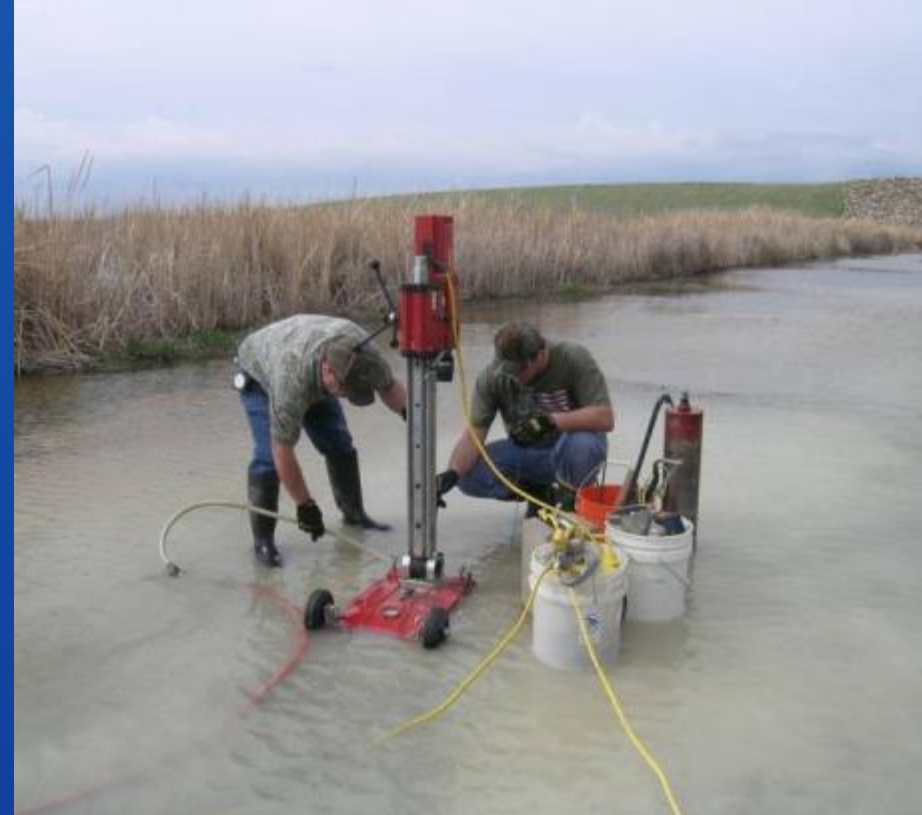
Core drilling – Glen Elder Dam Approach

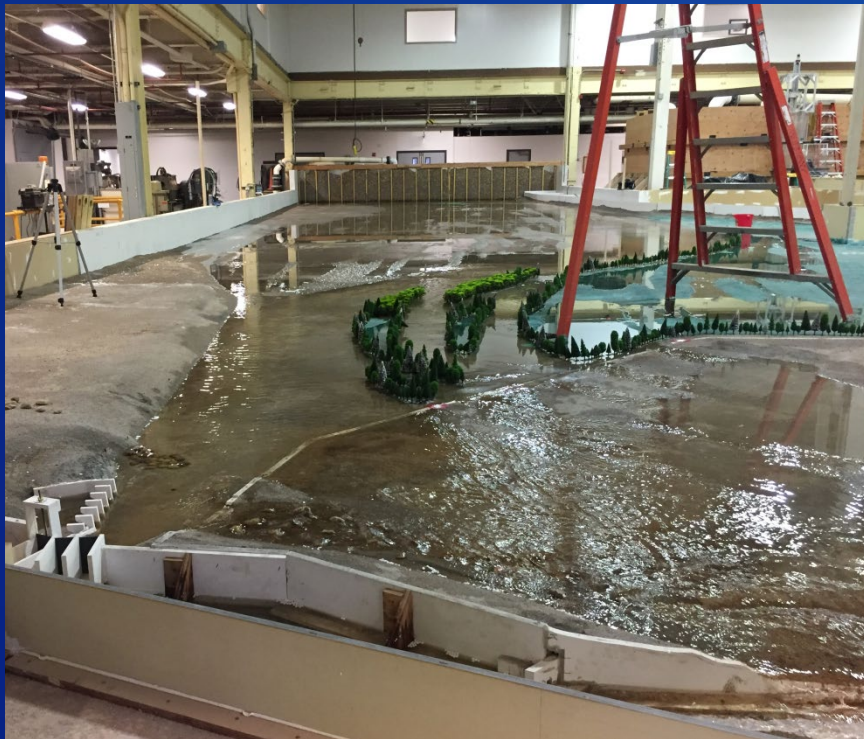
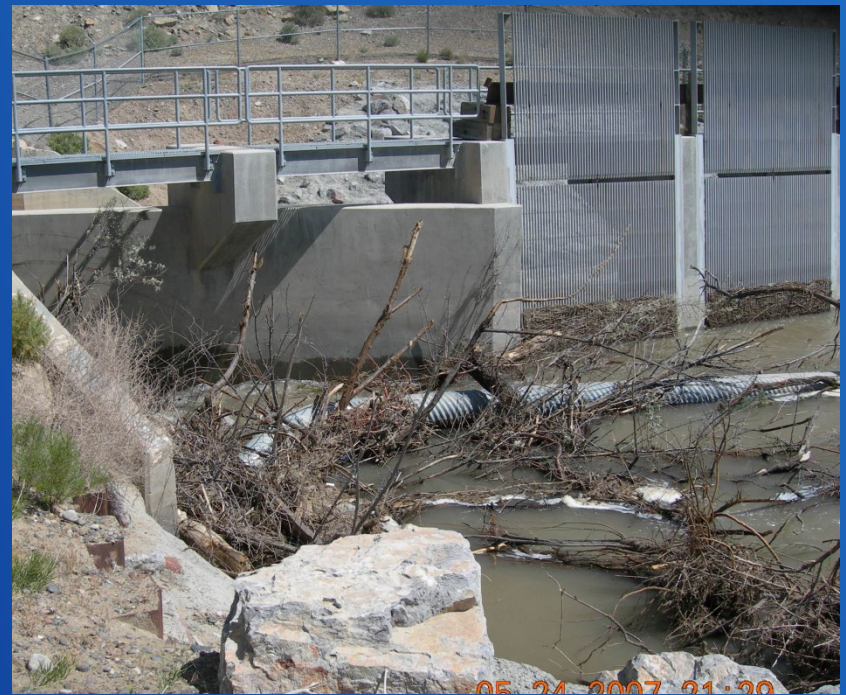
Hogback

- **1:60 Froude scale model**
 - Investigation of large debris pieces in the San Juan River

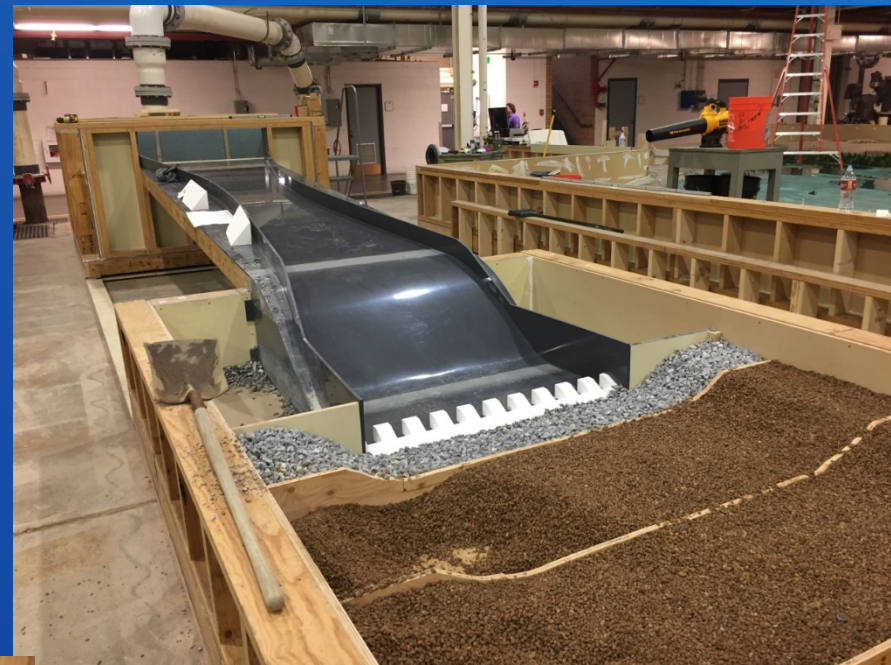
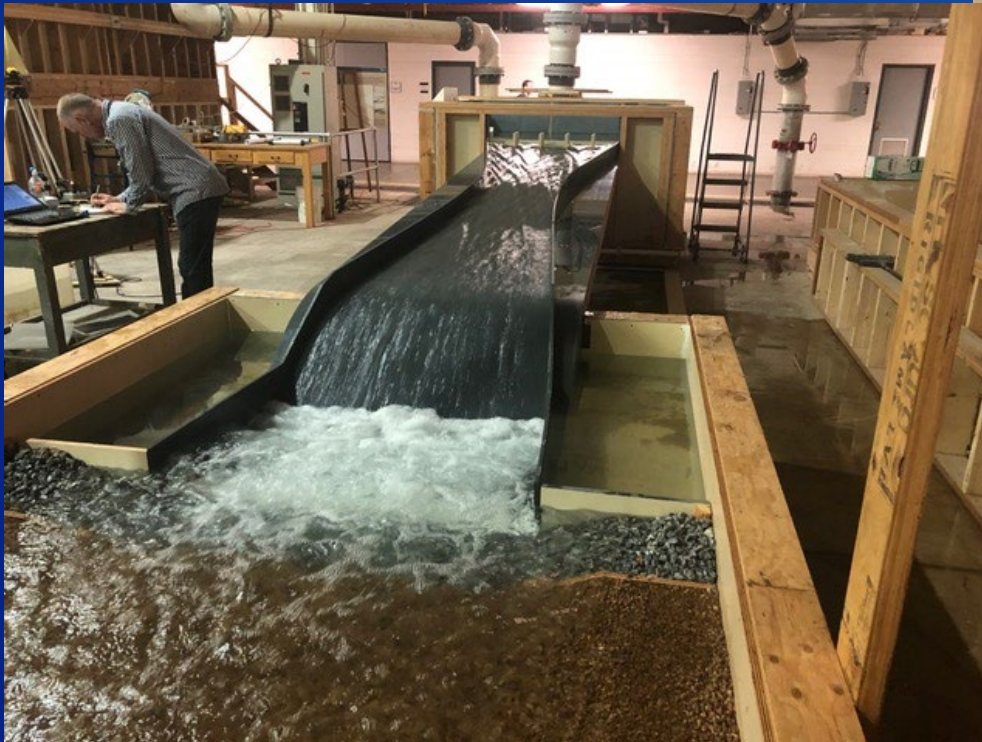
Cle Elum

- 1:50 Froude scale model
 - Investigation of erosion potential in tailwater area

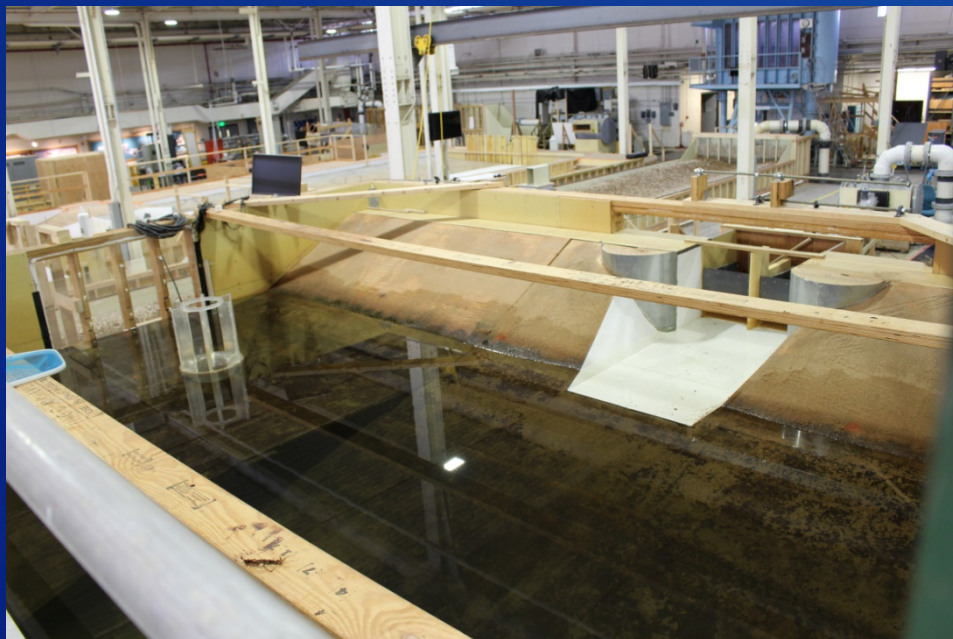
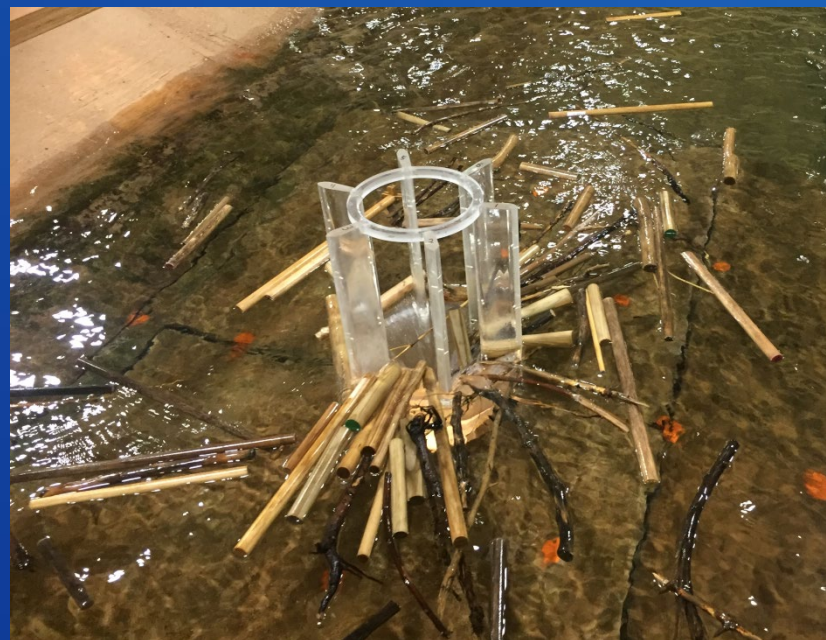
Dam Safety Reservoir Debris Model

- 1:18 Froude scale model of a radial gated ogee crest spillway and a morning glory spillway
 - Research to determine potential impacts to reservoir WSE and discharge capacity

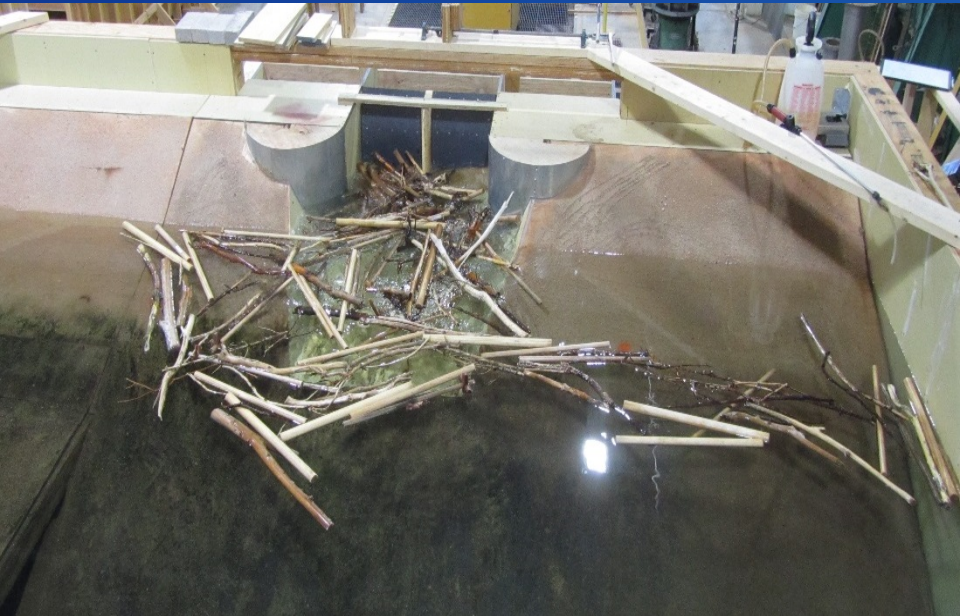
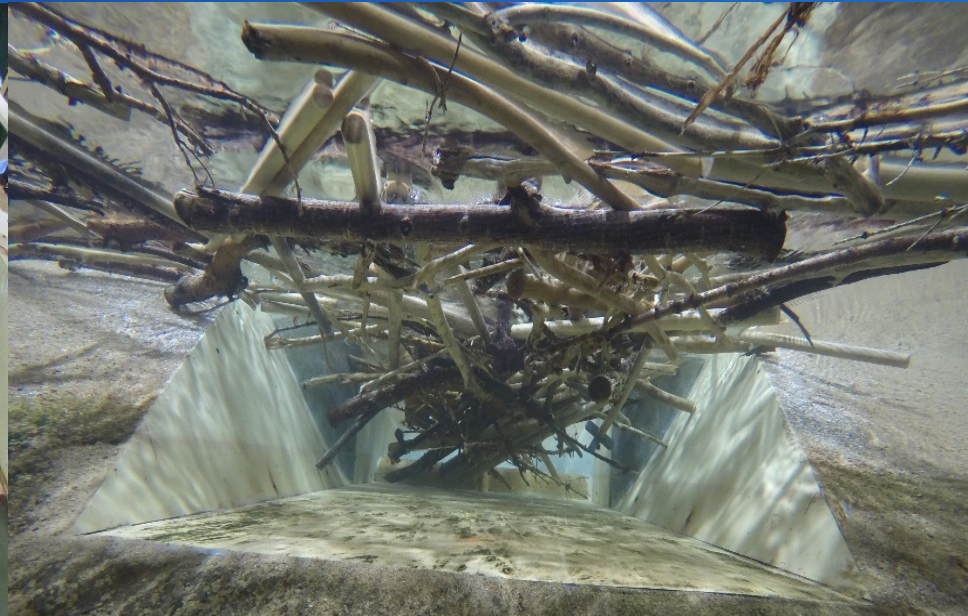
Final natural jam ($\Delta WSE = 2.5$ feet, $\Delta Q = -12.1\%$)

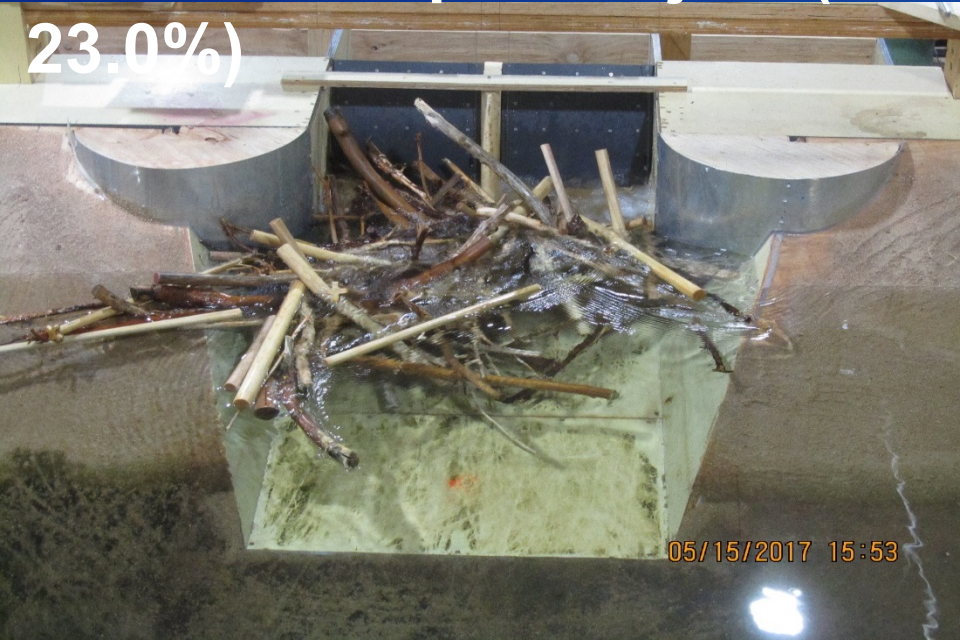
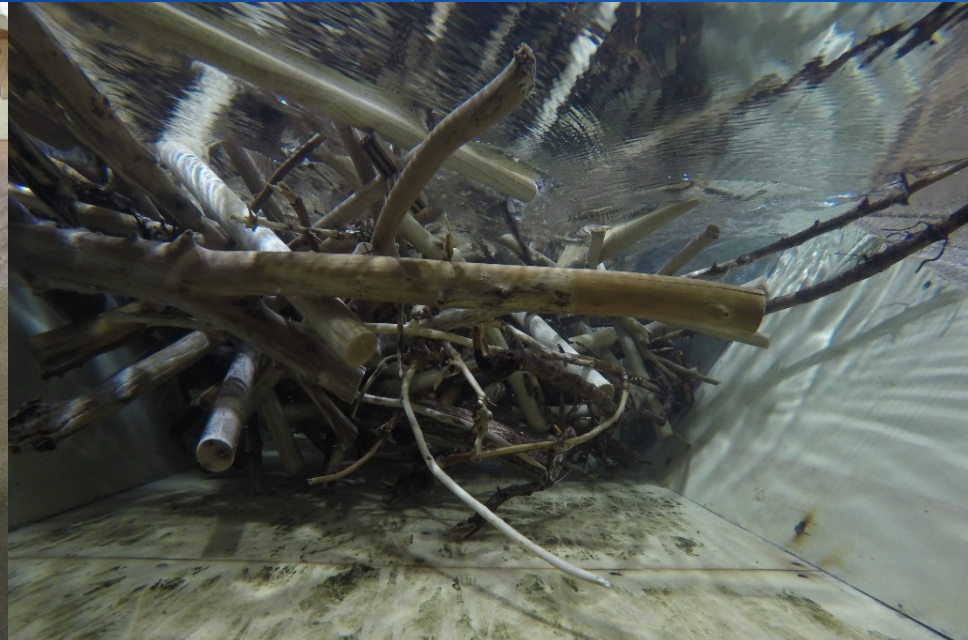
Manual compacted jam ($\Delta WSE = 5.3$ feet, $\Delta Q = -23.0\%$)

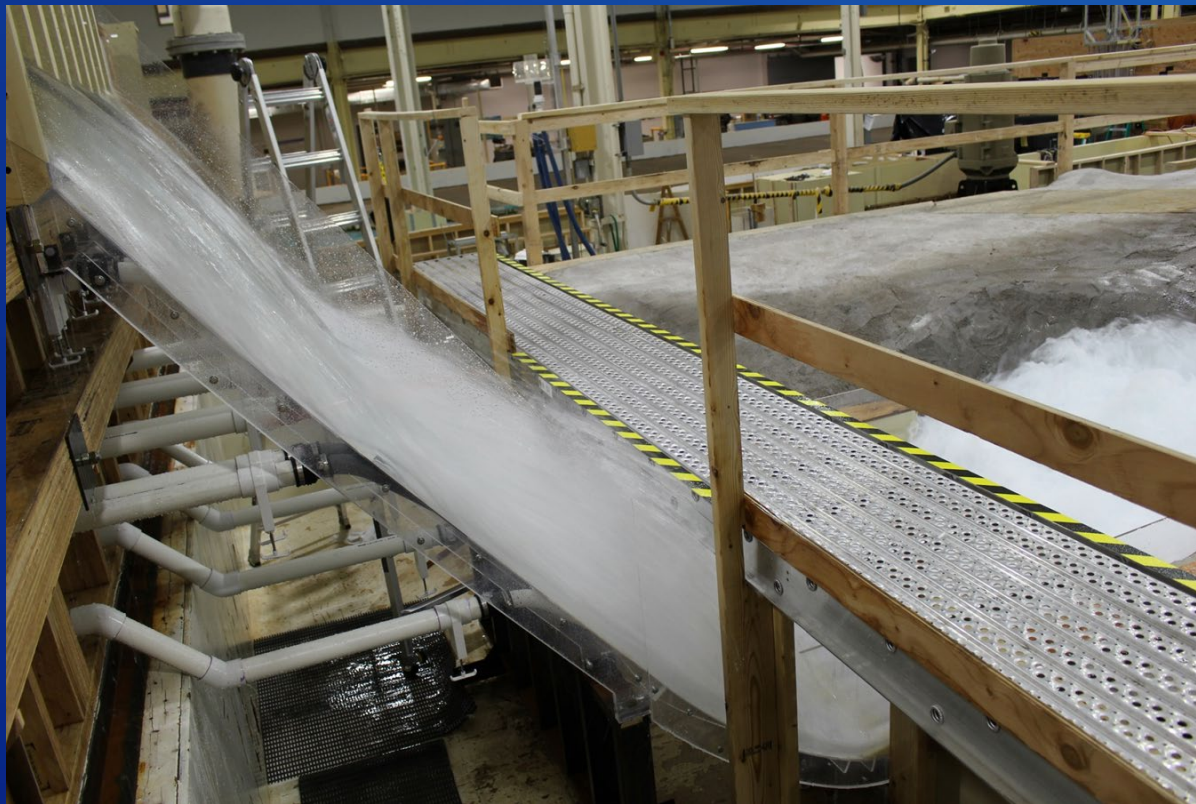
- 1:50 Froude Scale model to investigate design of potential Shasta Dam 18.5 foot raise
