Laser Road Surface Sensor Camera  
Evaluation Project–Aurora Project  
2004-02

# Laser Road Surface Sensor Camera Evaluation

project summary

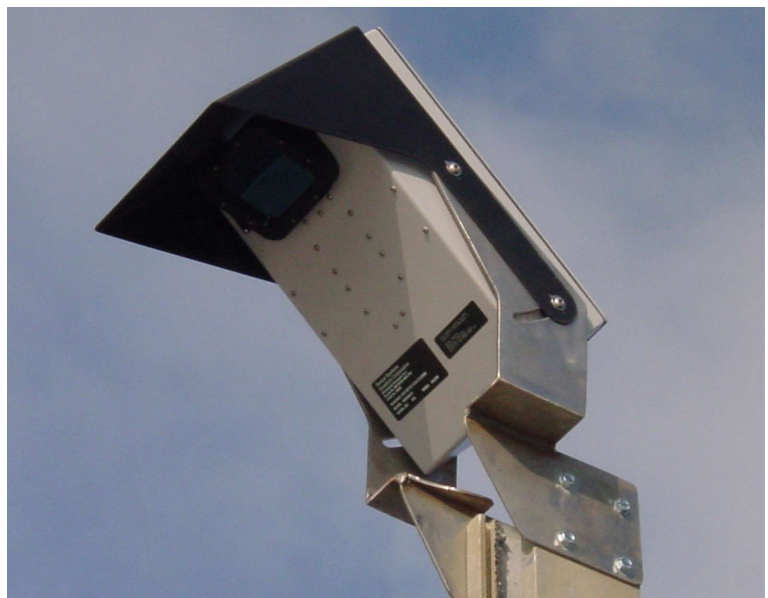
*LRSS sensor module and mounting bracket*

The LRSS was installed in two different locations during the test period. It was first installed on a rural concrete bridge crossing US Highway 30 during February and March 2004. The LRSS was mounted on a steel pole erected by the Iowa Department of Transportation (IaDOT). This pole was affixed to the bridge deck side rail. The camera was installed at the top of the pole to a slotted bracket that allowed adjustment of the sensor module. The electronics module was attached to the side of the pole. The camera was positioned to view an area in the middle of the bridge.
